Petrinja, Croatia December 29, 2020, Mw 6.4 Earthquake Joint Reconnaissance Report (JRR)

PETRINJA, CROATIA DECEMBER 29, 2020, M_w 6.4 EARTHQUAKE

JOINT RECONNAISSANCE REPORT (JRR)

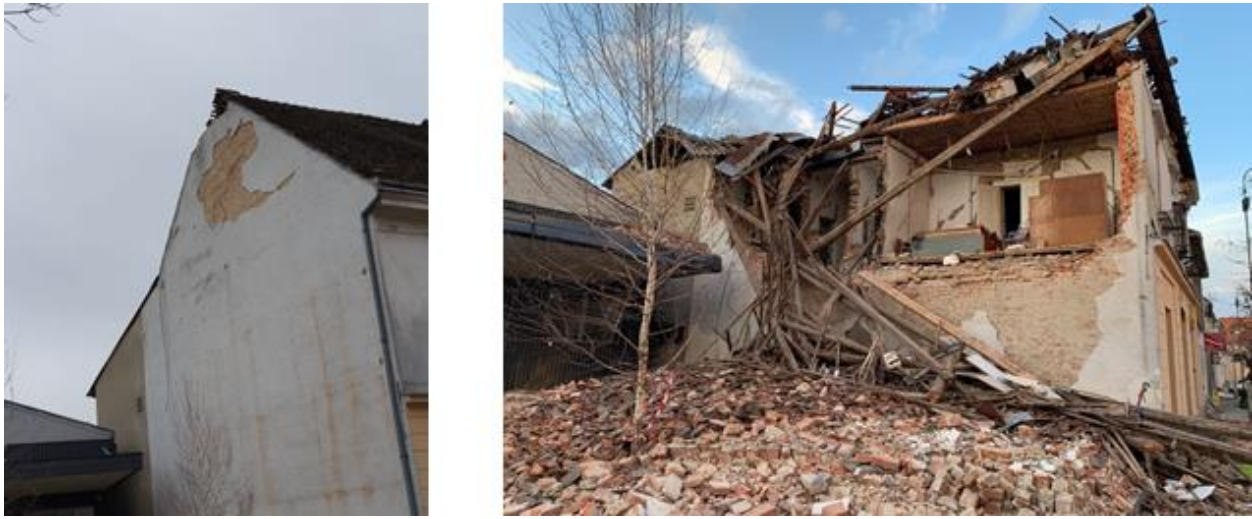
Figure 4.3. Typical wall and floor construction in older URM buildings, characterized by thick clay brick masonry walls, timber floors, and roofs. This building in Petrinja (adjacent to the KTC supermarket) was not significantly damaged in the December 28 M_w 5.2 earthquake but experienced gable wall and roof collapse in the December 29 M_w 6.4 earthquake (source: Joško Krolo).

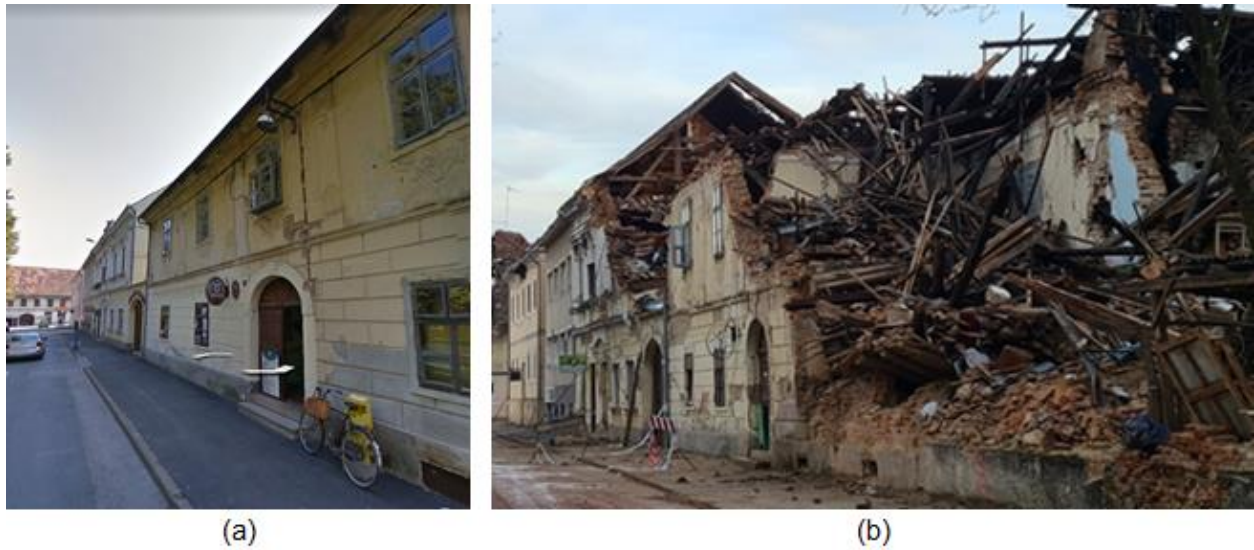
Figure 4.6. Collapsed URM buildings in downtown Petrinja (a) before the earthquake (source: Google Earth) and (b) after the earthquake (source: Nenad Bijelić).

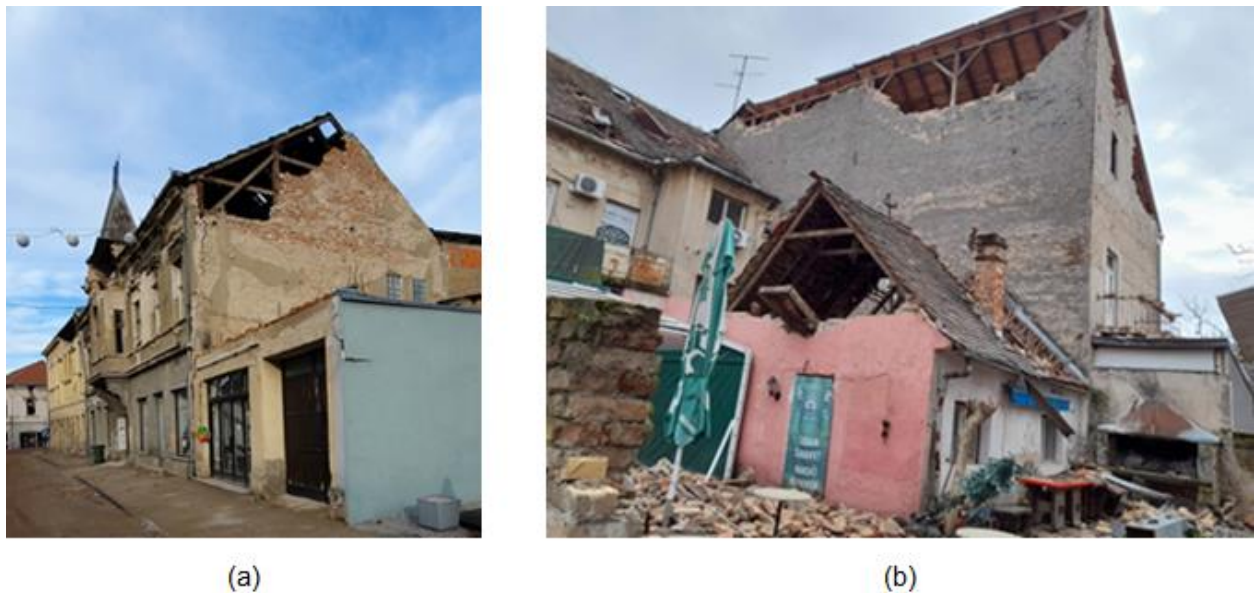
Figure 4.7. Out-of-plane failure of walls at the upper portion of buildings with wooden floors and roofs due to flexible diaphragm and the absence of adequate wall-to-floor connections: (a) older 2-story URM building in downtown Petrinja (source: Nenad Bijelić) and (b) rear wall of a 2-story building in Sisak (source: Kristijan Freiberger).

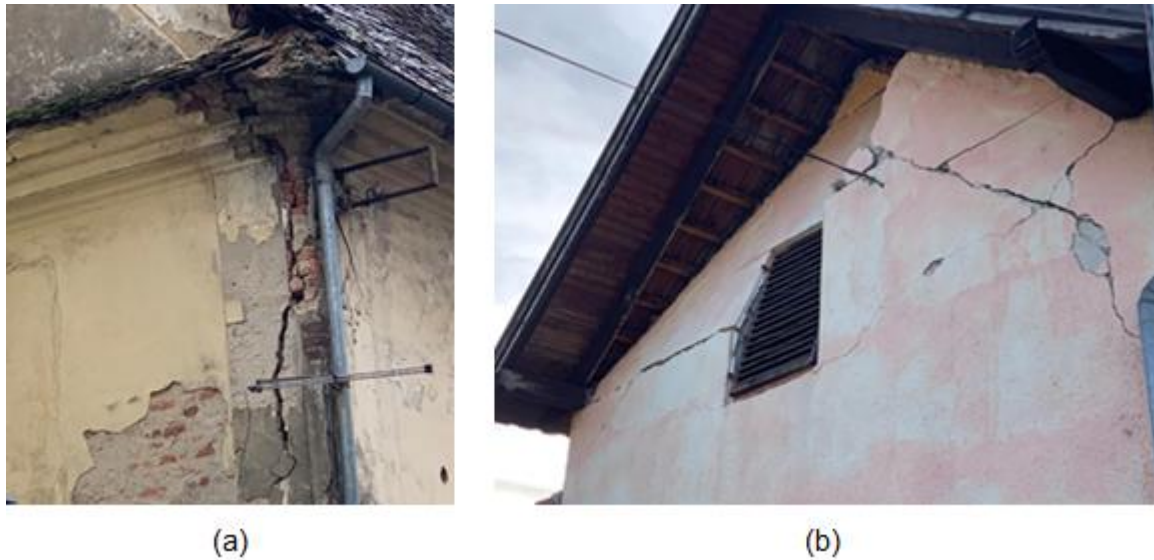
Figure 4.8. Out-of-plane damage of masonry walls: (a) vertical cracks (source: Damir Lazarević) and (b) cracking and onset of failure in gable walls (source: Nenad Bijelić).

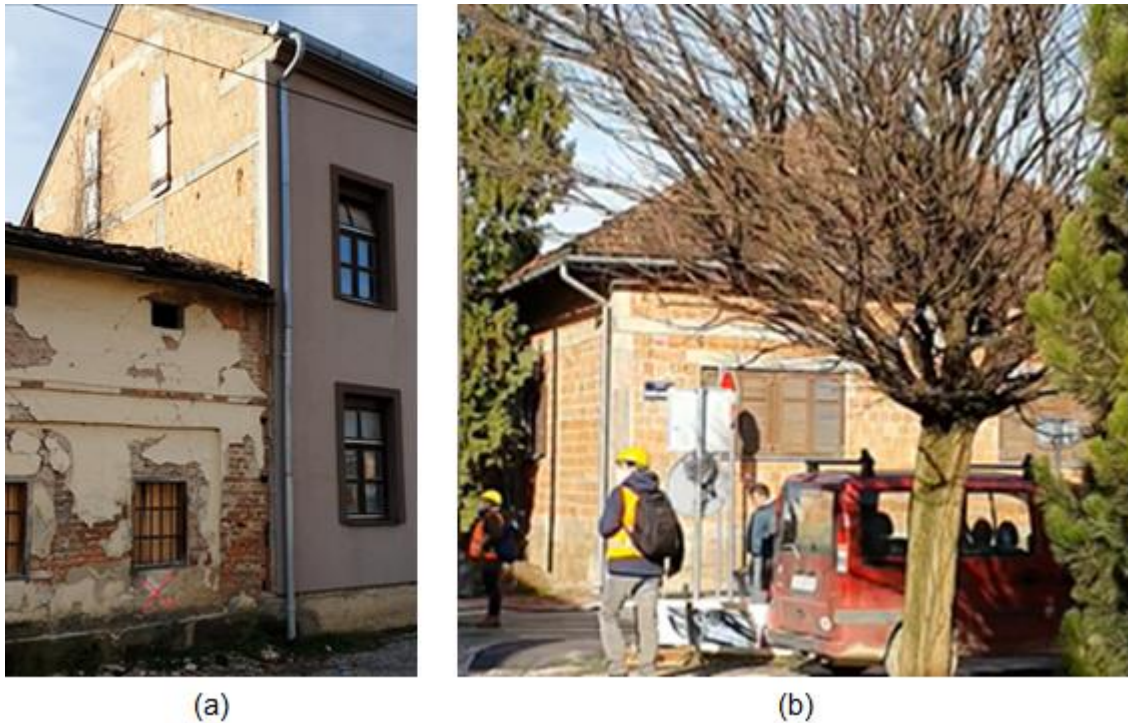
Figure 4.10. Examples of good performance of confined masonry buildings in Petrinja: (a) a two-story confined masonry building remained undamaged while an adjacent older URM building experienced severe damage; and (b) an undamaged single-story confined masonry building (source: Marko Bartolac).

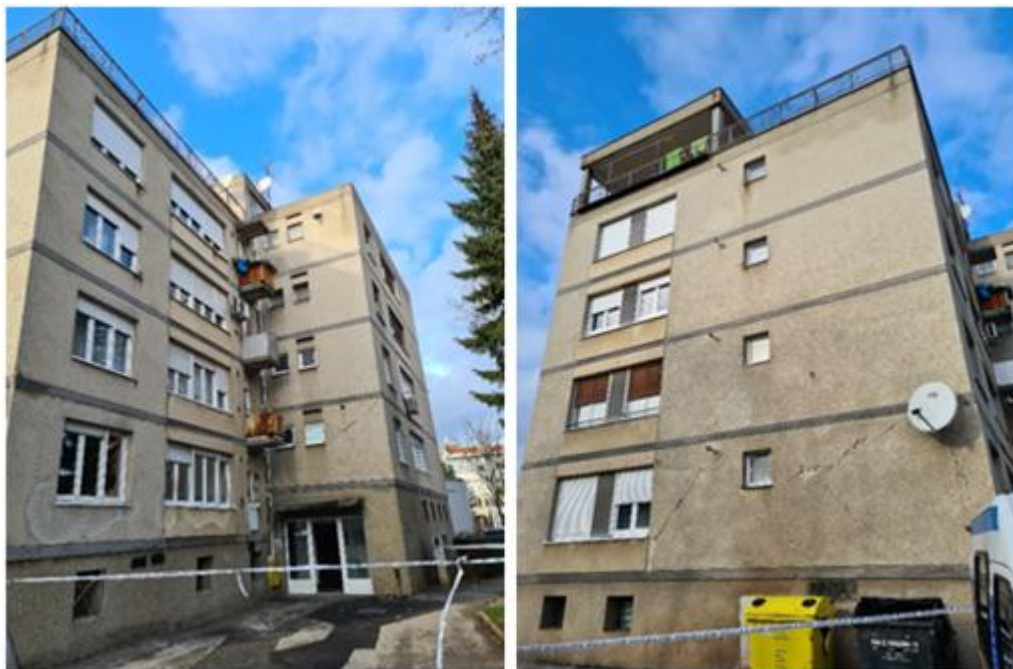
Figure 4.19. Damaged Building 3: exterior view and cracking pattern at the ground floor level (source: Nenad Bijelić).

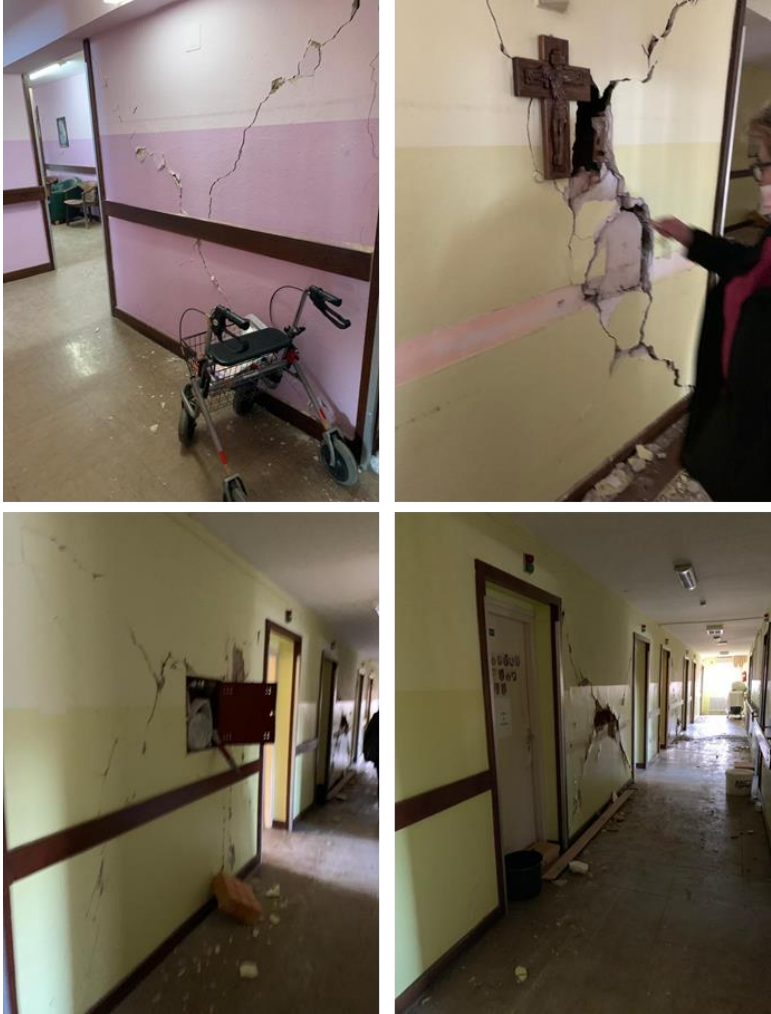
Figure 4.32. Damage to partition wall in the retirement home in Petrinja (source: Damir Lazarević).

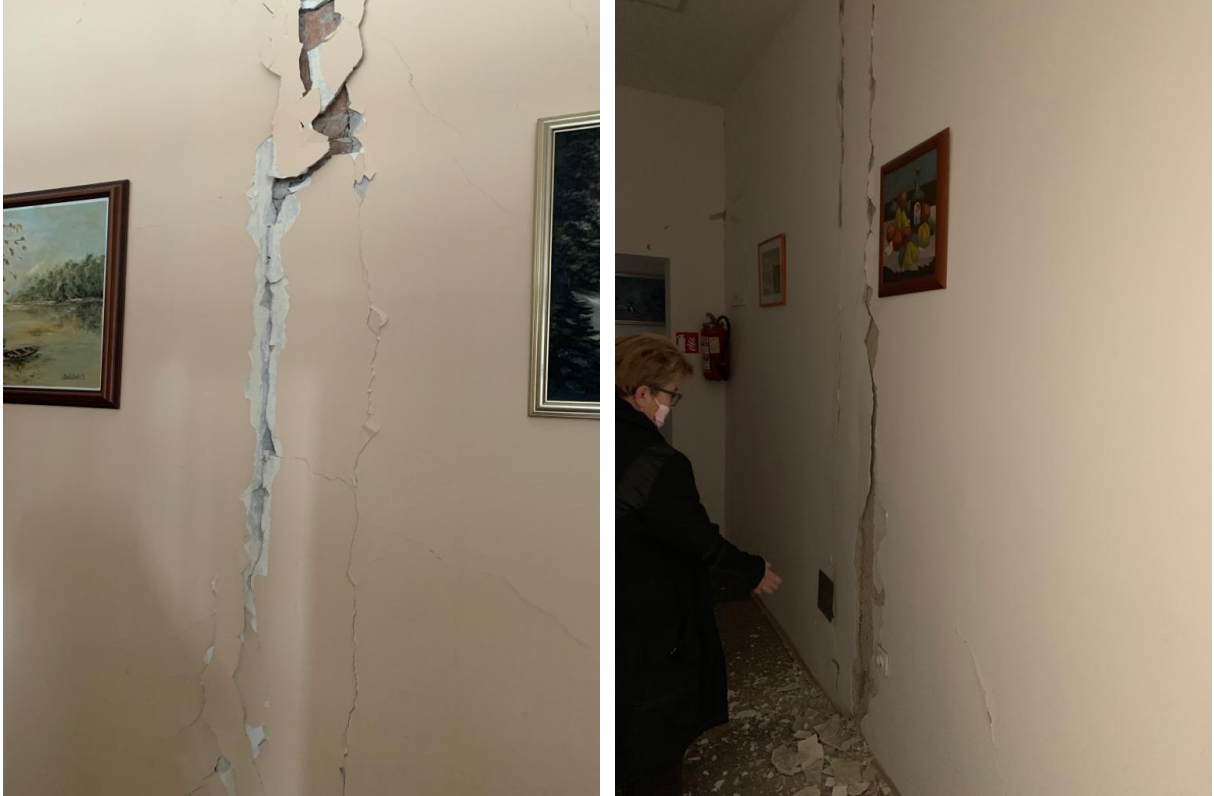
Figure 4.33. Cracks along the interface between a masonry infill and an RC column (source: Damir Lazarević).

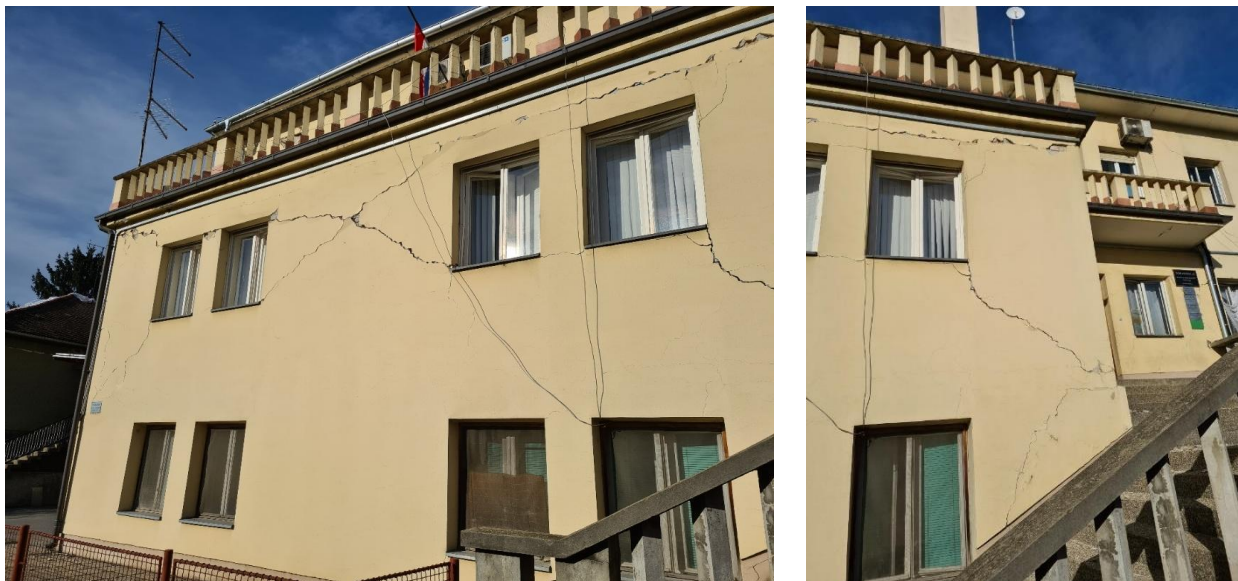
Figure 4.38. Photos showing the exterior of the health center in Petrinja with large shear cracks in the exterior walls (source: Domagoj Damjanović).

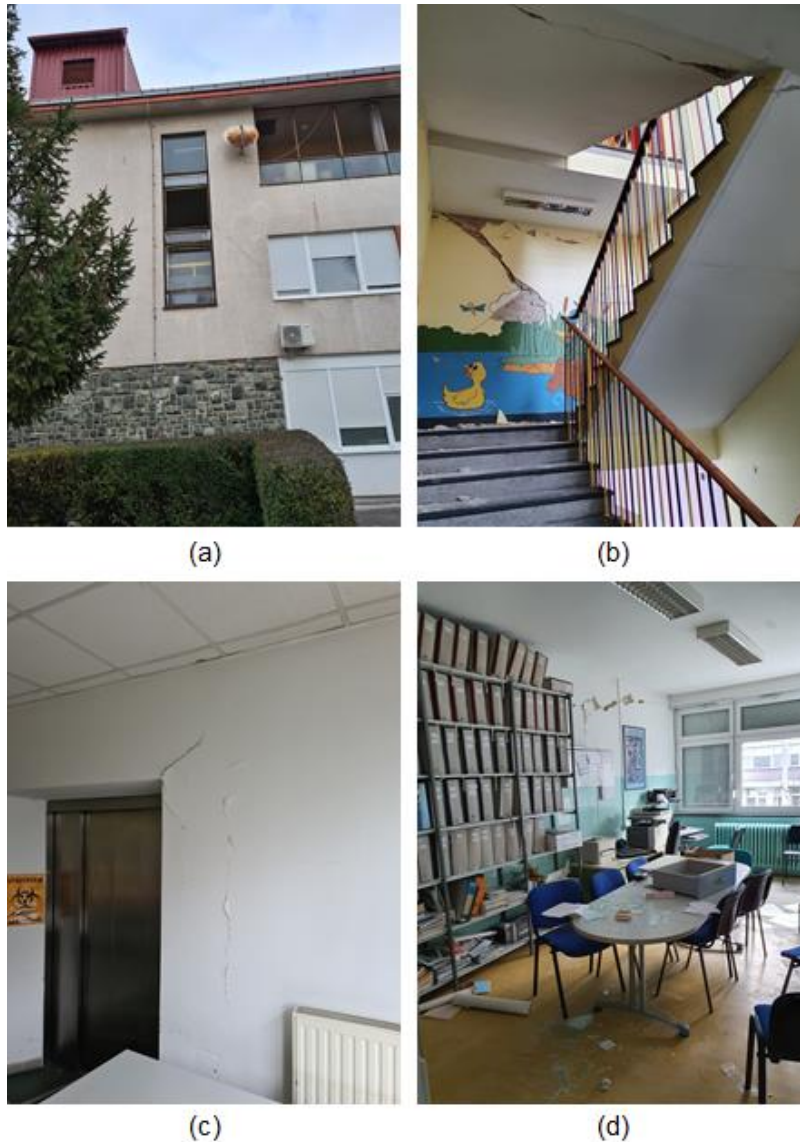
Figure 4.41. Building #1: (a) external view, (b) diagonal cracks in masonry infills, (c) cracks near elevator shafts, and (d) horizontal cracks along masonry-concrete joints (source: Nenad Bijelić).

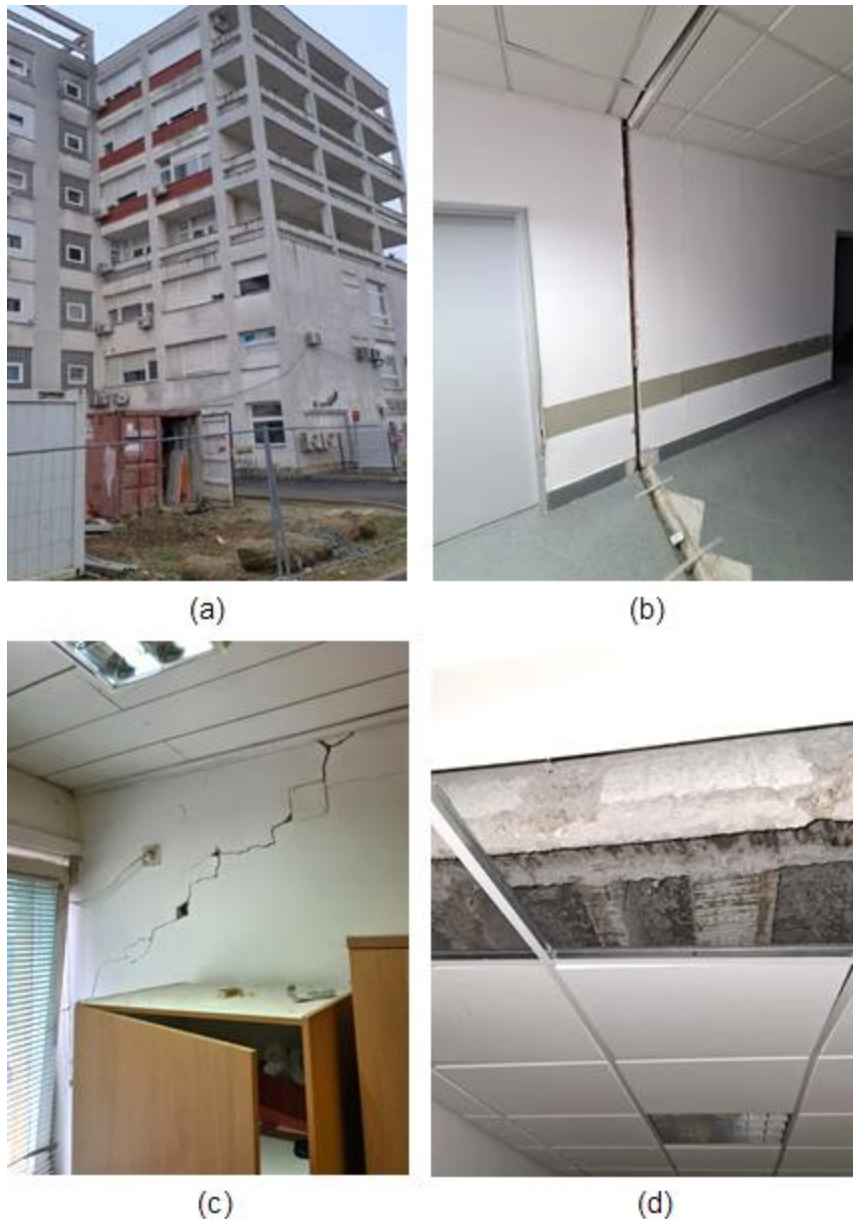
Figure 4.44. Building #5: (a) Outside view, (b) joint opening, (c) concrete wall cracking, and (d) fallen ceiling tiles (source: Nenad Bijelić).

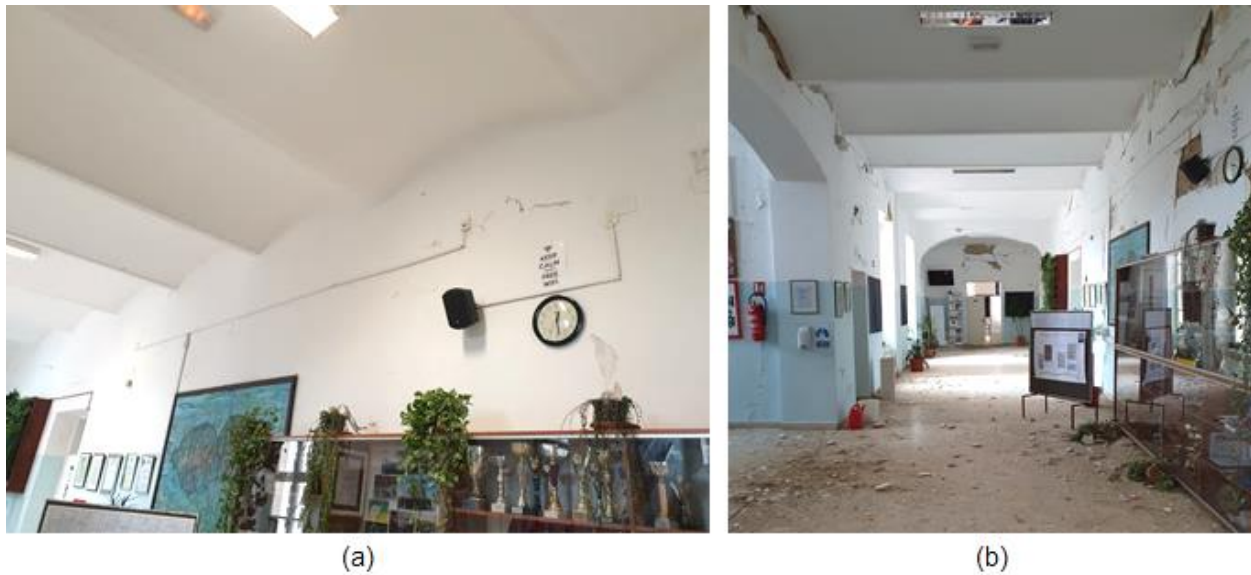
Figure 4.53. Interior of Petrinja High School: (a) minor damage caused by the December 28 earthquake (source: Domagoj Damjanović) and (b) significant damage caused by the December 29 earthquake (source: Marko Bartolac and Nenad Bijelić).

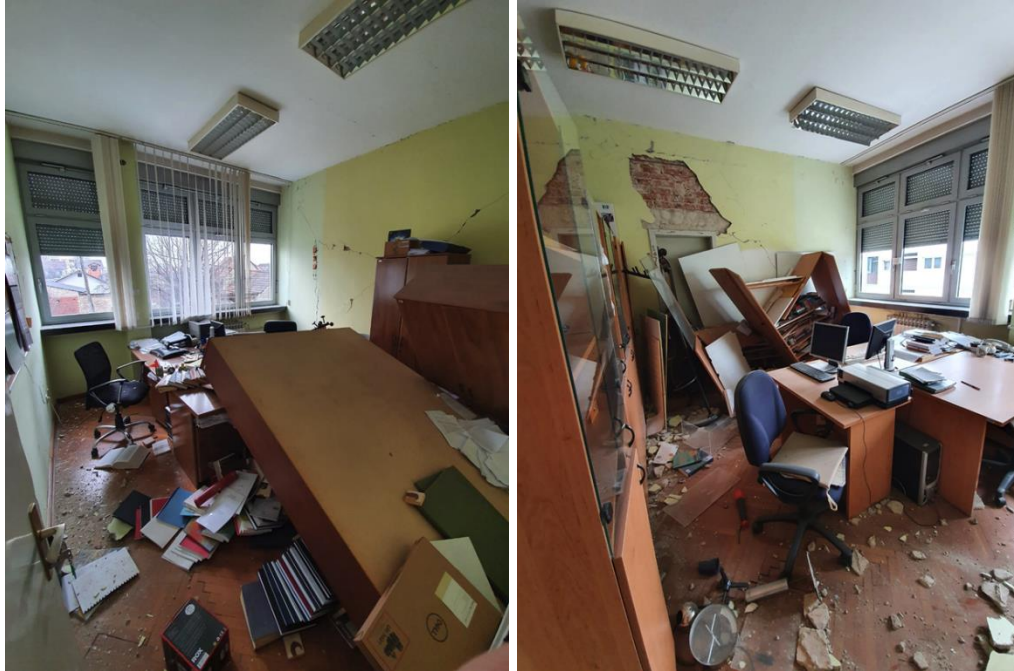
Figure 4.68. Diagonal cracks in infill walls and overturned shelves (source: Marko Bartolac).

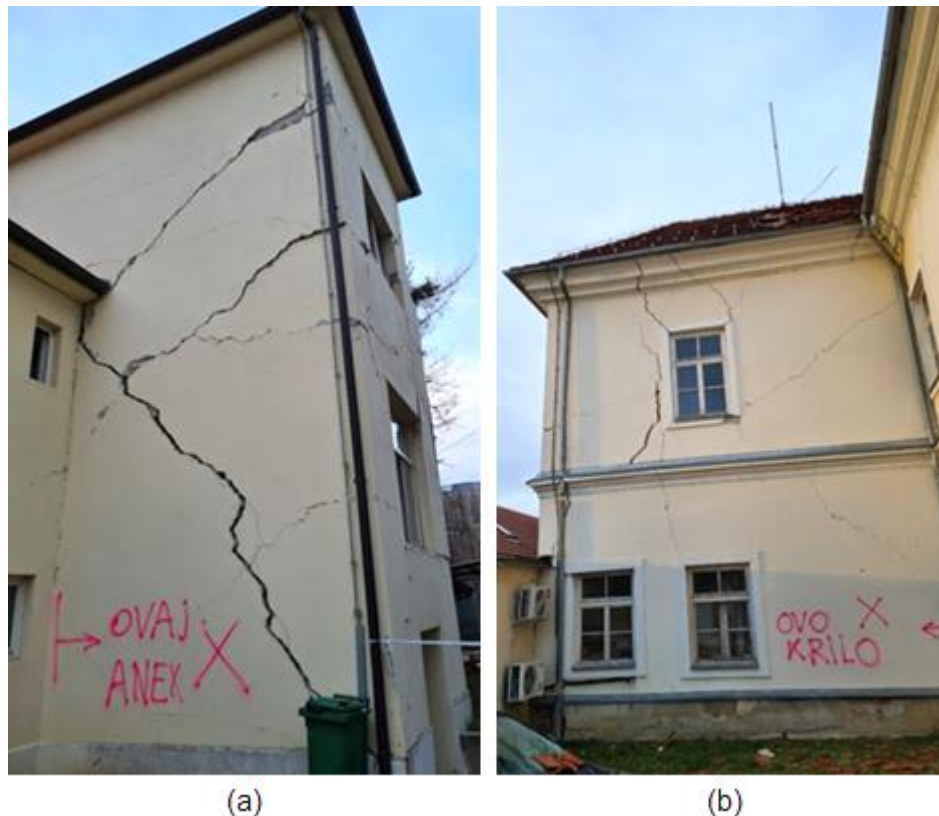
Figure 4.79. Town hall annexes after the earthquake: (a) Southwestern annex with widespread damage in the transverse wall (source: Nenad Bijelić) and (b) Northwestern annex with the widespread damage in the transverse wall (source: Nenad Bijelić).

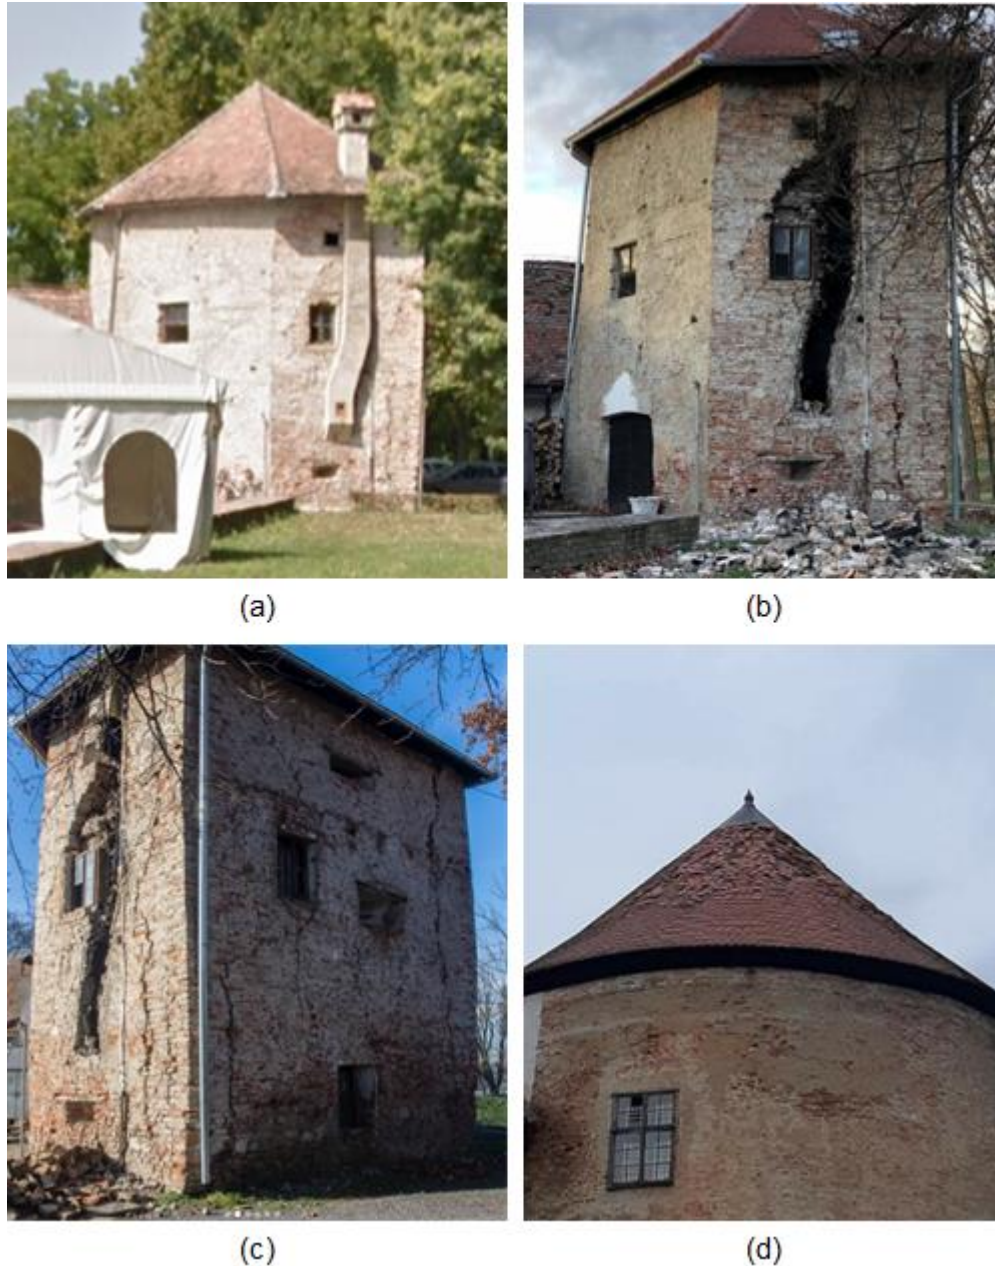
Figure 4.83. (a) Small tower connected to the Sisak fortress in 2011 (source: Google), (b, c) collapsed chimney in the small tower, and (d) damage to the tiles of the conical roof of one of the tower of the fortress (source: Instagram account starigradsisak and dvorcistarigardovi).

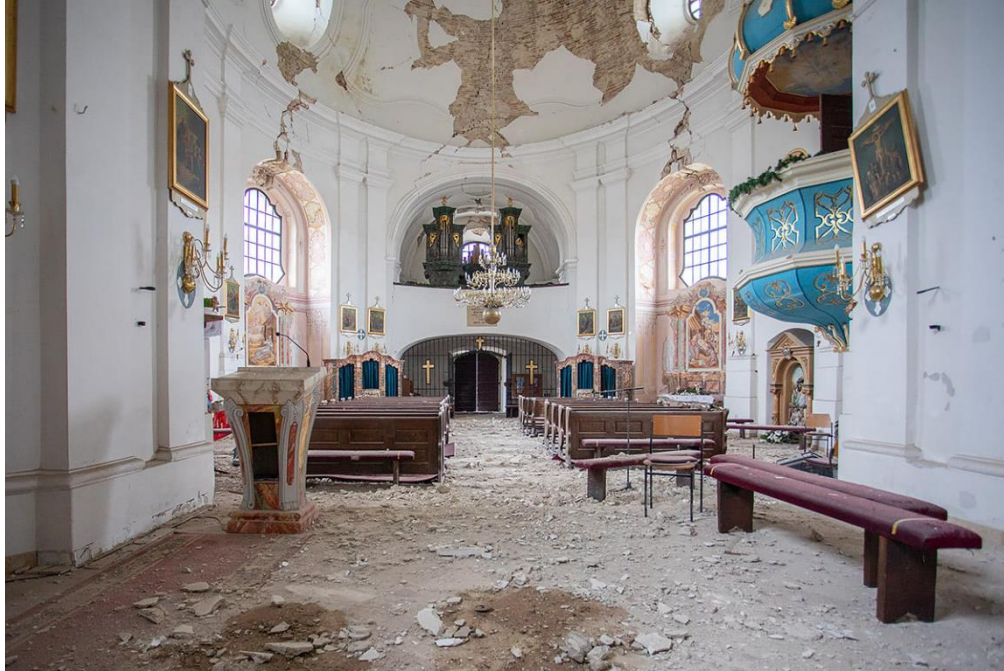
Figure 4.94. Interior of the Church of St. Marije Magdalene in Sela. Extensive cracking visible in the dome, as well as plaster detachment (source: Facebook Page Sisačka biskupija).

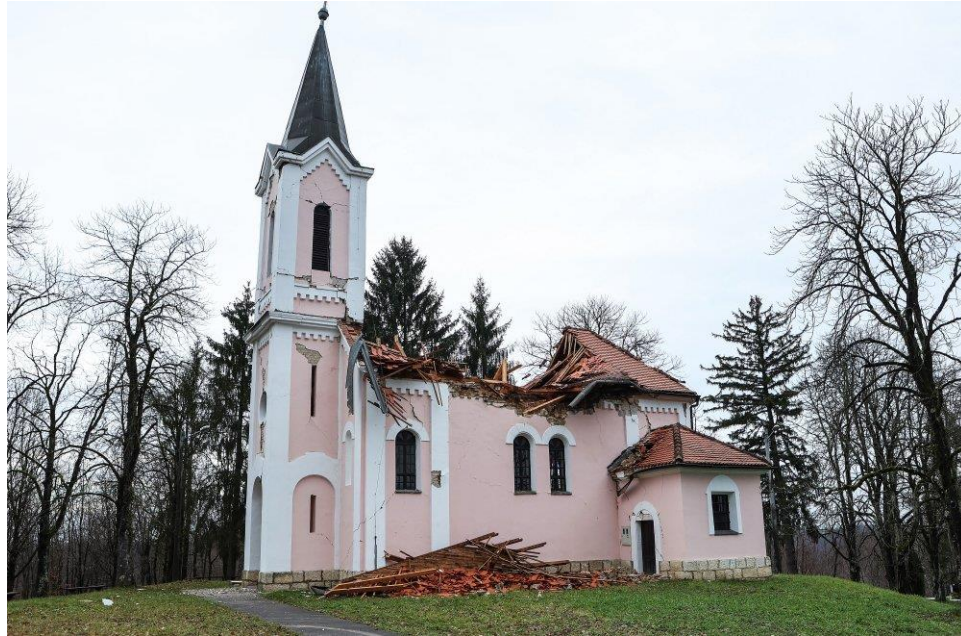
Figure 4.102. Church in Mračaj, near village Majur. Collapse of the timber roof structure and cover and severe cracking of the bell tower (source: Marko Pripic/PIXSELL).

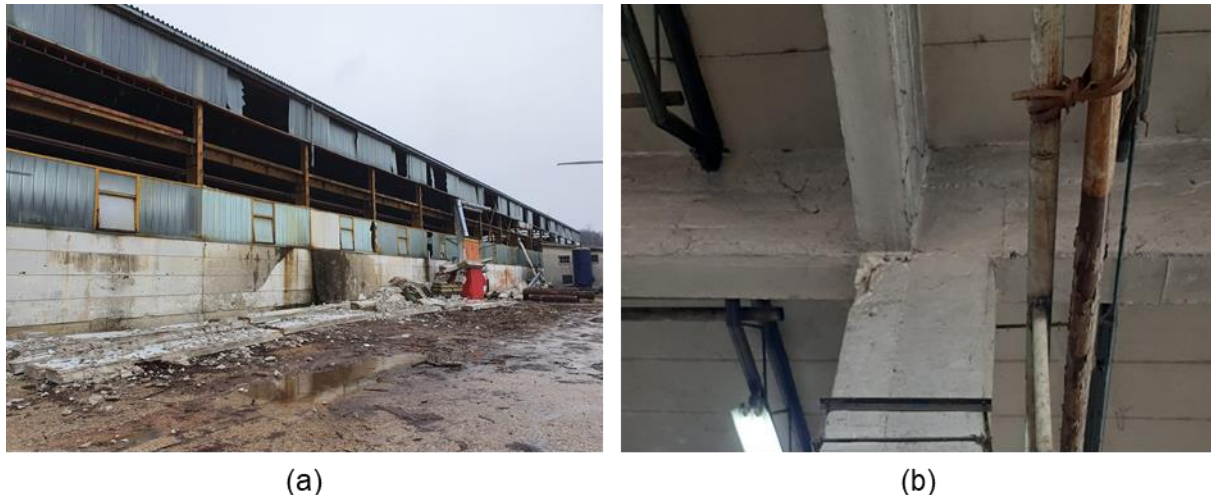
Figure 4.108. Damage to exterior cladding and concrete columns in an industrial facility in Sisačka ul. 116, 44250, Petrinja (source: Marko Bartolac).

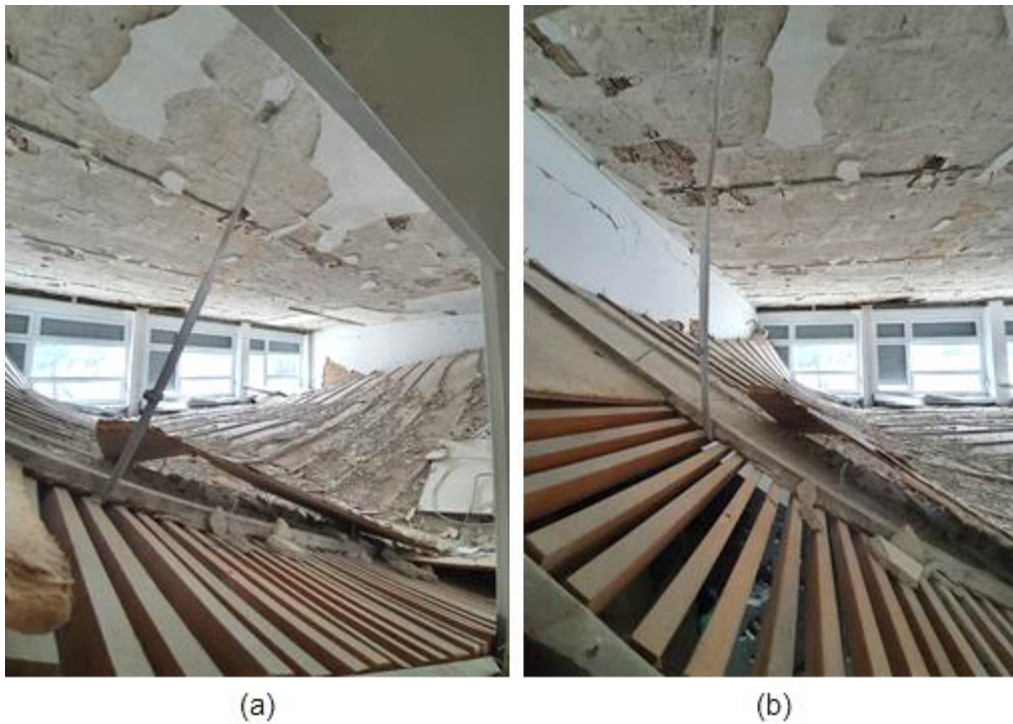
Figure 4.110. Ceiling collapse in 1962 university building (Učiteljski fakultet) (source: Marko Bartolac).

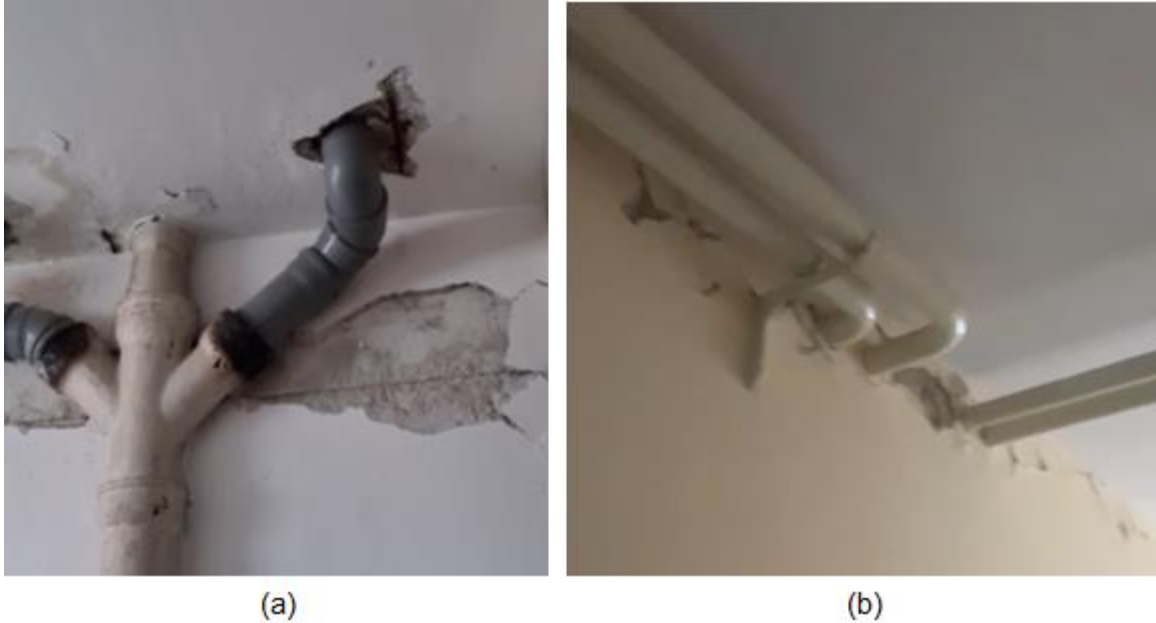
Figure 4.114. Examples of failures in piping systems in university building constructed in 1962 (Uciteljski fakultet) (source: Nenad Bijelić and Damir Lazarević).

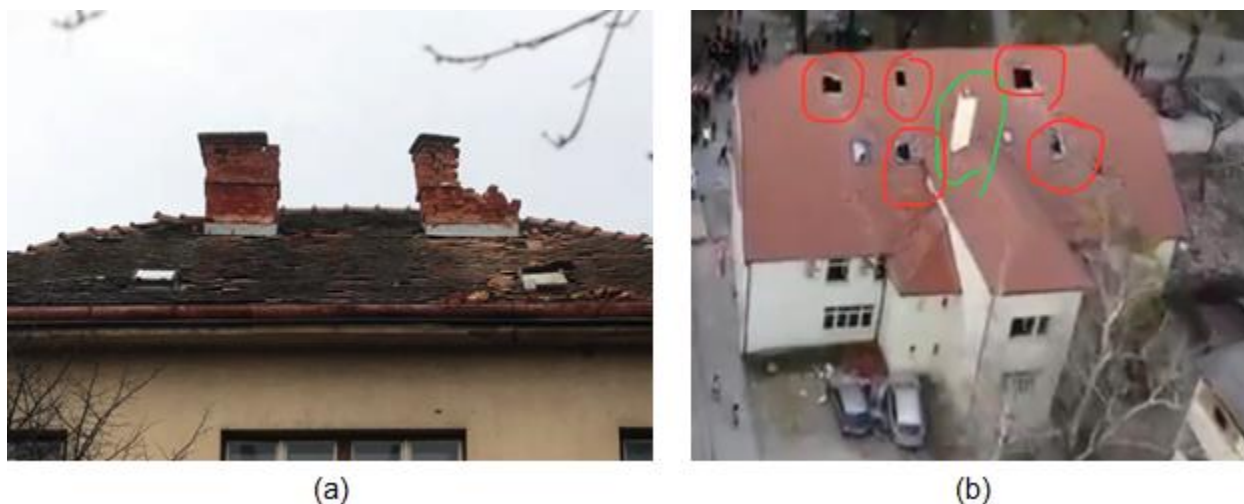
Figure 4.118. Damaged chimneys (source: (a) Getty and (b) Twitter 2021).

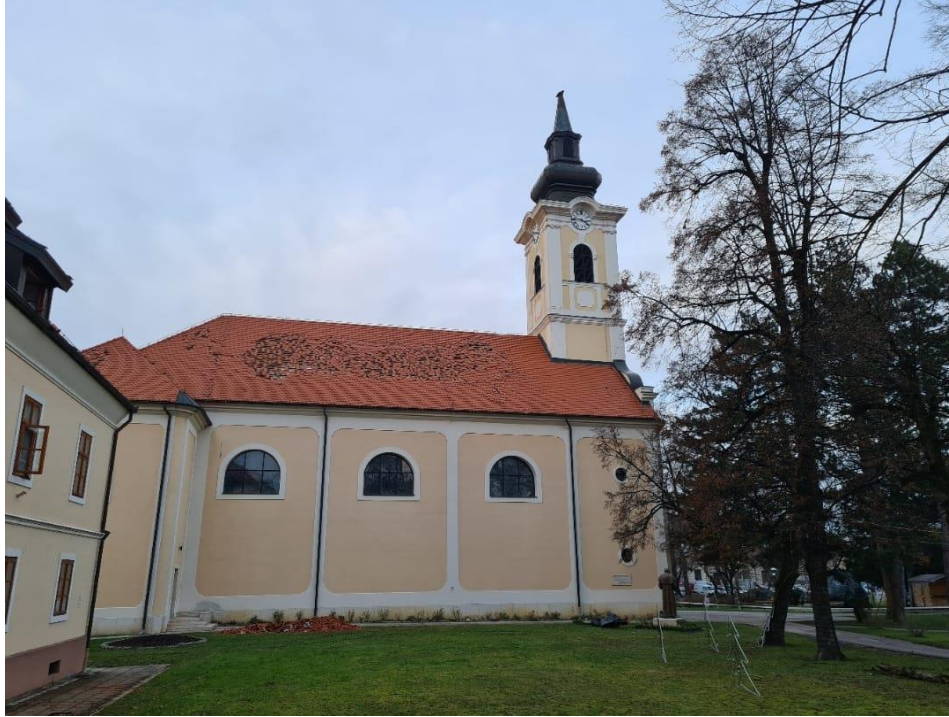
Figure 4.123. Damaged roof tiles on St. Lawrence church (crkva Sv. Lovre) in Petrinja (source: Nenad Bijelić).

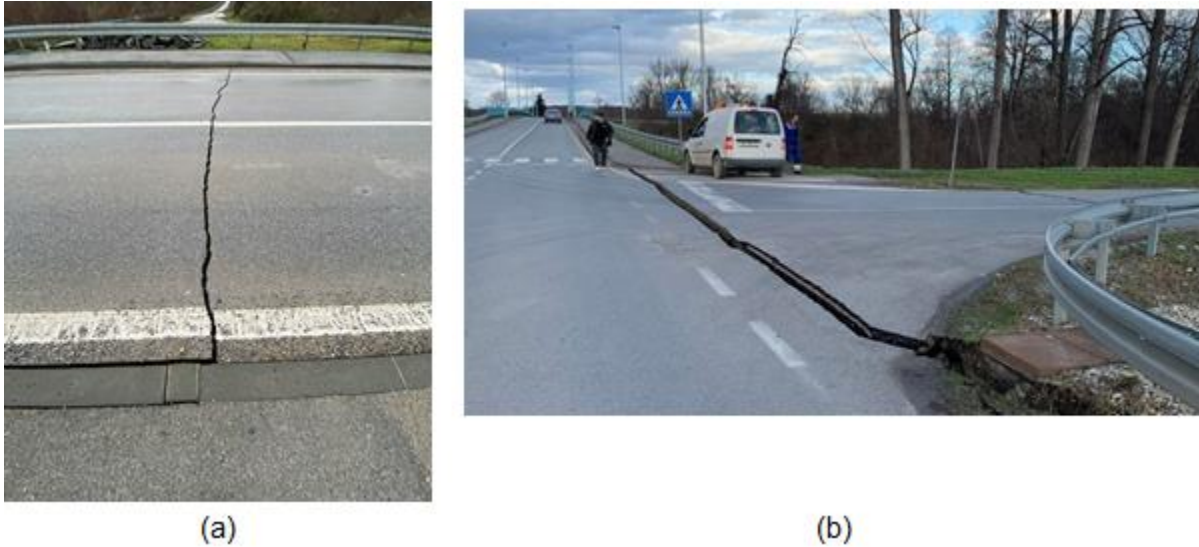
Figure 5.9. (a) A wide transverse crack at the Brest Bridge approach road (source: Mate Baričević) and (b) a wide fissure in the road close to Brest Bridge (source: Index.hr 2020d).

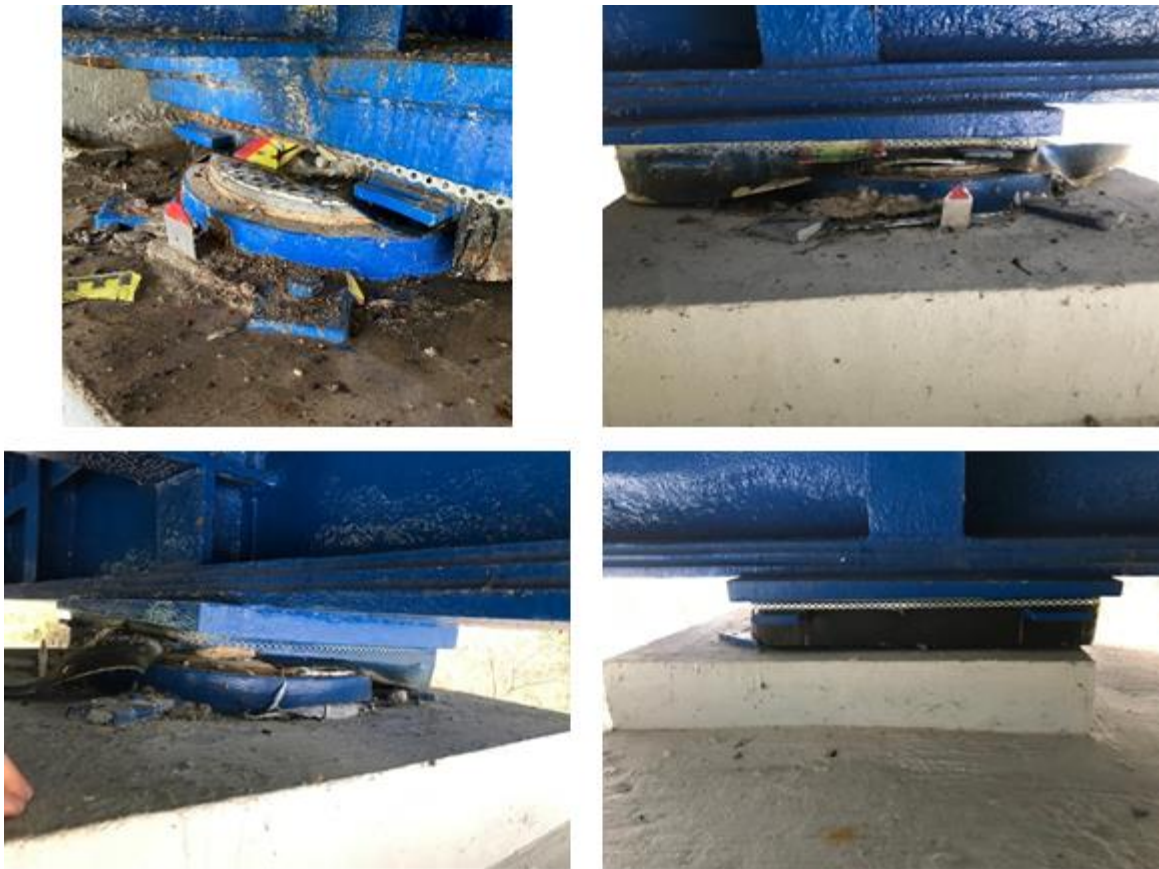
Figure 5.11. Rubber bearings at the abutments failed due to relative displacement demands between the support and the superstructure exceeding the capacity of the bearings, Galdovo Bridge (source: Mate Baričević).

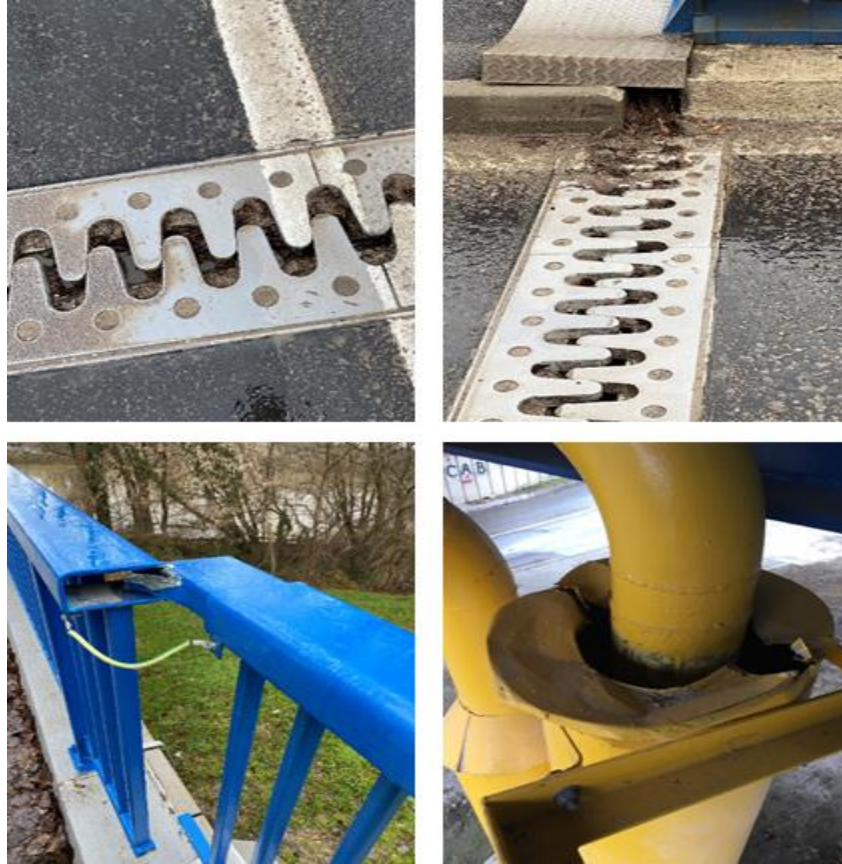
Figure 5.12. Damage due to lateral displacement of the bridge relative to the slab approach, Galdovo Bridge (source: Mate Baričević).

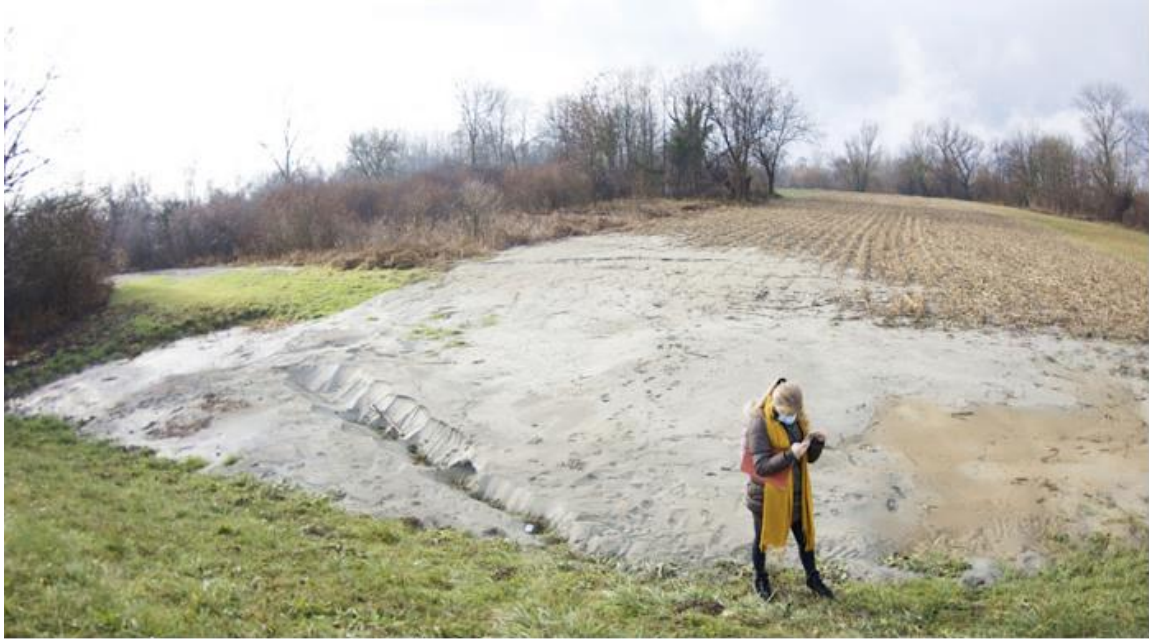
Figure 6.9. Liquefaction in Hrastelnica, Sisak (source: Vedran Jagodnik 45°30'2.538"N,16°24'58.842"E).

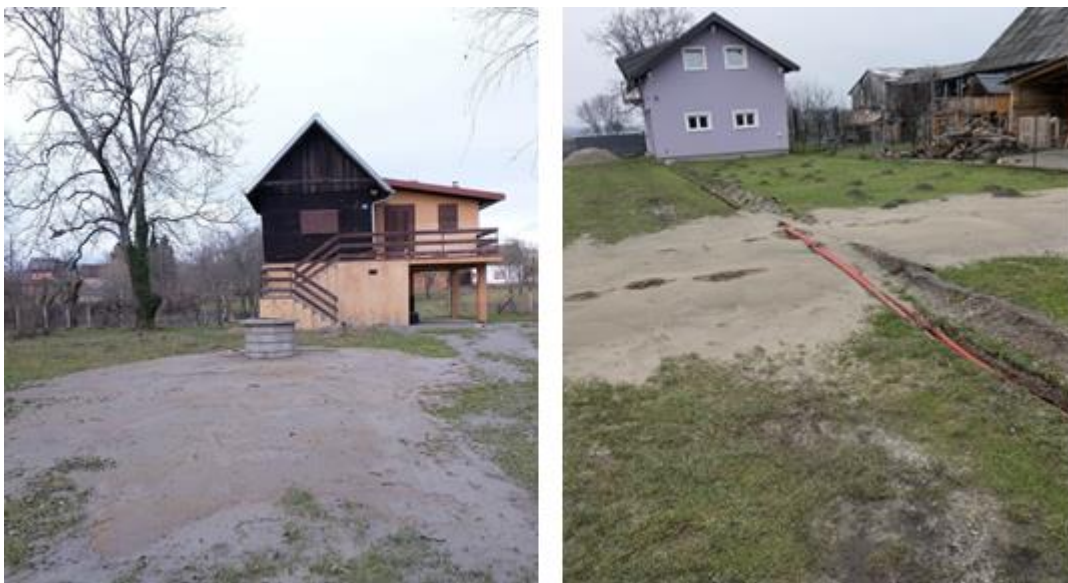
Figure 6.12. Liquefaction surface manifestation and floatation of manholes in Petrinja (left: 45° 29' 5.25"N, 16° 9' 52.306"E; right: 45° 31' 10.986"N, 16° 24' 16.416"E; source: Željko Arbanas).

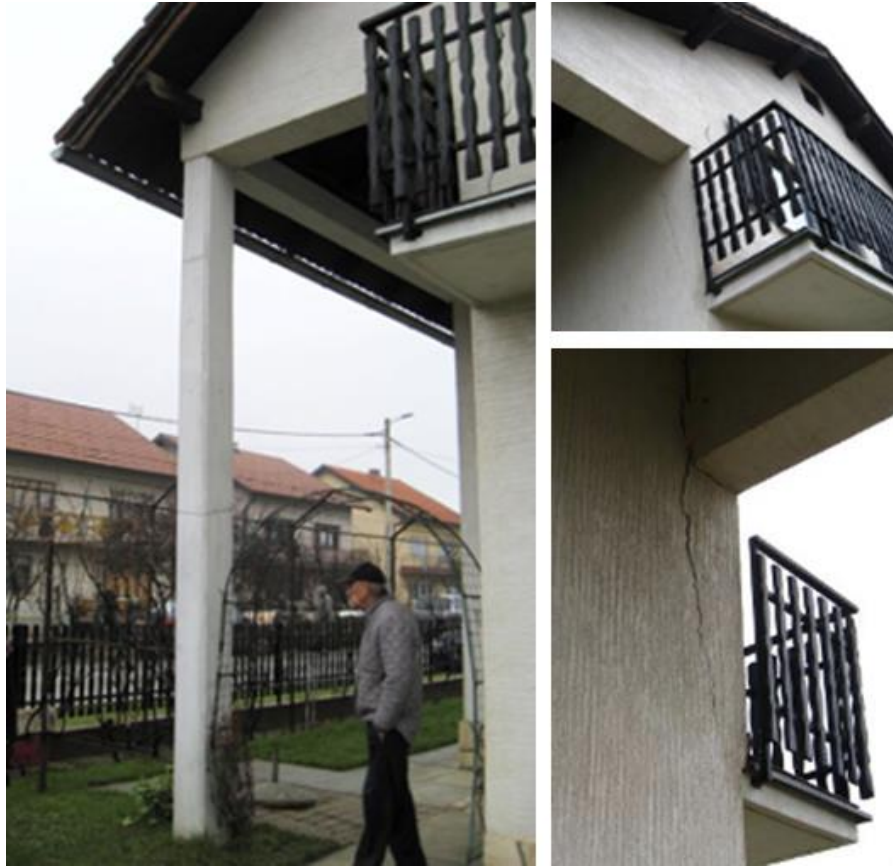
Figure 6.16. Liquefaction occurred under and around the residential building in the photograph. Sand appeared just next to the house, along the fence, and the area covered with bricks moved up. Cracks opened as the house sank. Petrinja, Ulica Vilima Muhe (45.43514, 16.2684, source: Sonja Zlatović).
