Petrinja, Croatia December 29, 2020, Mw 6.4 Earthquake Joint Reconnaissance Report (JRR)

PETRINJA, CROATIA DECEMBER 29, 2020, M_w 6.4 EARTHQUAKE

JOINT RECONNAISSANCE REPORT (JRR)

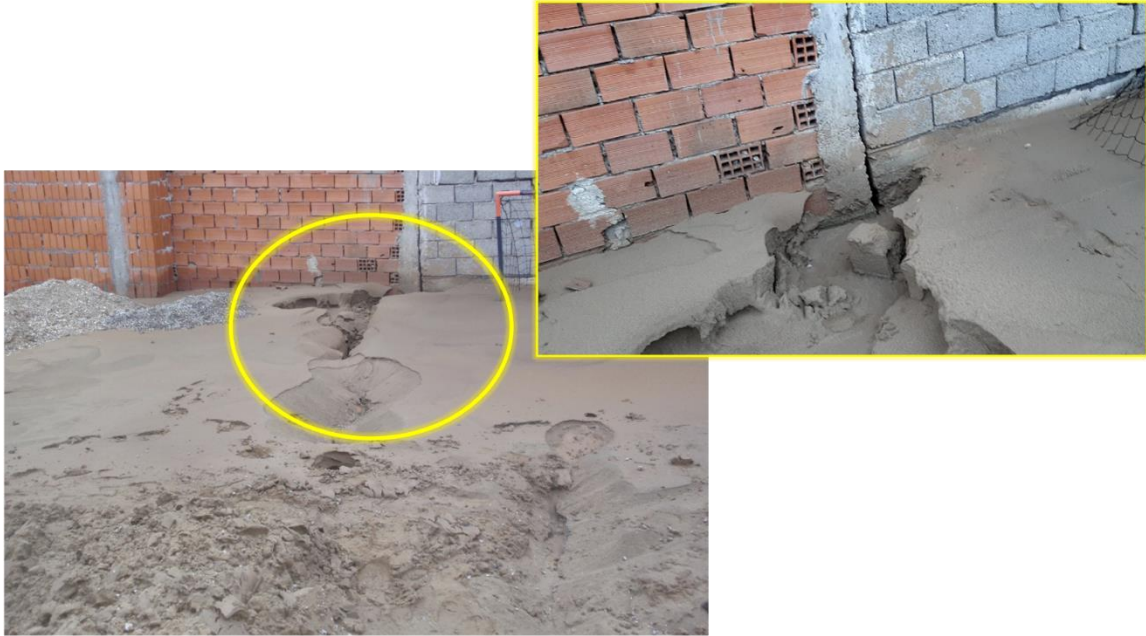
Figure 6.18. Crack between two houses due to liquefaction (45.4540, 16.2611). The line of liquefaction spreads through several yards and under houses, Brest Pokupski (source: Tomislav Ivšić, Sonja Zlatović, Igor Gukov).

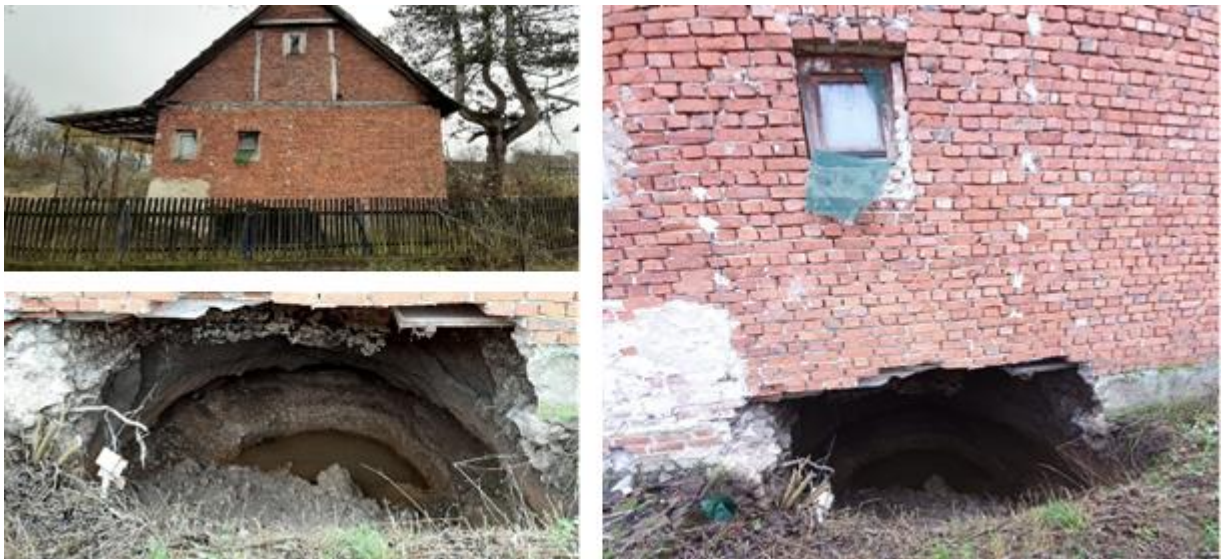
Figure 6.25. Sinkhole under a house with quite weak foundations (photos: left: Sonja Zlatović, right: Joško Krolo).

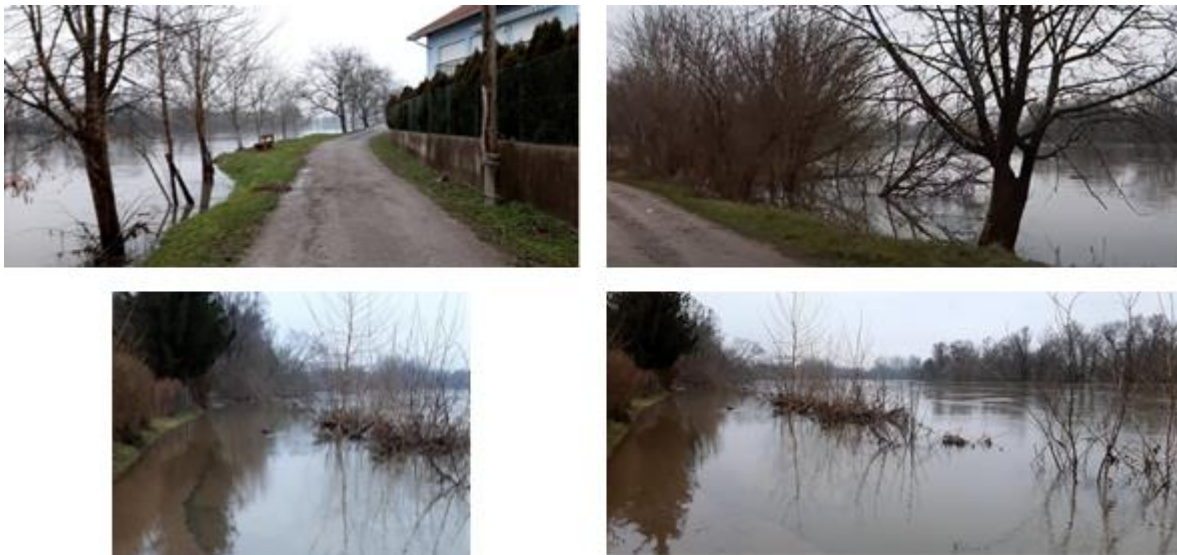
Figure 6.30. Landslide on the coast of the river Kupa, Letovanić (45.5082,16.2118, source Sonja Zlatović).
