StEER-EERI: 2023 Mw 7.8 Kahramanmaraş, Türkiye Earthquake Sequence Joint Preliminary Virtual Reconnaissance Report (PVRR)

Author(s):

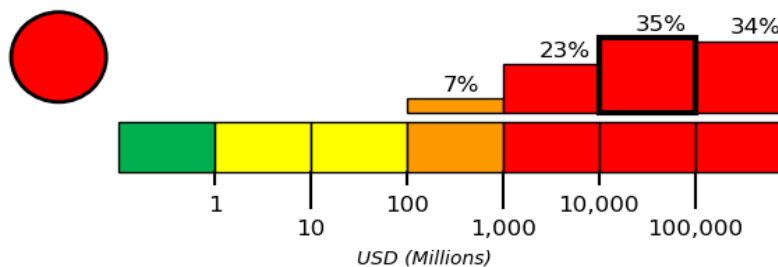
Figure 1.3. Economic losses estimated by PAGER for the Mw 7.8 earthquake (USGS 2023c).

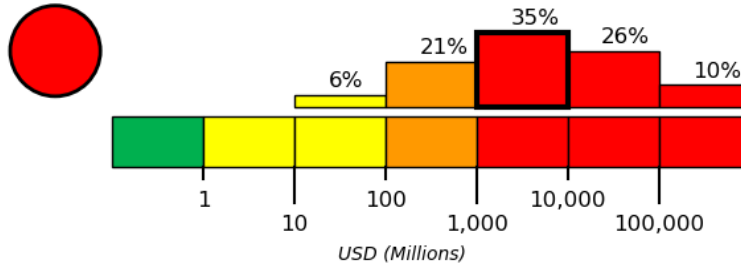
Figure 1.4. Economic losses estimated by PAGER for the Mw 7.5 earthquake (USGS 2023b).

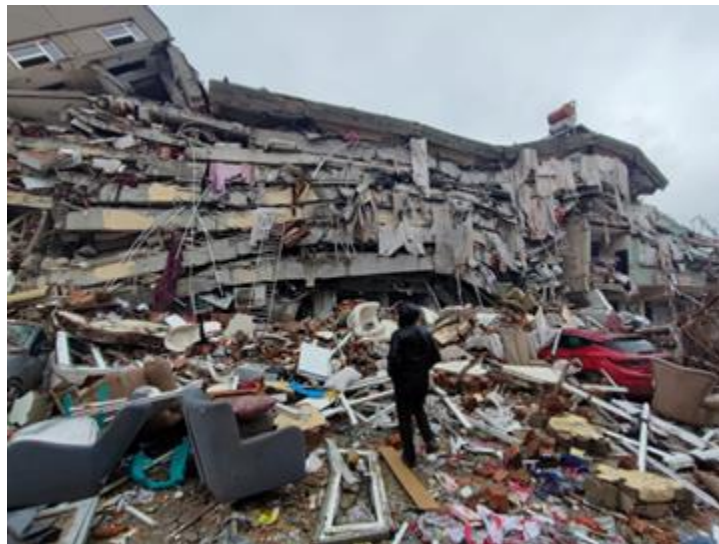
Figure 1.5. Collapsed multi-family residential building in Kahramanmaraş. The photograph illustrates how observed collapse scenarios lead to complete loss of contents and the inability to recover personal possessions (Source: [Reuters via CNN](#)).

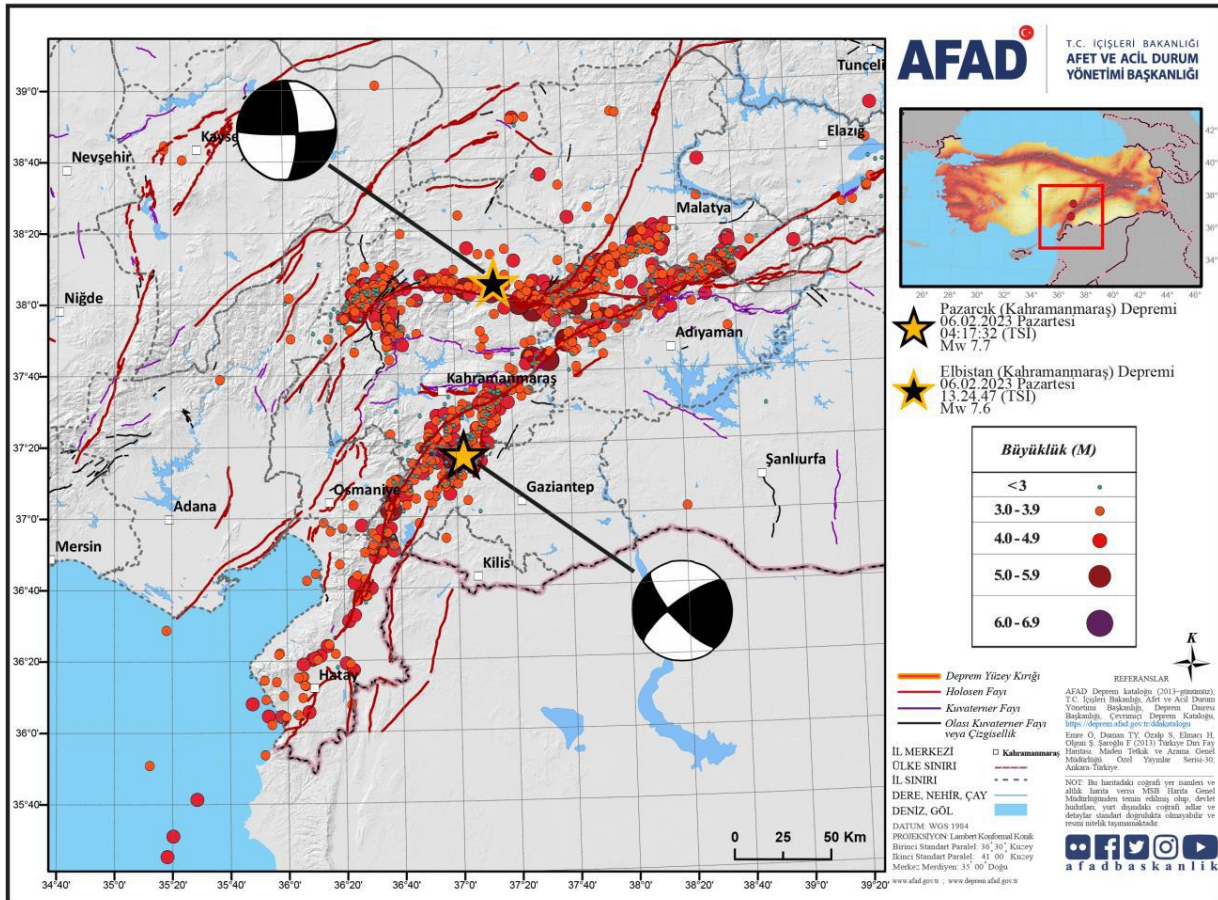
Figure 2.1. February 6, 2023, Pazarcık (Kahramanmaraş) Mw 7.7 and Elbistan (Kahramanmaraş) Mw 7.6 Earthquakes and corresponding aftershock activity (AFAD 2023b).

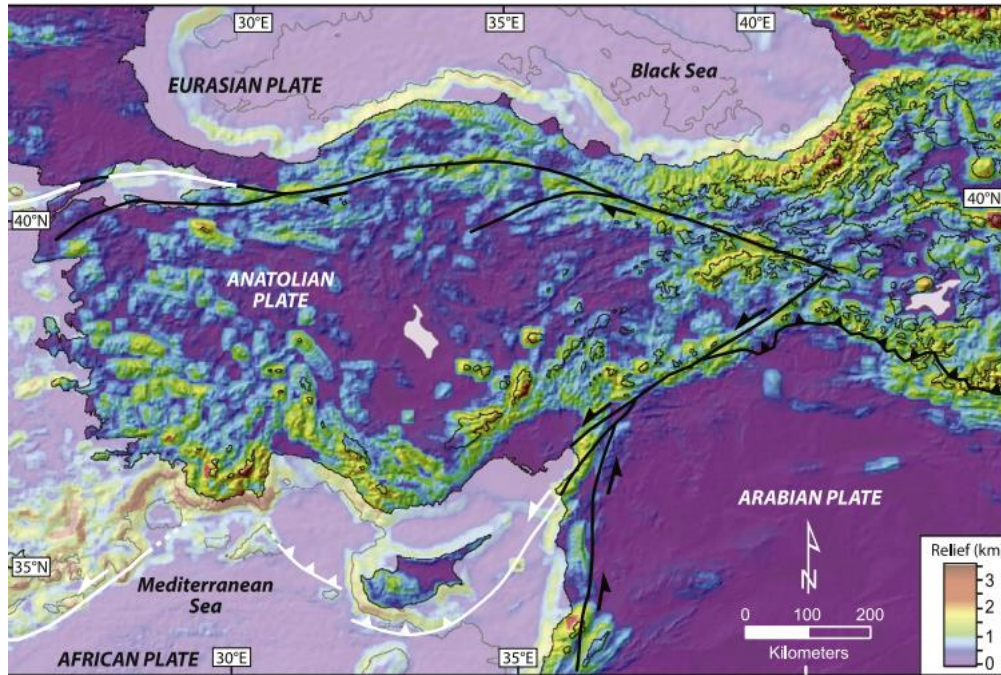
Figure 2.2. Convergence of the African, Arabian, and Eurasian plates with the Anatolian plate (Schildgen et al. 2014).

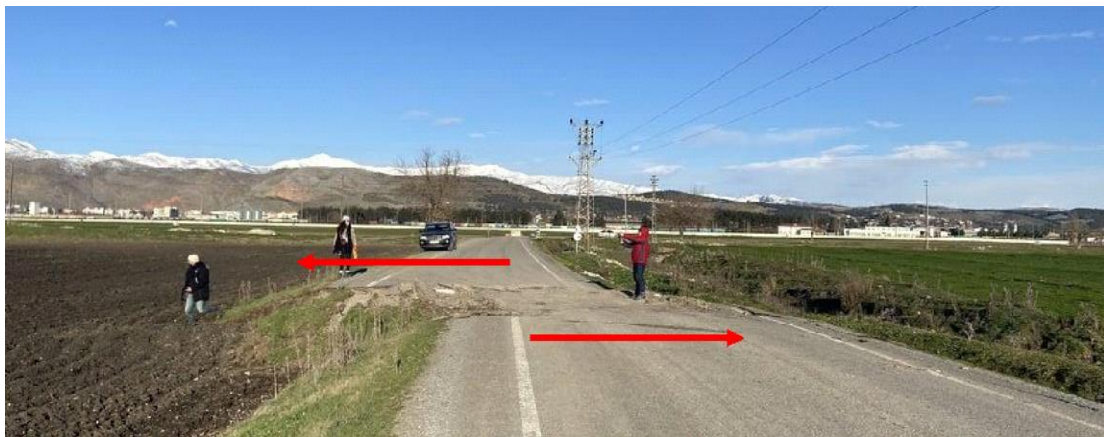
Figure 2.8. Fault slip of 3.0 to 3.5 m at the Anatolian plate from the February 6, 2023 earthquake sequence (adapted from reddit post by [u/kebabG 2023a](#), last accessed 2-20-2023).

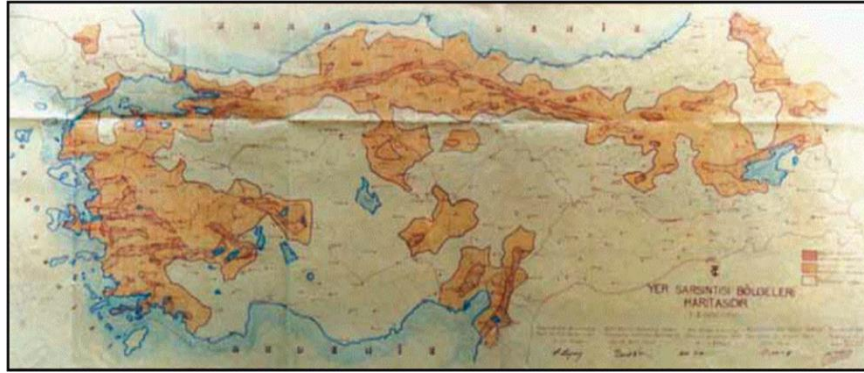
(a) High seismicity in dark red, less seismicity in light red, no seismicity in blank areas.

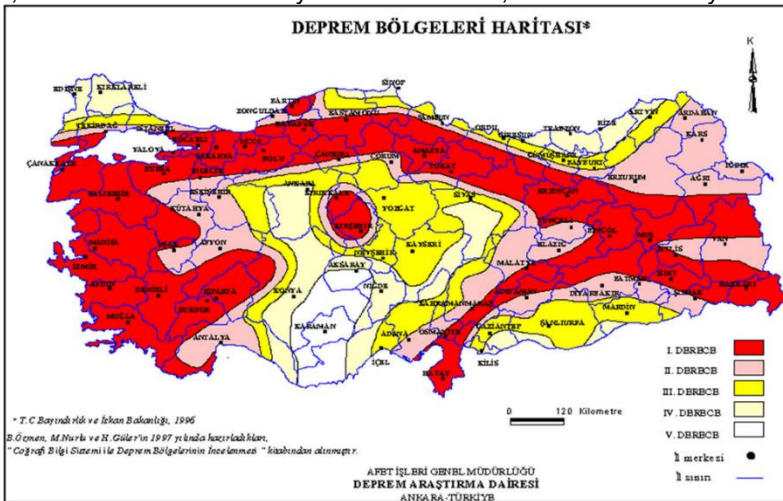
(c) Zone 1 in red of the highest seismicity, pink, yellow, and light yellow are Zone 2, 3, and 4, respectively, of decreasing seismic hazard, and blank areas of no seismicity.

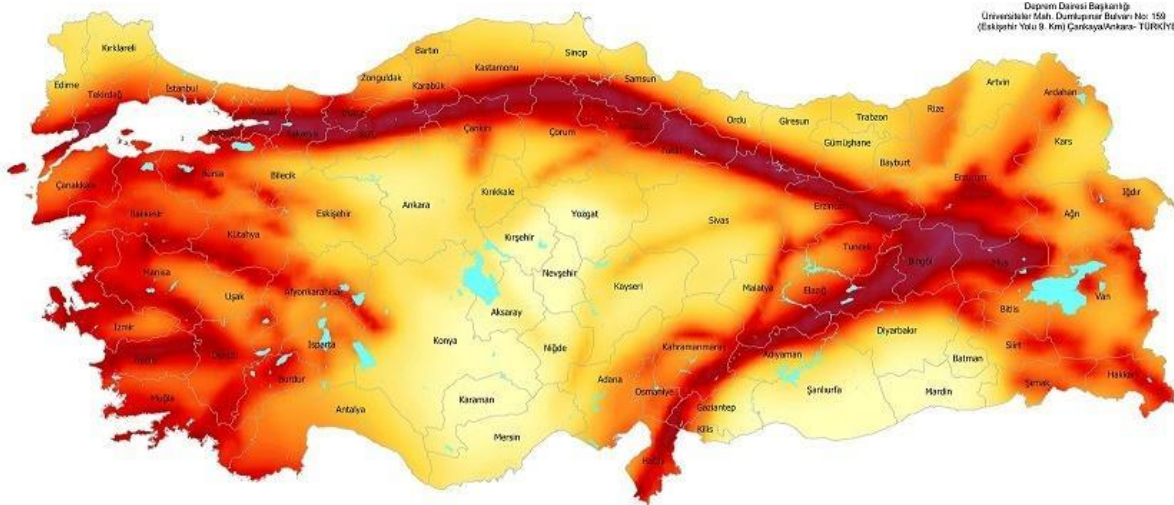
Bu harita, Afet ve Acil Durum Yönetimi Başkanlığı (AFAD) tarafından Ulusal Deprem Araştırma Programı (UDAP) kapsamında desteklenen UDAP-Ç-13-06 kod no'lu "Türkiye Sismik Tehlike Haritasının Güncellenmesi" başlıklı projenin sonuçları kullanılarak hazırlanmıştır.

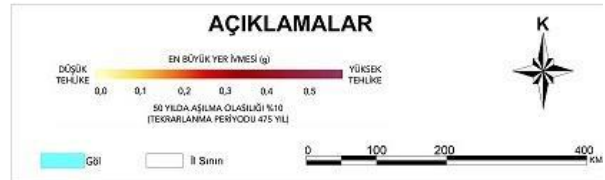
Figure 2.10. Seismic Hazard Map of Türkiye (2018). PGA values are shown for DBE (DD2), a recurrence period of 475 years, or 10% probability of exceedance in 50 years (AFAD 2023d).

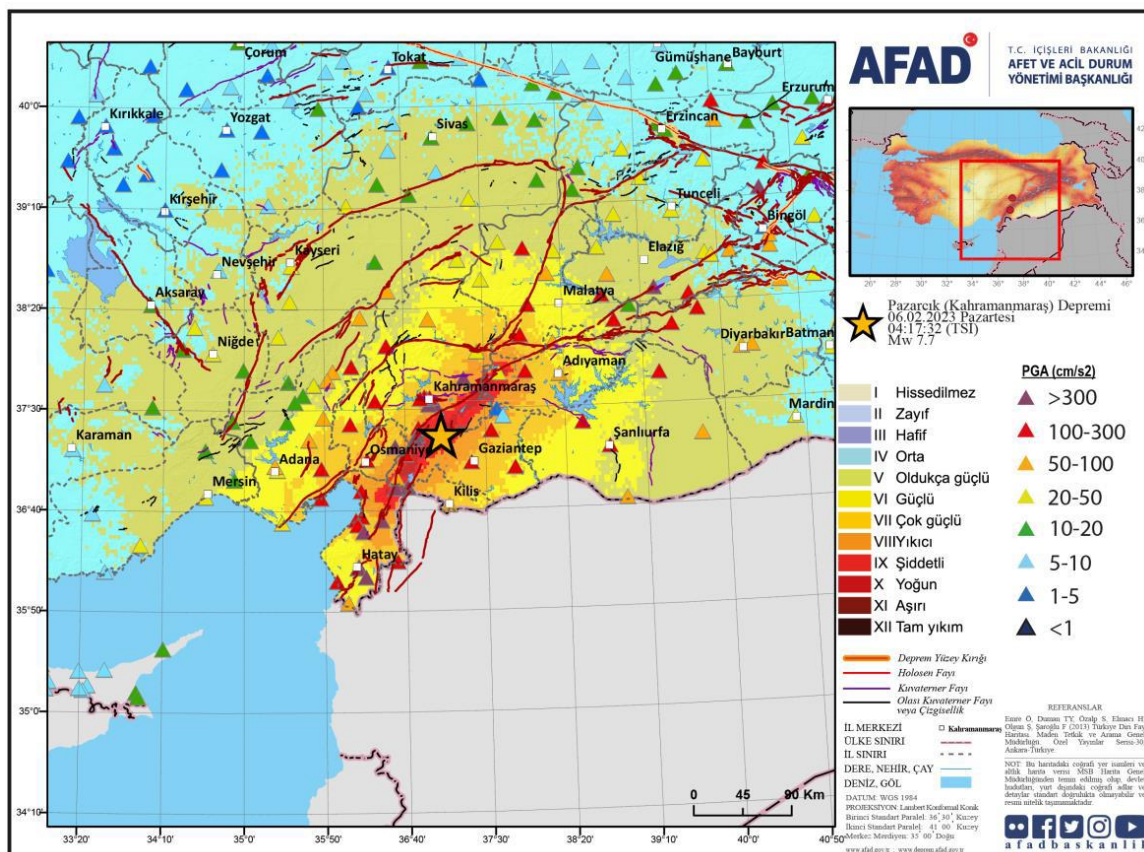
Figure 2.14. AFAD shakemap for the Mw 7.7 event at 01:17 UTC (1st event). Shakemap presents the AFAD-RED (AFAD-Rapid Earthquake Damage) estimations. Stations with triangles have the color-legend presenting the corresponding PGA records (AFAD 2023e).

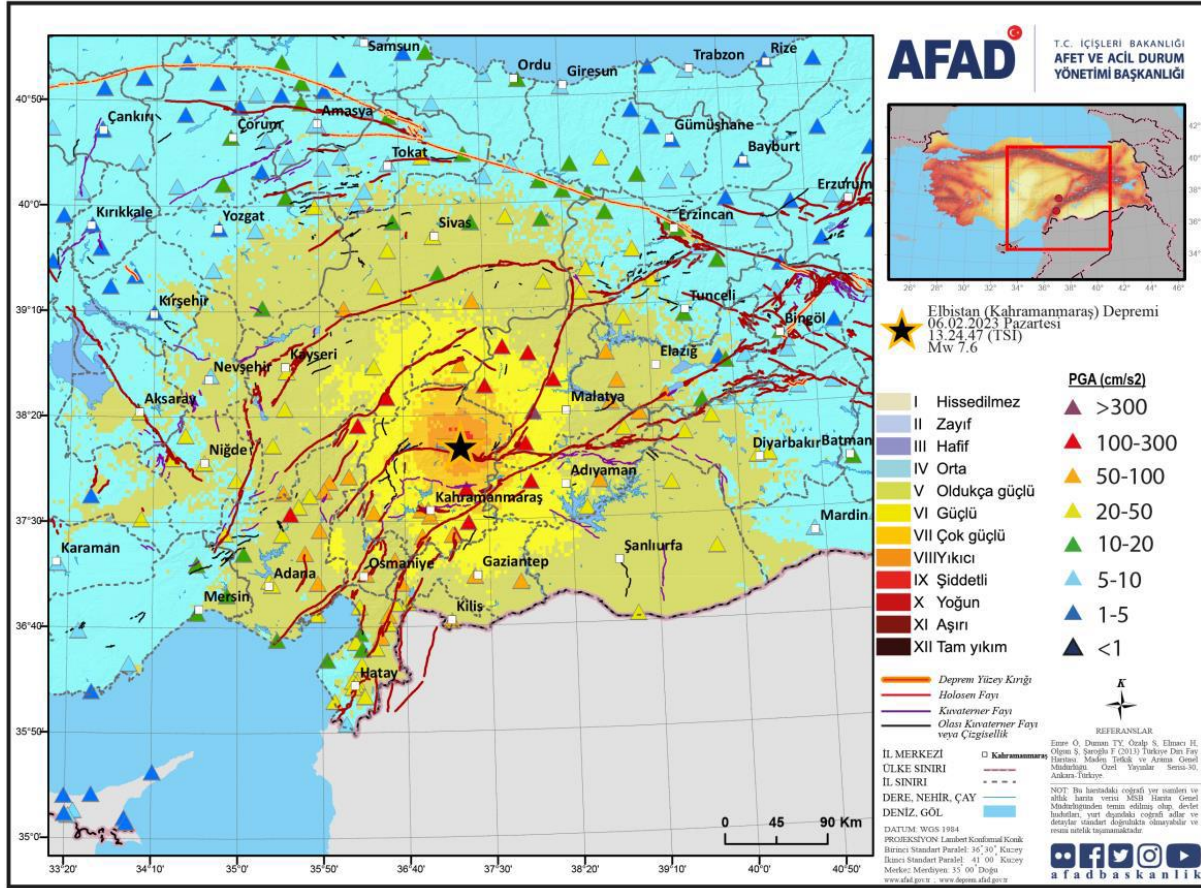
Figure 2.20. AFAD shakemap for the Mw 7.6 event at 10:24 UTC (2nd event). Shakemap presents the AFAD-RED estimations. Stations with triangles have the color-legend presenting the corresponding PGA records (AFAD 2023b).

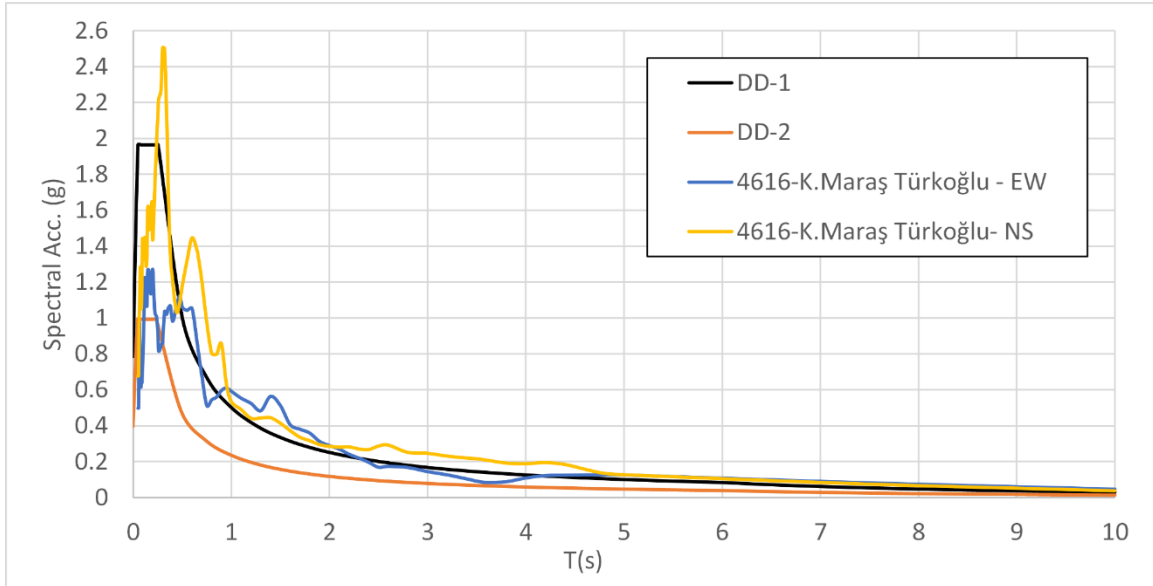
Figure 2.22. Spectral acceleration of the Mw 7.7 earthquake in comparison with the design spectra of DBE (DD-2) and MCE (DD-1) for horizontal components at station TK.4616.

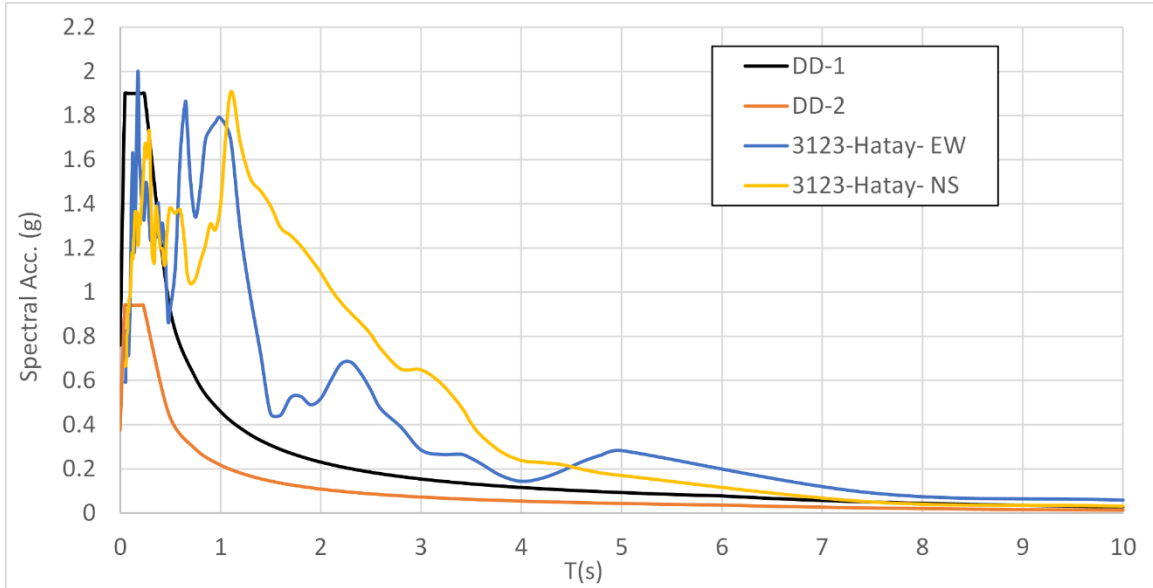
Figure 2.23. Spectral acceleration of Mw 7.7 earthquake compared with the design spectra of DBE (DD-2) and MCE (DD-1) for horizontal components at station TK.3123.

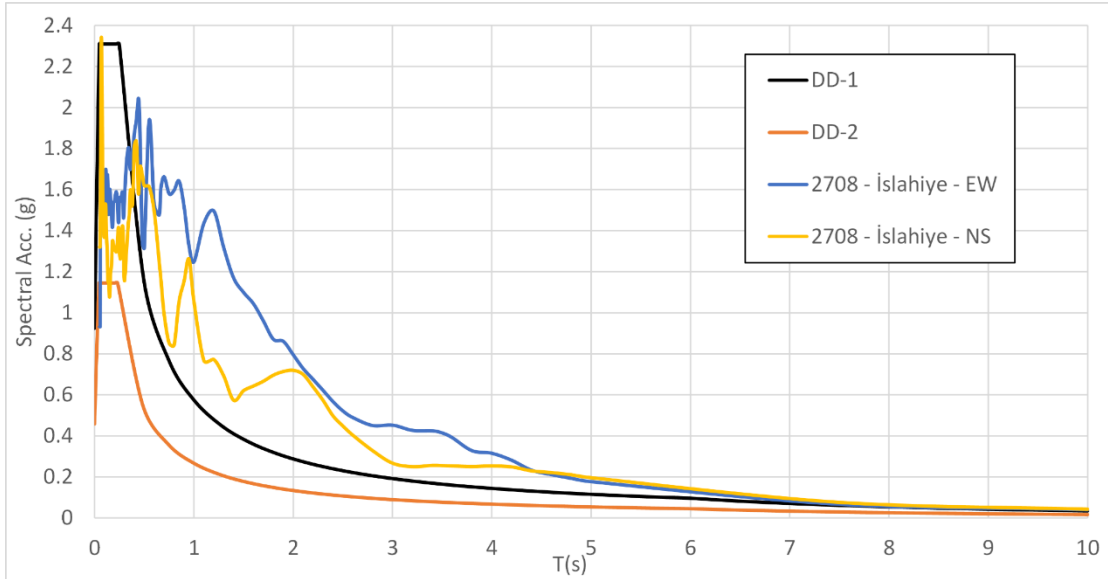
Figure 2.24. Spectral acceleration of Mw 7.7 earthquake compared with the design spectra of DBE (DD-2) and MCE (DD-1) for horizontal components at TK.2708.

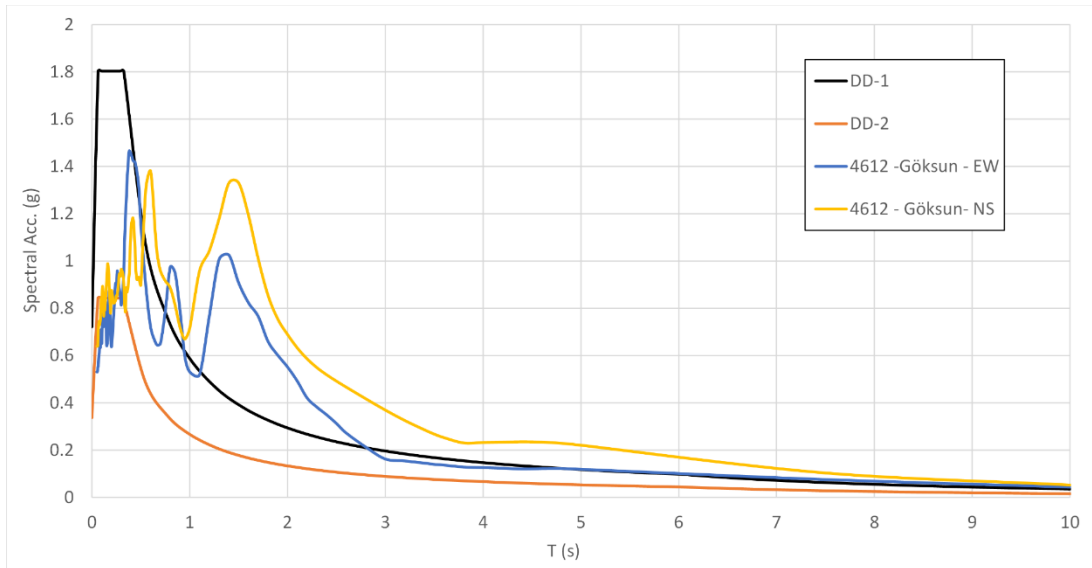
Figure 2.27. Spectral acceleration of Mw 7.6 earthquake in comparison with the design spectra of DBE (DD-2) and MCE (DD-1) for horizontal components at station TK.4612.

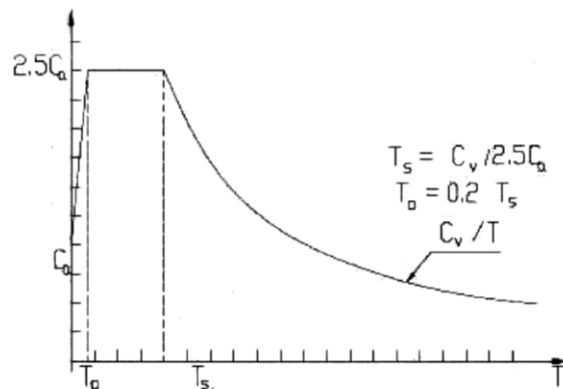
Figure 3.1. Current design response spectrum (spectral acceleration versus natural period) in Syria (Source: Arab Syrian Code for Design and Construction of Reinforced Concrete Buildings (2013), Appendix 2: Design of Earthquake-Resistant Buildings and Structures).

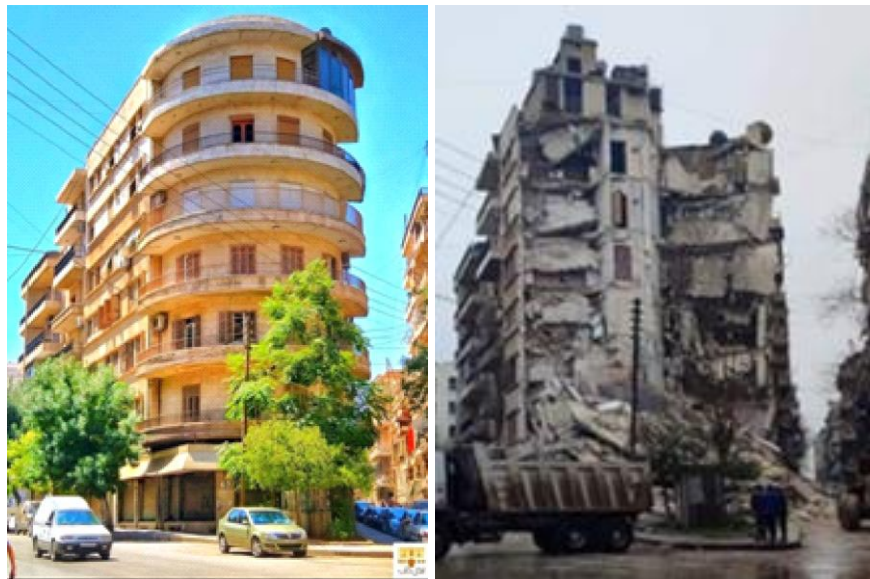
Figure 3.2. An Aleppo City mid-rise non-engineered building before and after the earthquakes, (Source: Salah Haj Ismail personal Archive).

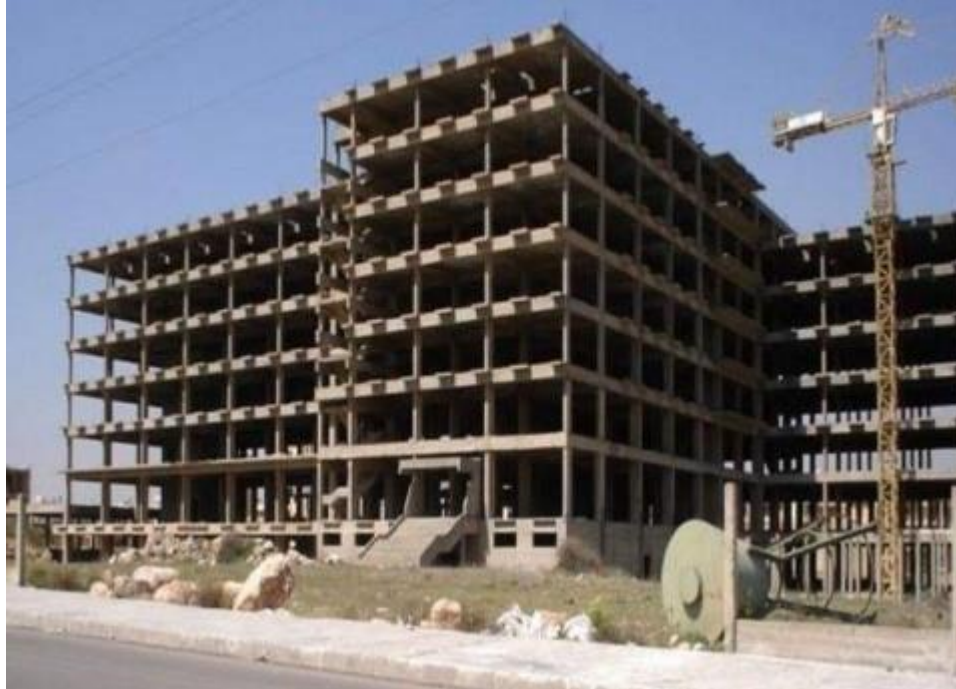
Figure 3.3. The structure of Aleppo military Hospital, Aleppo City - Construction was not compatible with the study (Source: Salah Haj Ismail personal Archive).

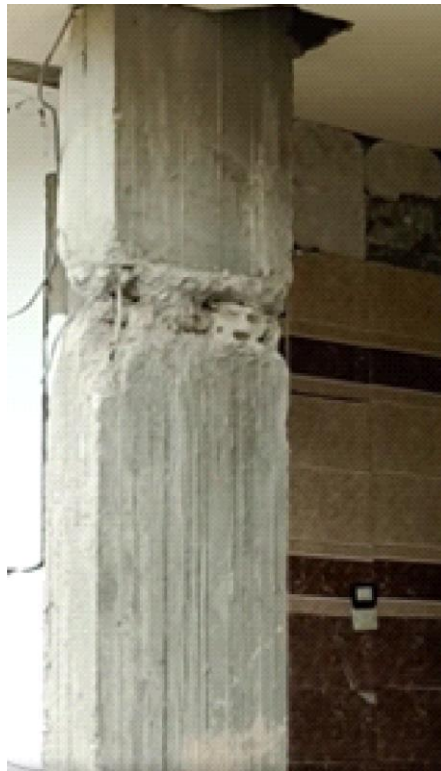
Figure 3.3. Damaged RC column with severe deficiency of reinforcement (Source: Personal image by Eng. M. Zakaria member of damage assessment commission).

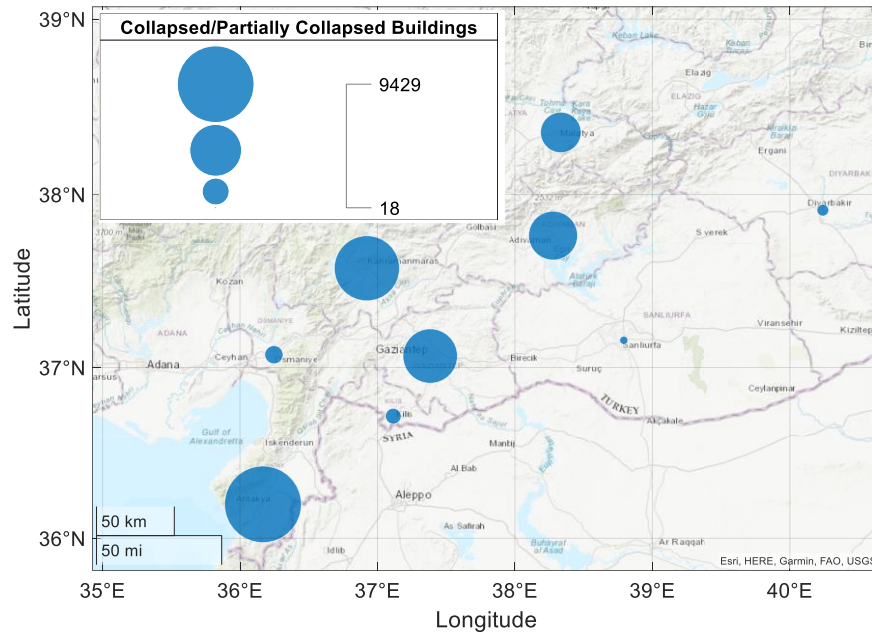
Figure 4.1. Total number of completely and partially collapsed buildings in several cities in Türkiye impacted by the earthquake sequence ([Türkiye Ministry of Environment, Urbanization and Climate Change](#)).

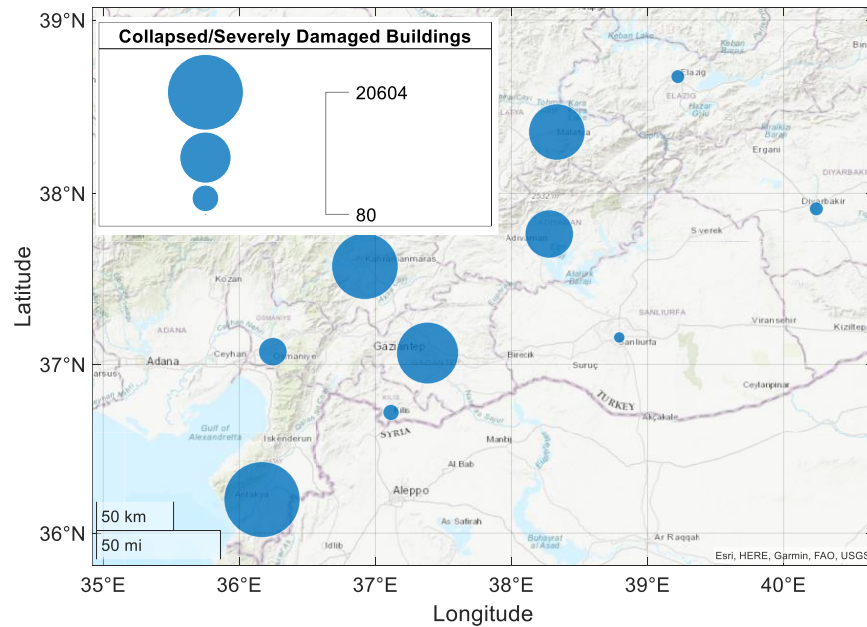
Figure 4.2. Total number of collapsed and severely damaged buildings in several cities in Türkiye impacted by the earthquake sequence ([Türkiye Ministry of Environment, Urbanization and Climate Change](#)).

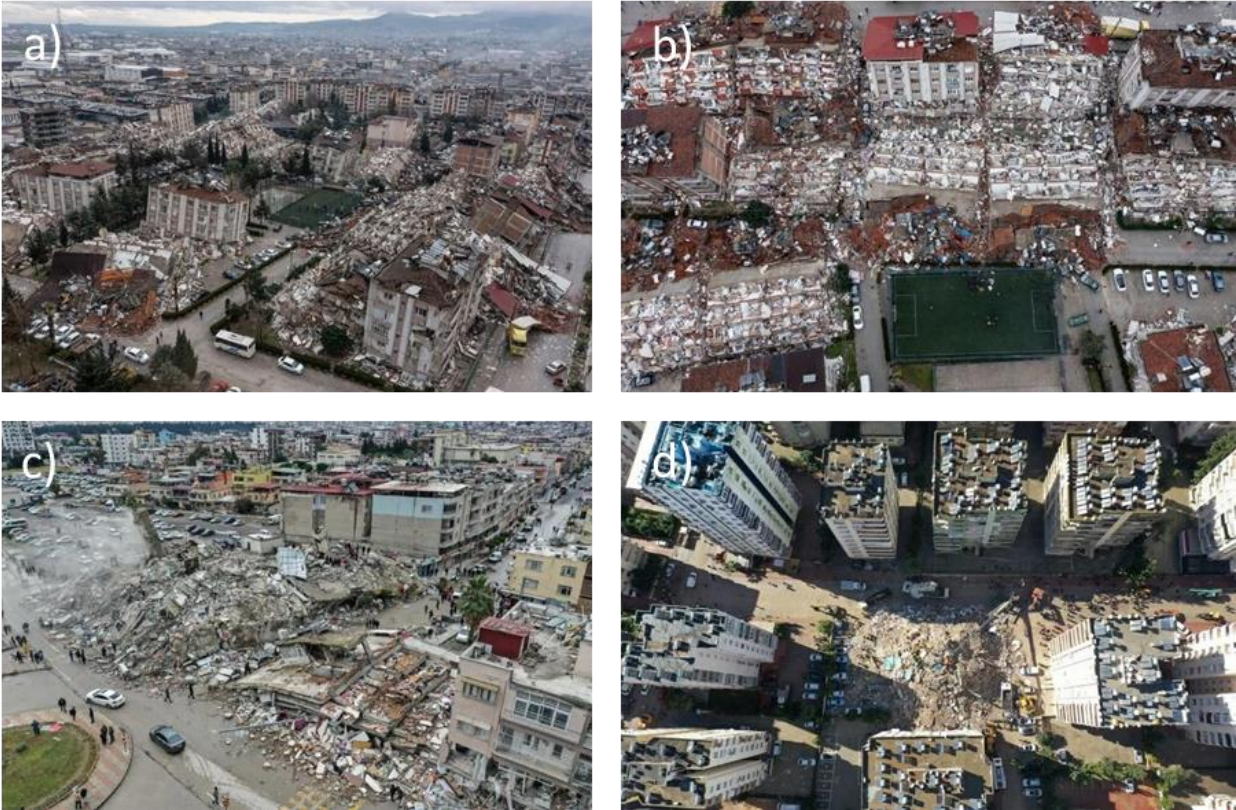
Figure 4.3. Aerial views of the extent of damage in some cities in Türkiye after the earthquakes: a) and b) show mid-rise RC residential buildings that have collapsed in a side-sway manner, while nominally identical buildings in the same developments are damaged but have not collapsed; c) shows two corner RC buildings that have collapsed, possibly due to torsional eccentricity; d) shows a single high-rise building that has collapsed among other similar high-rise buildings that did not collapse (Source: (a) [Getty Images via BBC](#), (b) [Independent](#), (c) [Getty Images via CNN](#), (d) [Getty Images via CNN](#)).

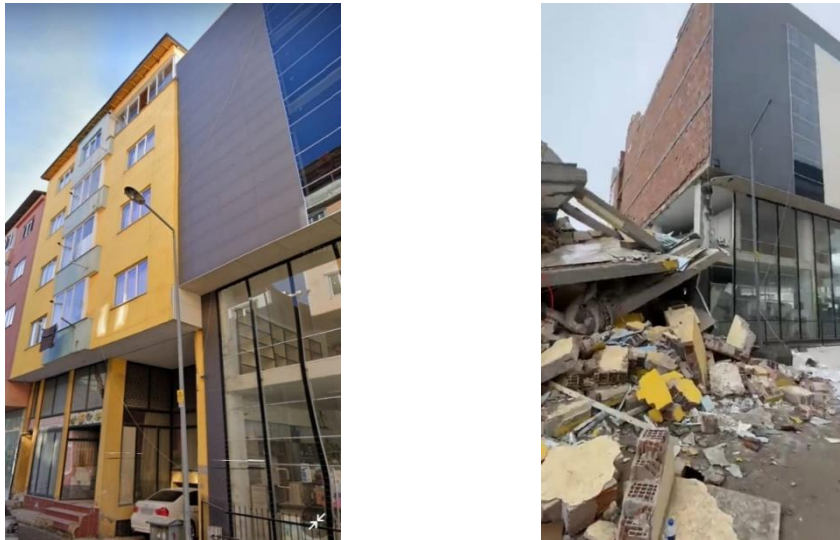
(a) Before (Source: [Google Maps](#)). (b) After (Source: [Eren Uslu via Twitter](#)).

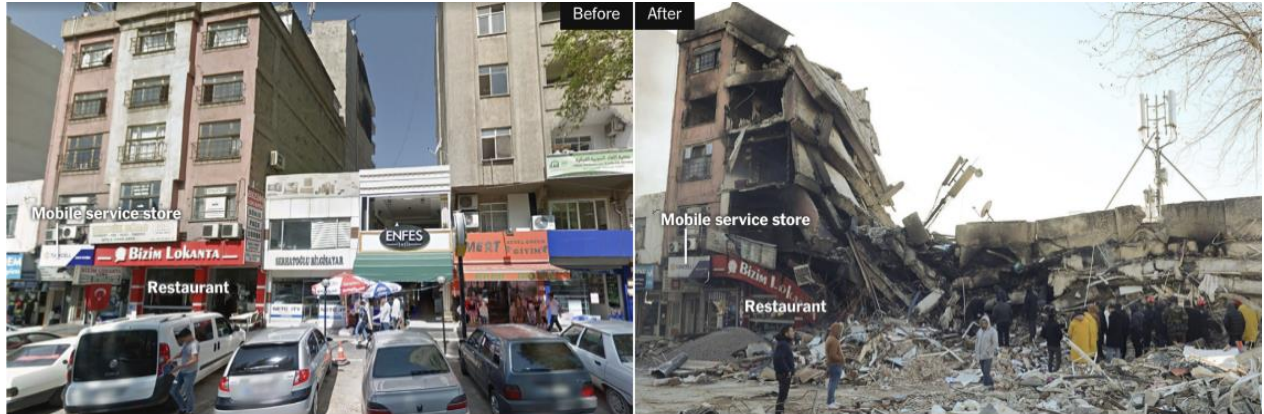
Figure 4.6. Collapse of buildings due to weak/soft story & pounding. The short 2-story building located between two mid-rise buildings, without adequate seismic separation, likely led to pounding between the roof slab of the 2-story building and the mid-height of the adjacent buildings. This has resulted in partial collapse of the building on the left and total collapse of the building on the right along with collapse of the 2-story (Source: [New York Times](#) 2023).

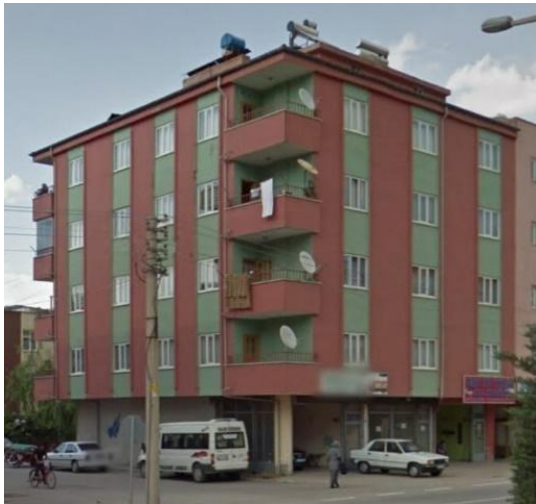
(a) Before (Source: [Google Maps](#)).

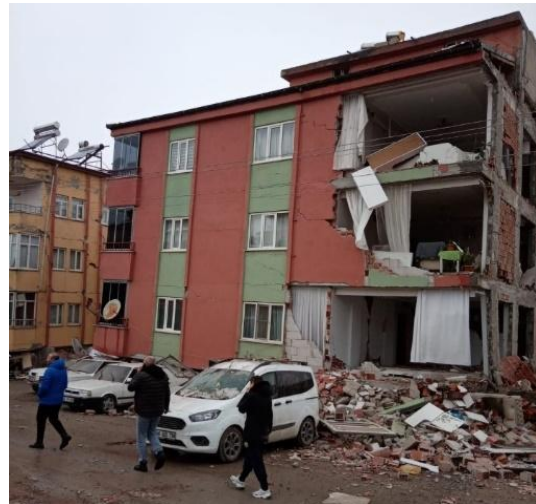
(b) After (Source: Kece, Local Assessor).

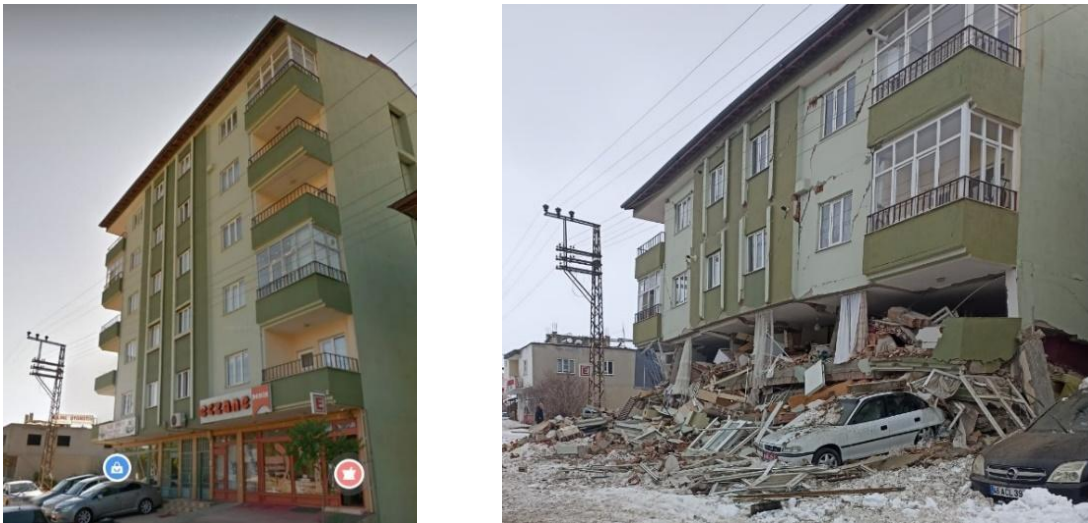
(a) Before (Source: [Google Maps](#)). (b) After (Source: Demirkapu, Local Assessor).

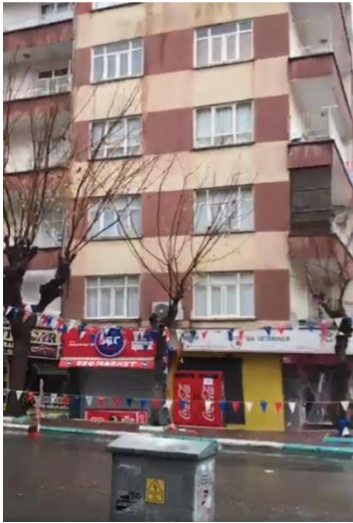
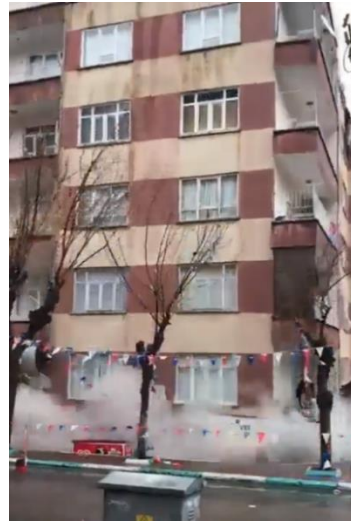
(a) Building prior to collapse. (b) Collapse of weak/soft story prior to gravity collapse.

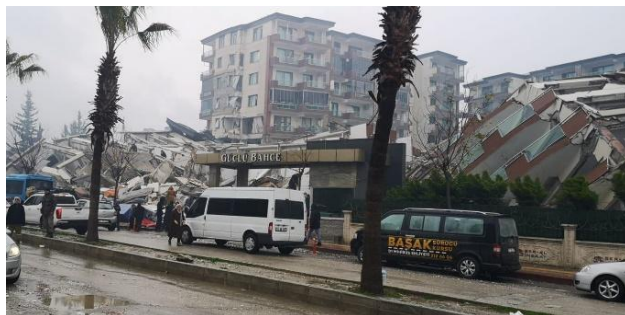
Figure 4.11. Güçlü Bahçe residential building complete collapse in Hatay (Source: [Twitter](#)).

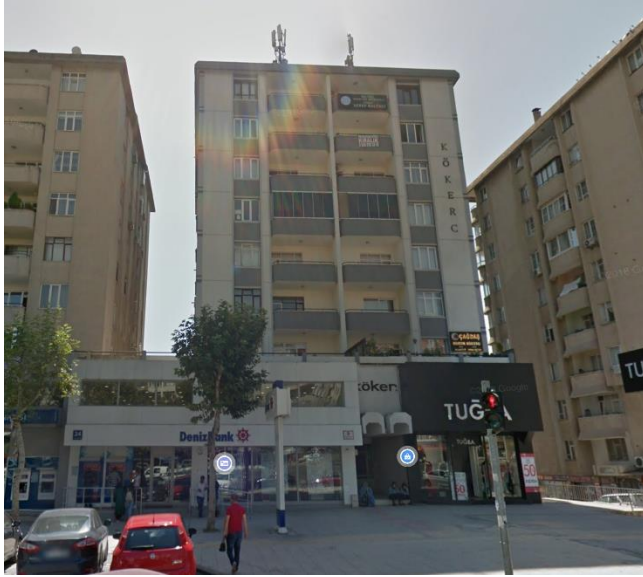
(a) Source: Google Street View (37.575, 36.93) 2018.

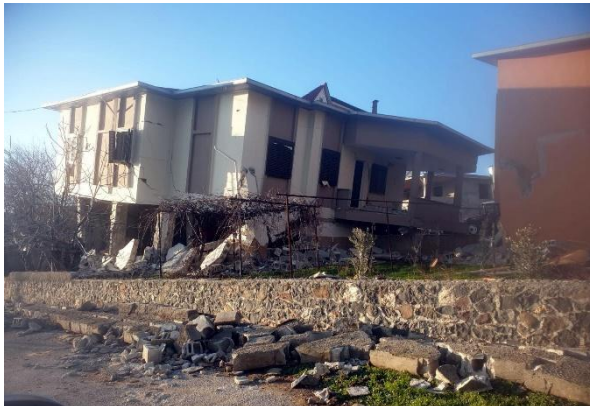
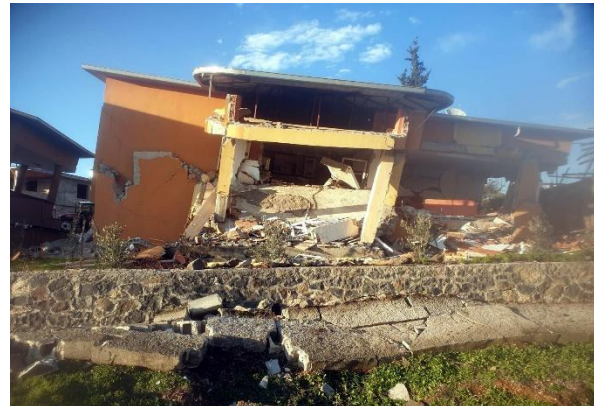
Figure 4.13. First story collapse of single-family RC residential buildings in Tevekkelli possibly due to weak and soft-story failures (Source: [Veryansin TV 2023](#)).

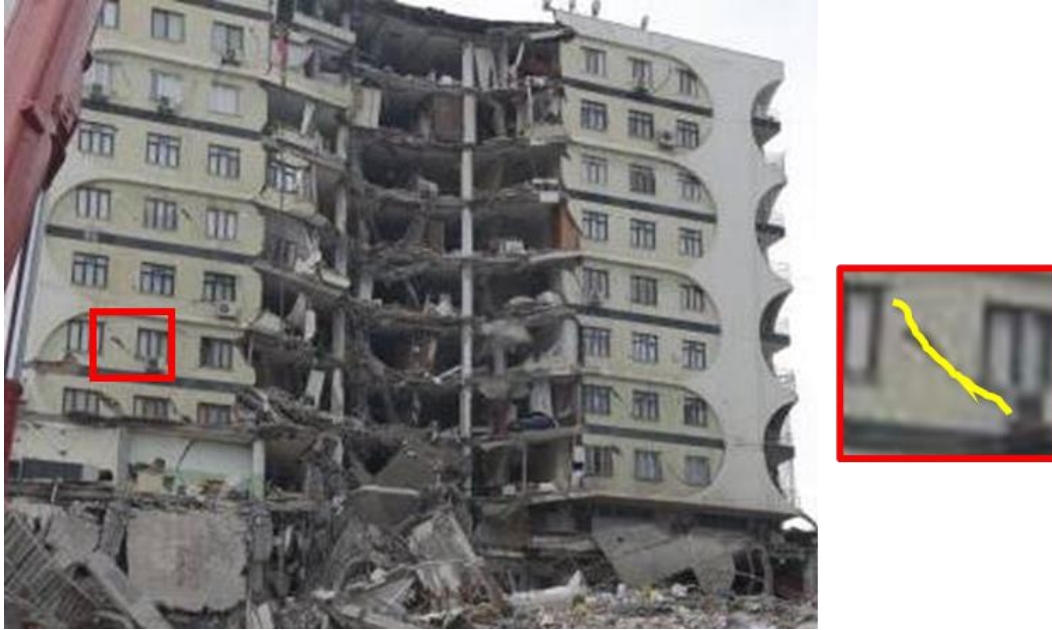
Figure 4.14. Partially collapsed building showing major diagonal cracks (refer to the insert) on the remaining towers, Diyarbakir (Source: [Getty Images](#)).

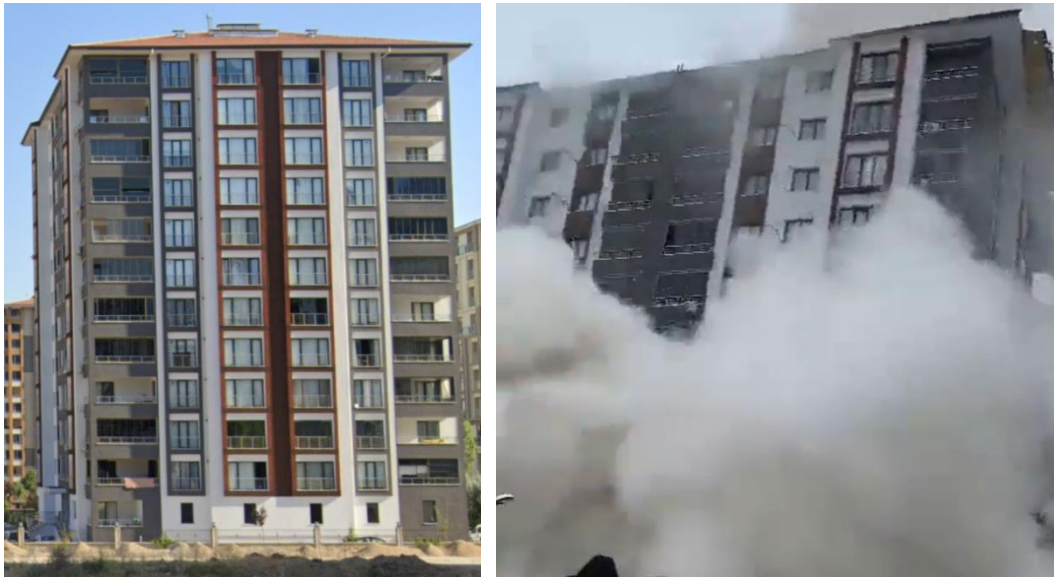
Figure 4.15. New residential towers before the earthquake sequence and during collapse due to the second earthquake (Mw 7.5), Bostanbasi, Malatya (38.32189N, 38.24656E) (Source: [Google Maps](#) & [Ibrahim Haskologlu via Twitter](#)).

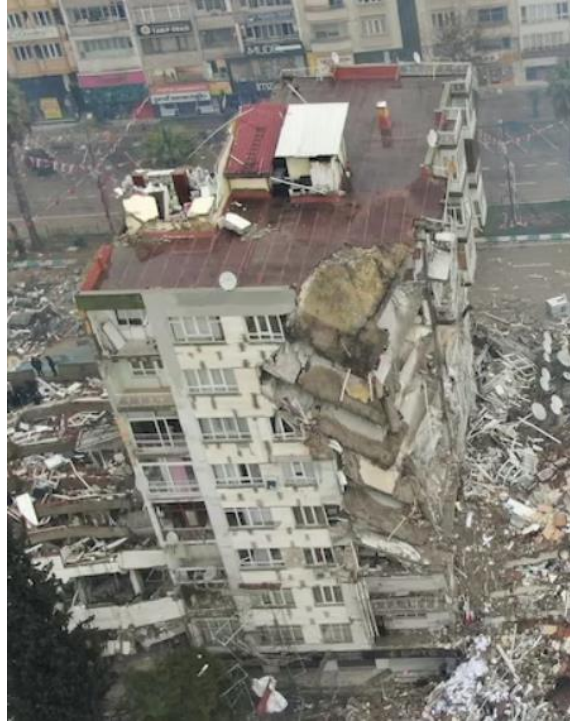
Figure 4.20. Partially collapsed of a multi-story building in Kahramanmaras, February 6 (Source: [Ihlas News Agency \(IHA\) via Reuters 2023a](#)).

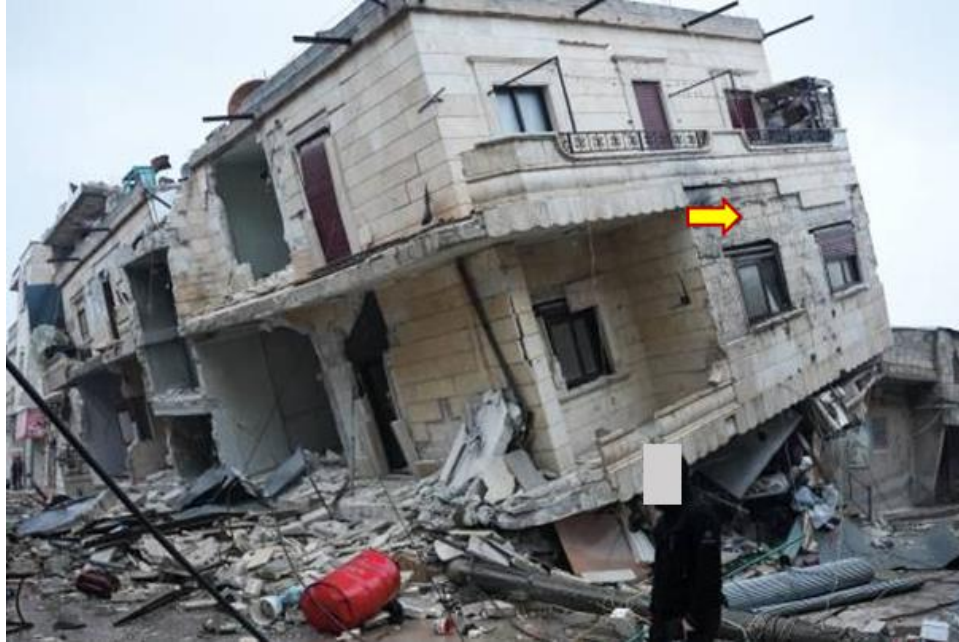
Figure 4.21. Soft-story collapse of a multi-family low-rise unreinforced masonry building in Aleppo (Source: [RAMI AL SAYED/AFP](#)).

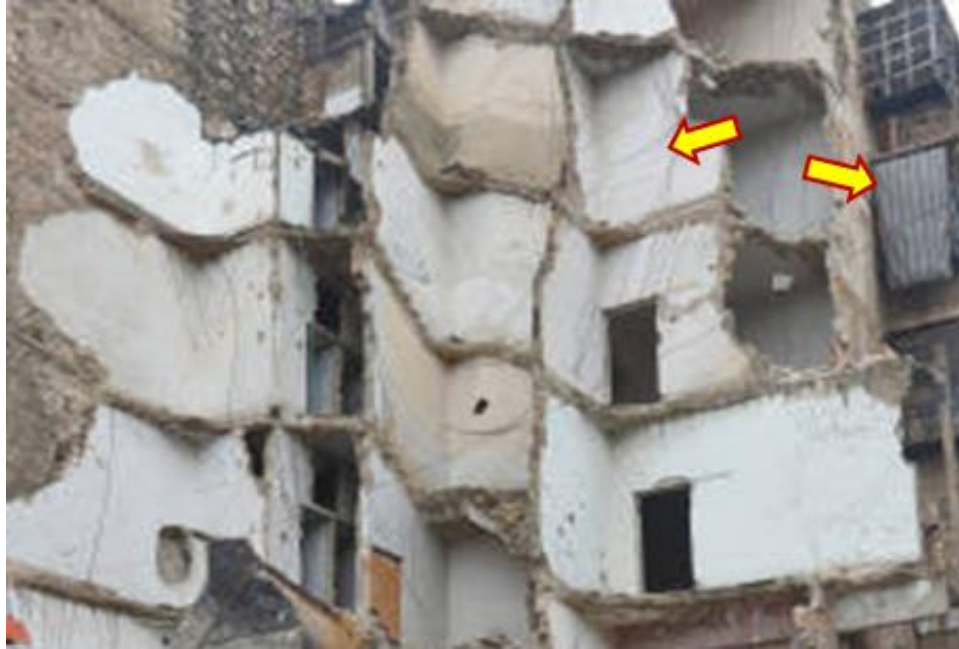
Figure 4.23. Ruins of a collapsed masonry building in Aleppo (Source: [LOUAI BESHARA/AFP, Getty Images](#)).

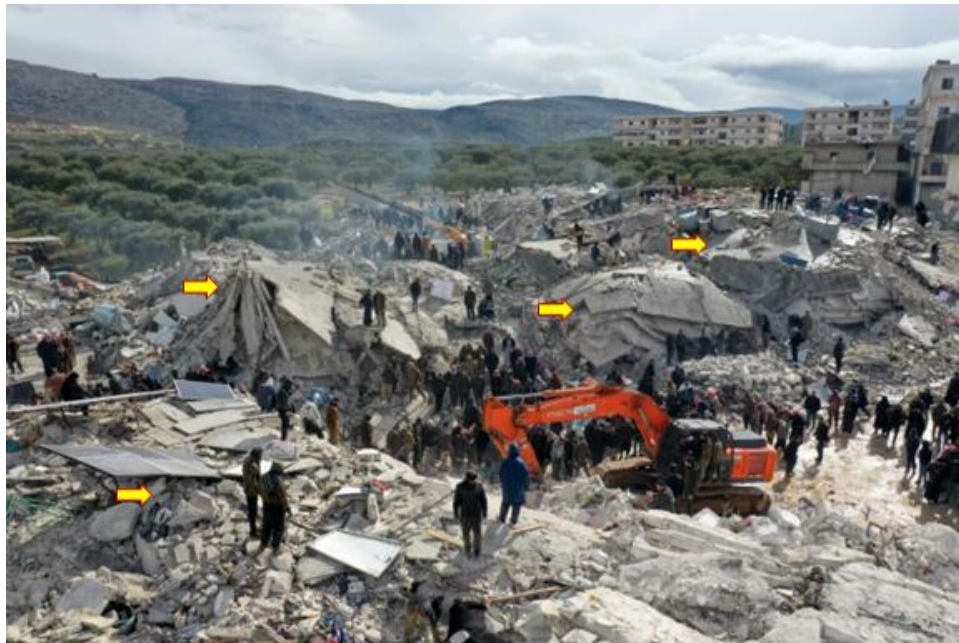
Figure 4.25. Pancaked collapse of masonry and RC buildings (shown with arrows) in Besnaya, Reef Idlib (Source: [AFP via npr.org](#)).

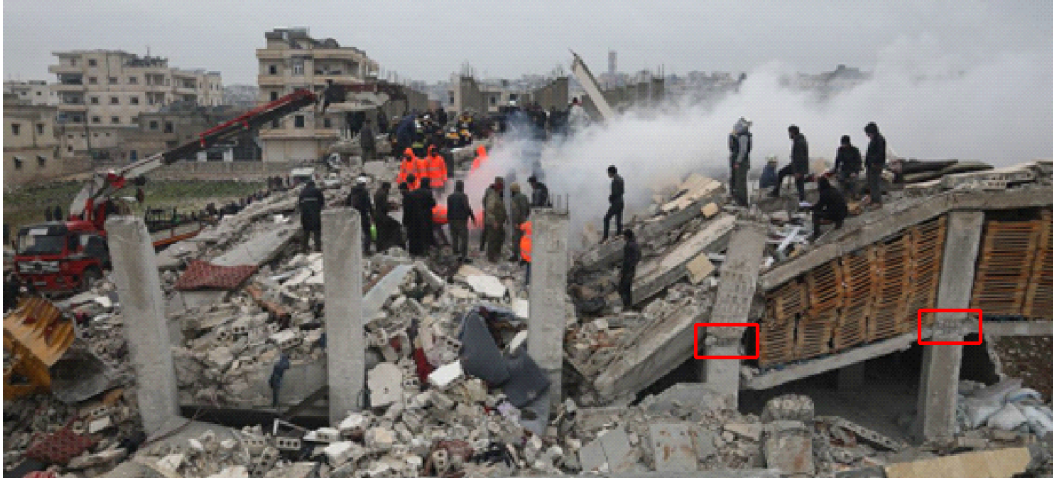
Figure 4.28. Slab failure in a collapsed building in Samada, Northern Syria (Source: <https://news.un.org/en/story/2023/02/1133177>). Notice the complete damage to the slab-column connection in the two right columns.

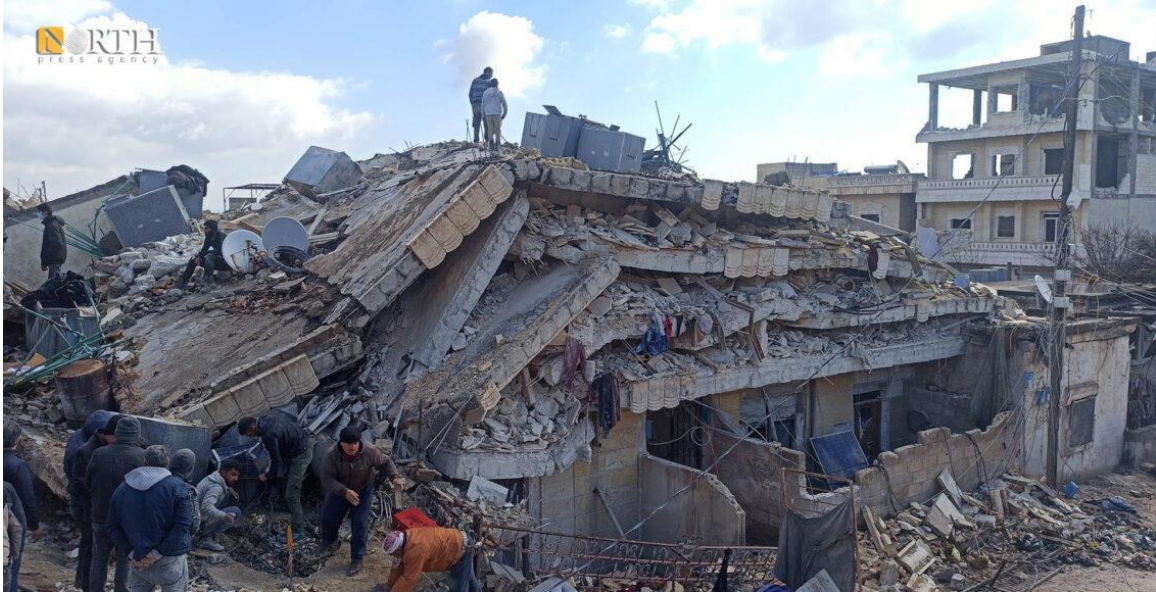
Figure 4.34. Pancaked concrete ribbed slab failure, likely built on unreinforced masonry bearing walls in Jinderis, Northern Syria. Notice the ribbed slab RC construction of the right neighboring building (Source: [NPASyria](#)).
