StEER-EERI: 2023 Mw 7.8 Kahramanmaraş, Türkiye Earthquake Sequence Joint Preliminary Virtual Reconnaissance Report (PVRR)

Author(s):

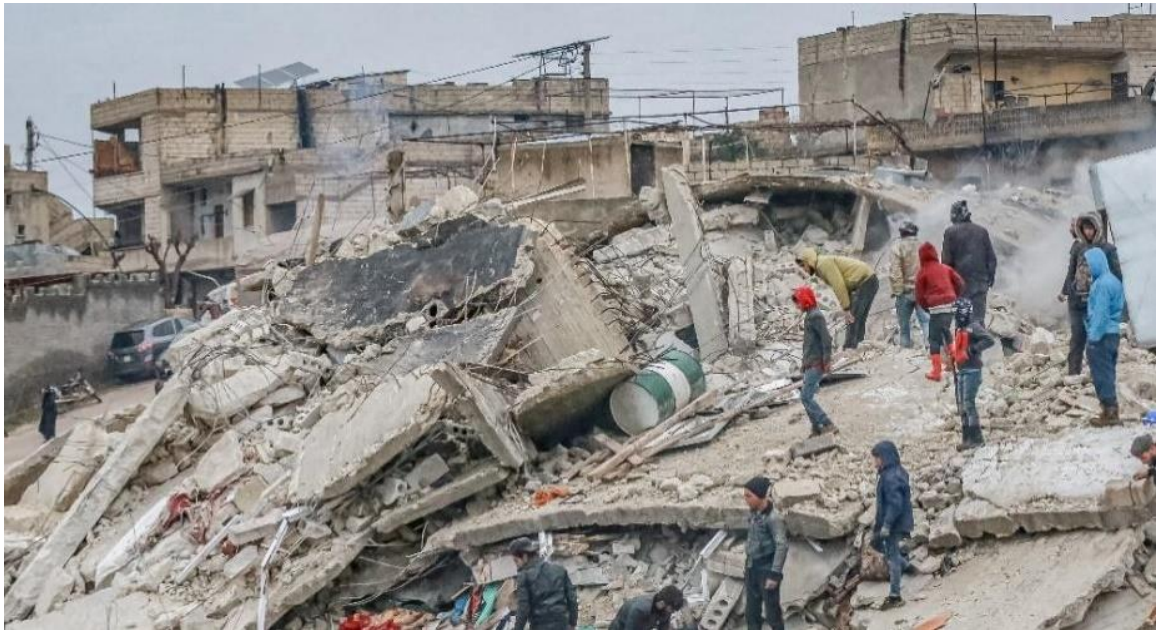
Figure 4.35. Collapsed concrete building near Idlib, Northern Syria. Notice the poor reinforcement of the columns (Source: [AFP](#)).

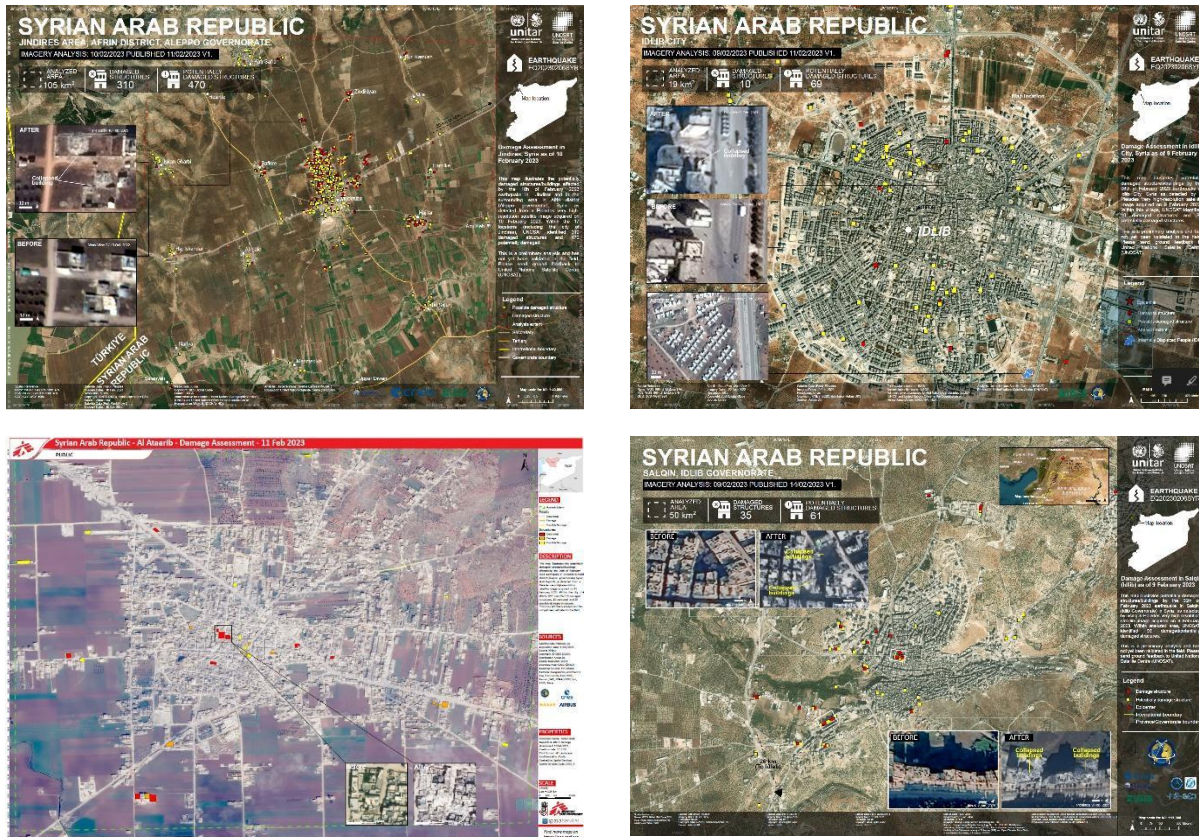
Figure 4.36. Damage assessment by UN satellite imagery of Northern Syria (Source: [Reliefweb](#) (left), [Reliefweb](#) (right)).

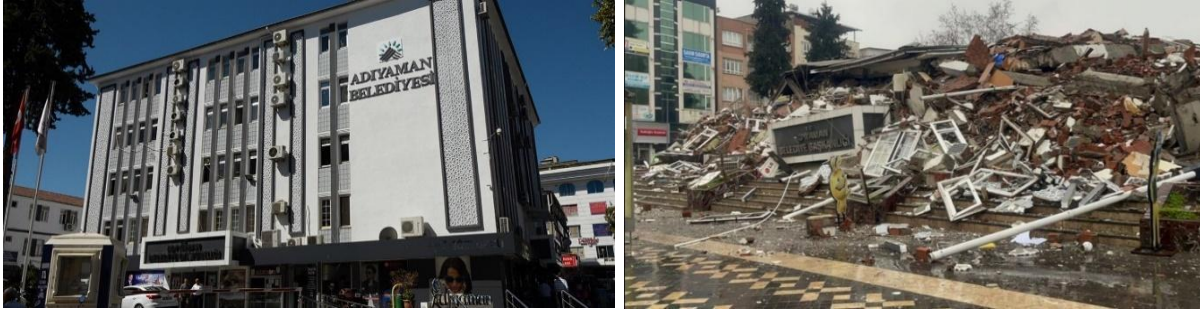
Figure 4.39. Adiyaman municipality building before and after the earthquake sequence (38.2441N, 36.9151E) (Source: [Twitter](#)).

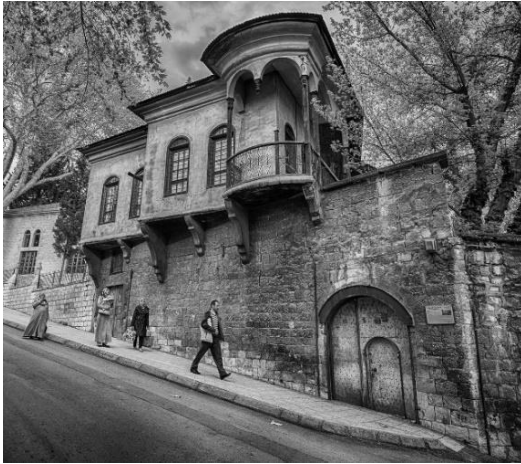
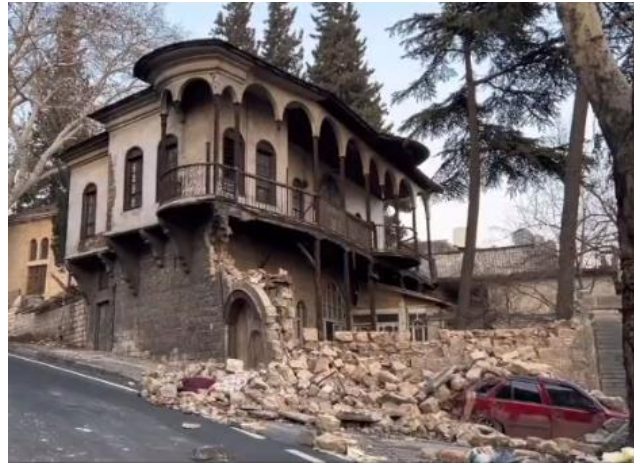
(a) Pre-earthquake sequence.

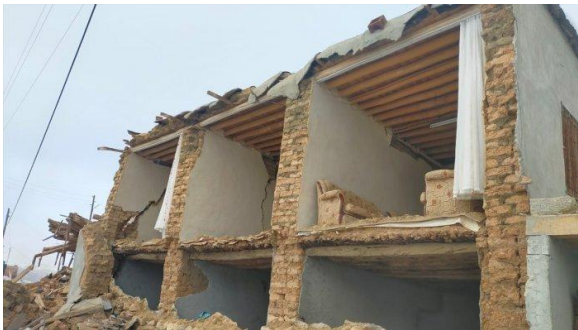
(a) Severely damaged house.

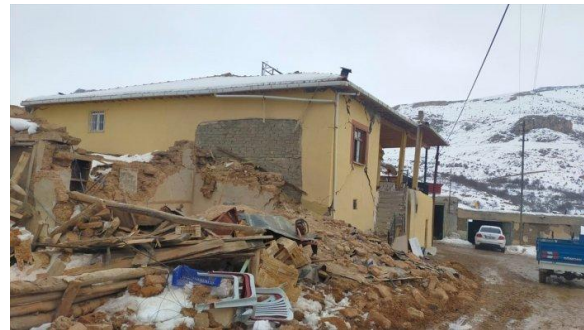
(b) Collapsed house.

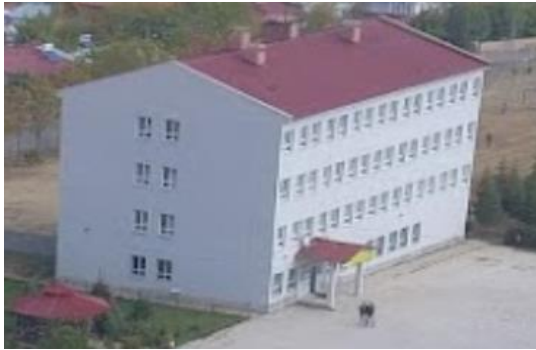
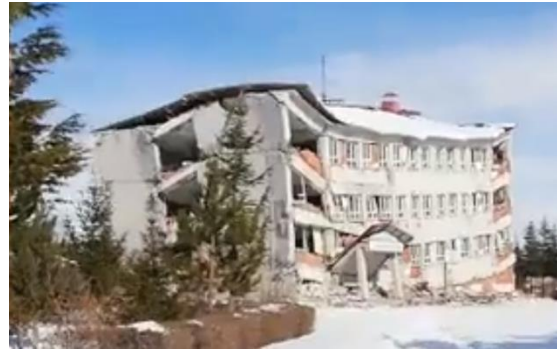
(a) Before the earthquake sequence.

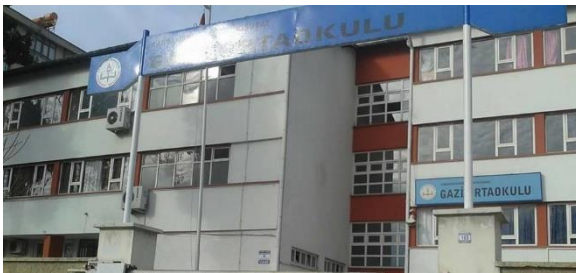
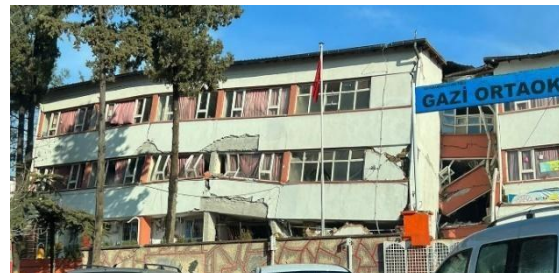
(a) Before the earthquake sequence.

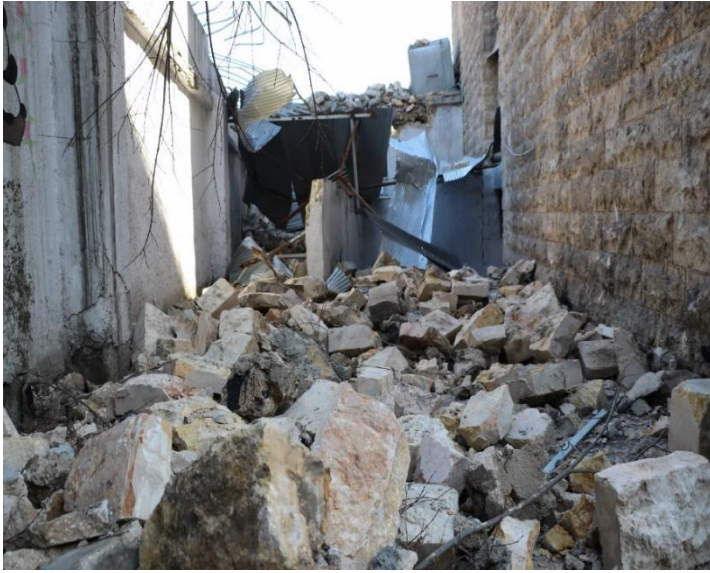
(a) Wreckage of damaged walls.

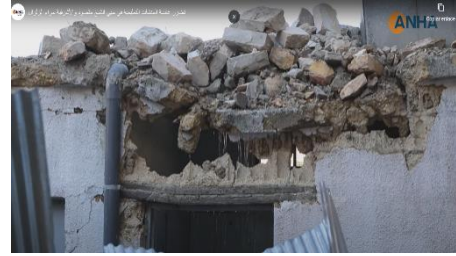
(b) Broken water lines.

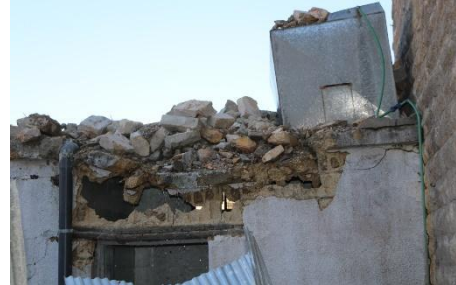
(c) Fallen non-structural component.

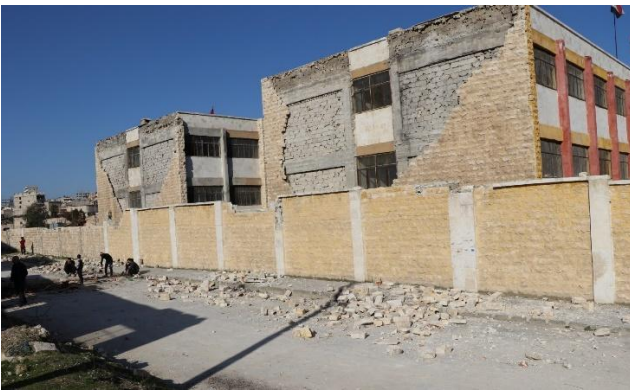
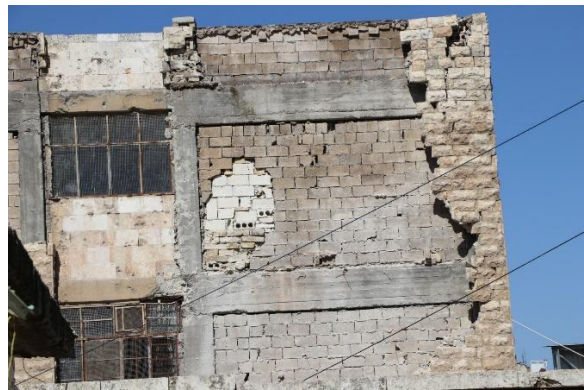
Figure 4.48. Damage at Martyr Judy Amanous School (Source: [ANHA](#)).

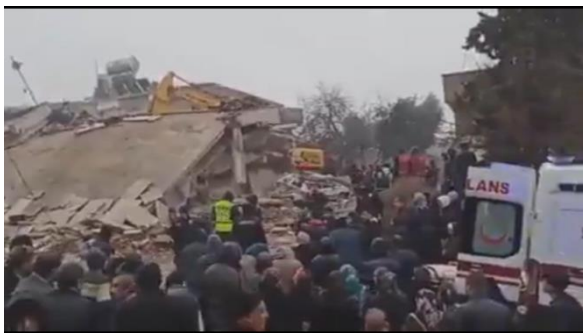
(a) Şanlıurfa City Hospital (Source: [Twitter](#)).

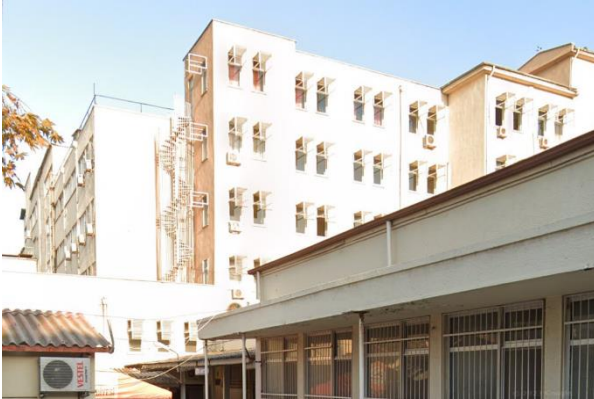
(a) Before the earthquake sequence (Source: [Google Street View](#)).

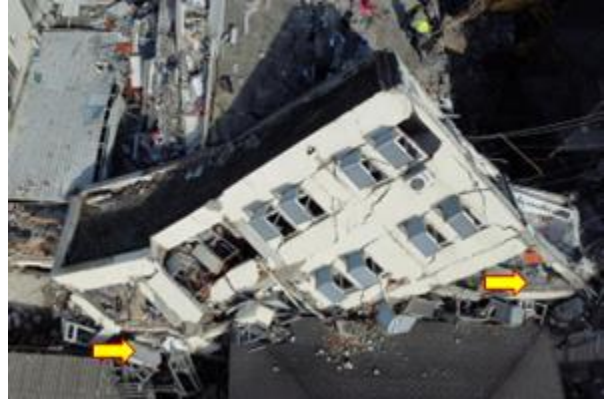
(b) After the earthquake sequence showing three fully collapsed stories of the RC structure (Source: [Reuters via ARAB NEWS](#)).

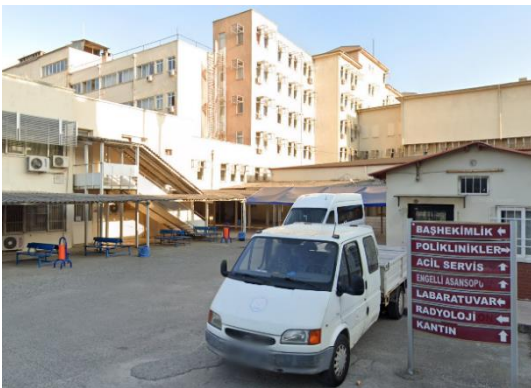
(a) Before the earthquake sequence ([Google Street View](#)).

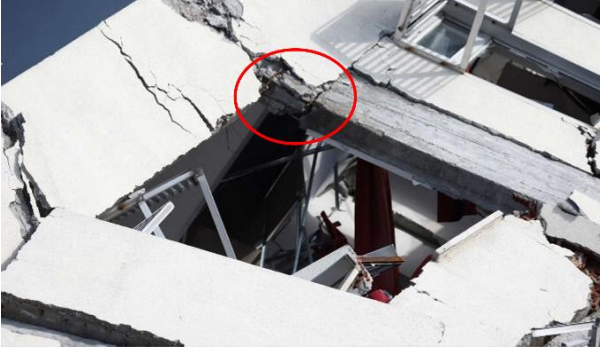
(a) Exposed reinforcing bars in beams and columns with evidence of corrosion, which could limit the ductility of the connection during the earthquake sequence (Reuters via [zawya.com](https://www.zawya.com)).

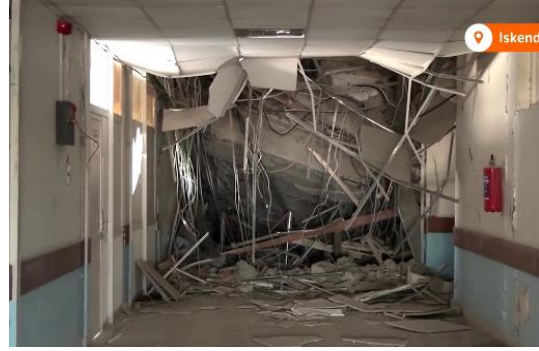
(b) Fallen panels from the ceiling and blocked corridor, indicating loss of functionality and giving evidence of the significant interior damage that can occur even if the exterior looks undamaged (extracted from [Reuters via Twitter](#)).

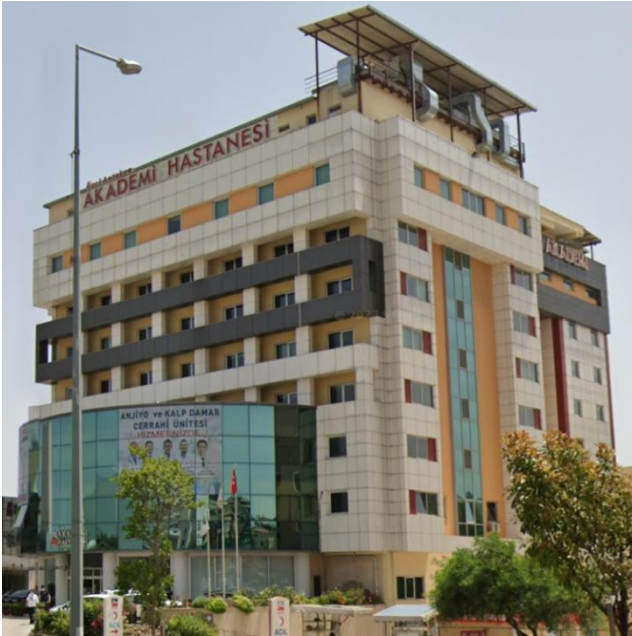
(a) Pre-earthquake view ([Google Maps](#))

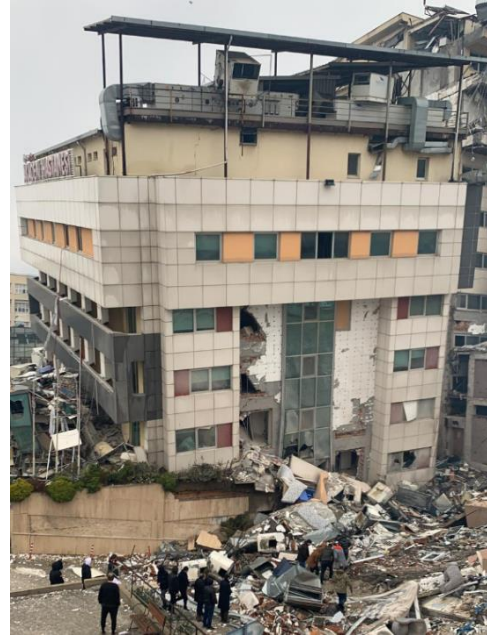
(b) Post-earthquake (3 of 9 stories fully collapsed, with the southern portion more damaged than the northern portion) (Source: [Twitter](#)).

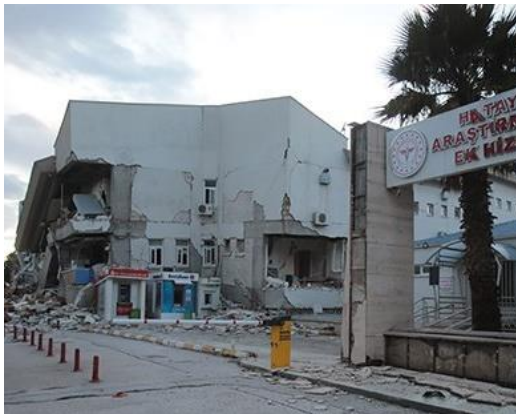
View of the southeast corner of the collapsed facility (Source: [DepoPhotos via Birgun.net](#)).

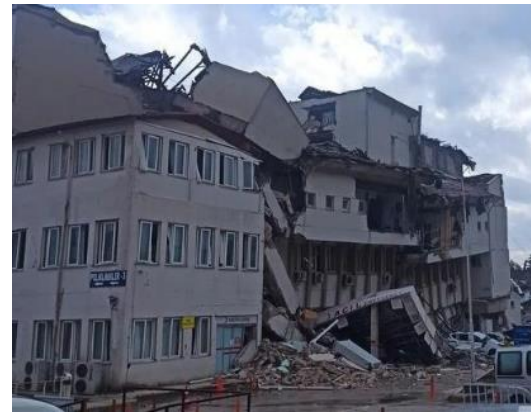
View of the northeast side of the collapsed facility (Source: [Twitter](#)).

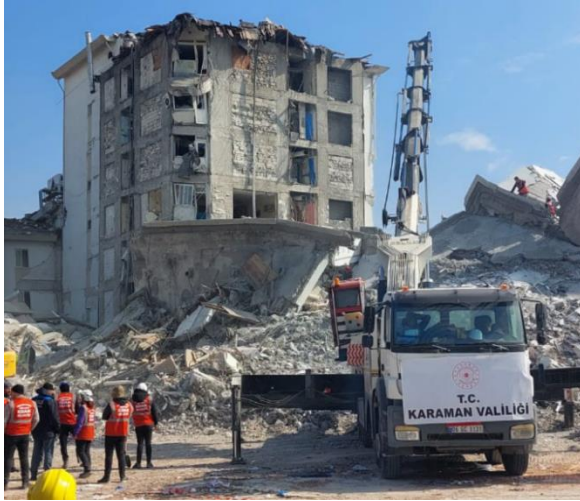
(a) Post-earthquake view from the west of the hospital ([Twitter](#)), showing minimal structural tie-in between the collapsed and still standing portions of the northwest wings of the hospital.

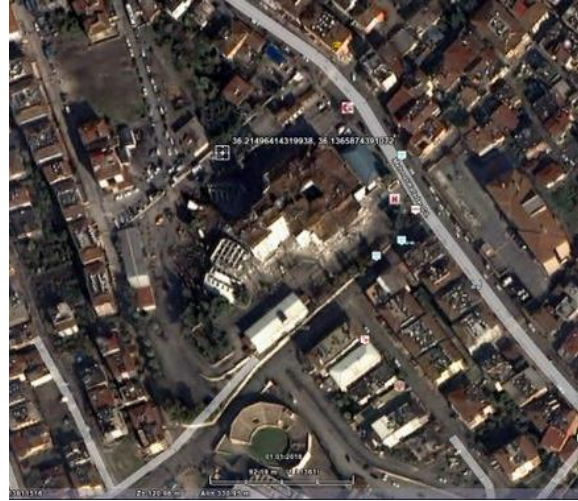
(b) Satellite image, centered on the hospital, showing adjacent infrastructure without total structural failure ([Twitter](#)).

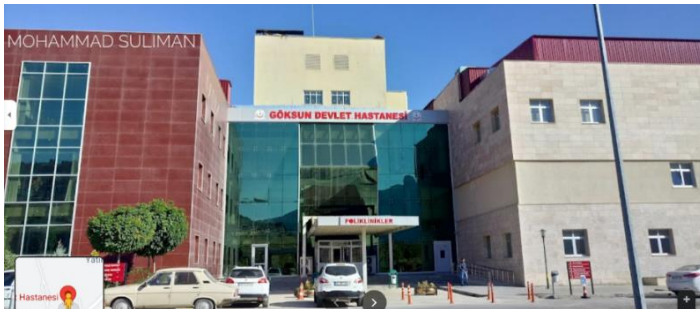
(a) Pre-earthquake ([Google Street View](#)).

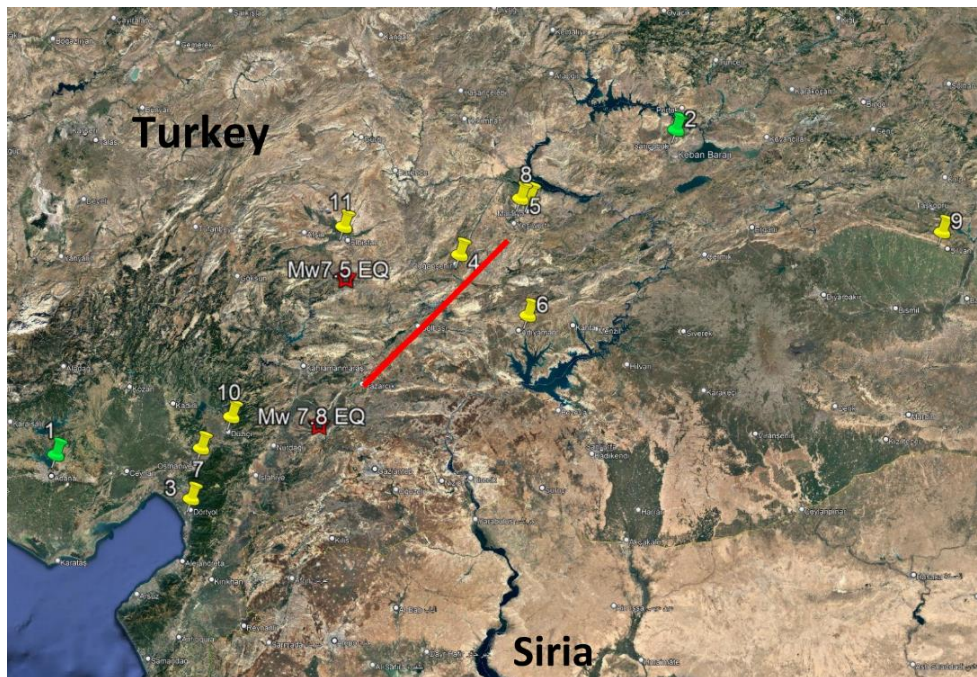
Figure 4.57. Locations of base-isolated hospitals in the regions affected by the earthquake sequence (Image courtesy of Dr. Michael C. Constantinou, University at Buffalo 2023).

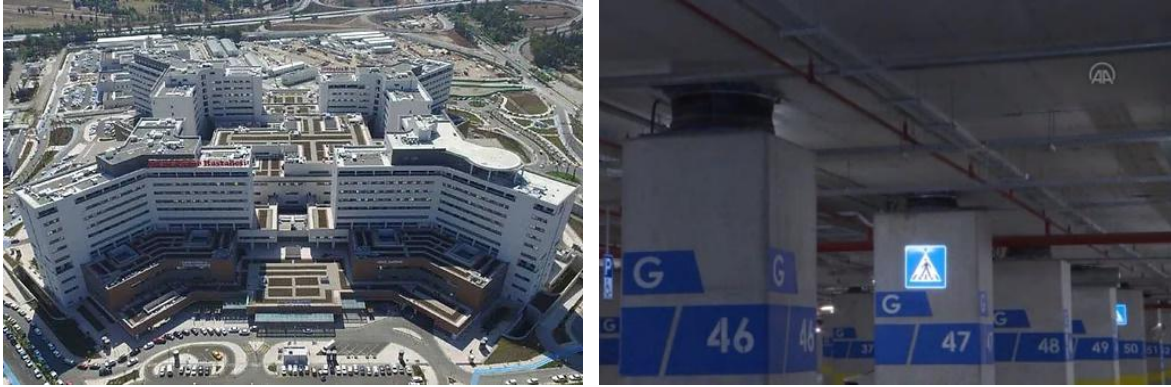
Figure 4.59. Adana City Hospital, 37.0301N 35.3483E (left) (Source: [EPS 2023](#)) and Frictional pendulum-type base-isolation devices in the hospital building (right) (Source: [Anadolu Ajansi 2023](#)).

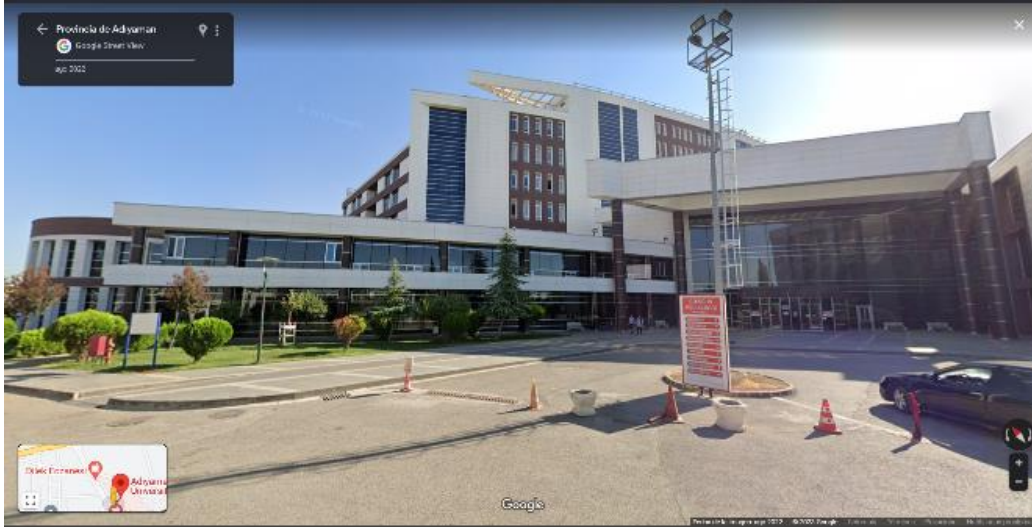
Figure 4.60. Pre-earthquake image of Adiyaman Training and Research Hospital, Adiyaman province, 37.7675N 38.3228E (Source: [Google Street View](#)).

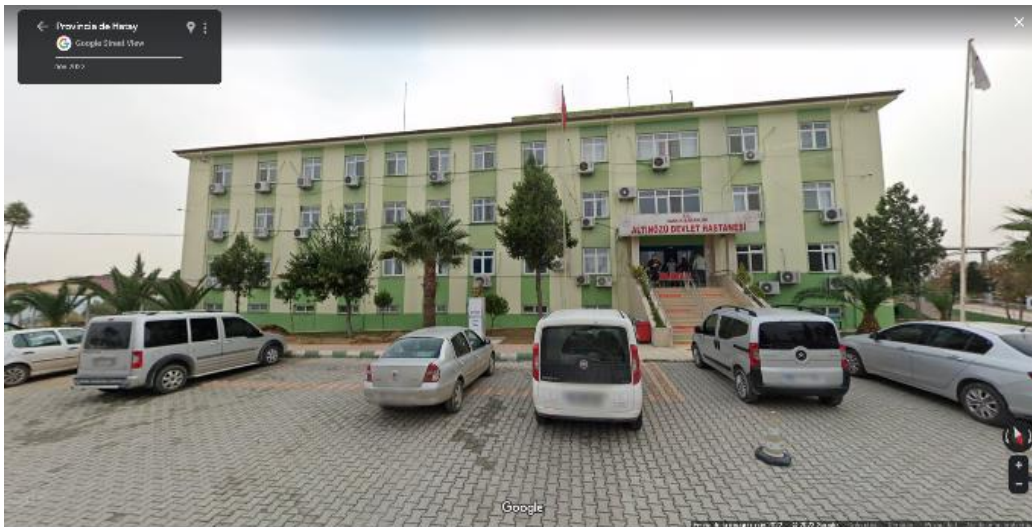
Figure 4.61. Pre-earthquake view of Altinozu State Hospital, Hatay province, 36.1120N 36.2437E (Source: [Google Street View](#)).

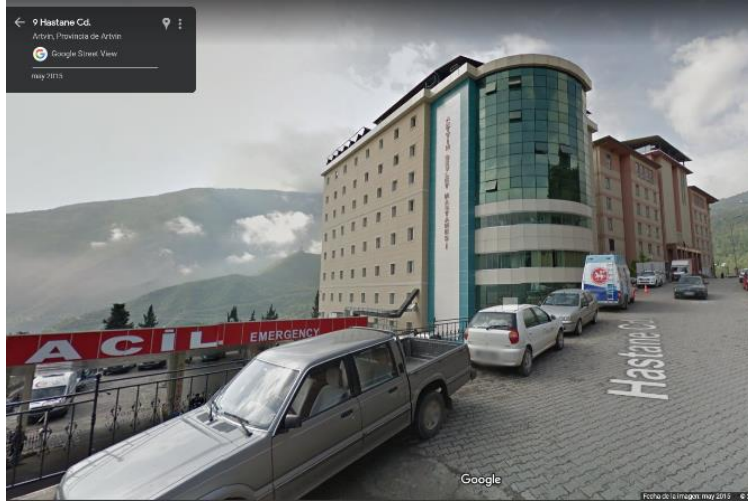
Figure 4.62. Pre-earthquake image of the Artvin State Hospital, Kahramanmaraş province, 37.5031N 37.3234E (Source: [Google Street View](#)).

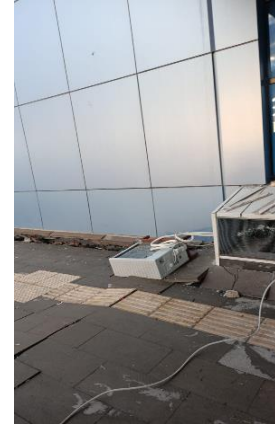
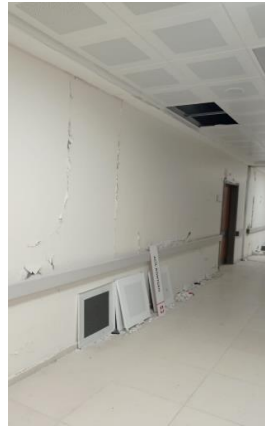
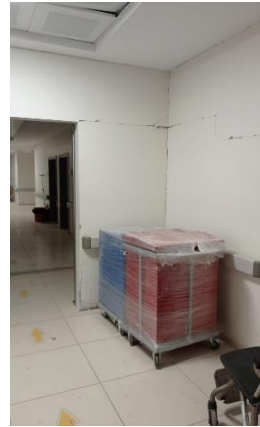
(c) Cracking evident in the covering of multiple gypsum/plaster division walls.

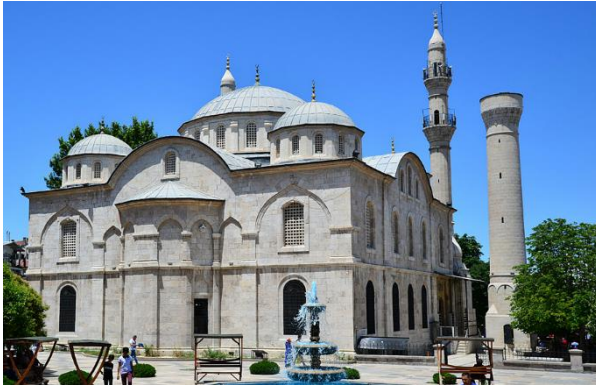
(a) Before the earthquake sequence.

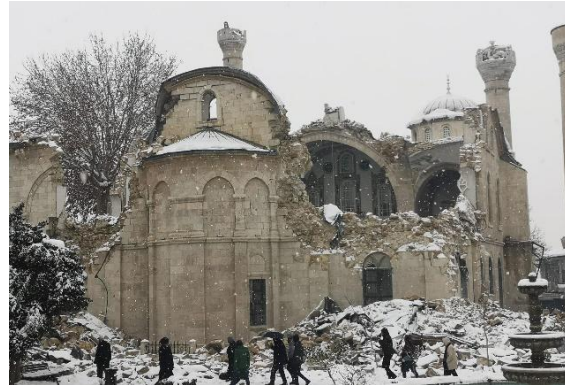
(b) After the earthquake sequence.

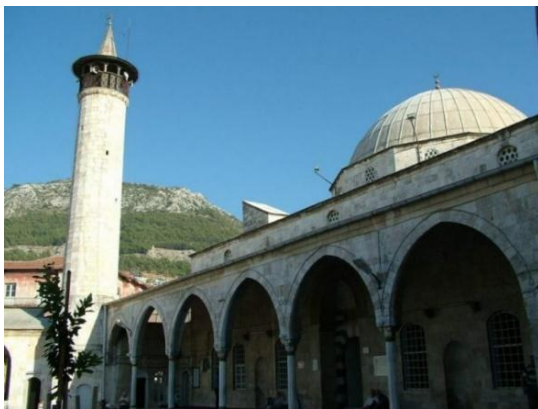
(a) Before the earthquake sequence.

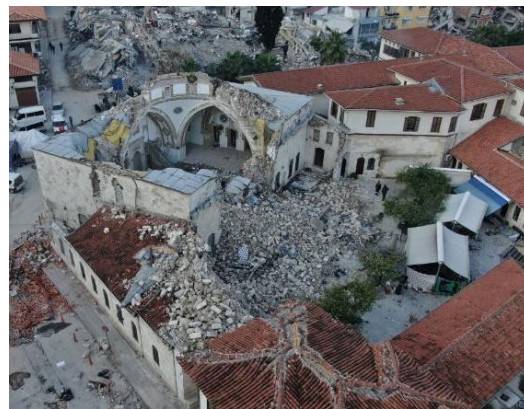
(b) After the earthquake sequence.

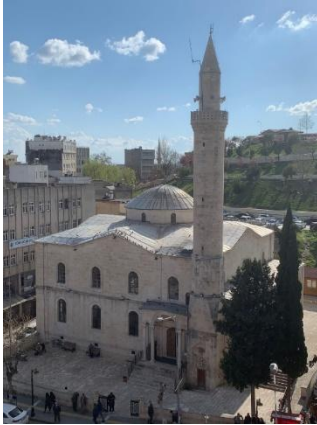
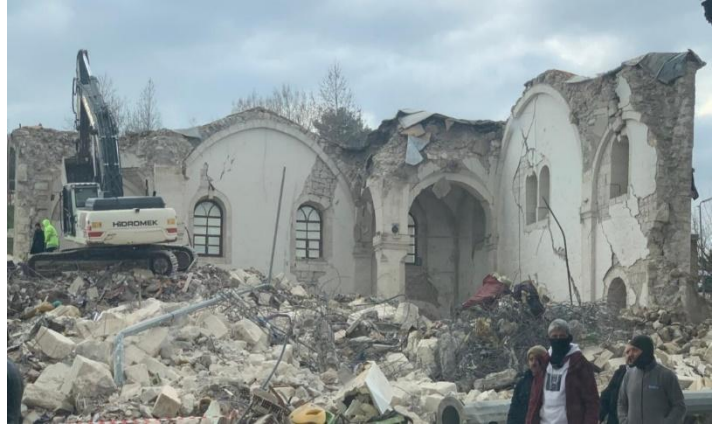
(a) Before the earthquake sequence.

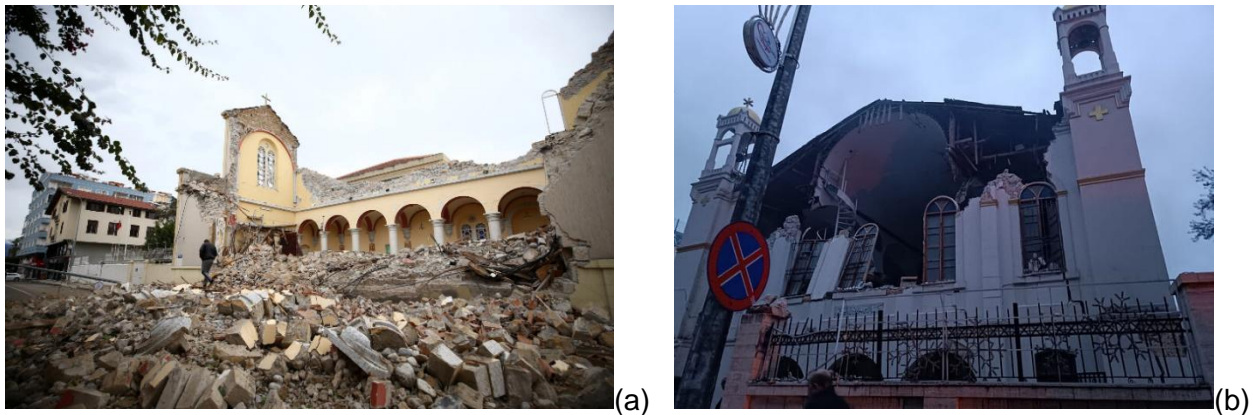
Figure 4.69. (a) Collapse of the arch roof structure of the Cathedral of the Annunciation in İskenderun (36.5876N 36.1655E) (Source: [New Arab 2023](#)); (b) Severe damage to St. Nicholas Orthodox Church in İskenderun due to out-of-plane failure of the gable end wall (36.5875N 36.1706E) (Source: [haber.sat7turk.com](#) 2023).

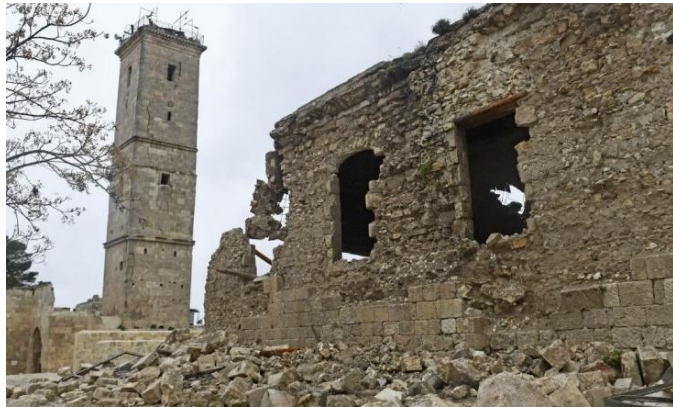
(a) Photograph from July 3, 2016.

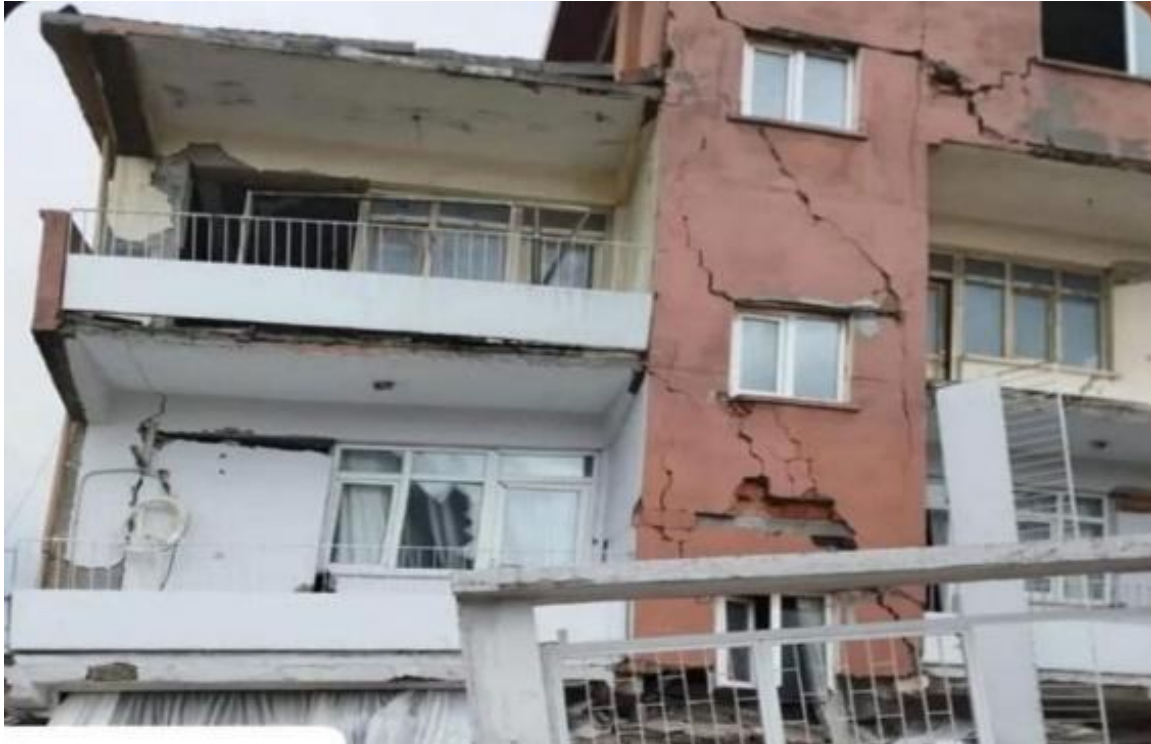
Figure 4.73. Examples of nonstructural components (bricks and parapets), which can be a falling hazard, in a residential building in Hatay, Türkiye. It was also announced that residents were stuck in the stairwell (Source: [Ozgur via Twitter](#) 2023).

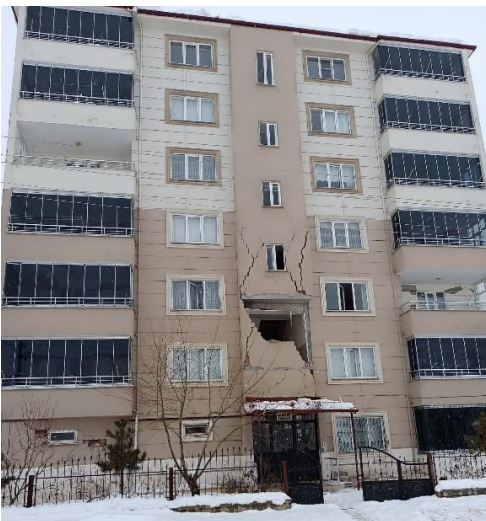
Exterior and interior infill walls experienced extensive damage during the earthquake sequence. Figure 4.75 shows the typical damage of nonstructural infill walls. These types of infill walls are reported in many buildings with low to high level damage to the structural system. The building shown in this figure was carefully inspected by a team on the site, and the building is reported to have medium level damage. Proper design of nonstructural infill walls would mitigate the damage level to these drift-sensitive nonstructural systems. The structure in Figure 4.75 can be considered as a case where the infill walls provided beneficial effects to the structural response.

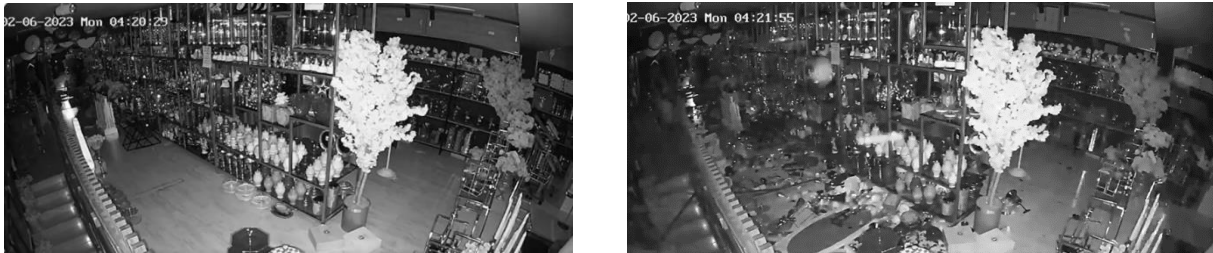
Figure 4.76. Items fallen off shelving units at a store in Gaziantep, Türkiye (Left: Before earthquake sequence; Right: After earthquake sequence) (Extracted from [Twitter](#) video).

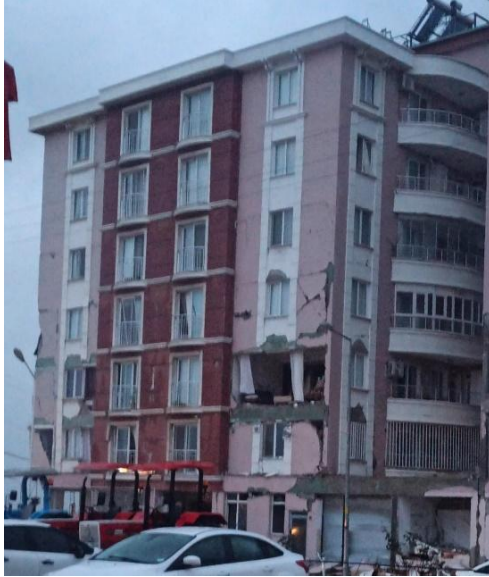
(a) Residents had difficulty exiting the building due to stairwell collapse (Source: [Tommy Shelby via Twitter](#)).

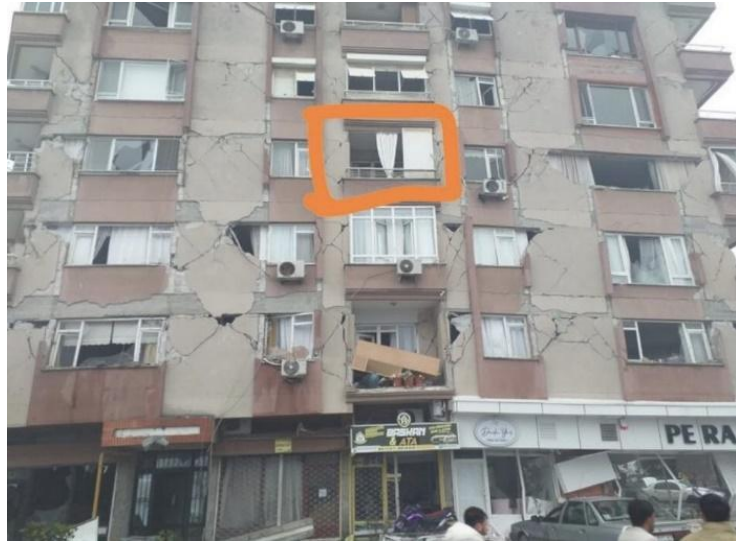
(b) Residents sought help from a rescue team as they were stuck inside the building due to stairwell collapse (Source: Husamettin Dogan via [Twitter](#)).

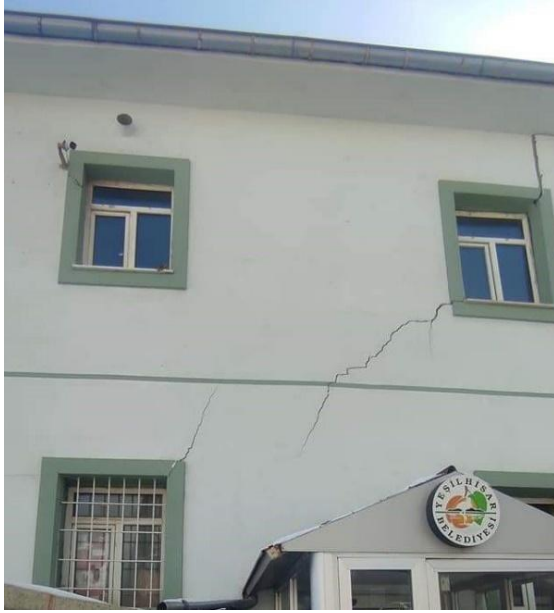
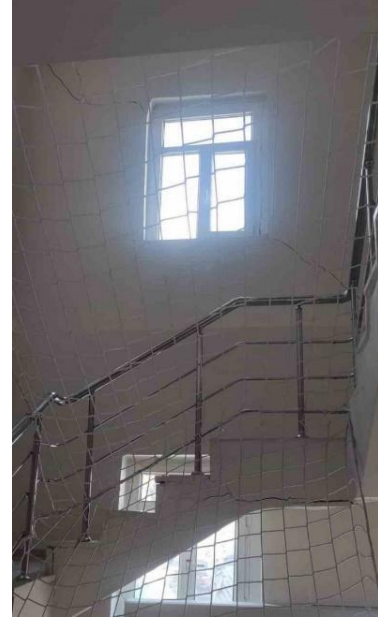
(a) Diagonal tension cracks of building exterior wall. (b) Crack parallel to stair run direction.

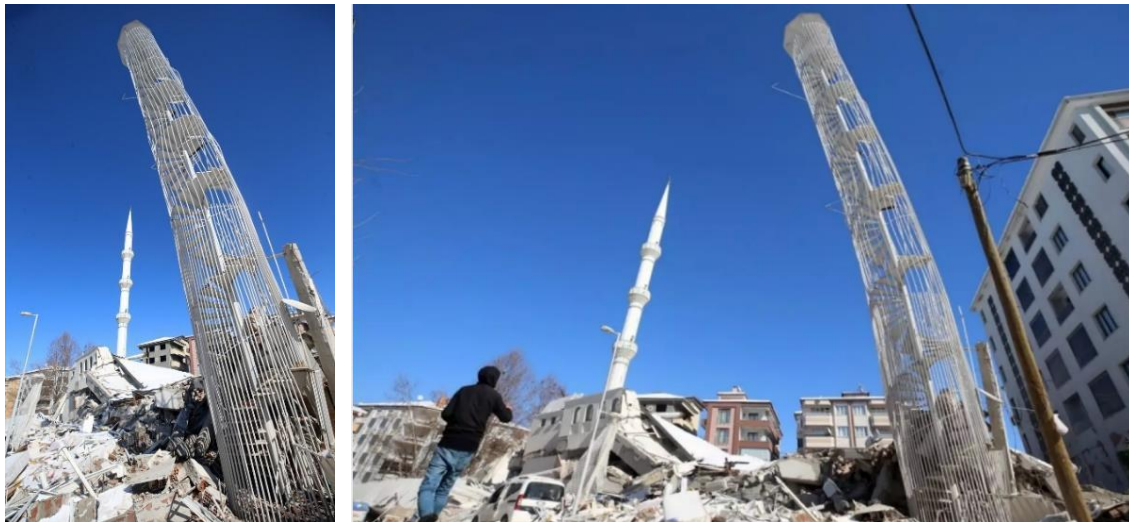
Figure 4.80. A 5-story RC building collapsed, but the steel stair stood alone, Malatya, Türkiye (Source: [TRHaber](https://www.TRHaber.com) 2023).

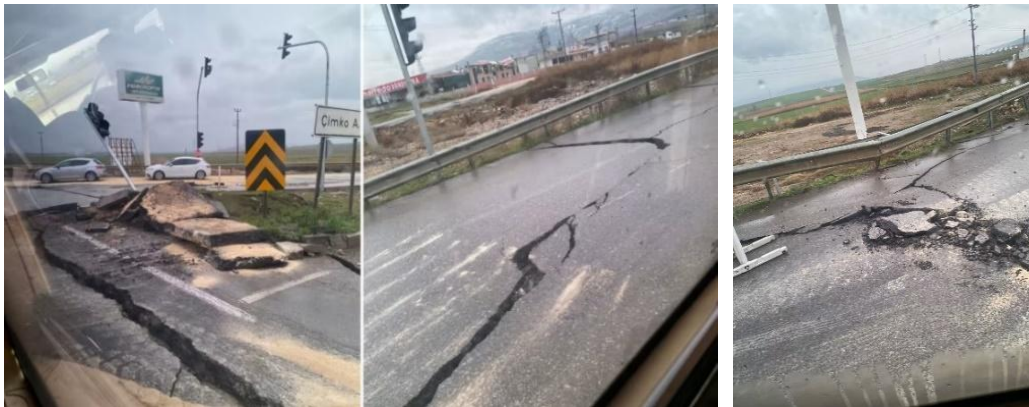
Figure 5.2. Surface failure of roadway (Source: [Channel News Asia](#)).

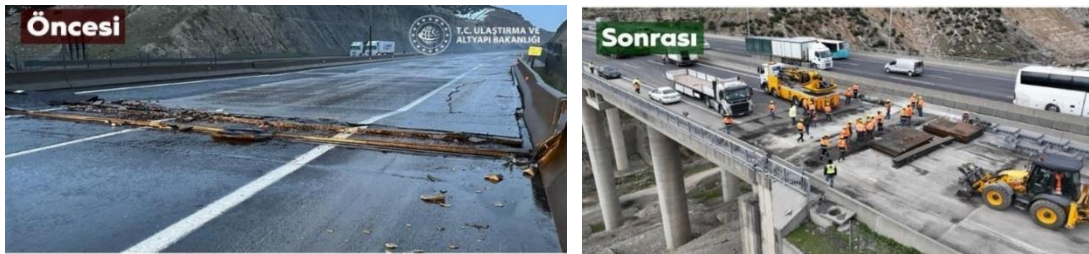
Figure 5.4. Damage and repair work of an expansion joint of a bridge on Adana-Gaziantep Highway (Source: [Twitter](#)).

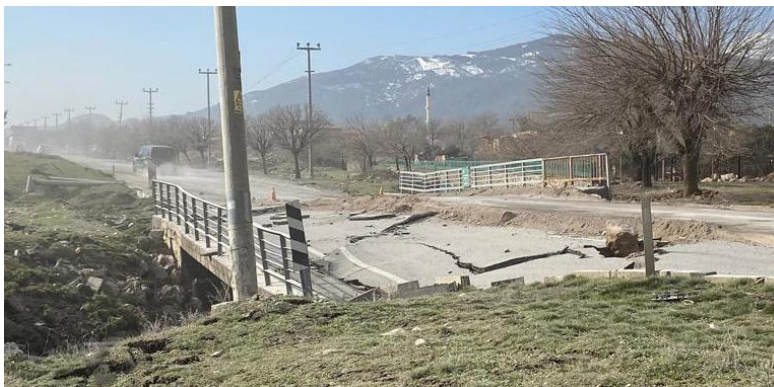
Figure 5.5. Extensive damage at the deck of Şekeroba Bridge (Source: [Olay53](https://www.olay53.com)).

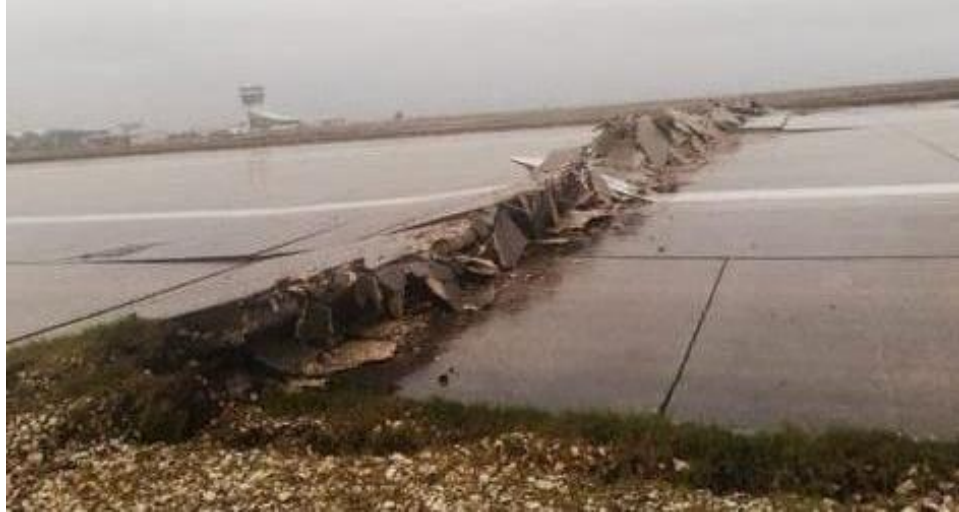
Figure 5.7. Hatay Airport in southeastern Türkiye has suspended operations due to runway damage caused by the earthquake sequence (Source: [Twitter](#)).

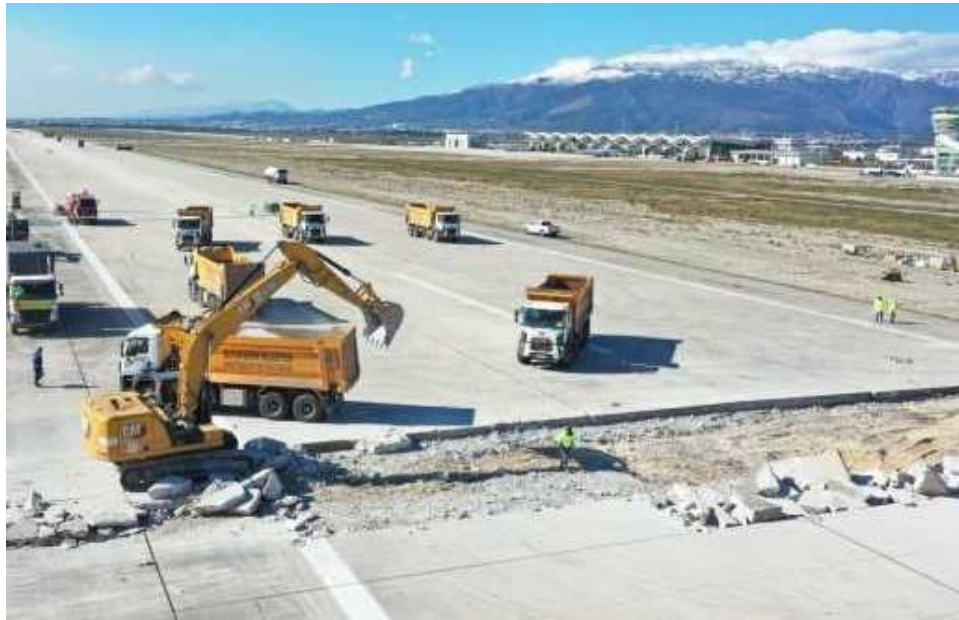
Figure 5.8. Image posted on February 8 1:04 am documenting repair work on the Hatay airport runway (Source: [Railynews](#)).

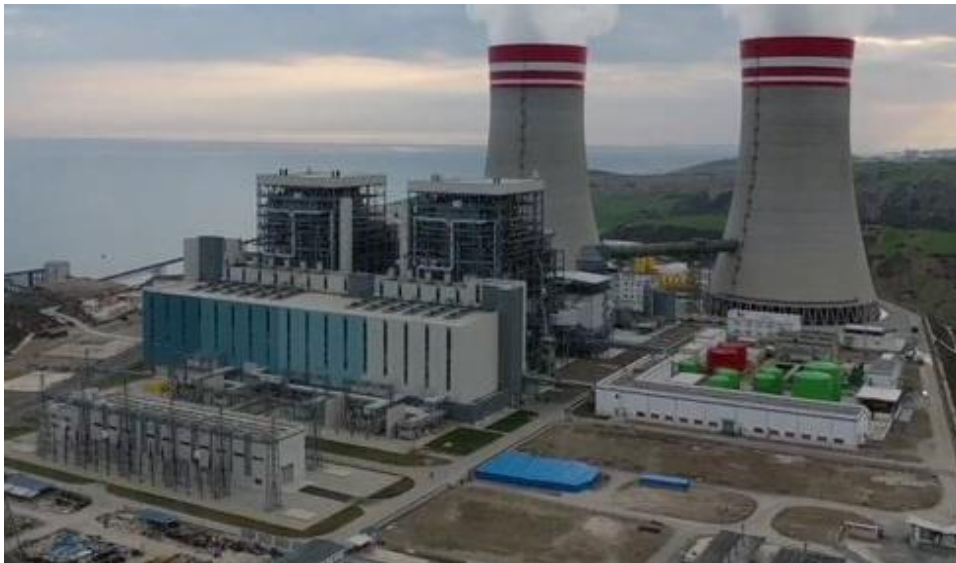
Figure 5.10. Undamaged Hunutlu thermal power plant in the Adana province (Source: [Twitter](#)).

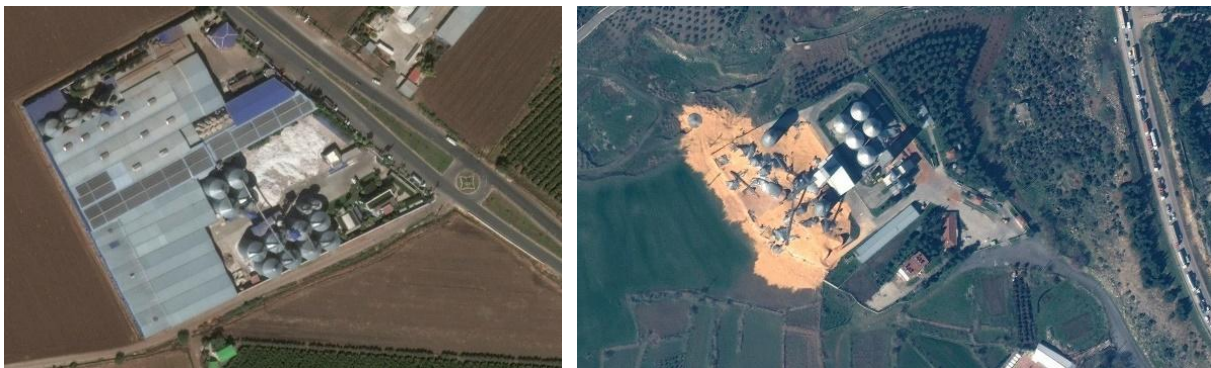
Figure 5.12. Aerial views of the damage of grain silos near Kırıkhan (Left) and near Nurdağı (Right) (Source: [CNN](#)).

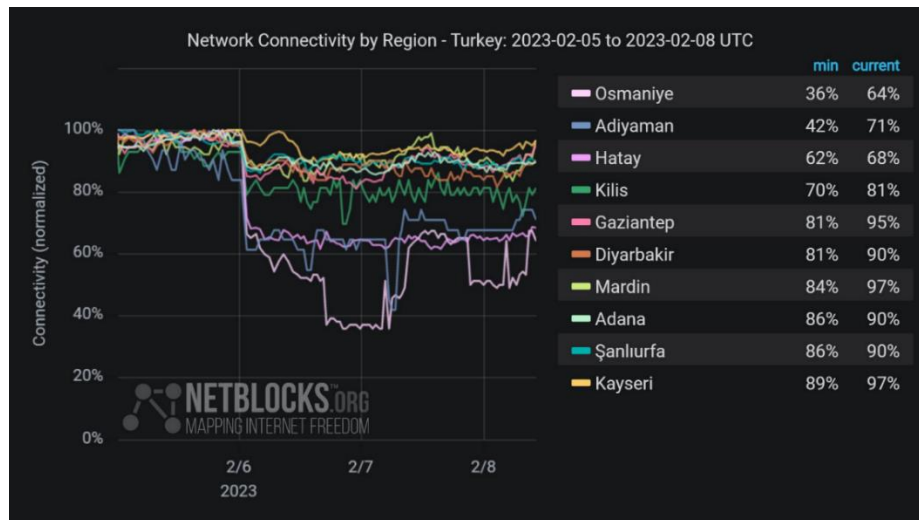
Figure 5.14. Recovery of data infrastructure in cities of Türkiye impacted by the event (Source: [Twitter](#)).

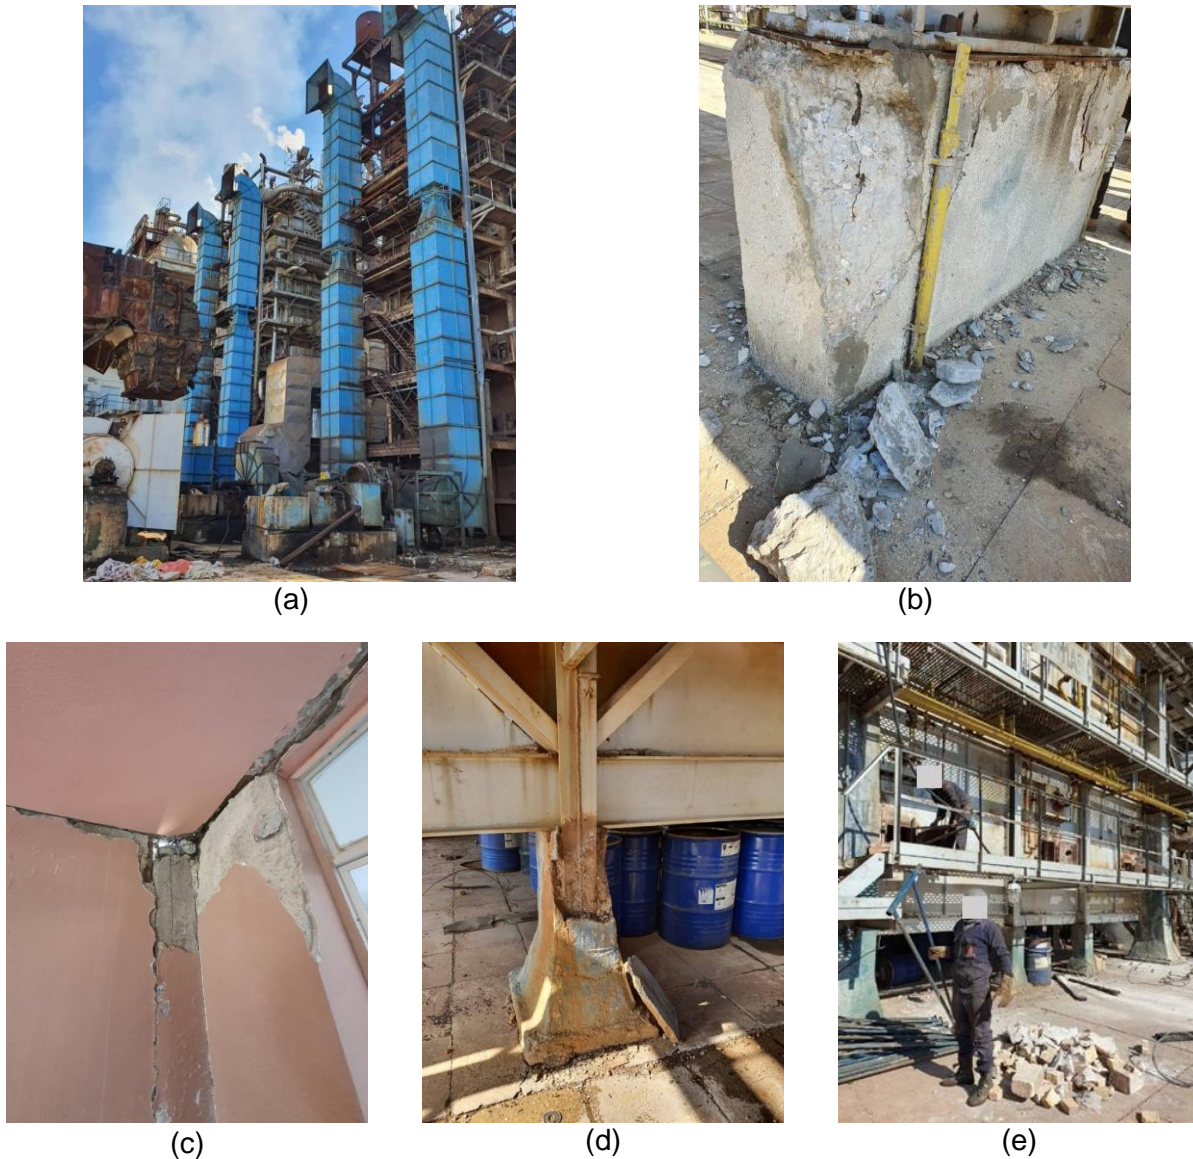
Figure 5.15. Damage of Baniyas Oil Refinery in Syria (Source: [Syrian Ministry of Oil and Mineral Resources](#)).
