StEER-EERI: 2023 Mw 7.8 Kahramanmaraş, Türkiye Earthquake Sequence Joint Preliminary Virtual Reconnaissance Report (PVRR)

Author(s):

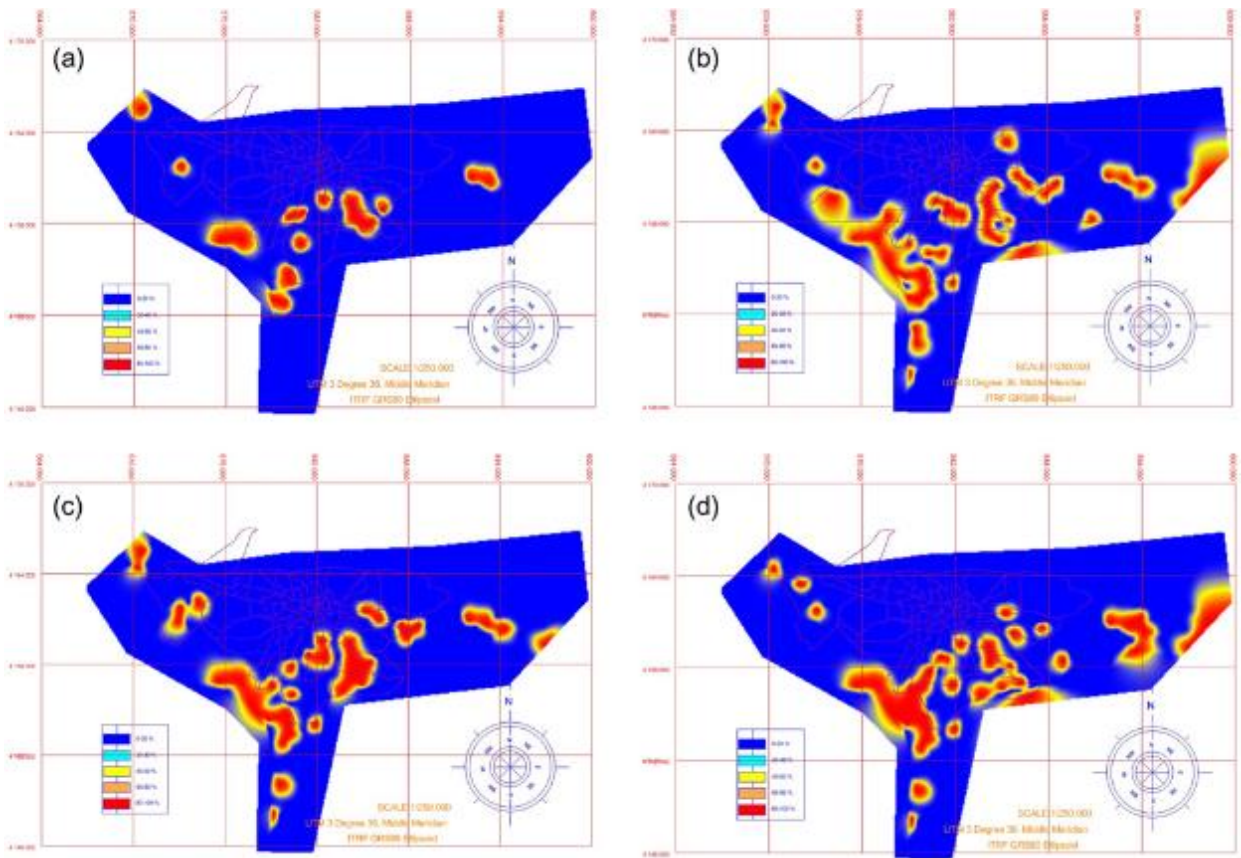
Figure 6.7. The liquefaction map for the Kahramanmaraş region at depths: (a) 1.5 m to 3.0 m, (b) 6.0 m to 7.5 m, (c) 9.0 m to 10.5 m, and (d) 13.5 m to 15.0 m (Cabalar et al. 2019). Note that blue and colors indicate the smallest and largest potential for liquefaction.

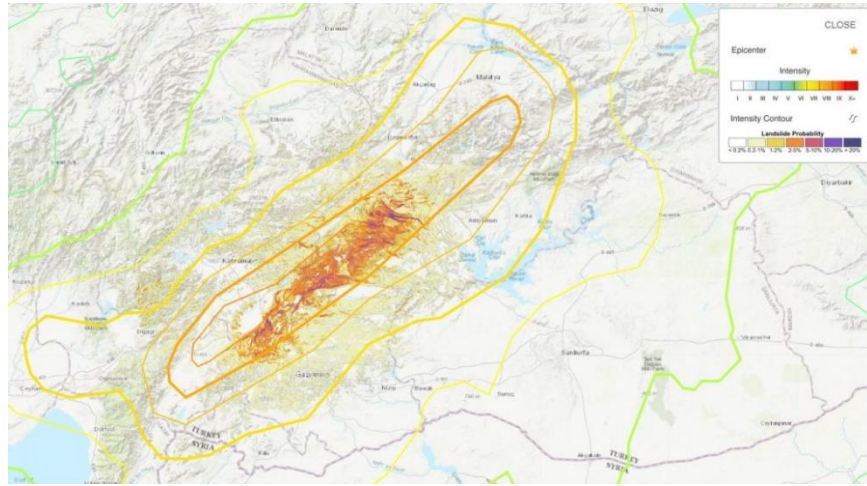
Figure 6.8. Initial USGS landslide probability map for Feb. 6, 2023 earthquake near Nurdağı in Gaziantep, Türkiye.

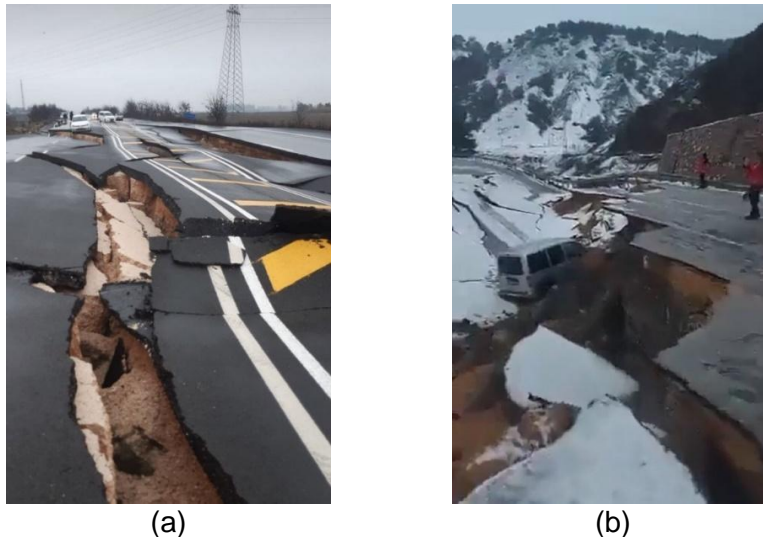
Figure 6.9. (a) Potential lateral spread failure (Source: [Reuters via National Post](#)). (b) Landslide & lateral spreading failure (Source: Extracted from [Sokagin Sesi Gazetesi, Twitter](#)).

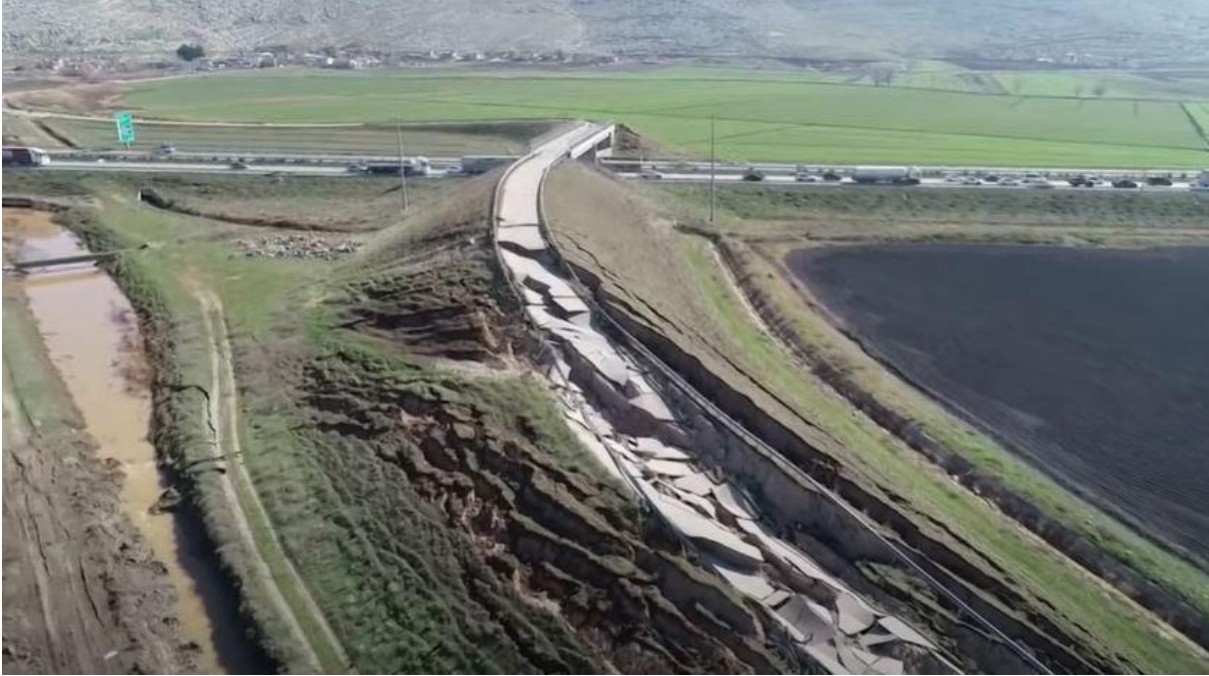
Figure 6.11. Failure of the embankment road in the village of Koseli, which passes over the Adiyaman-Sanlıurfa-Gaziantep Highway in the Adiyaman province (Source: [Reuters via Washington Post](#)).
