Petrinja, Croatia December 29, 2020, Mw 6.4 Earthquake Joint Reconnaissance Report (JRR)

Report

Joint Reconnaissance Team Leaders: Eduardo Miranda, Stanford University Svetlana Brzev, University of British Columbia / SUZI-SAEE Nenad Bijelić, Swiss Federal Institute of Technology Lausanne (EPFL) Field Assessment Structural Team (FAST) Authors: (in alphabetical order) Željko Arbanas, University of Rijeka Marko Bartolac, University of Zagreb Nenad Bijelić, Swiss Federal Institute of Technology Lausanne (EPFL) Vedran Jagodnik, University of Rijeka Damir Lazarević, University of Zagreb Snježana Mihalić Arbanas, University of Zagreb Sonja Zlatović, Zagreb University of Applied Sciences Virtual Assessment Structural Team (VAST) Authors: (in alphabetical order) Andrés Acosta, Stanford University Dimitrios Lignos, EPFL Jorge Archbold, UC Berkeley Ting Lin, Texas Tech University James Bantis, Stanford University Marko Marinković, University of Belgrade Jovana Borozan, SUZI-SAEE Armando Messina, Stanford University Ivana Božulić, EPFL Sebastián Miranda, Univ. del Desarrollo Nikola Blagojević, ETH Zurich Alan Poulos, Stanford University Cristian Cruz, Univ. Técnica Federico Santa María Giuli

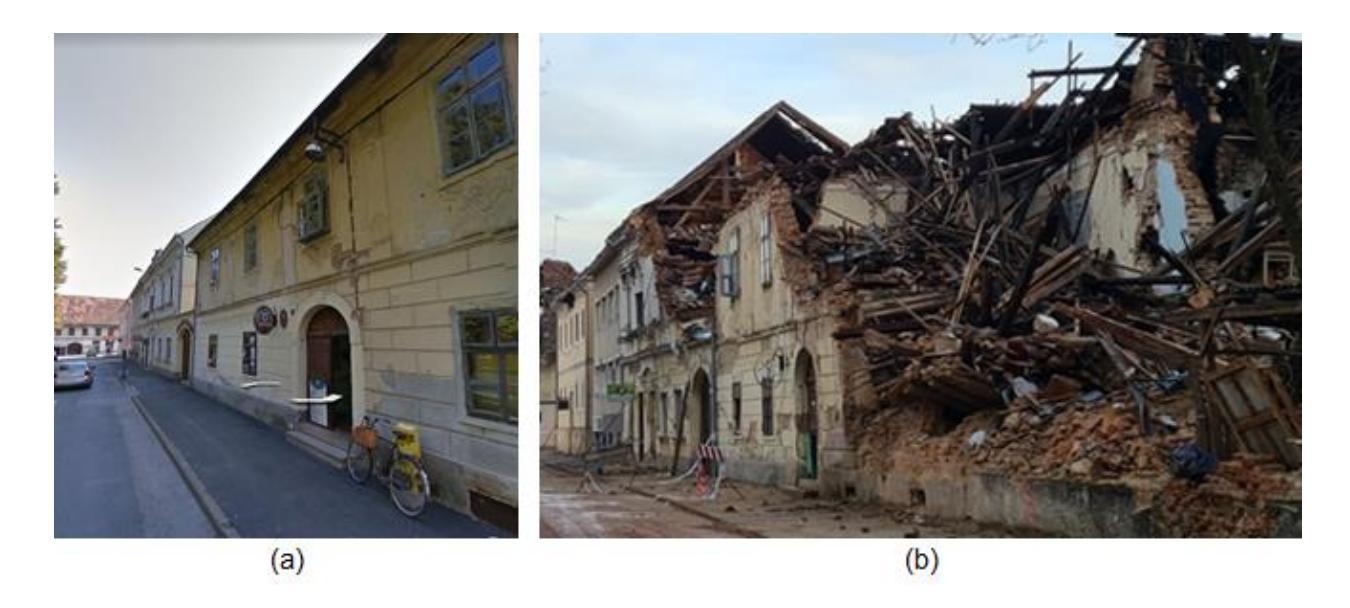
Figure 4.6. Collapsed URM buildings in downtown Petrinja (a) before the earthquake (source: Google Earth) and (b) after the earthquake (source: Nenad Bijelić).

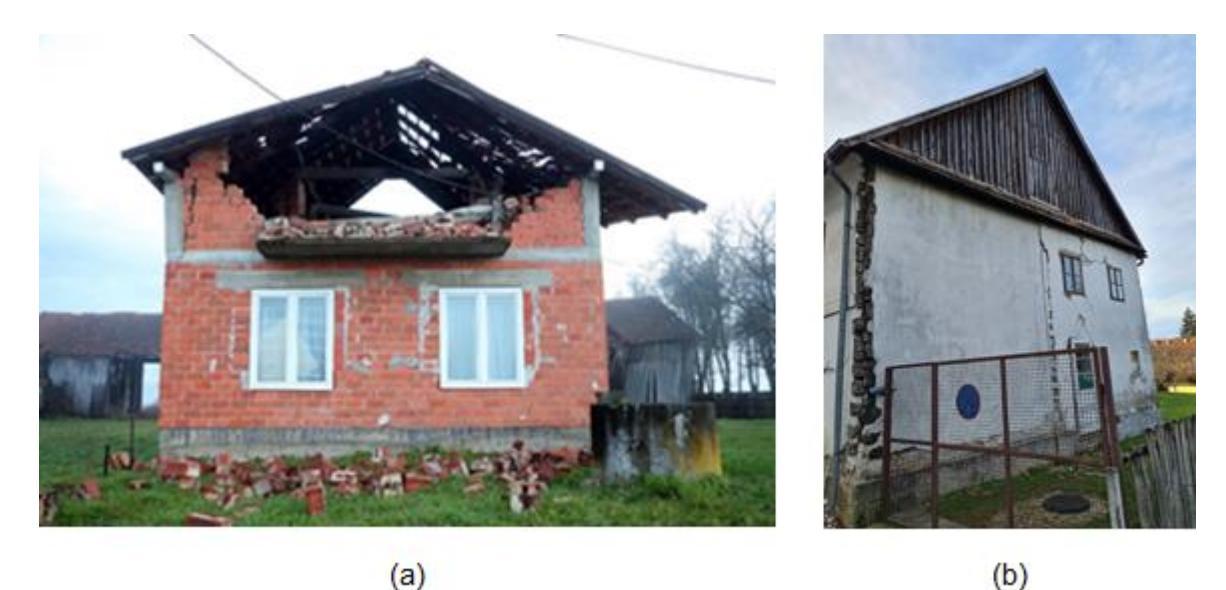
Figure 4.9. Performance of gable walls: (a) collapsed gable wall in a partially confined masonry building (with discontinuous RC tie column) and without a RC ring beam along the wall-to-roof interface (source: Sanjin Strukic/Pixel) and (b) good performance of a gable wall in a form of light-weight wooden panel (source: Nenad Bijelić).

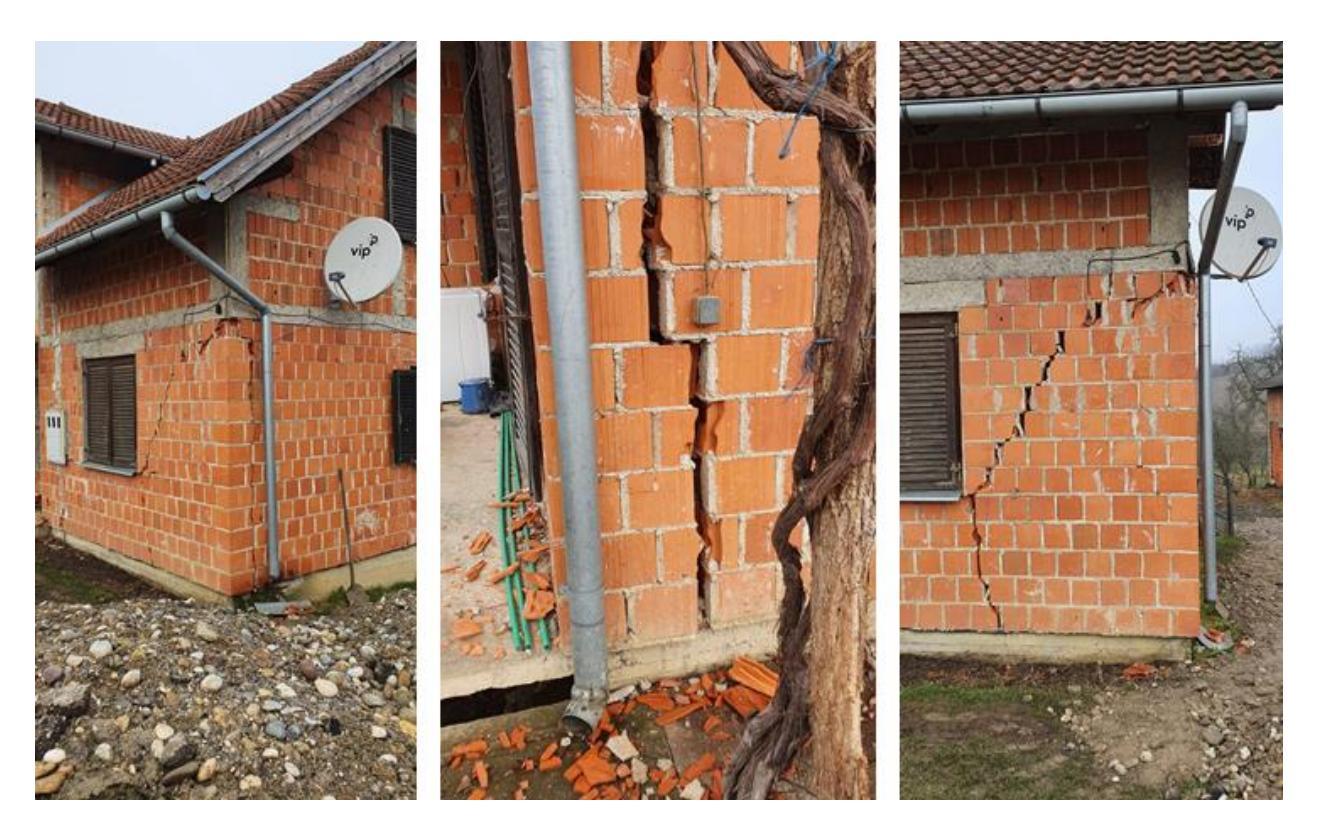
Figure 4.13. Damage of a partially confined masonry building in the Graberje village due to the absence of RC tie-columns at wall intersections. The damage is in the form of wide vertical cracks along the wall intersection and stepped shear cracks expanding from the ground to the second floor slab (source: Hrvoje Ljubojević, Tenzor d.o.o).

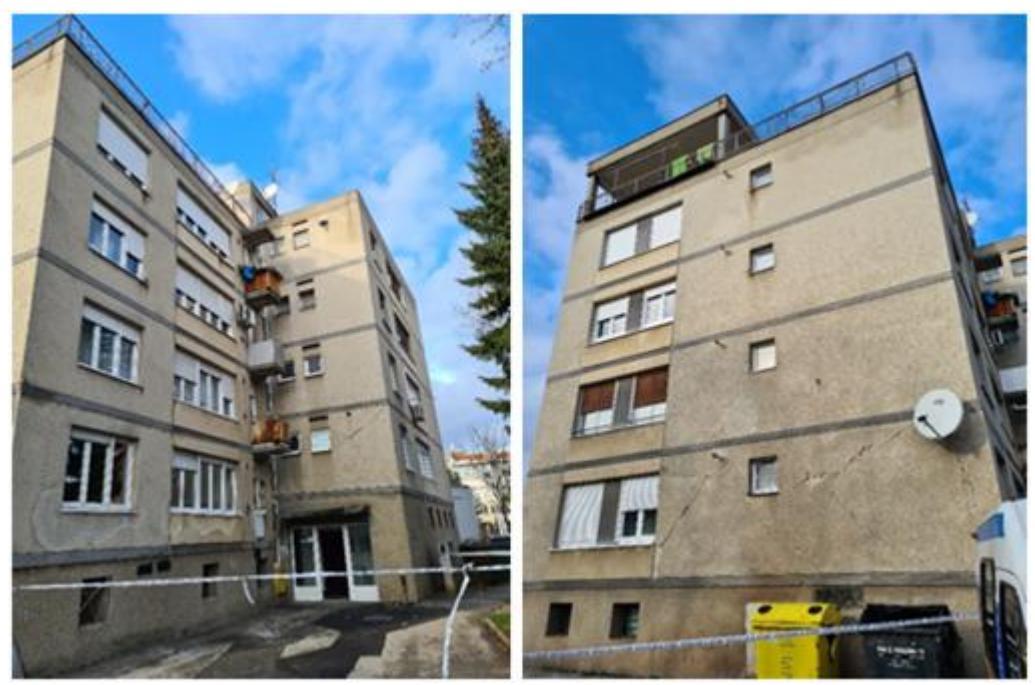
Figure 4.19. Damaged Building 3: exterior view and cracking pattern at the ground floor level (source: Nenad Bijelić).

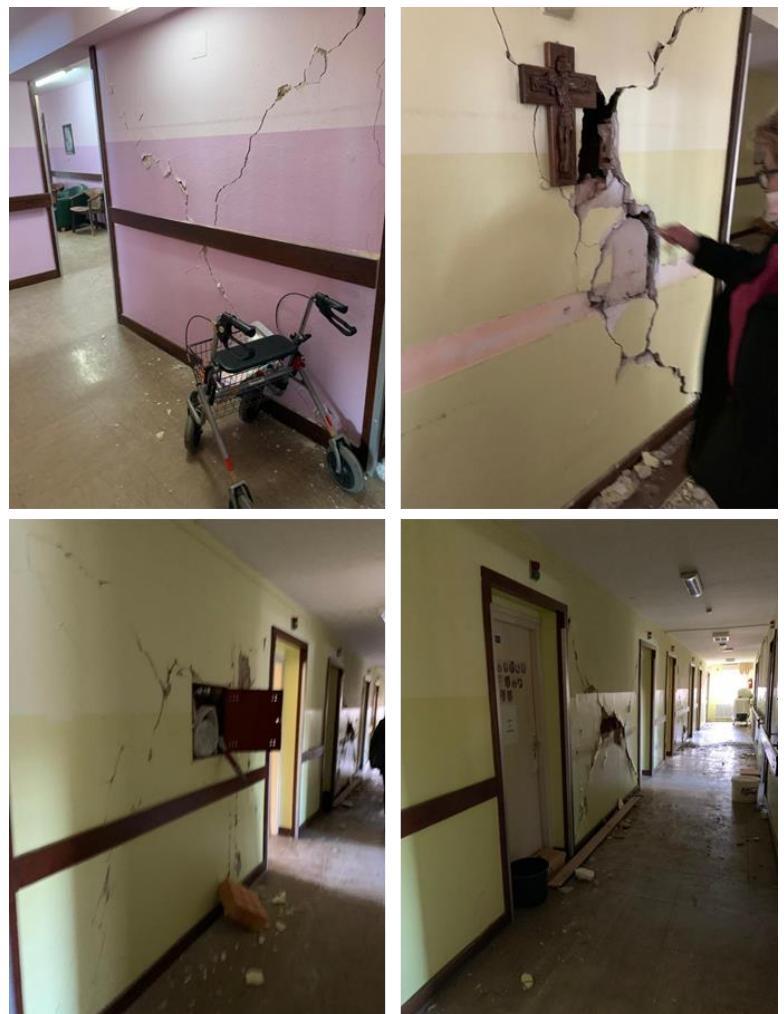
Figure 4.32. Damage to partition wall in the retirement home in Petrinja (source: Damir Lazarević).

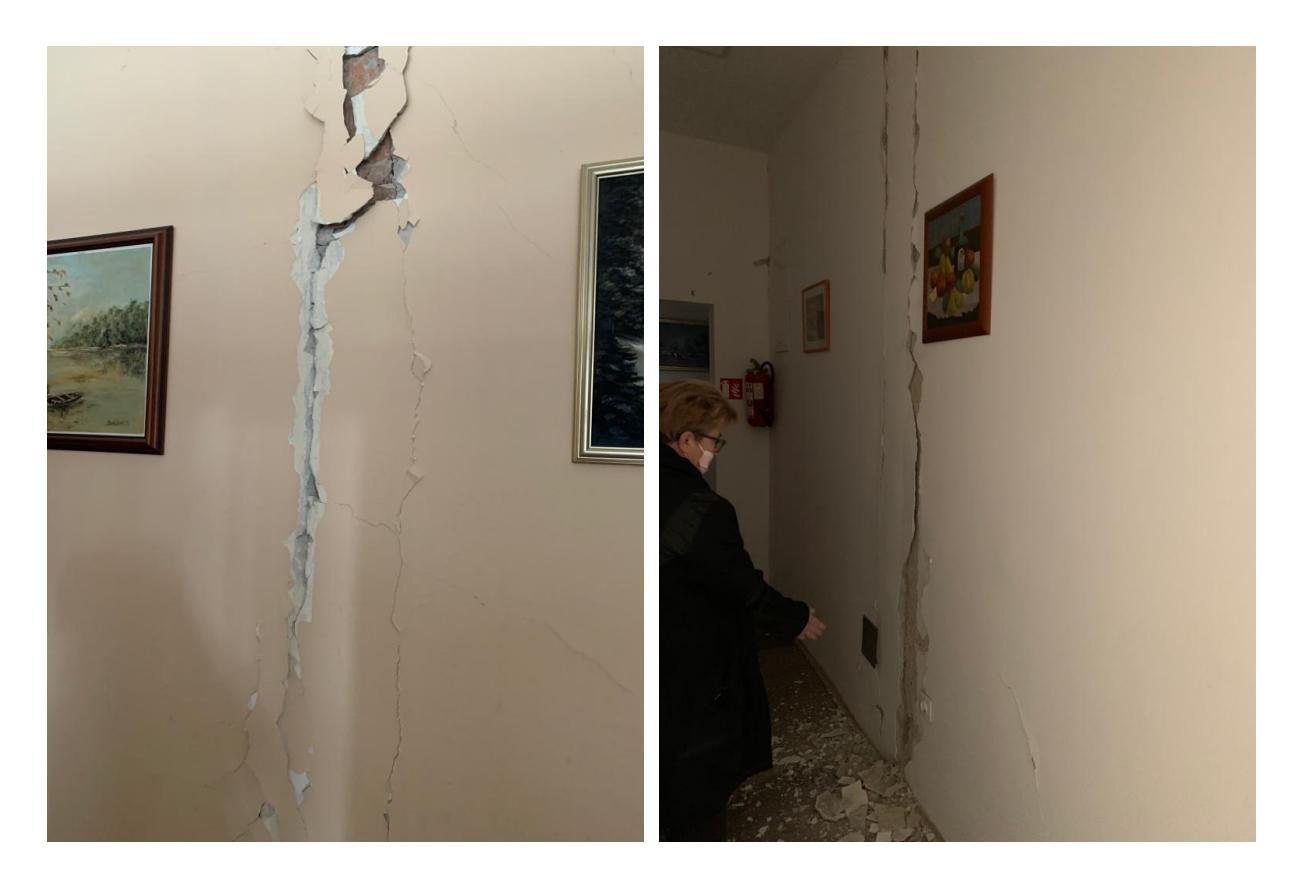
Figure 4.33. Cracks along the interface between a masonry infill and an RC column (source: Damir Lazarević).

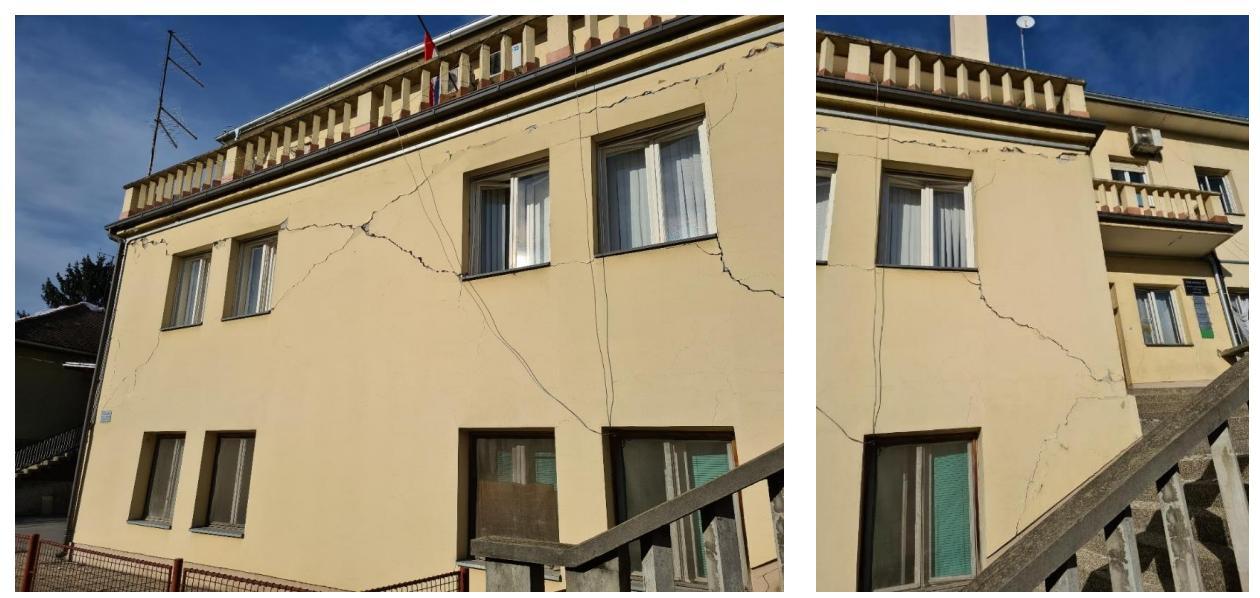
Figure 4.38. Photos showing the exterior of the health center in Petrinja with large shear cracks in the exterior walls (source: Domagoj Damjanović).

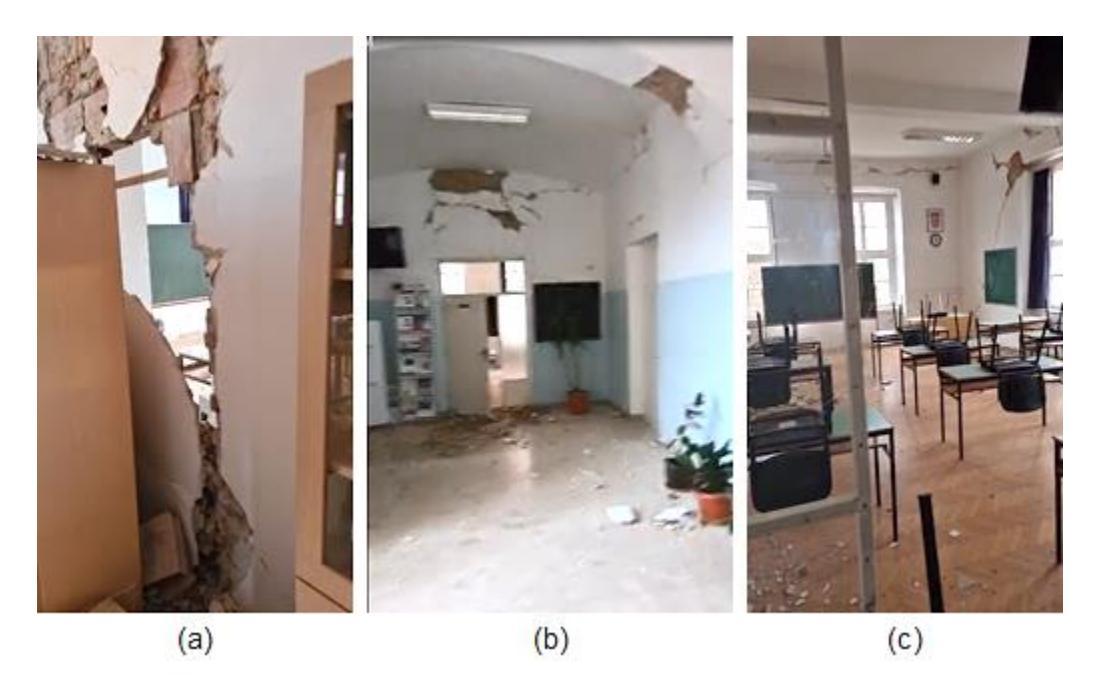
Figure 4.48. Interior damage to the First Primary School in Petrinja: (a) partial collapse of an interior partition wall showing its hollow clay tile construction, (b) damage to the interior walls, and (c) shear crack propagating from the corner of the window opening, highlighting the brittle nature of the construction (source: Nenad Bijelić).

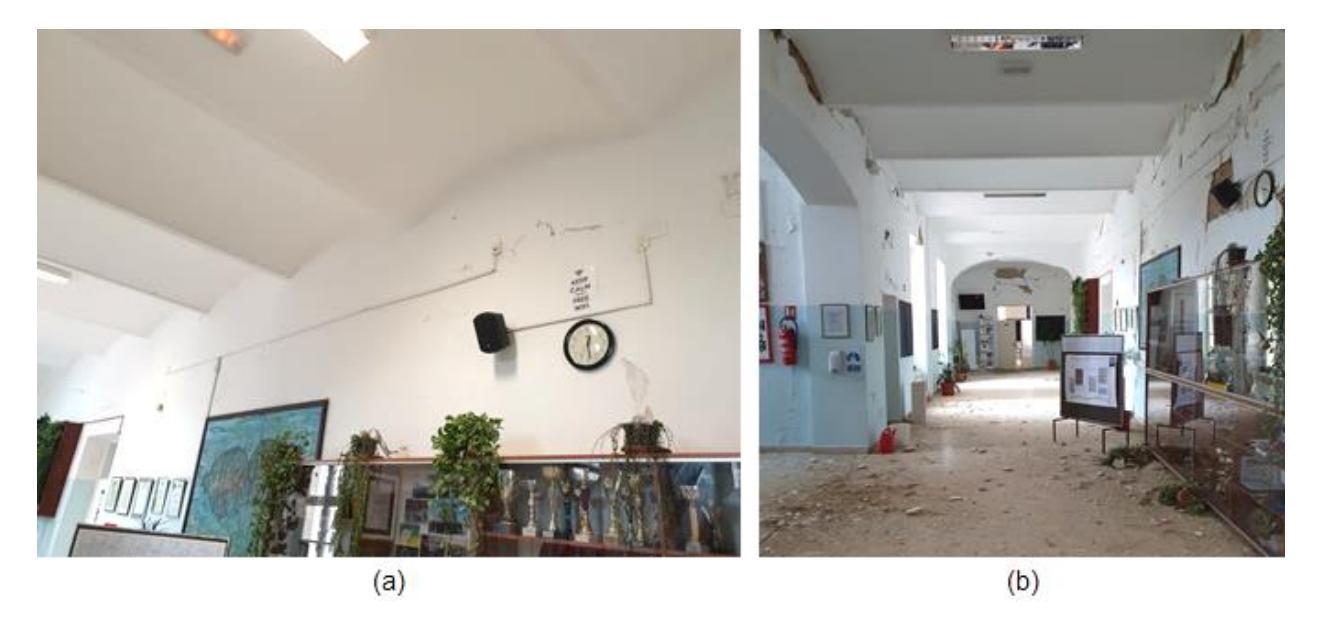
Figure 4.53. Interior of Petrinja High School: (a) minor damage caused by the December 28 earthquake (source: Domagoj Damjanović) and (b) significant damage caused by the December 29 earthquake (source: Marko Bartolac and Nenad Bijelić).

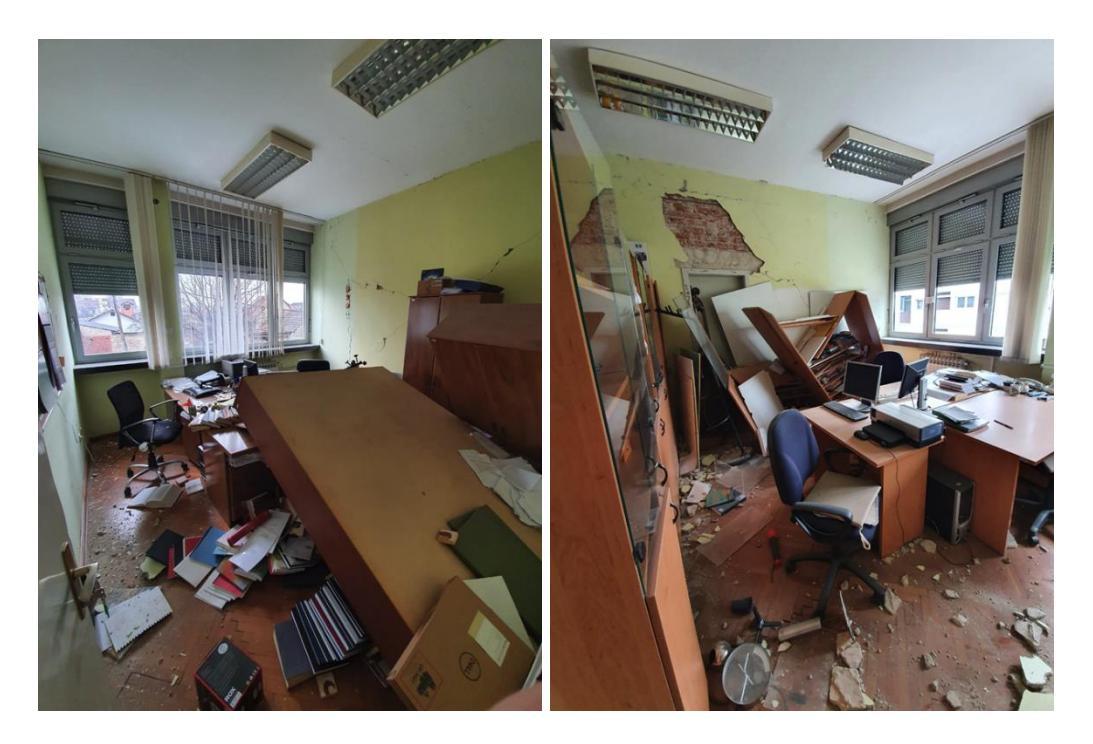
Figure 4.68. Diagonal cracks in infill walls and overturned shelves (source: Marko Bartolac).

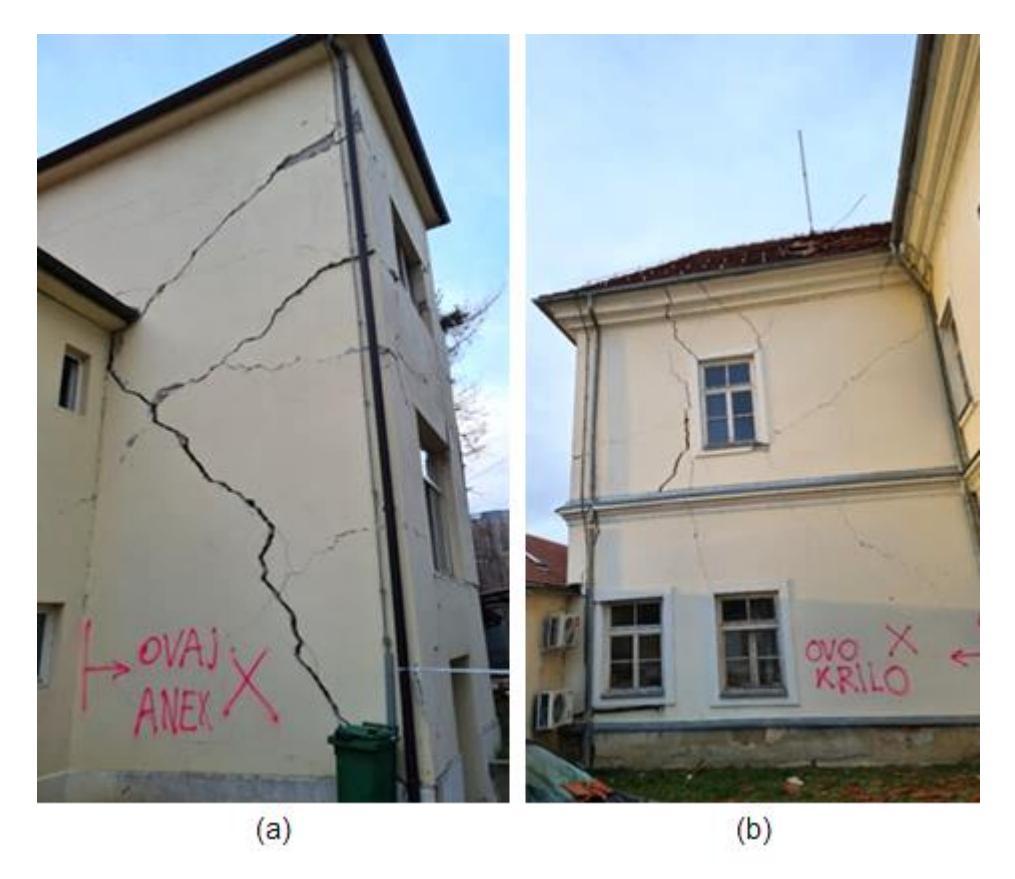
Figure 4.79. Town hall annexes after the earthquake: (a) Southwestern annex with widespread damage in the transverse wall (source: Nenad Bijelić) and (b) Northwestern annex with the widespread damage in the transverse wall (source: Nenad Bijelić).

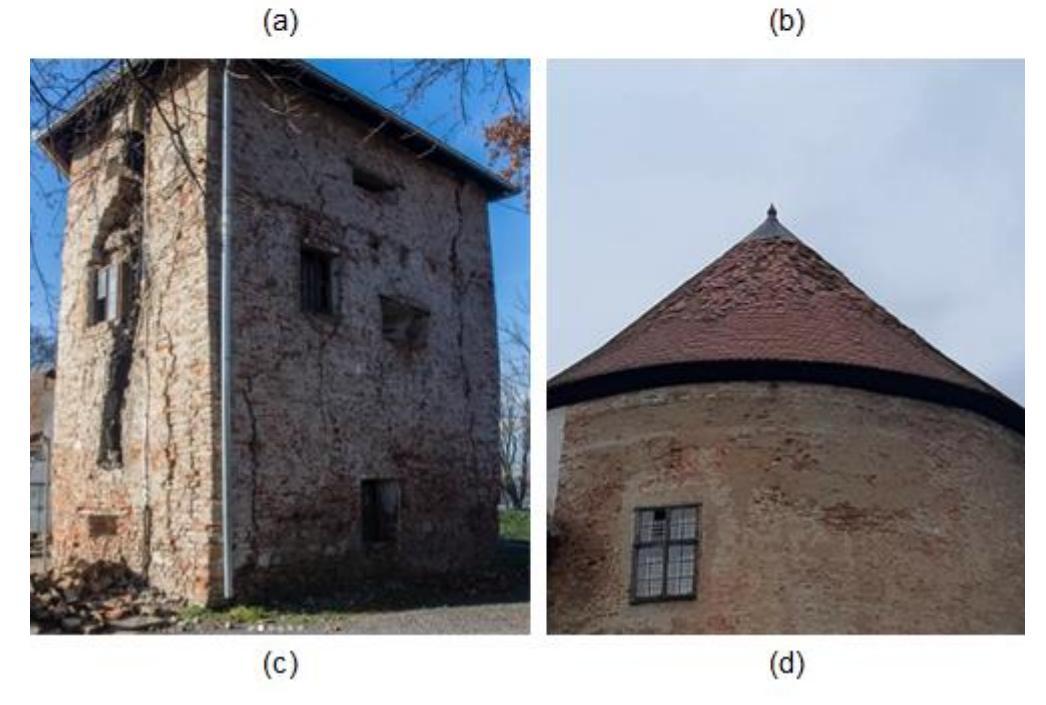
Figure 4.83. (a) Small tower connected to the Sisak fortress in 2011 (source: Google), (b, c) collapsed chimney in the small tower, and (d) damage to the tiles of the conical roof of one of the tower of the fortress (source: Instagram account starigradsisak and dvorcistarigardovi).

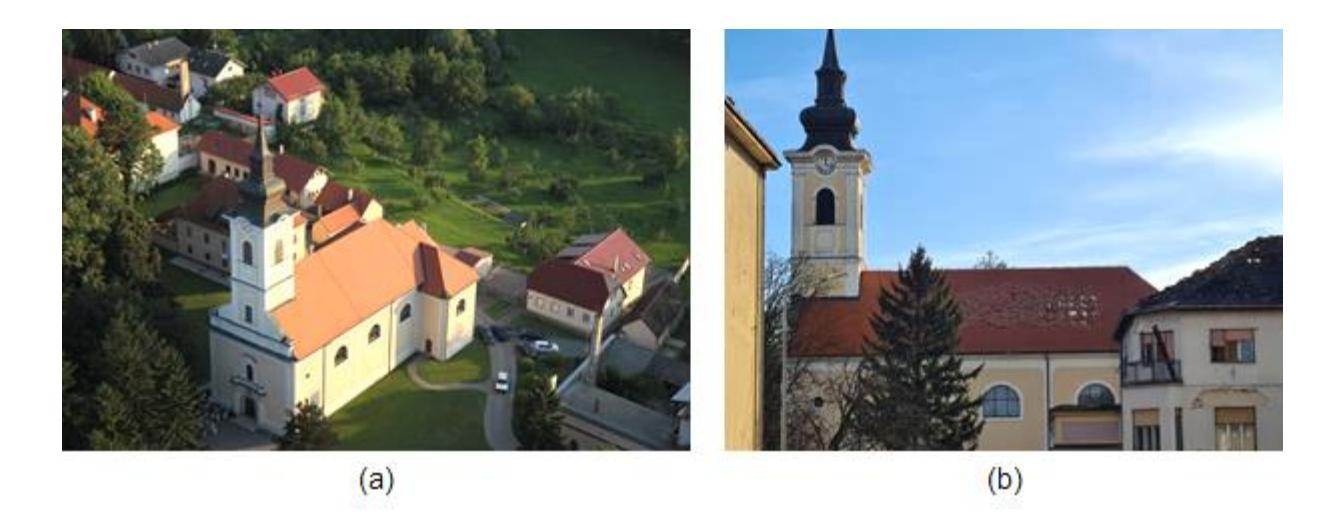
Figure 4.85. (a) St. Lawrence Church before the earthquake (source: petrinjaturizam.hr/upoznaj-petrinju/kultura) and (b) after the earthquake, roof tiles were displaced (source: Nenad Bijelić).

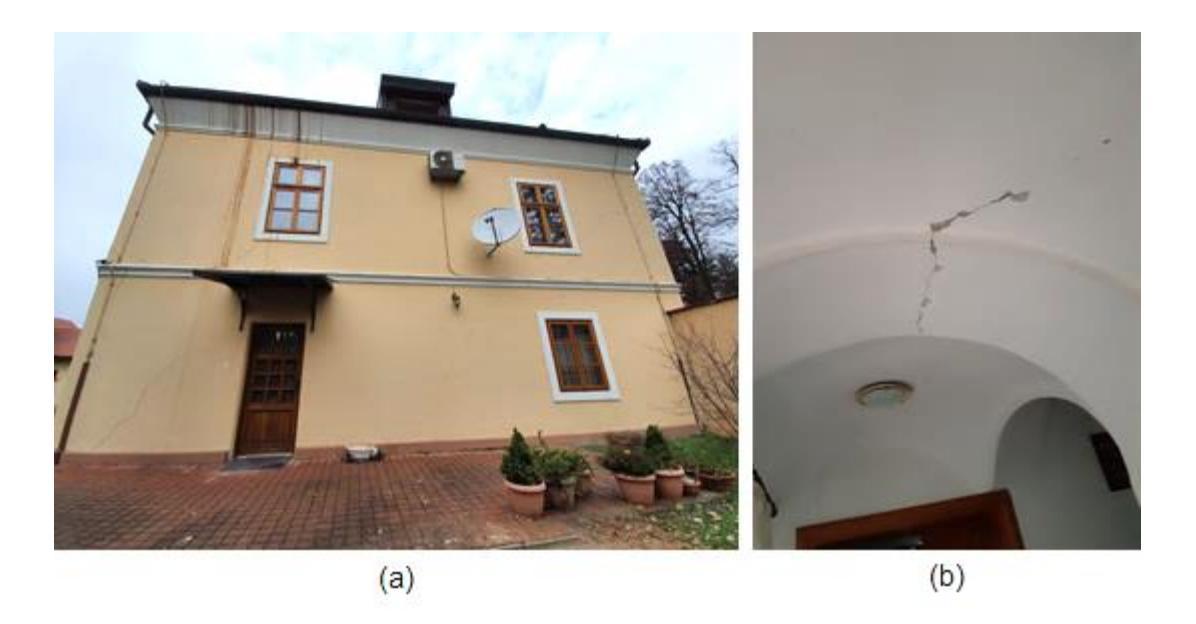
Figure 4.87. St. Lawrence parish church rectory that was built in 1783 in late Baroque style: (a) Façade shows diagonal cracks in the piers. Overall response was good. It is possible that small openings to the total area of walls had a beneficial effect. Chimneys collapsed. (b) Cracked vault inside the house (source: Marko Bartolac).

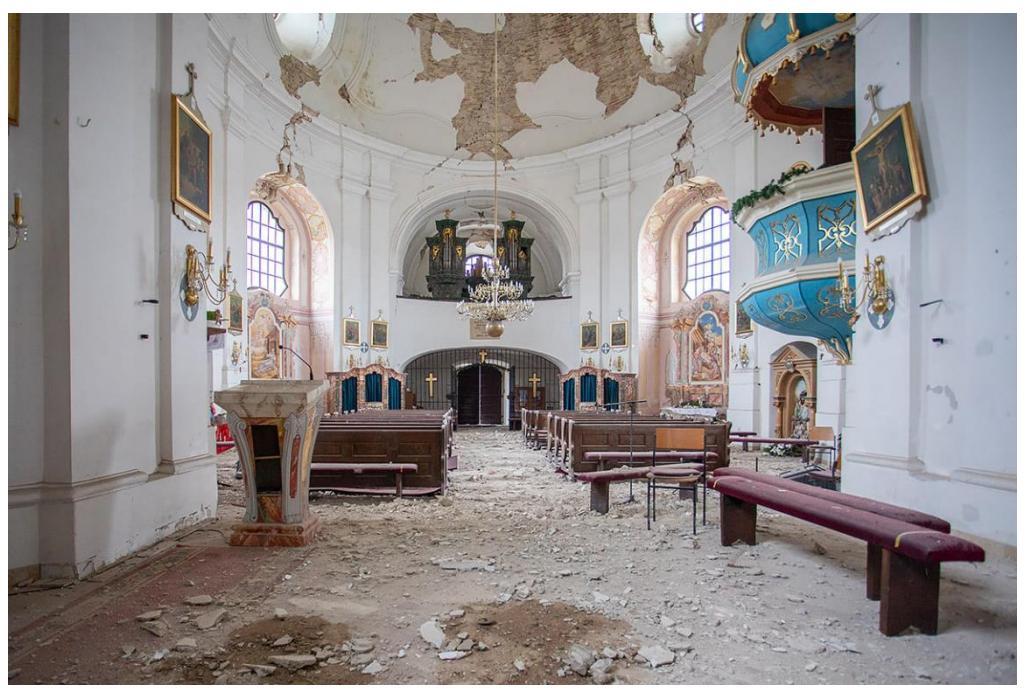
Figure 4.94. Interior of the Church of St. Marije Magdalene in Sela. Extensive cracking visible in the dome, as well as plaster detachment (source: Facebook Page Sisačka biskupija).

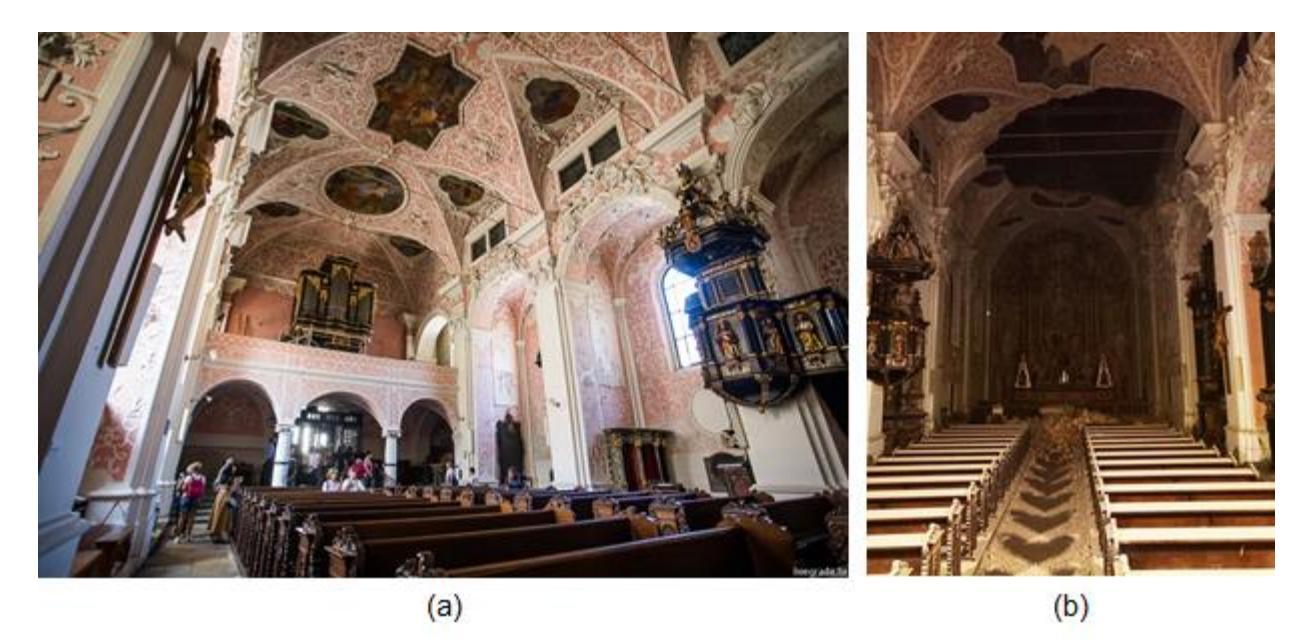
Figure 4.96. (a) Vault of the Church before the earthquake (source: Lice grada 2021) and (b) The collapse of the vault (source: Zagrebacka nadbiskupija).

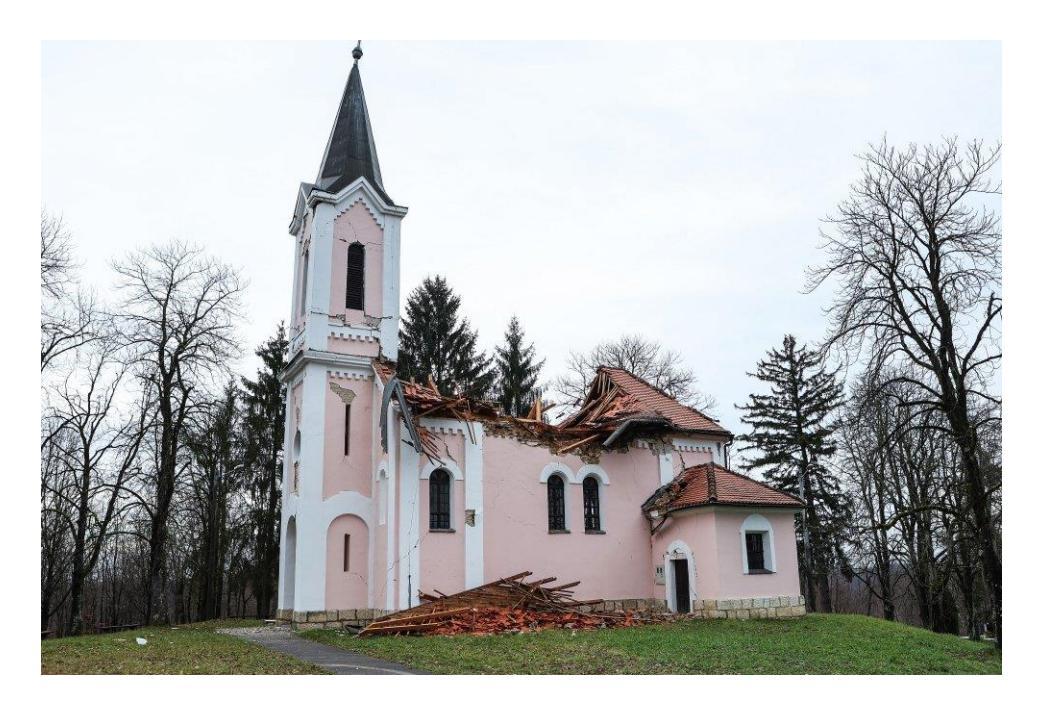
Figure 4.102. Church in Mračaj, near village Majur. Collapse of the timber roof structure and cover and severe cracking of the bell tower (source: Marko Pripic/PIXSELL).

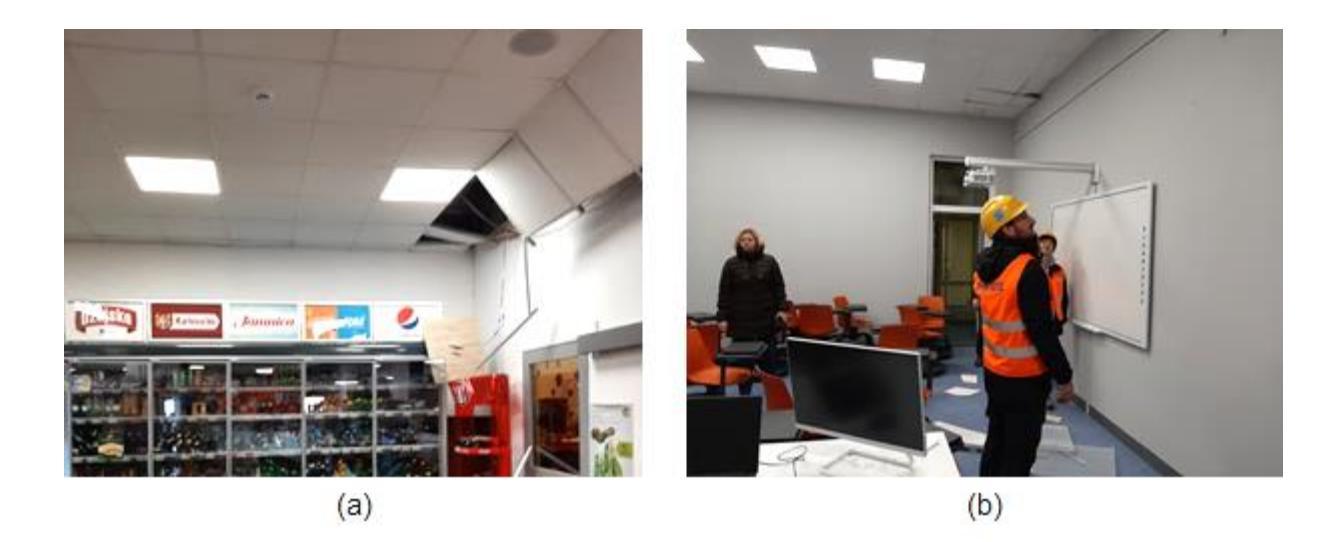
Figure 4.109. Damage to: (a) ceiling systems in a single-story commercial store and (b) Elementary School Mate Lovraka in UI. Mirka Antolića 18, 44250, Petrinja (source: Sonja Belovarac Radenović (a), Marko Bartolac (b)).

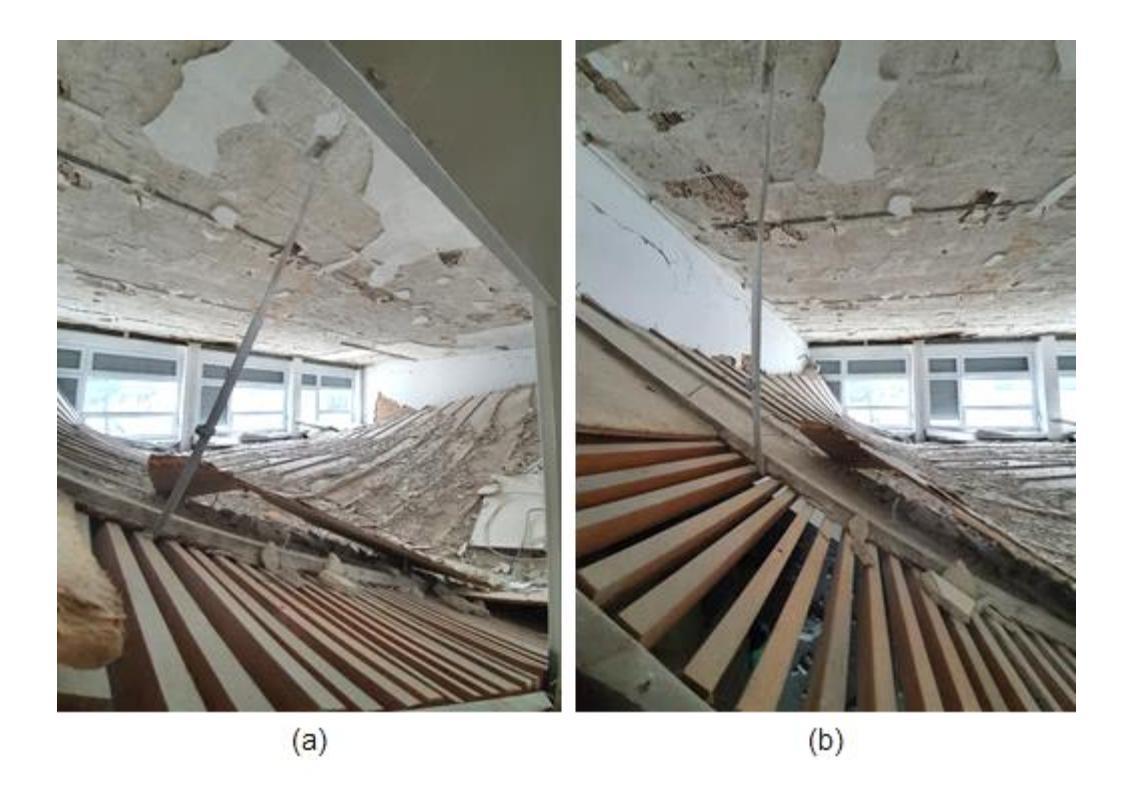
Figure 4.110. Ceiling collapse in 1962 university building (Učiteljski fakultet) (source: Marko Bartolac).

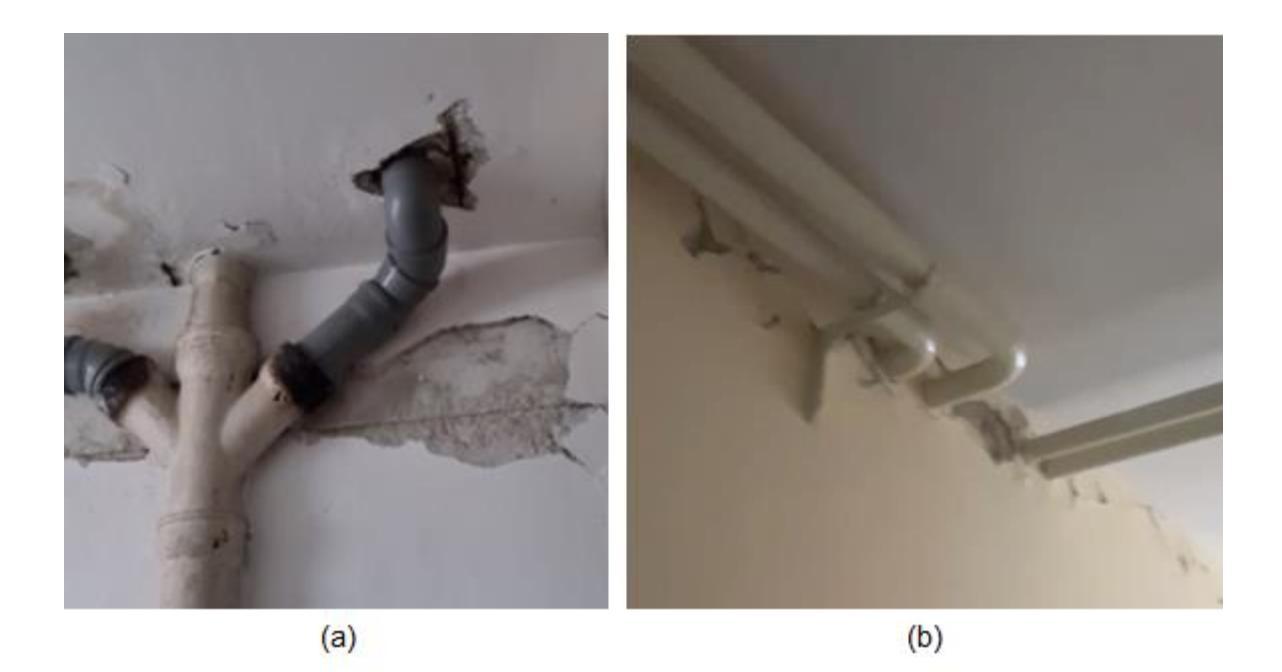
Figure 4.114. Examples of failures in piping systems in university building constructed in 1962 (Uciteljski fakultet) (source: Nenad Bijelić and Damir Lazarević).

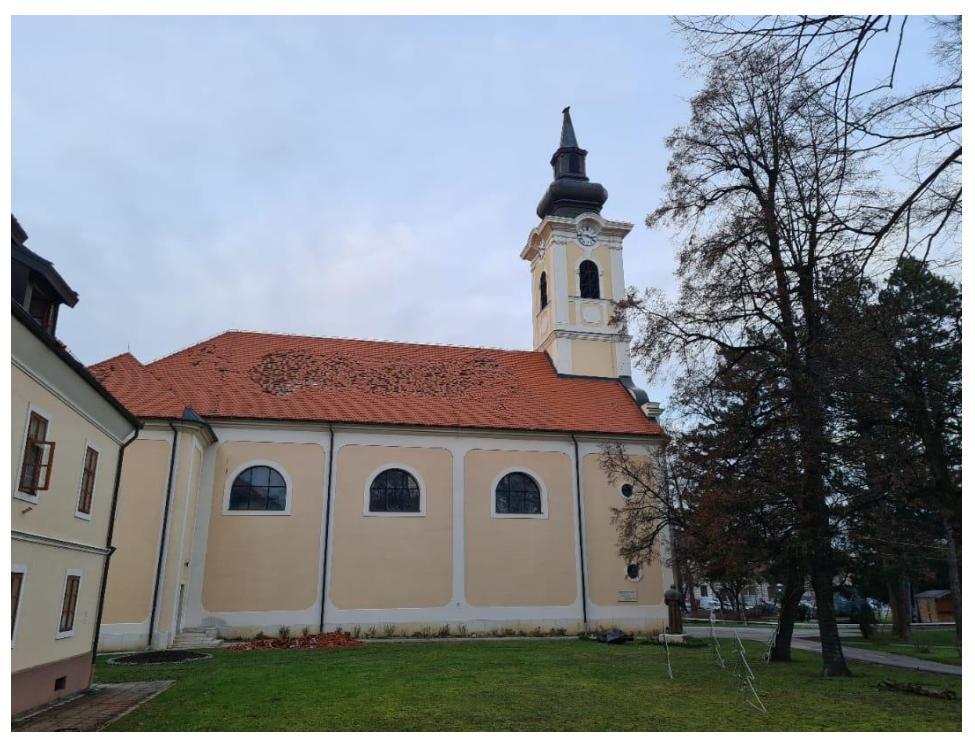
Figure 4.123. Damaged roof tiles on St. Lawrence church (crkva Sv. Lovre) in Petrinja (source: Nenad Bijelić).

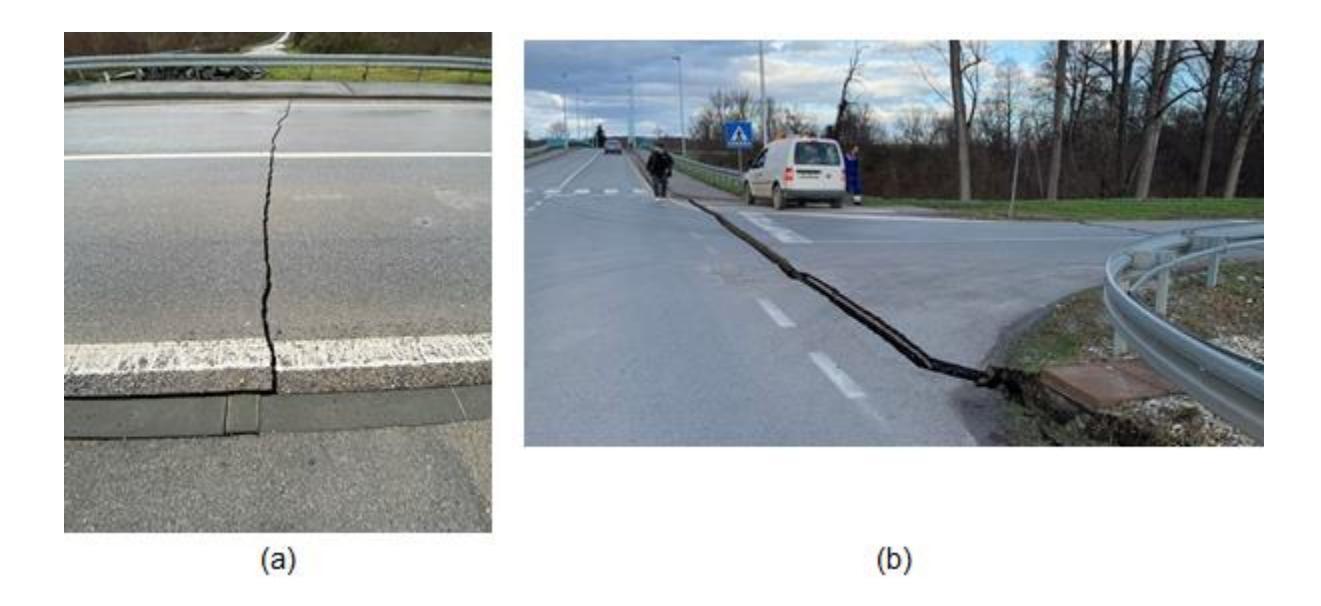
Figure 5.9. (a) A wide transverse crack at the Brest Bridge approach road (source: Mate Baričević) and (b) a wide fissure in the road close to Brest Bridge (source: Index.hr 2020d).

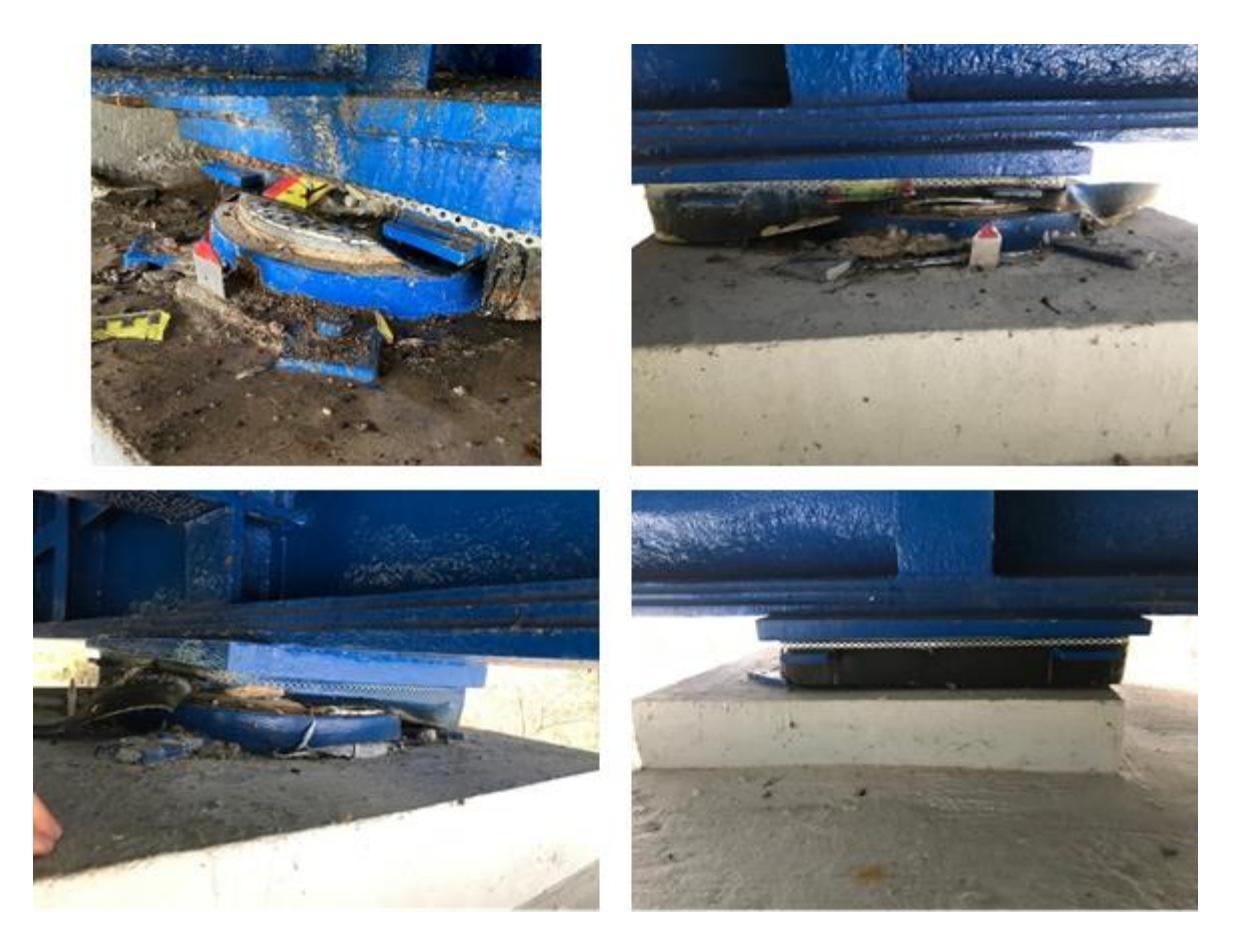
Figure 5.11. Rubber bearings at the abutments failed due to relative displacement demands between the support and the superstructure exceeding the capacity of the bearings, Galdovo Bridge (source: Mate Baričević).

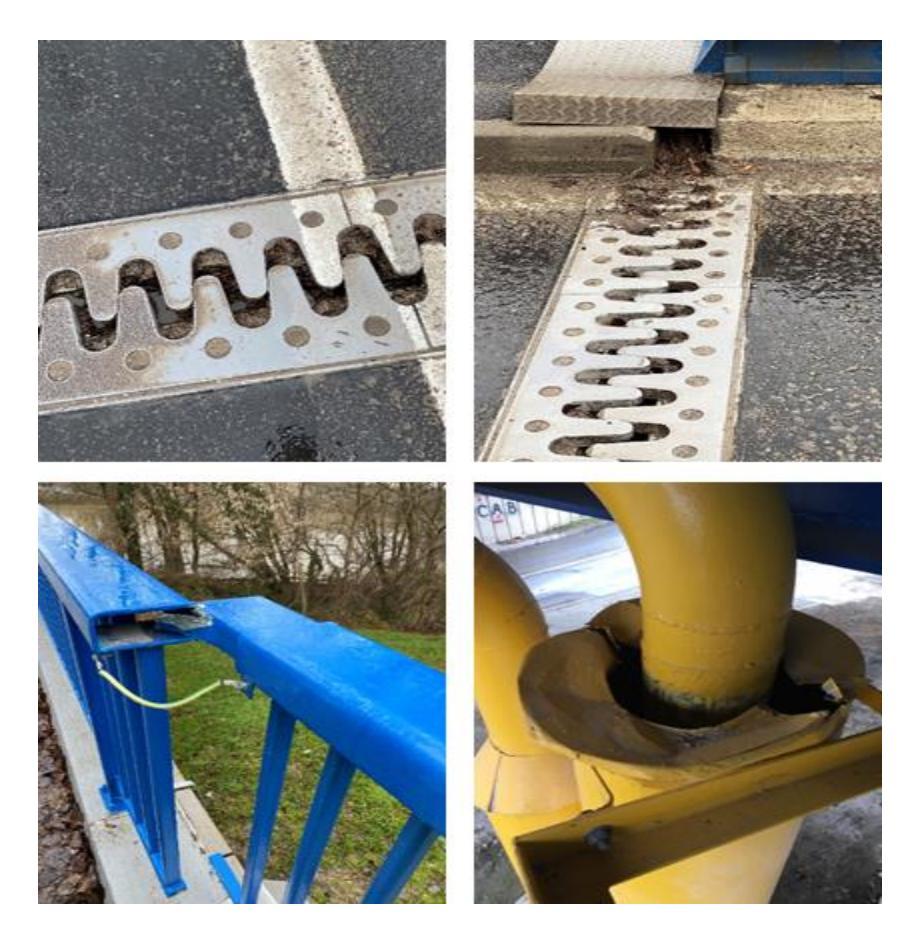
Figure 5.12. Damage due to lateral displacement of the bridge relative to the slab approach, Galdovo Bridge (source: Mate Baričević).

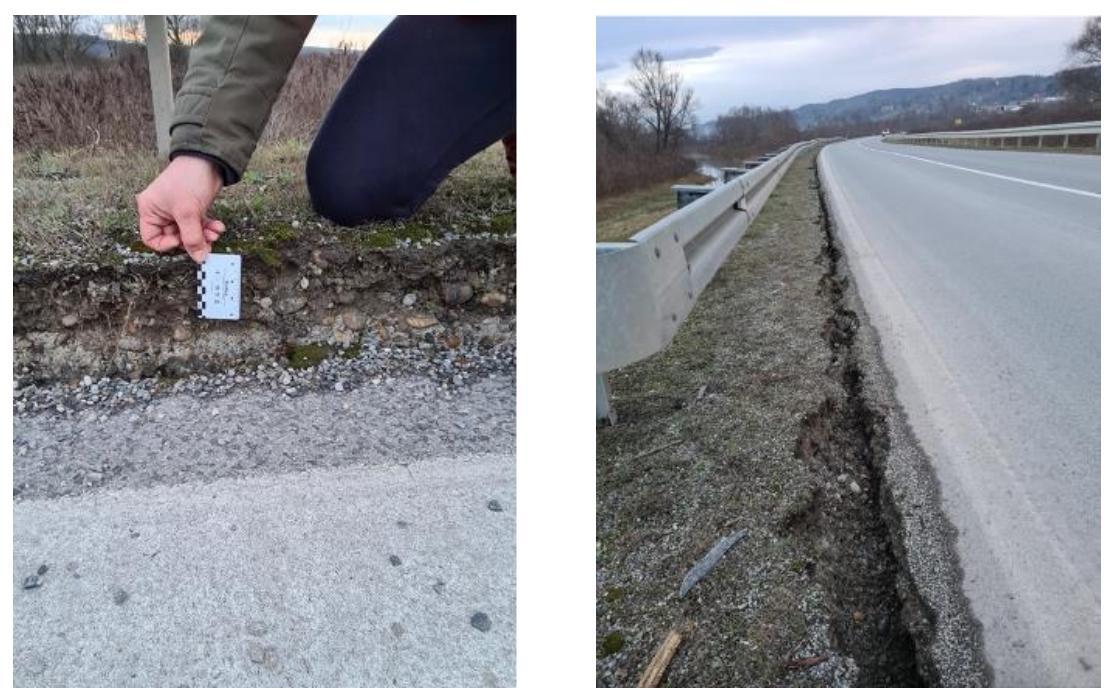
Figure 5.17. Ground failure of a road close to Brest Bridge (source: Nenad Bijelić).

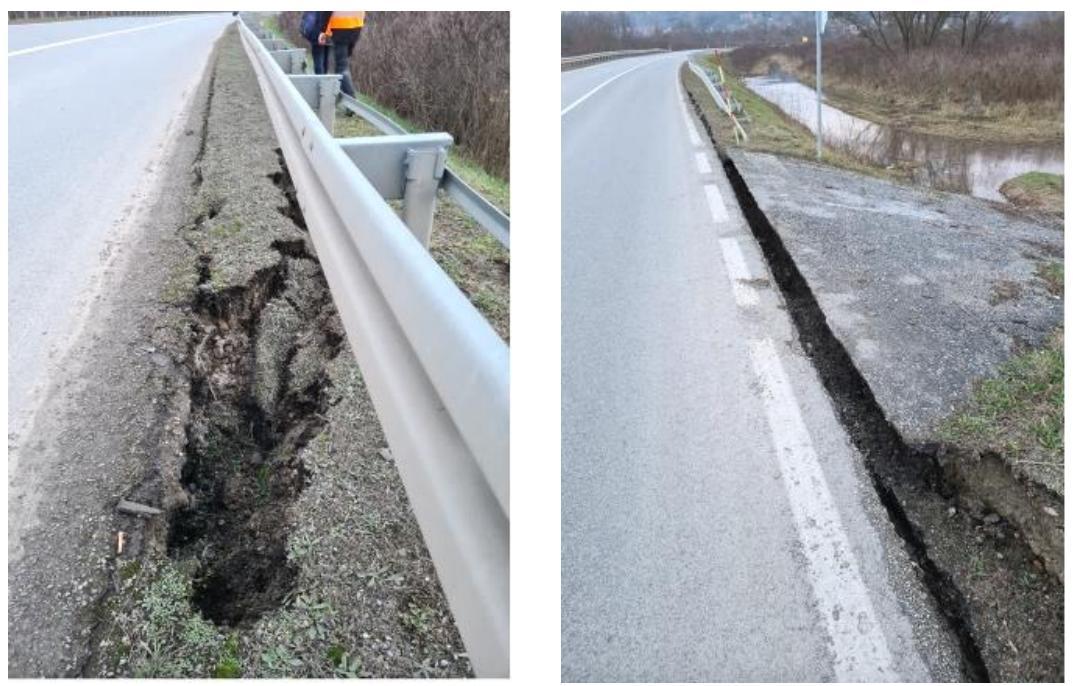
Figure 5.18. Partial ground slide due to reduced ground bearing capacity in the road close to Brest Bridge (source: Nenad Bijelić).
