Petrinja, Croatia December 29, 2020, Mw 6.4 Earthquake Joint Reconnaissance Report (JRR)

Report

Joint Reconnaissance Team Leaders: Eduardo Miranda, Stanford University Svetlana Brzev, University of British Columbia / SUZI-SAEE Nenad Bijelić, Swiss Federal Institute of Technology Lausanne (EPFL) Field Assessment Structural Team (FAST) Authors: (in alphabetical order) Željko Arbanas, University of Rijeka Marko Bartolac, University of Zagreb Nenad Bijelić, Swiss Federal Institute of Technology Lausanne (EPFL) Vedran Jagodnik, University of Rijeka Damir Lazarević, University of Zagreb Snježana Mihalić Arbanas, University of Zagreb Sonja Zlatović, Zagreb University of Applied Sciences Virtual Assessment Structural Team (VAST) Authors: (in alphabetical order) Andrés Acosta, Stanford University Dimitrios Lignos, EPFL Jorge Archbold, UC Berkeley Ting Lin, Texas Tech University James Bantis, Stanford University Marko Marinković, University of Belgrade Jovana Borozan, SUZI-SAEE Armando Messina, Stanford University Ivana Božulić, EPFL Sebastián Miranda, Univ. del Desarrollo Nikola Blagojević, ETH Zurich Alan Poulos, Stanford University Cristian Cruz, Univ. Técnica Federico Santa María Giuli

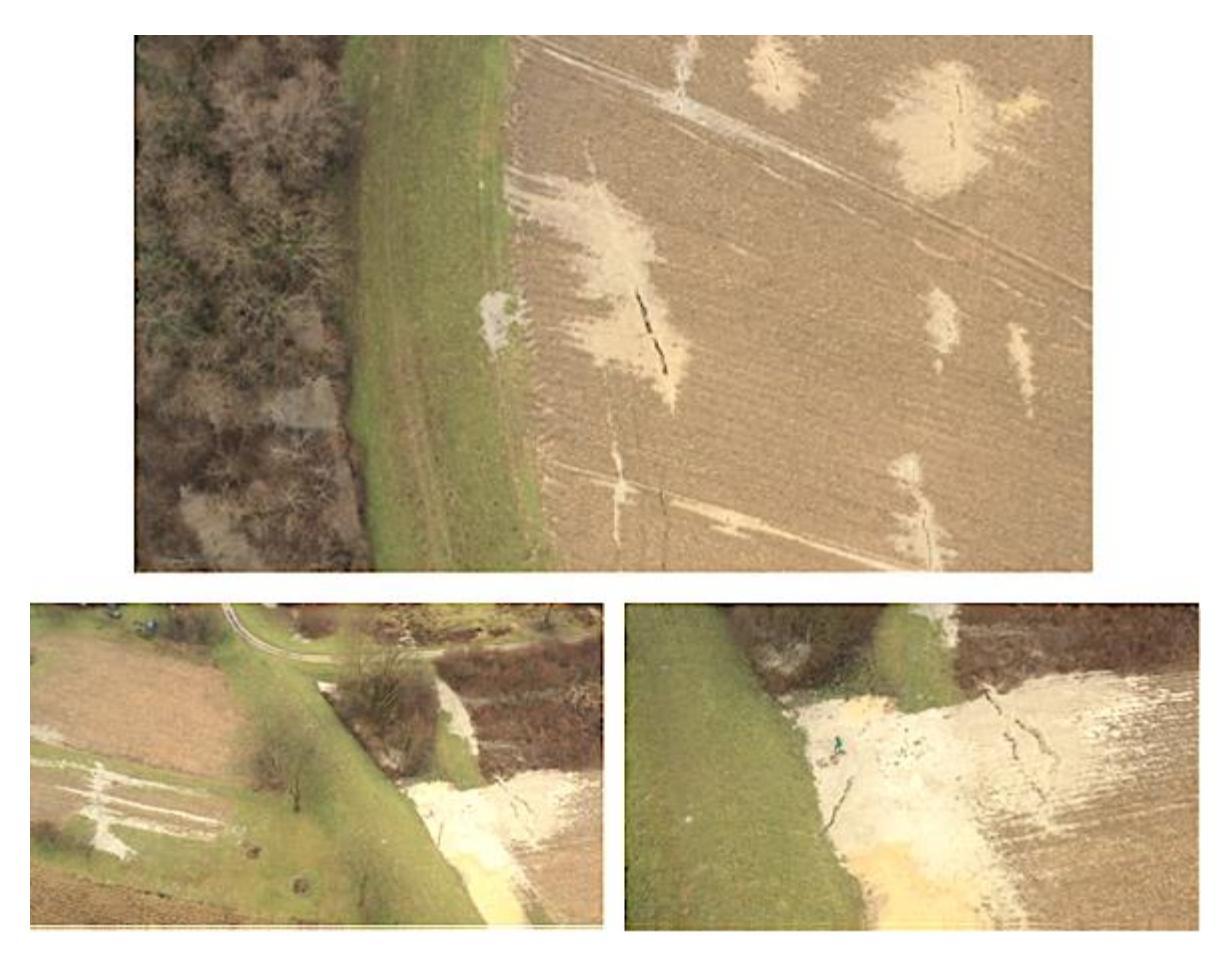
Figure 6.8. Liquefaction near Hrastelnica and Sisak. The proximity of these liquefaction surface manifestations to levees indicates that liquefaction was a definite mechanism contributing to the levee failures (see later subsection). The bottom right image is a close-up of the bottom left (source: Croatian Waters Archive).

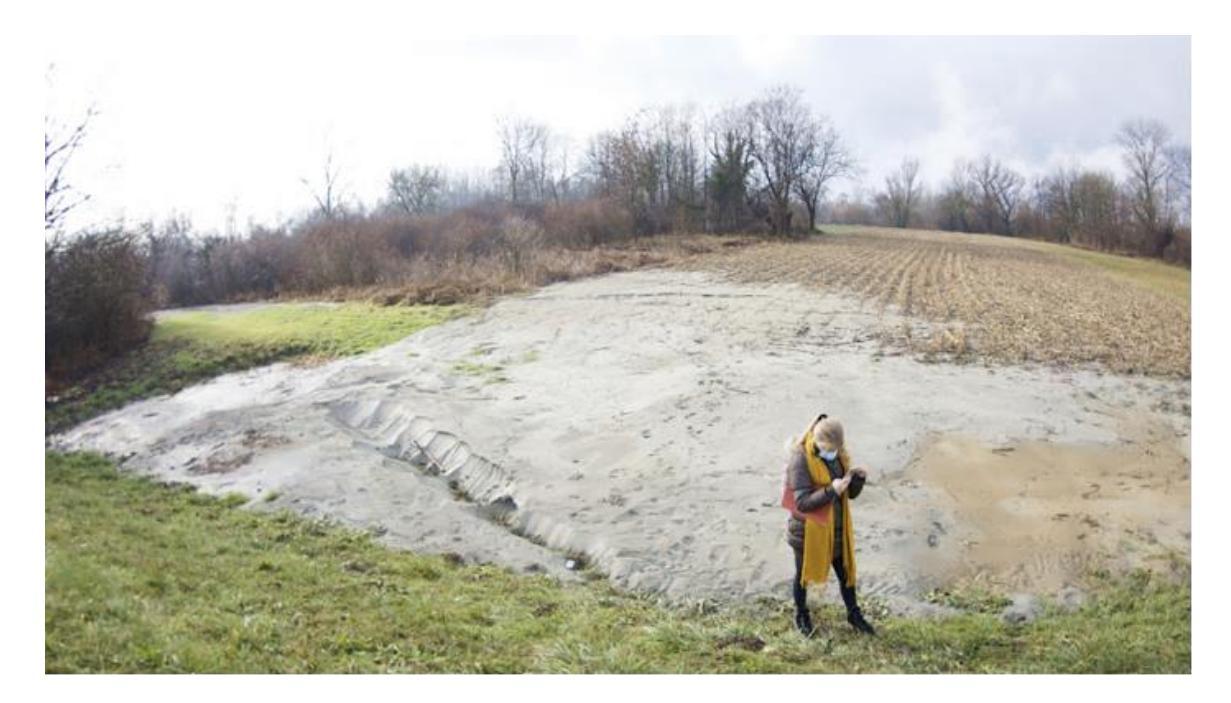
Figure 6.9. Liquefaction in Hrastelnica, Sisak (source: Vedran Jagodnik 45°30'2.538"N,16°24'58.842"E).

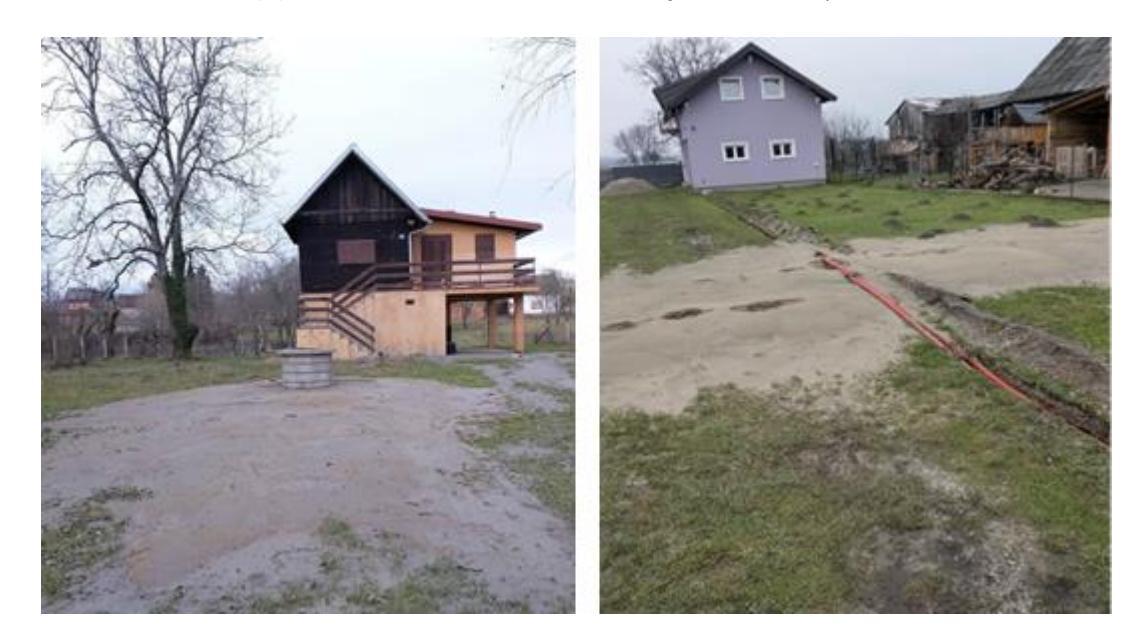
Figure 6.12. Liquefaction surface manifestation and floatation of manholes in Petrinja (left: 45° 29' 5.25"N, 16° 9' 52.306"E; right: 45° 31' 10.986"N, 16° 24' 16.416"E; source: Željko Arbanas).

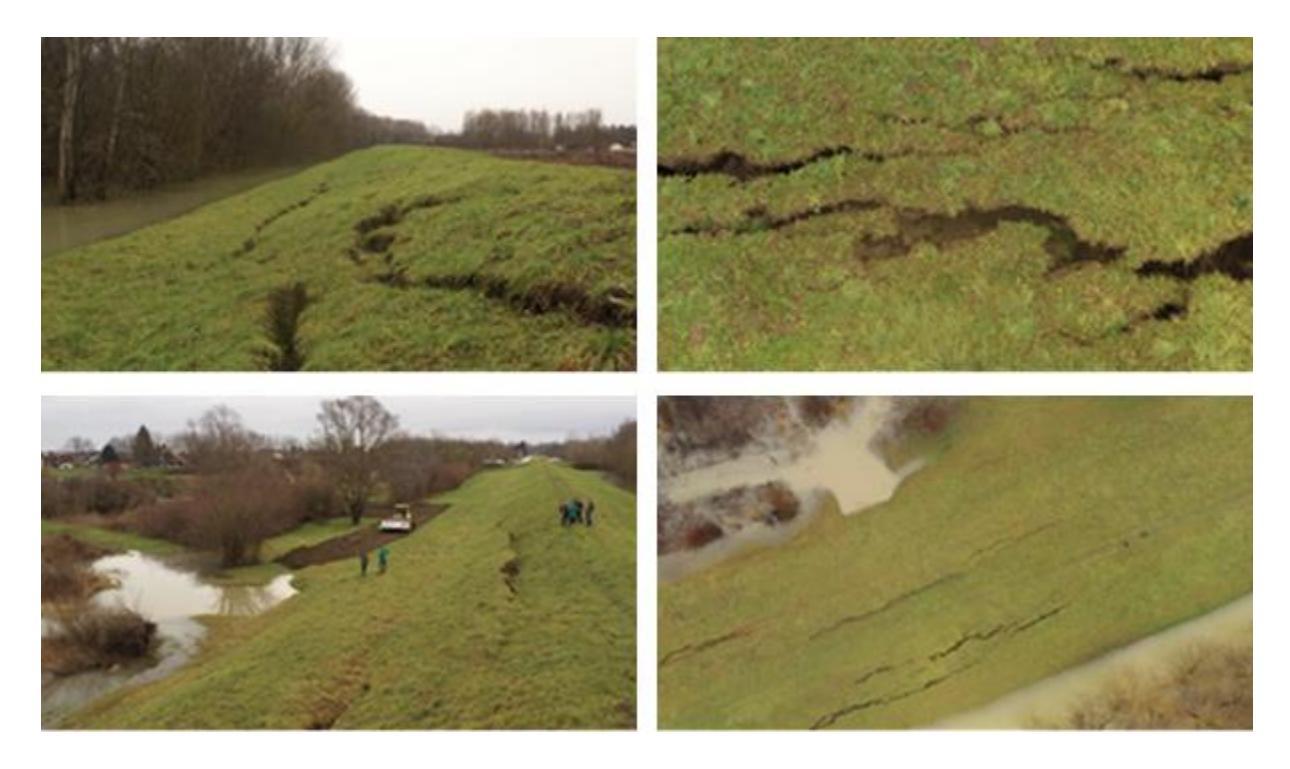
Figure 6.14. Embankment / levee failure by river Sava in Galdovo (source: Croatian Waters Archive).

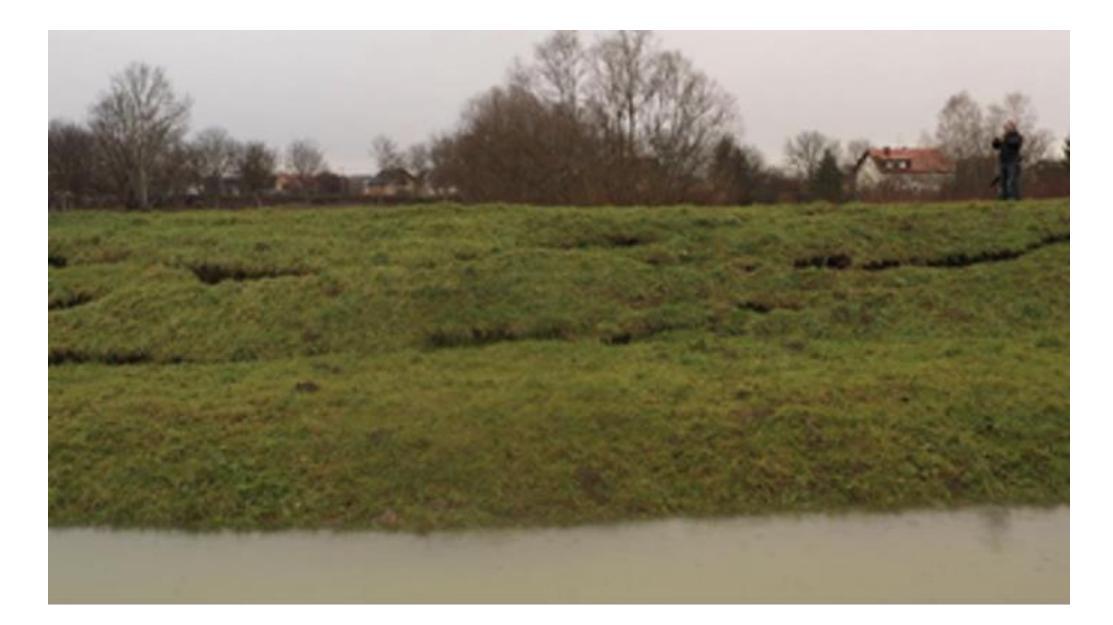
Figure 6.15. Embankment failure of river Sava near Hrastelnica (source: Croatian Waters Archive).

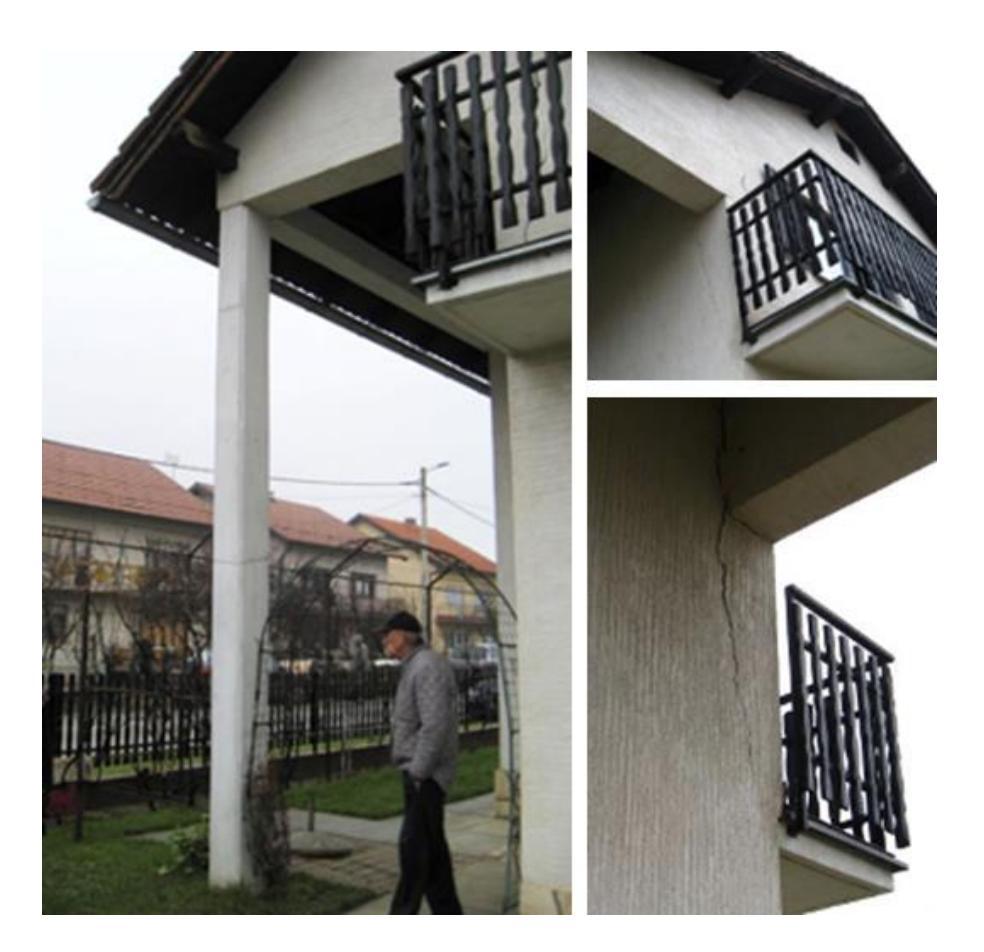
Figure 6.16. Liquefaction occurred under and around the residential building in the photograph. Sand appeared just next to the house, along the fence, and the area covered with bricks moved up. Cracks opened as the house sank. Petrinja, Ulica Vilima Muhe (45.43514, 16.2684, source: Sonja Zlatović).

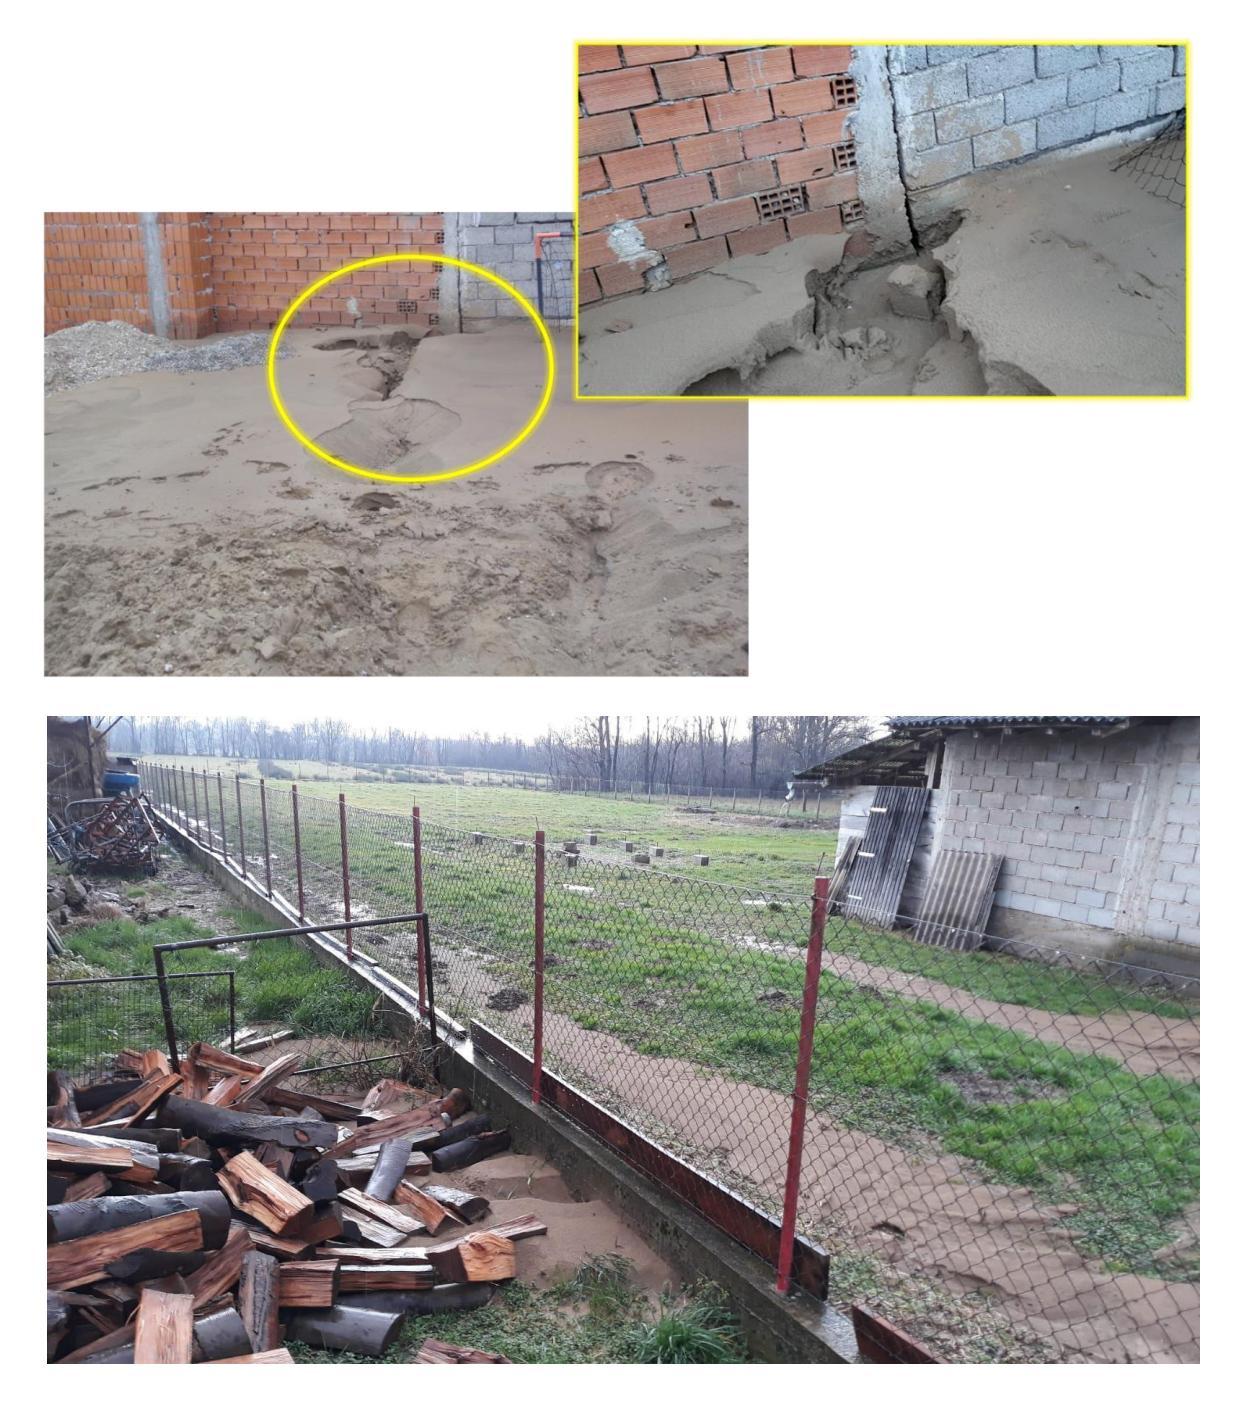
Figure 6.18. Crack between two houses due to liquefaction (45.4540, 16.2611). The line of liquefaction spreads through several yards and under houses, Brest Pokupski (source: Tomislav Ivšić, Sonja Zlatović, Igor Gukov).

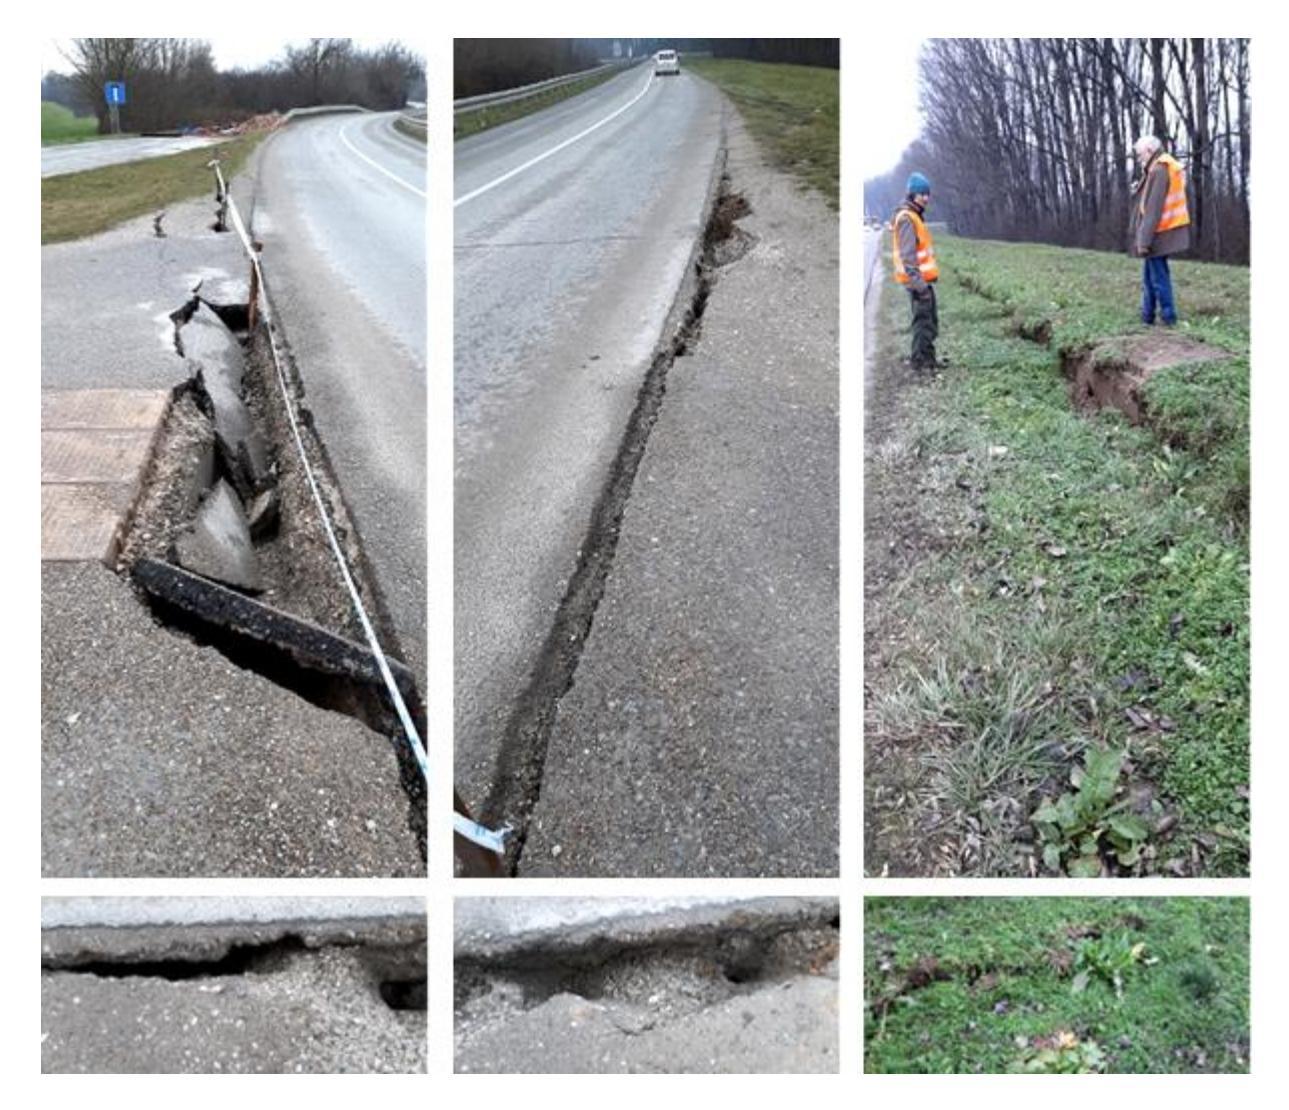
Figure 6.21. Settlement of the area between the embankment and the road between Petrinja and the bridge for Brest Pokupski (source Sonja Zlatović). The likely cause for the damage depicted in the left and middle photos, which is compatible with the extensive liquefaction that occurred in the broader area. The right photo shows a longitudinal subvertical crack of the embankment due to subsidence.

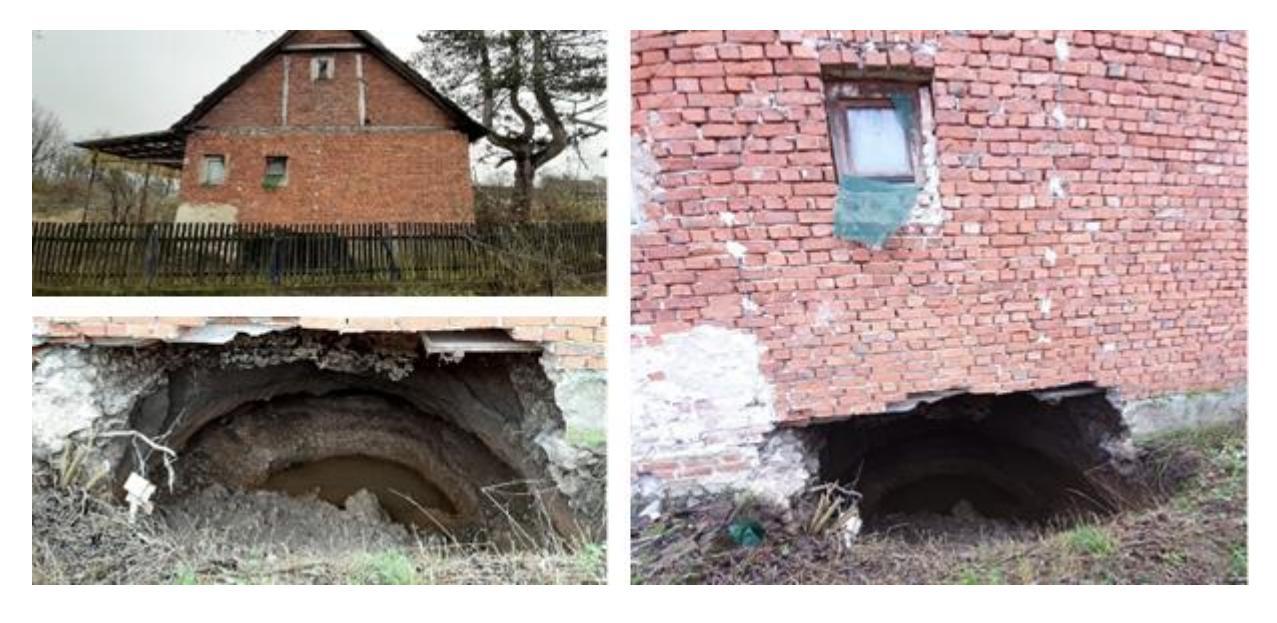
Figure 6.25. Sinkhole under a house with quite weak foundations (photos: left: Sonja Zlatović, right: Joško Krolo).
