StEER-EERI: 2023 Mw 7.8 Kahramanmaras, Türkiye Earthquake Sequence Joint Preliminary Virtual Reconnaissance Report (PVRR)

JOINT PRELIMINARY VIRTUAL RECONNAISSANCE REPORT (PVRR)

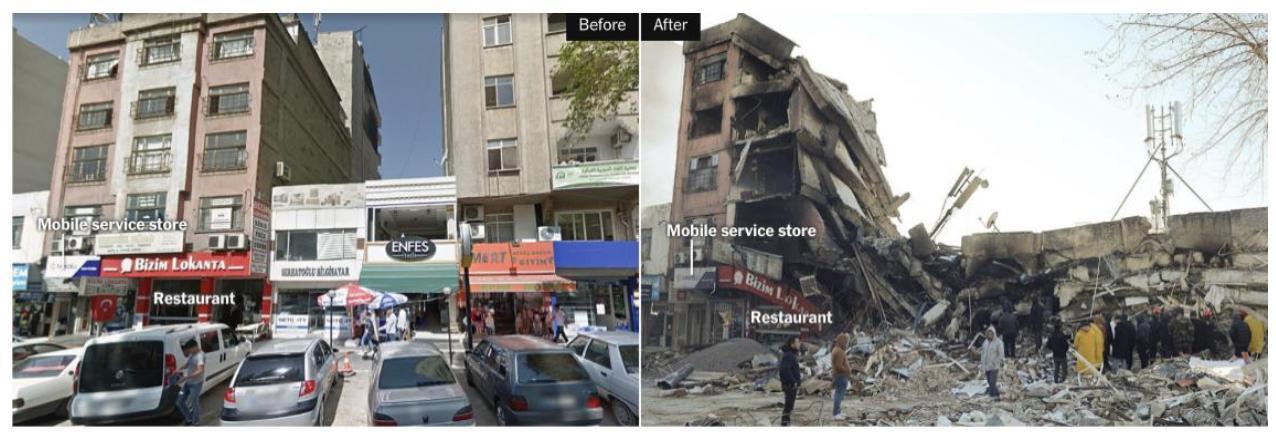
Figure 4.6. Collapse of buildings due to weak/soft story & pounding. The short 2-story building located between two mid-rise buildings, without adequate seismic separation, likely led to pounding between the roof slab of the 2-story building and the mid-height of the adjacent buildings. This has resulted in partial collapse of the building on the left and total collapse of the building on the right along with collapse of the 2-story (Source: <u>New York Times</u> 2023).

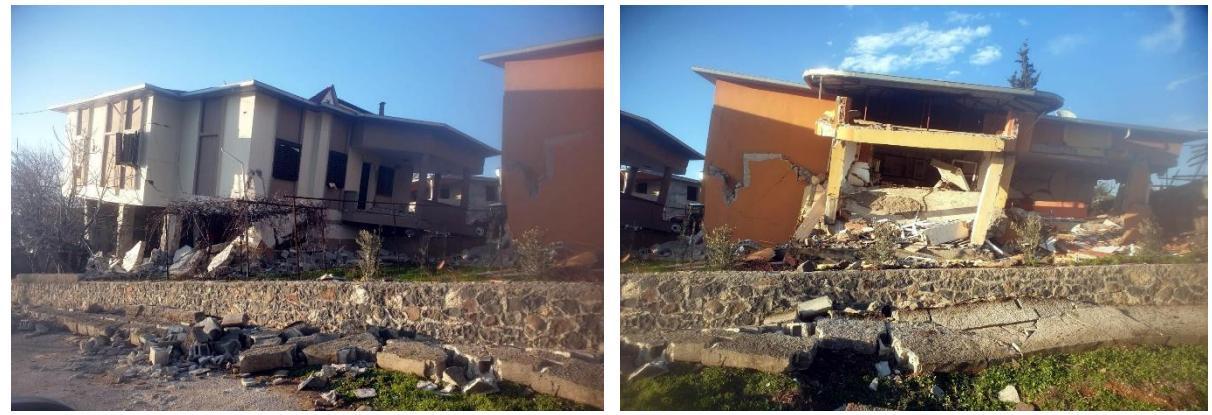
(10) The 2-story buildings in Figure 4.13 might have collapsed due to the combined effect of soft and weak stories and accompanying torsional response.

Figure 4.13. First story collapse of single-family RC residential buildings in Tevekkelli possibly due to weak and soft-story failures (Source: <u>Veryansin TV 2023</u>).

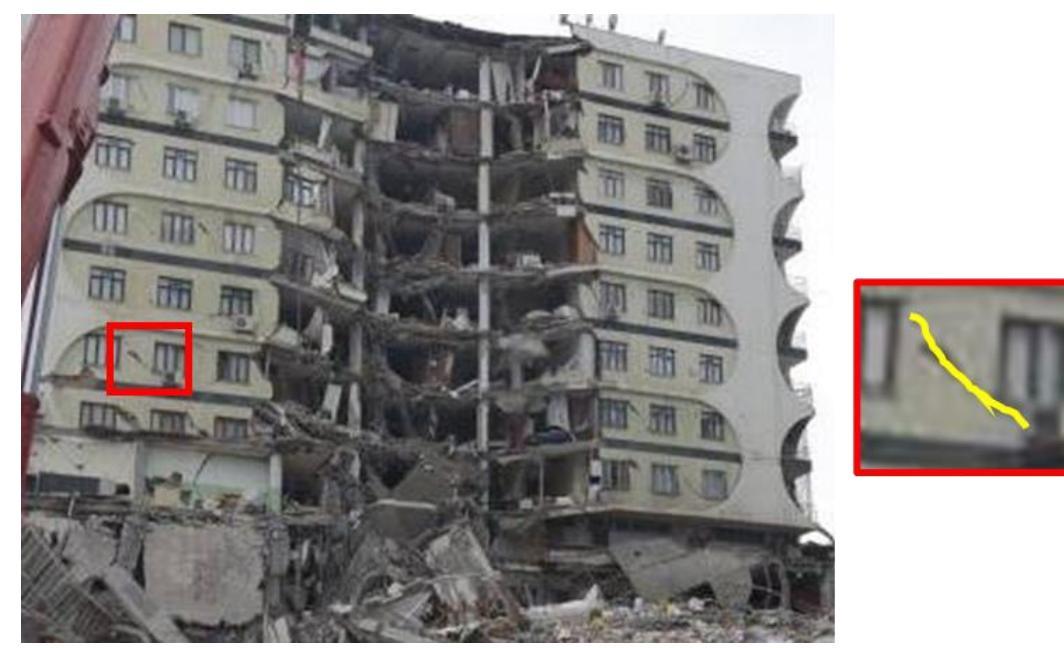
Figure 4.14. Partially collapsed building showing major diagonal cracks (refer to the insert) on the remaining towers, Diyarbakir (Source: <u>Getty Images</u>).

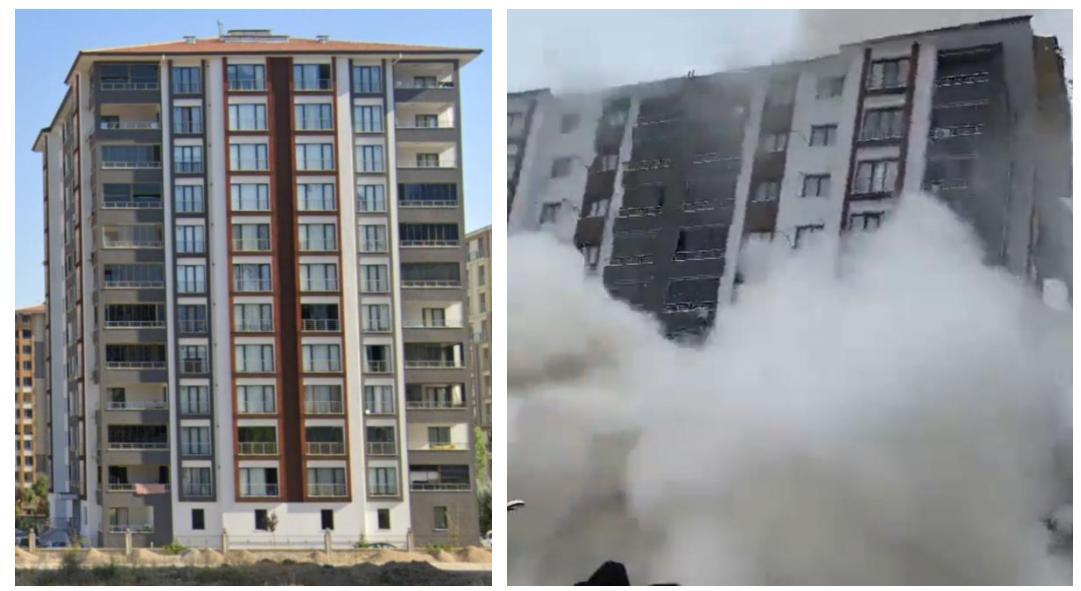
Figure 4.15. New residential towers before the earthquake sequence and during collapse due to the second earthquake (Mw 7.5), Bostanbasi, Malatya (38.32189N, 38.24656E) (Source: <u>Google Maps & Ibrahim Haskologlu via Twitter</u>).

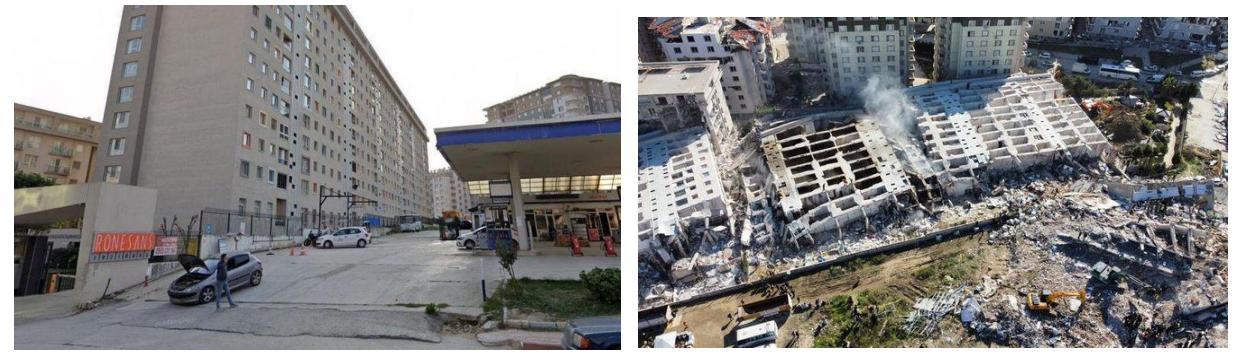
Figure 4.17. Potential sidesway collapse of the Rönesans residence, Hatay (Source: <u>AFP via</u> <u>Middle East Eye</u>).

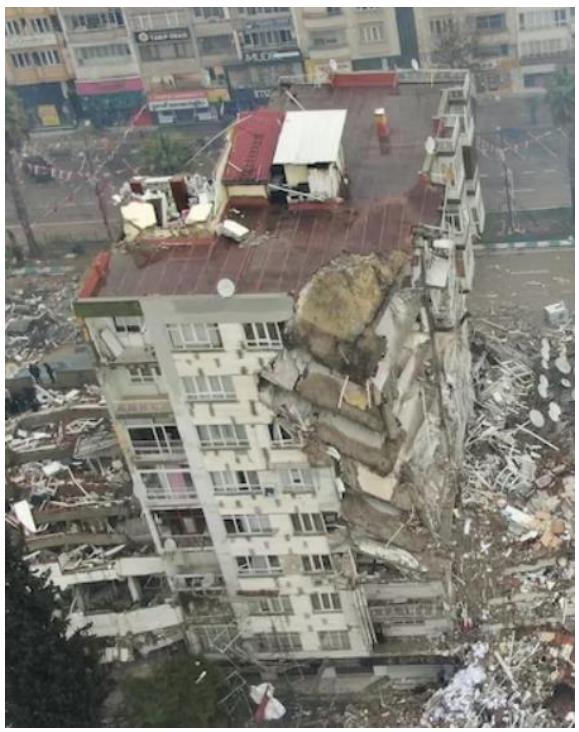
Figure 4.20. Partially collapsed of a multi-story building in Kahramanmaras, February 6 (Source: <u>Ihlas News Agency (IHA) via Reuters 2023a</u>).

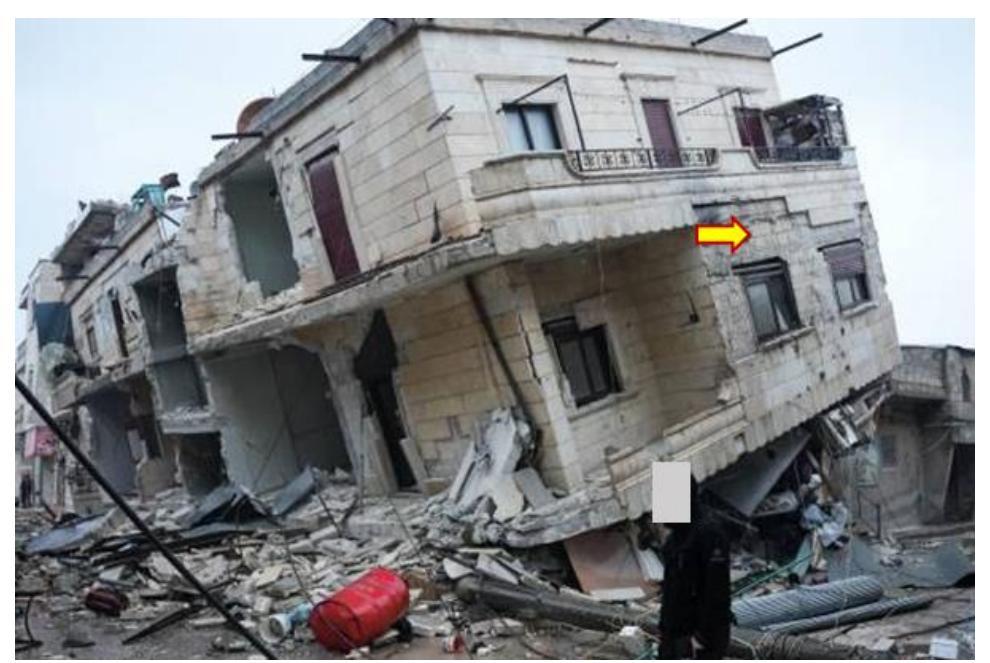
Figure 4.21. Soft-story collapse of a multi-family low-rise unreinforced masonry building in Aleppo (Source: <u>RAMI AL SAYED/AFP</u>).

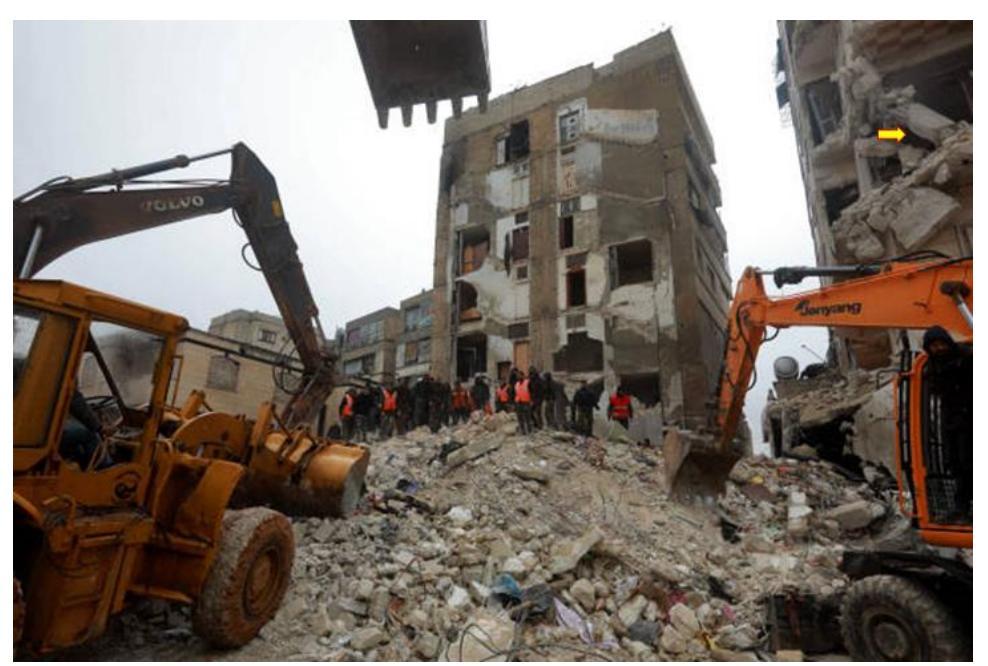
Figure 4.24. Ruins of a collapsed building with severely damaged RC columns (shown with arrows) in the adjacent building, Hama (Source: LOUAI BESHARA/AFP, Getty Images).

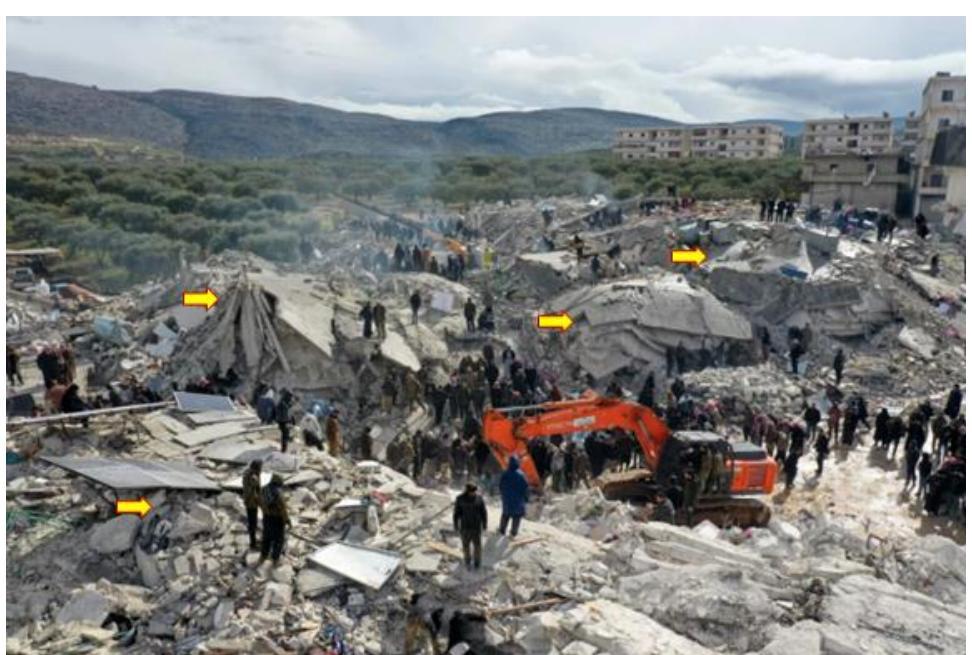
Figure 4.25. Pancaked collapse of masonry and RC buildings (shown with arrows) in Besnaya, Reef Idlib (Source: <u>AFP via npr.org</u>).

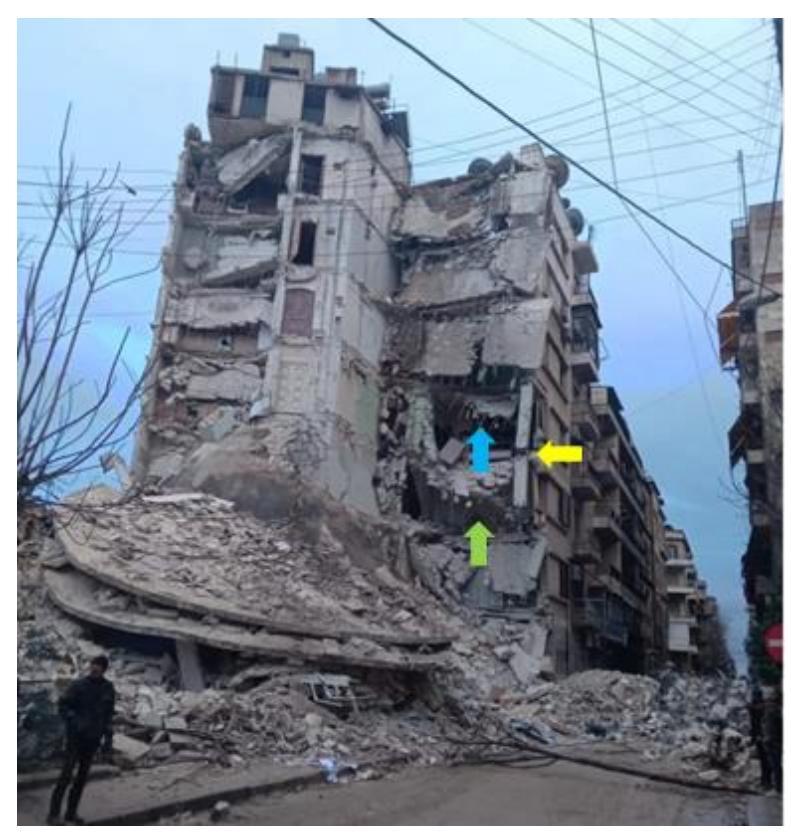
Figure 4.27. A partially collapsed building in Syria. Notice light column reinforcement (yellow arrow), the absence of beams and slab integrity steel (blue arrow), and poor reinforcing bars anchorage (green arrow) (Source: <u>https://yle.fi/a/74-20016582</u>).

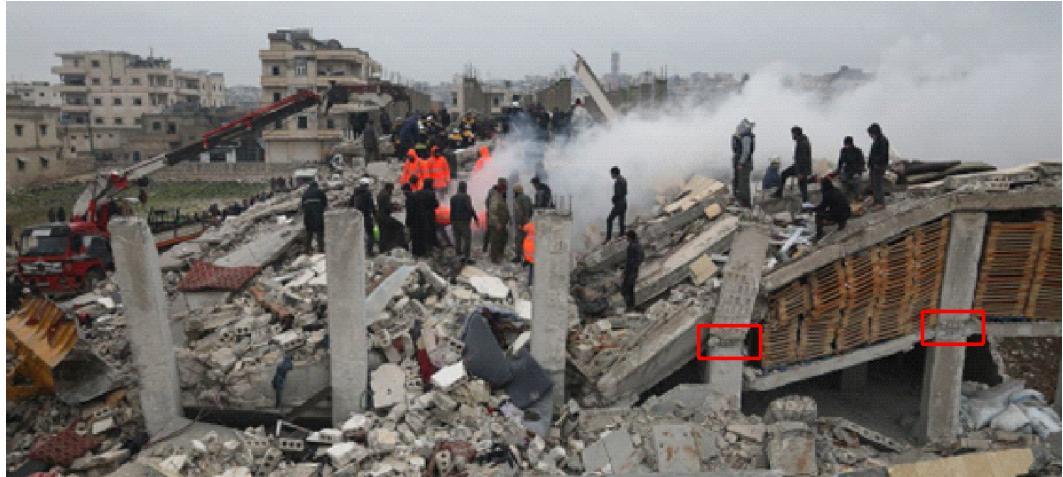
Figure 4.28. Slab failure in a collapsed building in Samada, Northern Syria (Source: <u>https://news.un.org/en/story/2023/02/1133177</u>). Notice the complete damage to the slab-column connection in the two right columns.

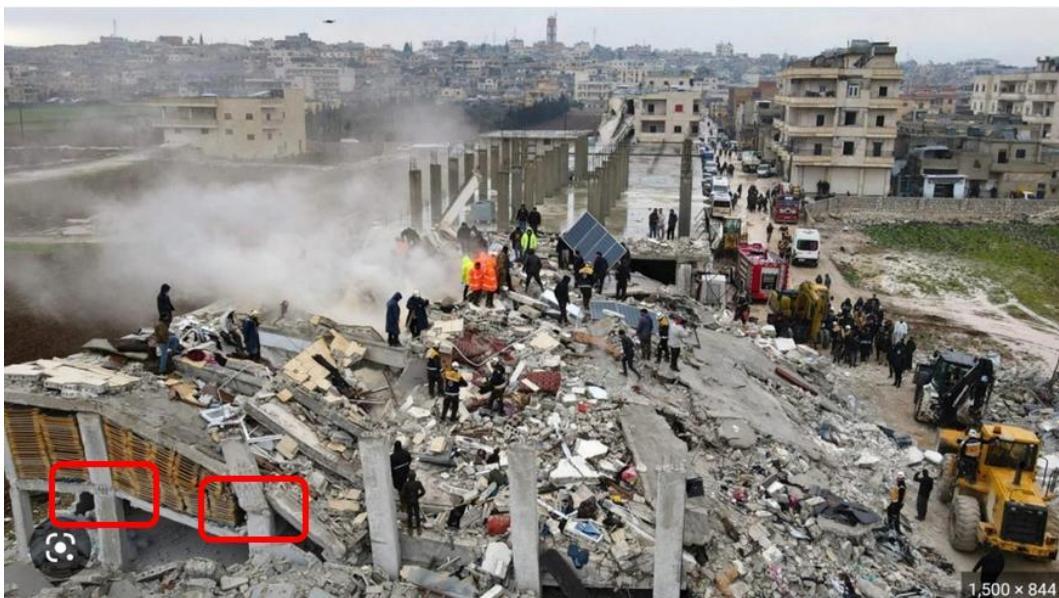
Figure 4.29. A collapsed building in Samada, Northern Syria (Source: <u>Reuters</u>). Notice the light column reinforcement and separation of slab from columns (in red rectangles) in the collapsed building.

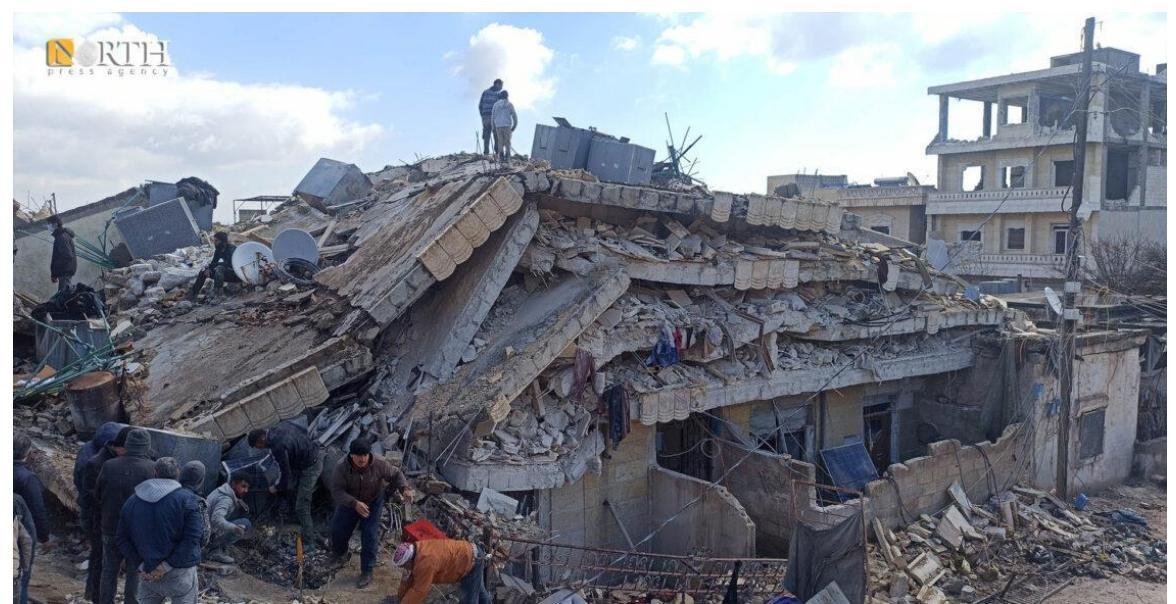
Figure 4.34. Pancaked concrete ribbed slab failure, likely built on unreinforced masonry bearing walls in Jinderis, Northern Syria. Notice the ribbed slab RC construction of the right neighboring building (Source: <u>NPASyria</u>).

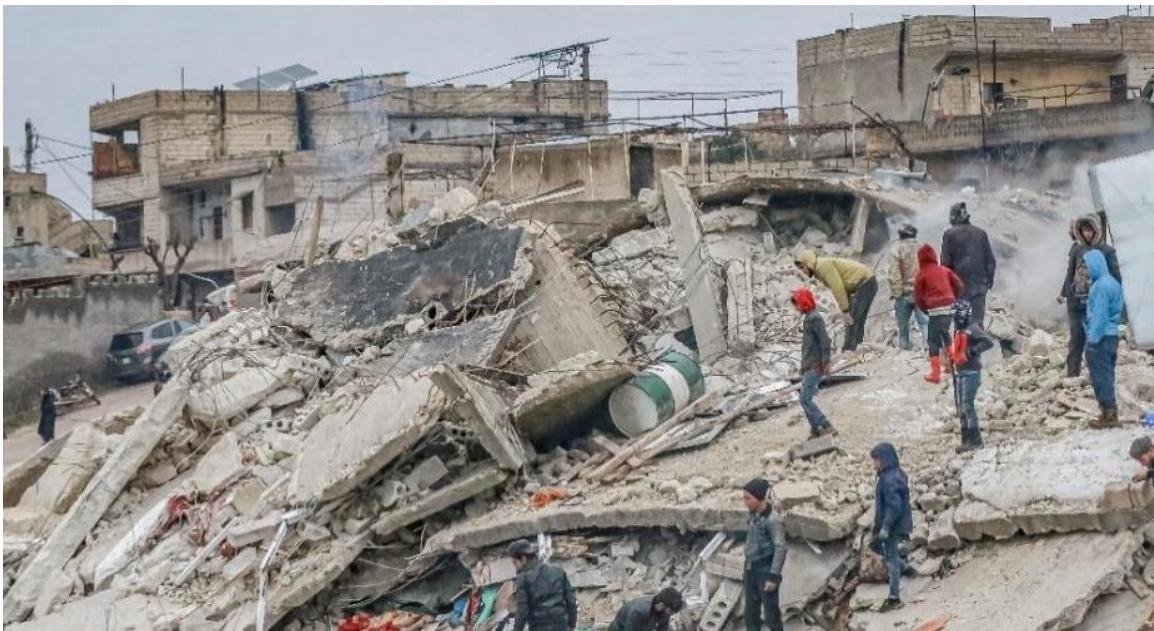
Figure 4.35. Collapsed concrete building near Idlib, Northern Syria. Notice the poor reinforcement of the columns (Source: AFP).

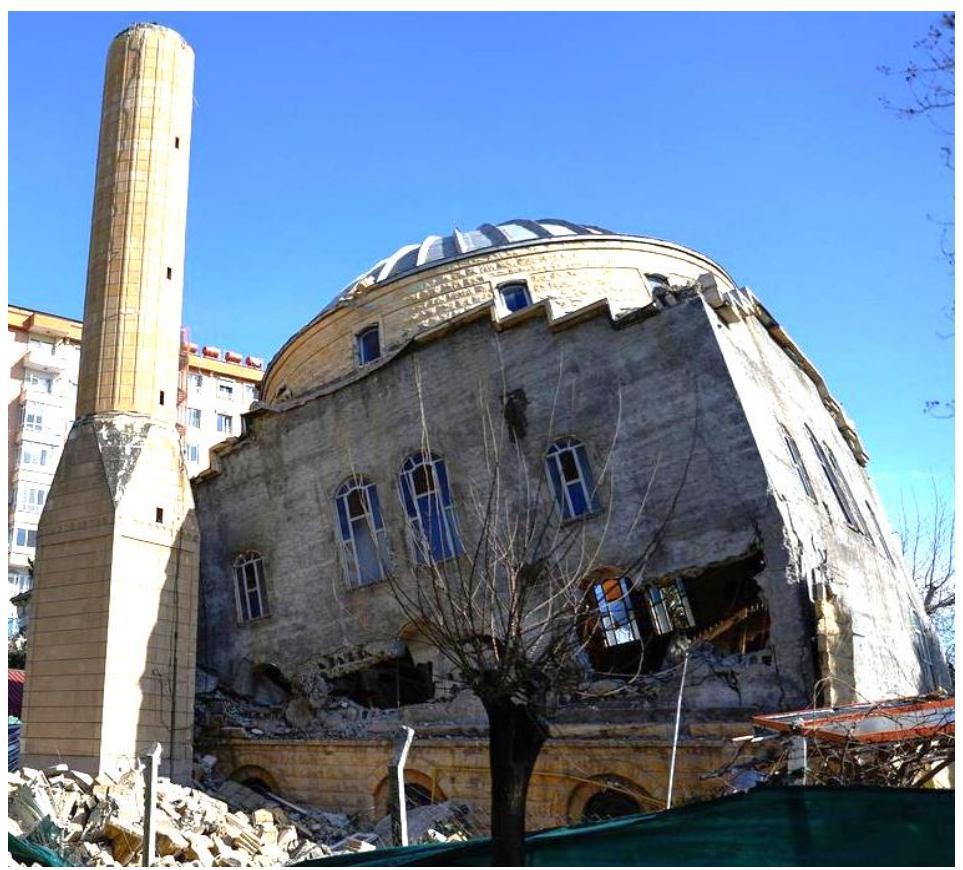
Figure 4.68. Partial collapse of an exterior wall of a mosque in Kahramanmaras, Turkiye, while the domed roof remained intact (Source: Reuters via the <u>Independent 2023</u>).

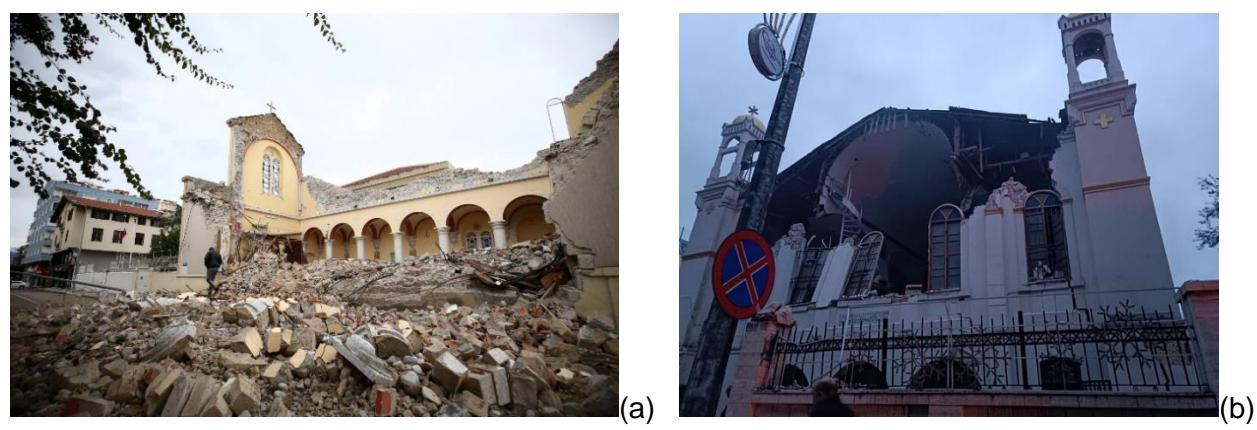
Figure 4.69. (a) Collapse of the arch roof structure of the Cathedral of the Annunciation in İskenderun (36.5876N 36.1655E) (Source: <u>New Arab 2023</u>); (b) Severe damage to St. Nicholas Orthodox Church in İskenderun due to out-of-plane failure of the gable end wall (36.5875N 36.1706E) (Source: <u>haber.sat7turk.com</u> 2023).

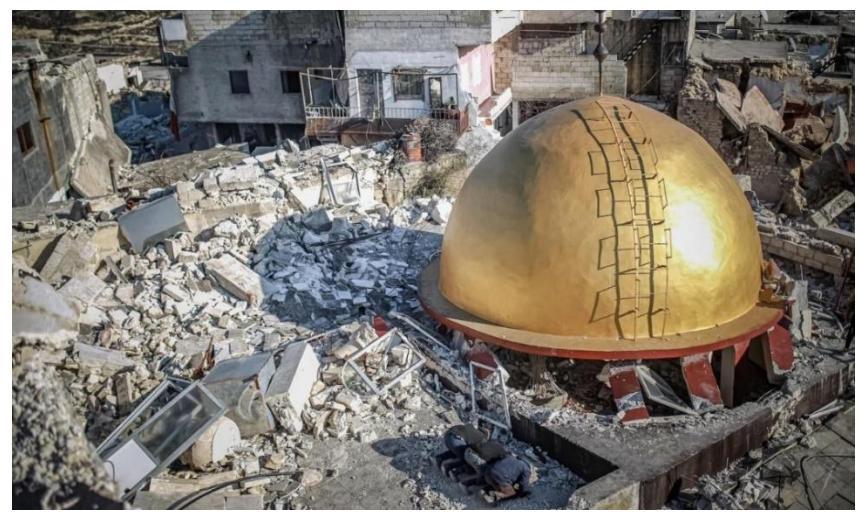
Figure 4.72 Collapsed mosque in Idlib, Northwest Syria (Source: Getty Images via Foreign Policy, 2023). The heavy dome roof appears to have been supported on a long-span roof supported by rectangular reinforced concrete columns with inadequate reinforcement.

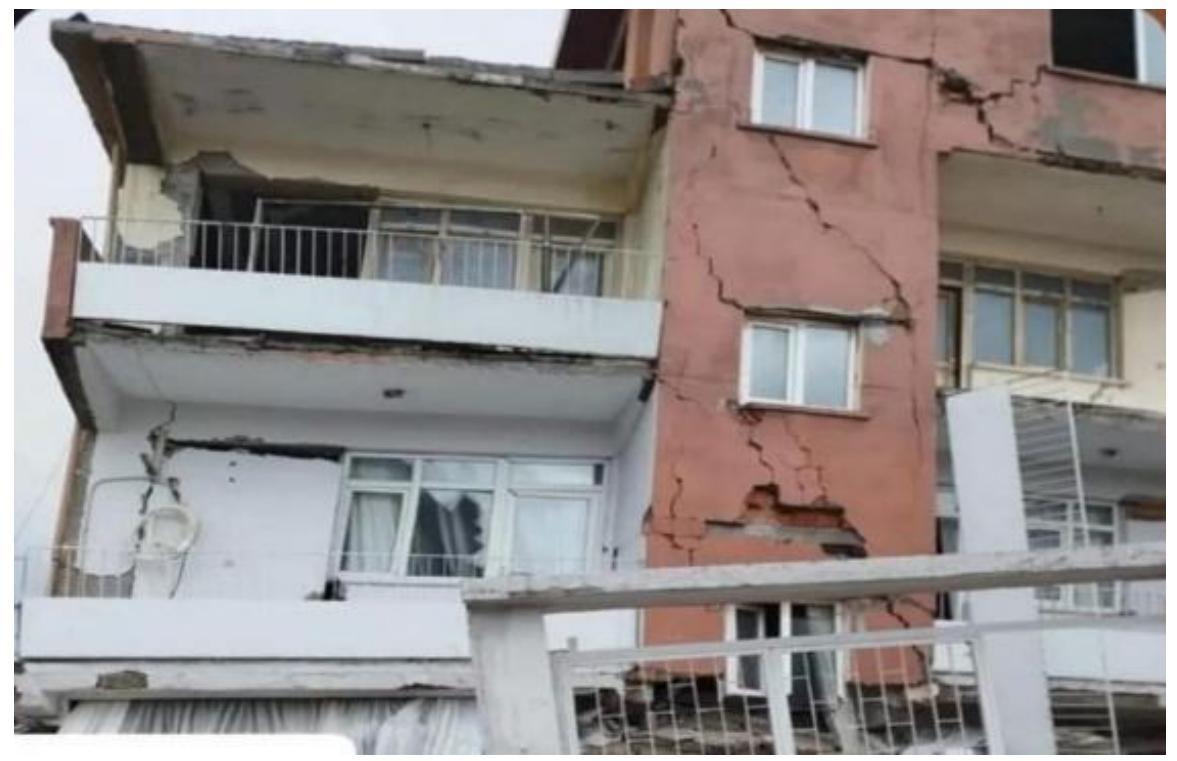
Figure 4.73. Examples of nonstructural components (bricks and parapets), which can be a falling hazard, in a residential building in Hatay, Türkiye. It was also announced that residents were stuck in the stairwell (Source: <u>Ozgur via Twitter</u> 2023).

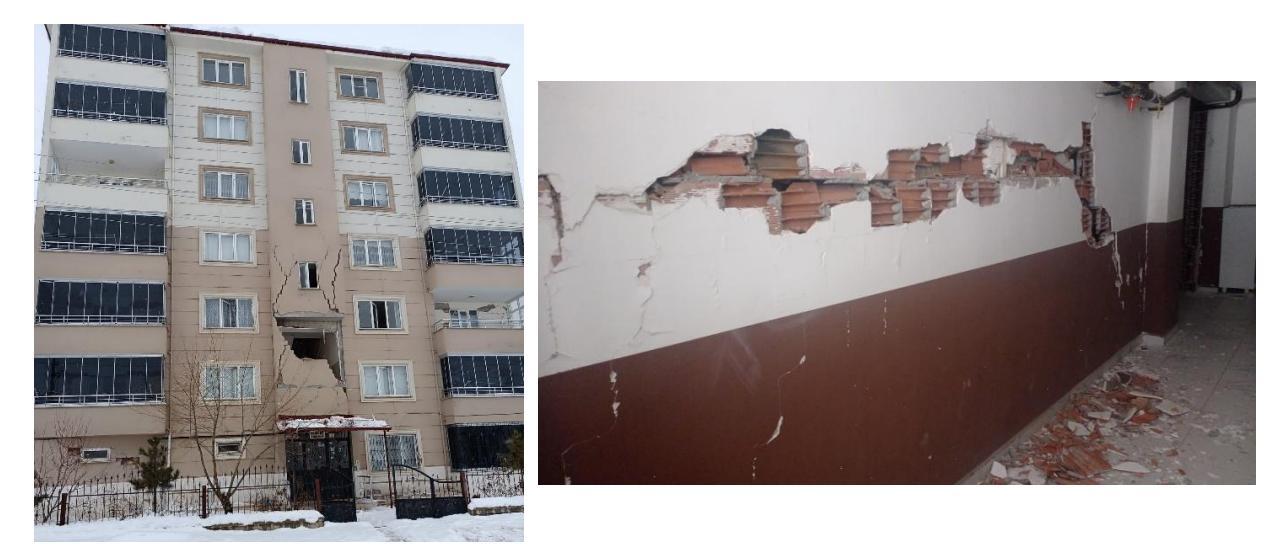
(a) Exterior walls. (b) Interior wall. **Figure 4.75.** Damage to non-structural infill walls (Source: Demirkapu, Local Assessor).

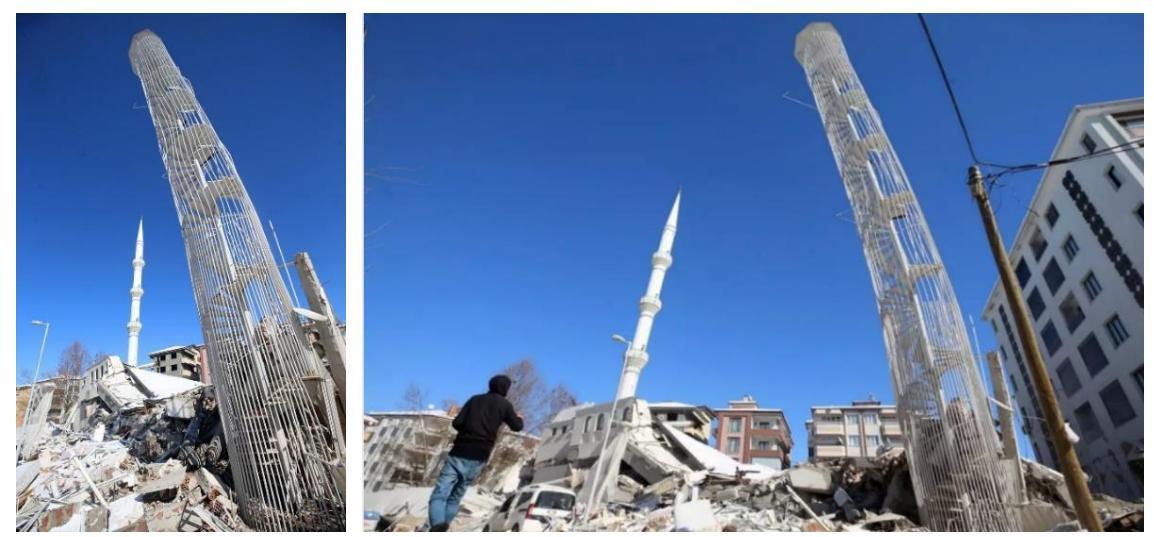
Figure 4.80. A 5-story RC building collapsed, but the steel stair stood alone, Malatya, Türkiye (Source: <u>TRHaber</u> 2023).

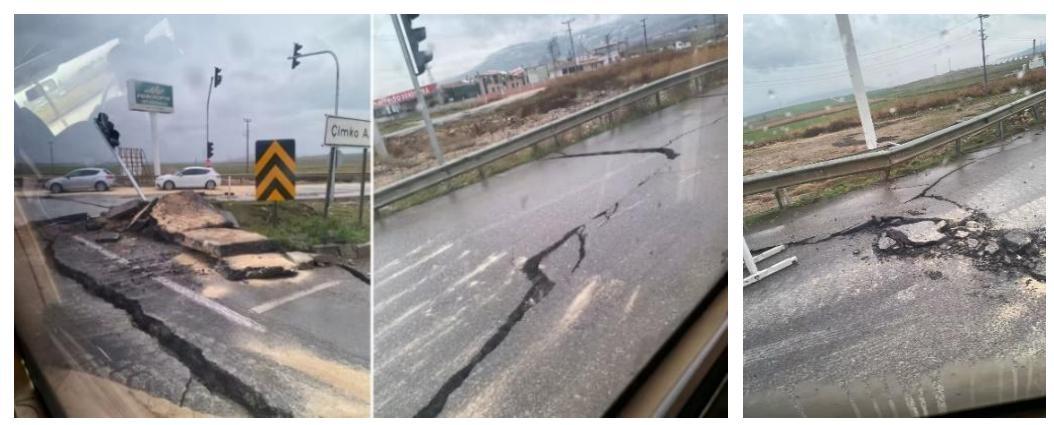
Figure 5.2. Surface failure of roadway (Source: Channel News Asia).

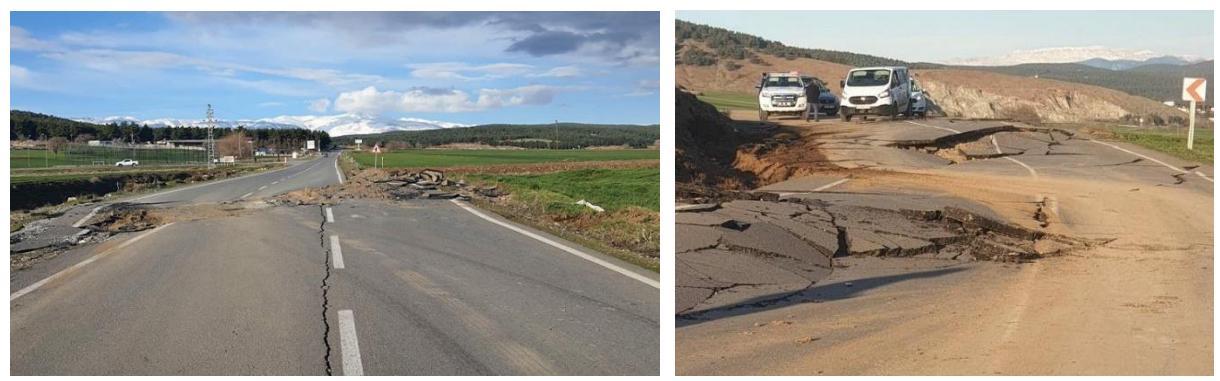
Figure 5.3. Shifting (differential movement) of the roadway near the Tevekkelli village (Source: Veryansin TV).

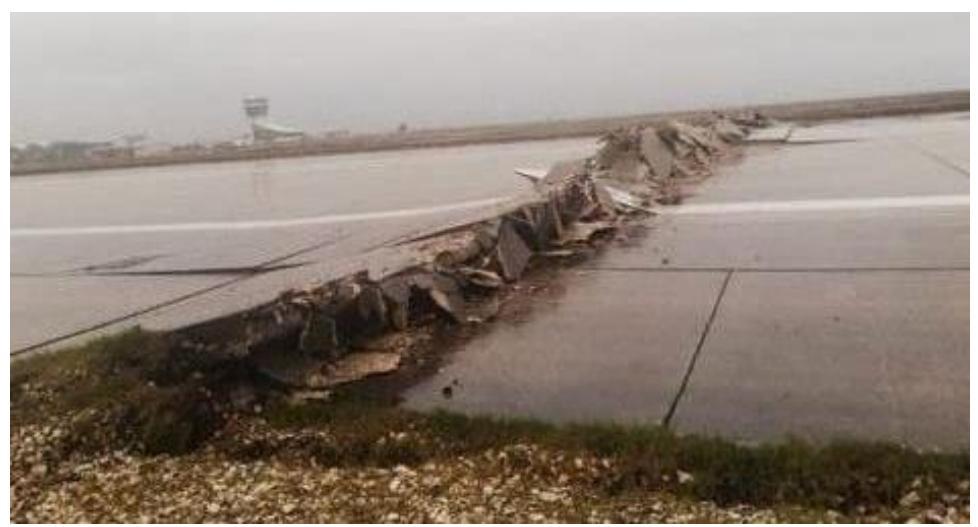
Figure 5.7. Hatay Airport in southeastern Türkiye has suspended operations due to runway damage caused by the earthquake sequence (Source: <u>Twitter</u>).

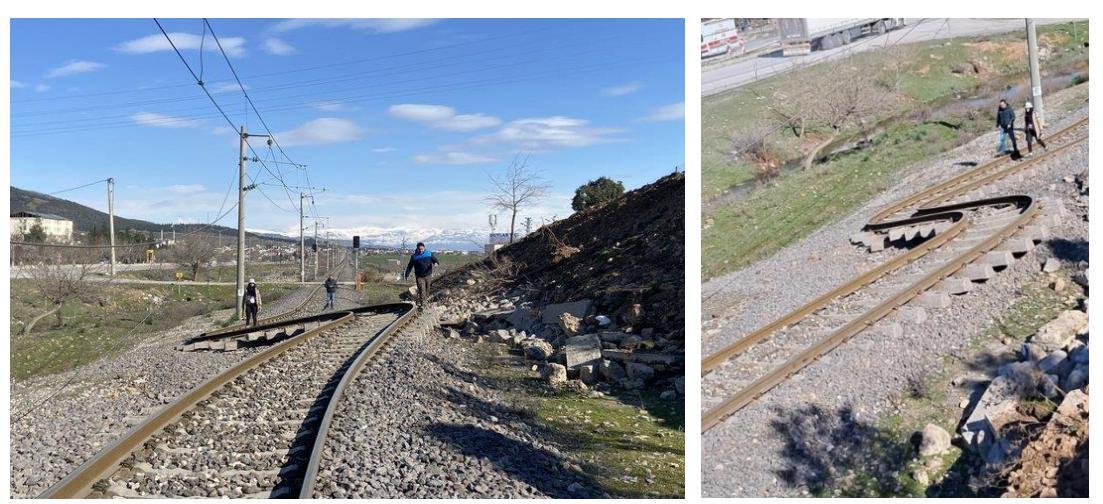
Figure 5.9. Deformed railway between Kahramanmaraş, Türkoğlu, and Gaziantep, İslahiye (Sources: <u>Reddit</u> (left) and <u>Facebook</u> (right)).

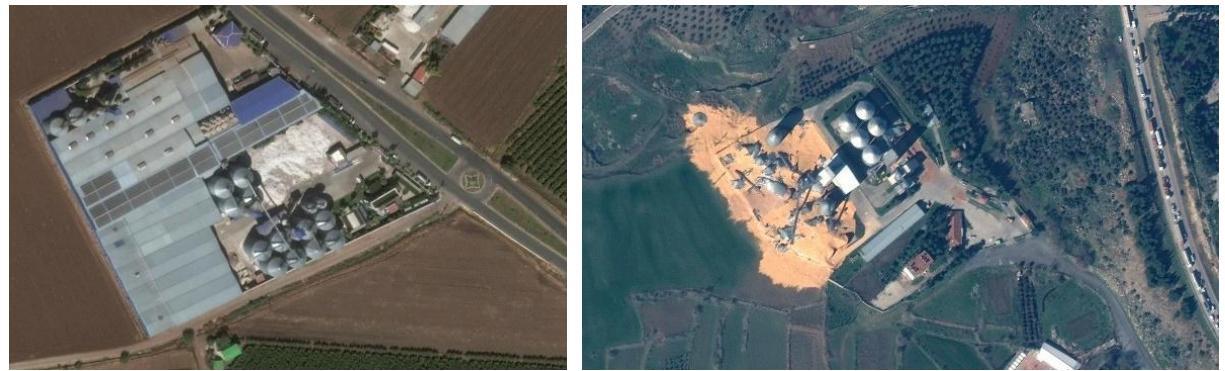
Figure 5.12. Aerial views of the damage of grain silos near Kırıkhan (Left) and near Nurdağı (Right) (Source: <u>CNN</u>).

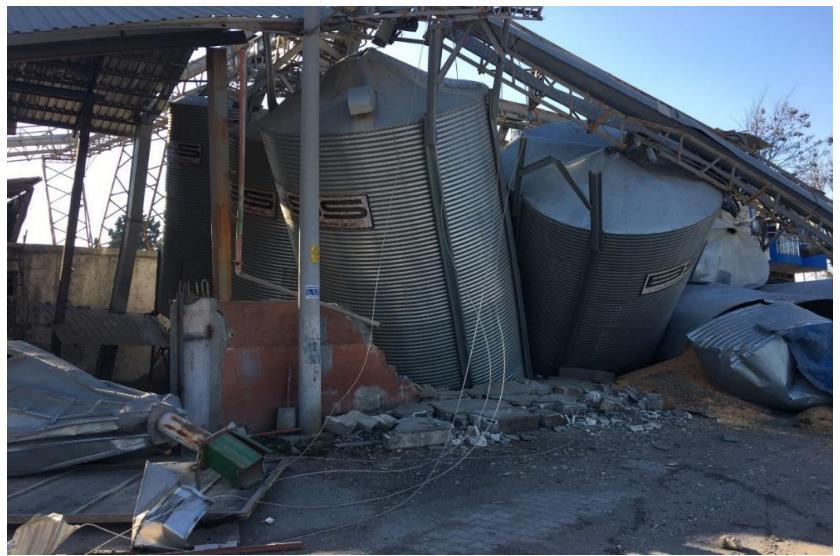
Figure 5.13. Steel storage containers damaged during the earthquake sequence due to failure of roof (Source: Mustafa Kerem Kockar via Linkedin).

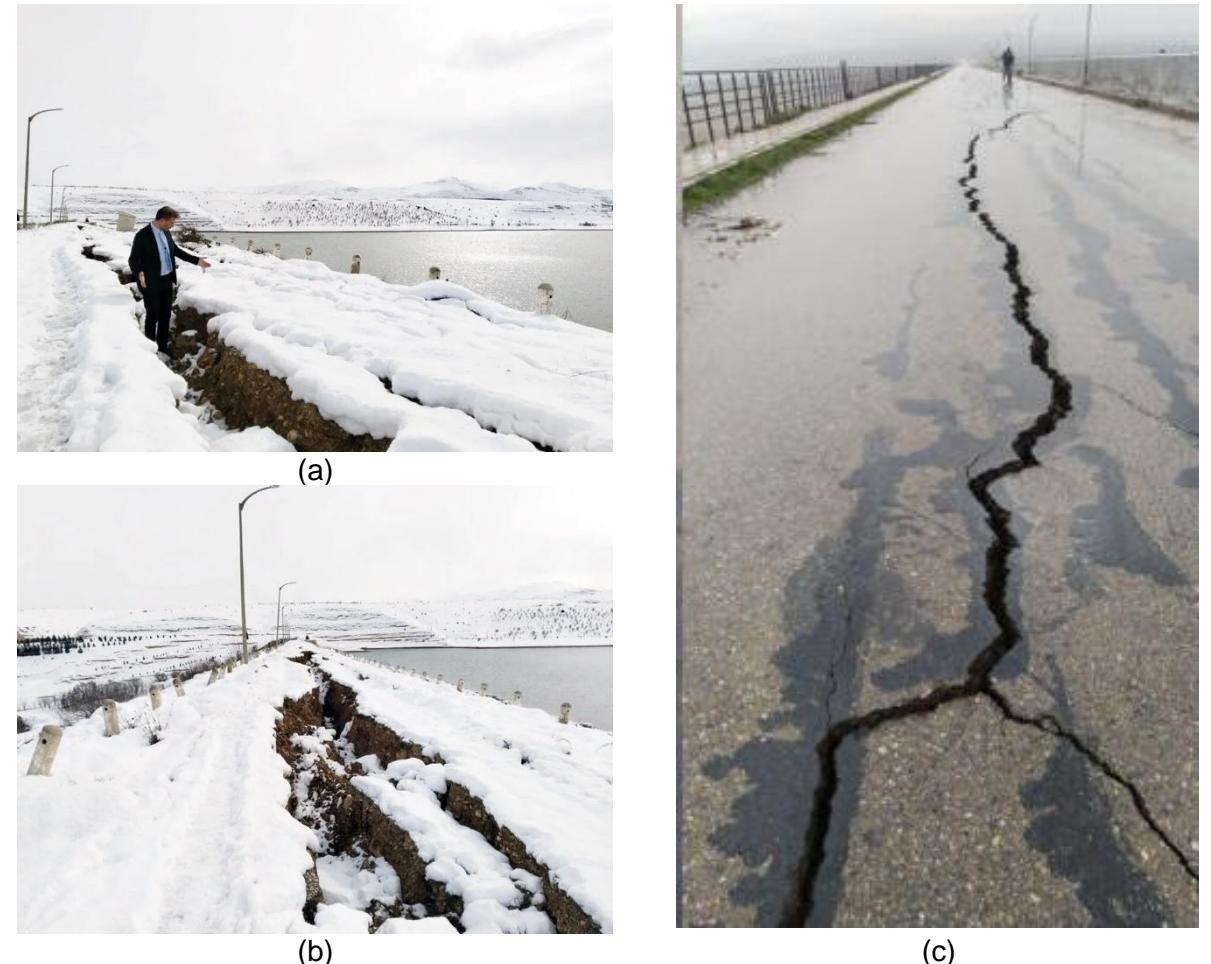
Figure 6.10. (a-b) Sultansuyu Dam with cracks along its central axis (Source: <u>ntv.com</u>) and (c) longitudinal and transverse cracks in the Afrin dam (Source: <u>Syrian Television via misbar.com</u>).

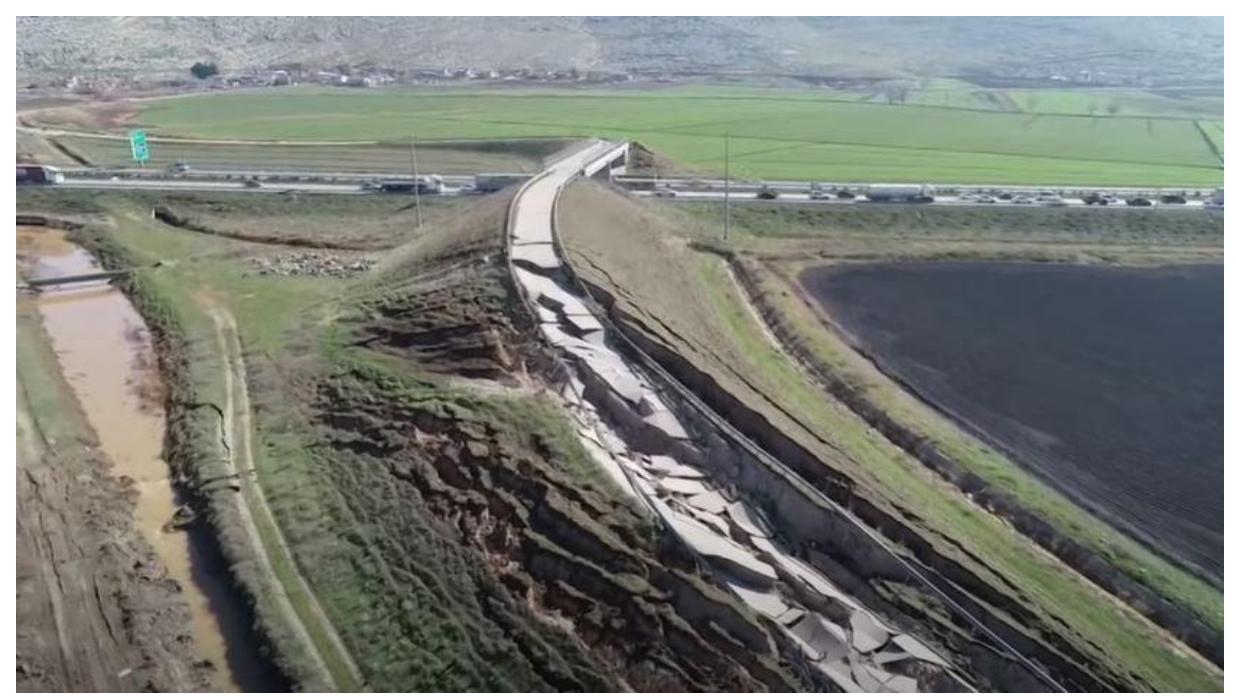
Figure 6.11. Failure of the embankment road in the village of Koseli, which passes over the Adıyaman-Sanliurfa-Gaziantep Highway in the Adıyaman province (Source: <u>Reuters via</u> <u>Washington Post</u>).
