Towards autonomous inspection of concrete deterioration in sewers with legged robots

Journal of Field Robotics 37(S 8), <https://doi.org/10.1002/rob.21964>

Towards Autonomous Inspection of Concrete Deterioration in Sewers with Legged Robots

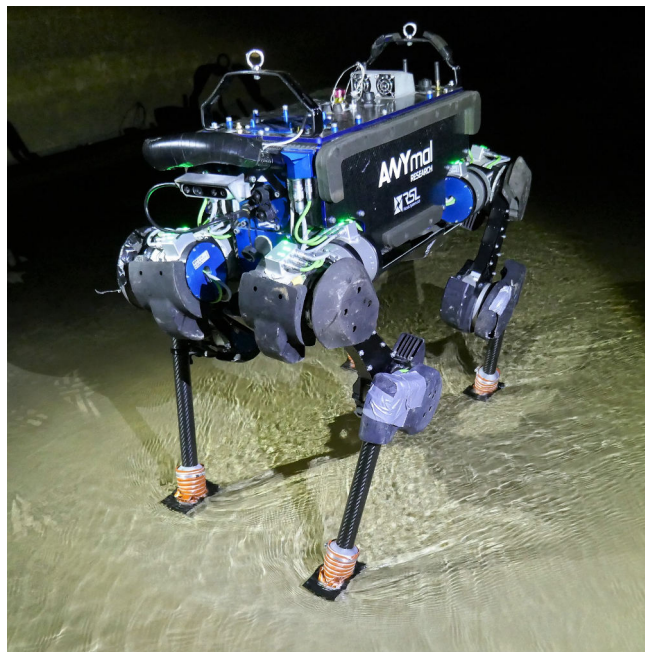
ANYmal (Figure 1) is a 30 kg quadruped robot driven by twelve series elastic actuators mounted at the joints. The dimensions of the robot are 800 mm x 600 mm x 700 mm when standing. With its legs tucked up, it is 800 mm x 600 mm x 400 mm which allows it to be deployed through a common utility hole. The kinematic structure of the robot is designed to achieve an extensive range of motion, allowing it to overcome obstacles and manipulate the environment. The structure is made primarily of aluminum and carbon fiber to minimize weight. Shock absorbers and

Figure 1: Depiction of *ANYmal* with custom feet deployed in the sewers of Zurich.

Kevlar plates protect exposed components from impacts. *ANYmal* is designed in a modular fashion: each actuator unit consists of a motor, gears, and drive electronics and is connected over the EtherCAT bus. The connection between sub-assemblies such as the legs are easily accessible, and water-proof quick connectors are used for power and communication lines. This allows component-level ingress protection as well as fast and simple maintenance in case of hardware failure.

For localization and navigation, the machine is equipped with a LIDAR (Velodyne VLP16) sensor mounted on top of the torso. A front-mounted stereo depth camera (Intel RealSense D435) provides a local map of the terrain to assess traversability and assist foothold planning. Additional sensors modules, such as RGB and thermal cameras, can be mounted for inspection tasks. Powerful LEDs provide sufficient illumination in dark environments. *ANYmal* can operate partially or fully autonomously with on-board batteries. The battery allows the system to traverse up to 3.6 km with a trotting gait at 0.5 m/s on a single charge. Optionally, the robot can be recharged without human interaction via a docking station in case long-term autonomy is required [Kolvenbach and Hutter, 2018].

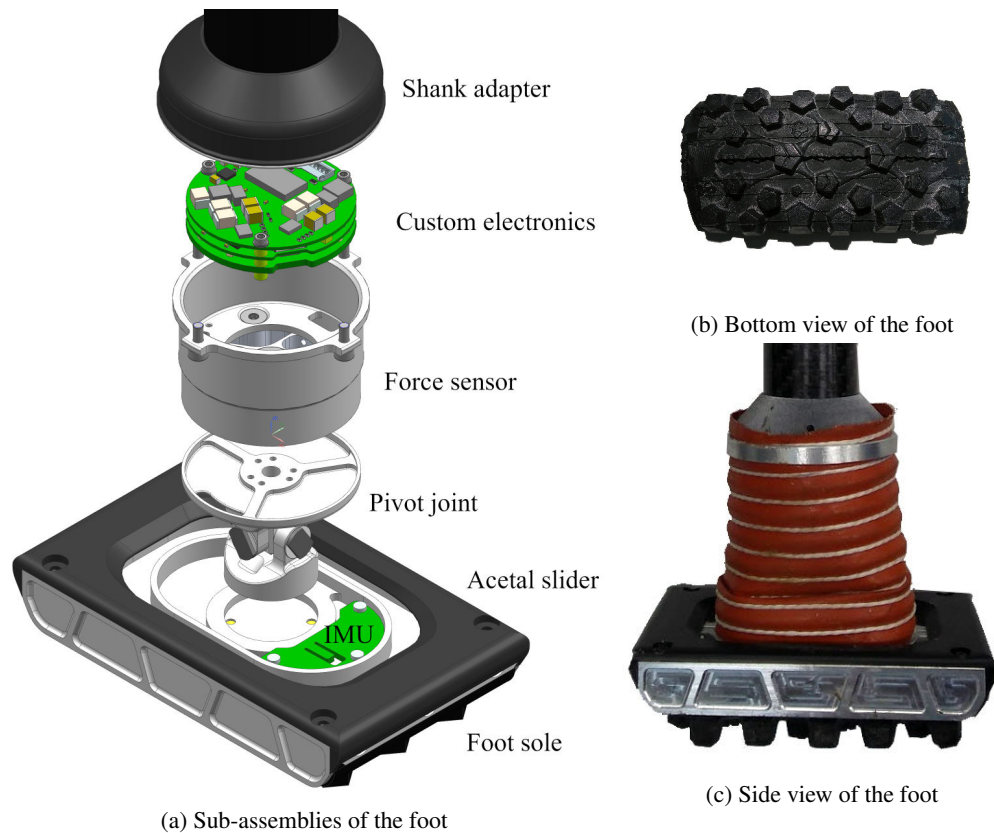
We designed sensor-equipped, adaptive feet to enhance locomotion on the rough and slippery terrains encountered in sewers while measuring local ground inclination and surface properties. Similar to the rest of the robot, the feet have to be sufficiently robust to operate continuously in a challenging environment. The design is based on the adaptive foot proposed in previous work of our group [Käslin et al., 2018]. The foot consists of a large flat contact surface that can comply to the local ground inclination without interfering with the locomotion of the robot. With a possible inclination of the terrain of up to 25° , the range of motion for ground compliance is set to 50° around the pitch axis and 30° around the roll axis. Since each leg only allows for hip abduction/adduction, hip flexion/extension and knee flexion/extension, the foot compliance around yaw prevents slipping while turning. Weighing 314 g (including cabling and connectors), it is lighter than both the original point foot and the previous adaptive foot. Figure 2a illustrates the sub-assemblies of the foot, which are described in the following.

1) *Foot sole*: The sole has a surface area of 60 cm^2 (100 mm x 60 mm) and is made from an off-road rubber tire featuring 5 mm studs for increased traction (Figure 2b). The sole is connected to a metal rim by clamping, which avoids peeling and gluing issues. Damping foam is placed between the rubber sole and the metal structure to reduce the peak loads resulting from impact forces during walking. An acetal slider avoids the foot getting stuck on overhanging edges and retains the metal rim.

2) *Pivot joint*: The pivot joint features a lightweight universal joint with integrated end stops to provide the required ground compliance. It is surrounded by an Ester Polyurethane rubber tube of Shore A70 that provides the retaining force to reset the foot to its initial position after deflection.

3) *Force sensor*: A custom, in-house developed six-axis force/torque sensor is placed above the pivot joint to measure the forces acting on the foot. It consists of a force sensing element with strain gauges. The sensor is lightweight and robust and allows sensing up to 1000 N along the z-axis and 400 N along the x and y-axis. The maximum torque the sensor can sense is specified as 10 Nm. The accuracy lies within 1.5% of the measured value while the repeatability lies below 0.05%⁴. The measurements are filtered at 800 Hz by an integrated sinc filter with cut-off frequency of 1255 Hz. The sensor is temperature compensated to minimize drift during operation.

4) *Custom electronics*: The electronics of the foot consists of two IMUs (MPU-9250), a force sensor and a microcontroller board. One of the IMUs is located in the sole, while the other is integrated with the PCB in the shank. The IMU's linear acceleration is filtered with a cut-off frequency of 460 Hz while the angular velocity is filtered with a cut-off frequency of 184 Hz. Both the IMUs and the force sensor are connected to the microcontroller via the serial peripheral interface bus (SPI). The IMUs are read out at 1 kHz and force measurements are obtained at 400 Hz. The microcontroller board is connected to the robot via EtherCAT and powered through the auxiliary 12 V power line. A PCB with analog-to-digital converters and a microcontroller processes analog signals coming from strain gauges to compute the forces and torques. Sensor data is recorded on the high-level side at 400 Hz.

Figure 2: Overview of the newly developed foot for sewer inspection.

5) *Shank*: The carbon fiber shank connects the foot to the knee of the robot. The shank is sealed and features a conical slider for protection of the force sensor.

6) *Sealing*: The joint is protected by thick bellows (visible in Figure 2c), mechanically clamped to the structure and sealed, which improves the ingress protection rating compared to previous work. O-rings and sealants have been used for all the matching surfaces. Water-proof cable glands and connector have been used for the cables.

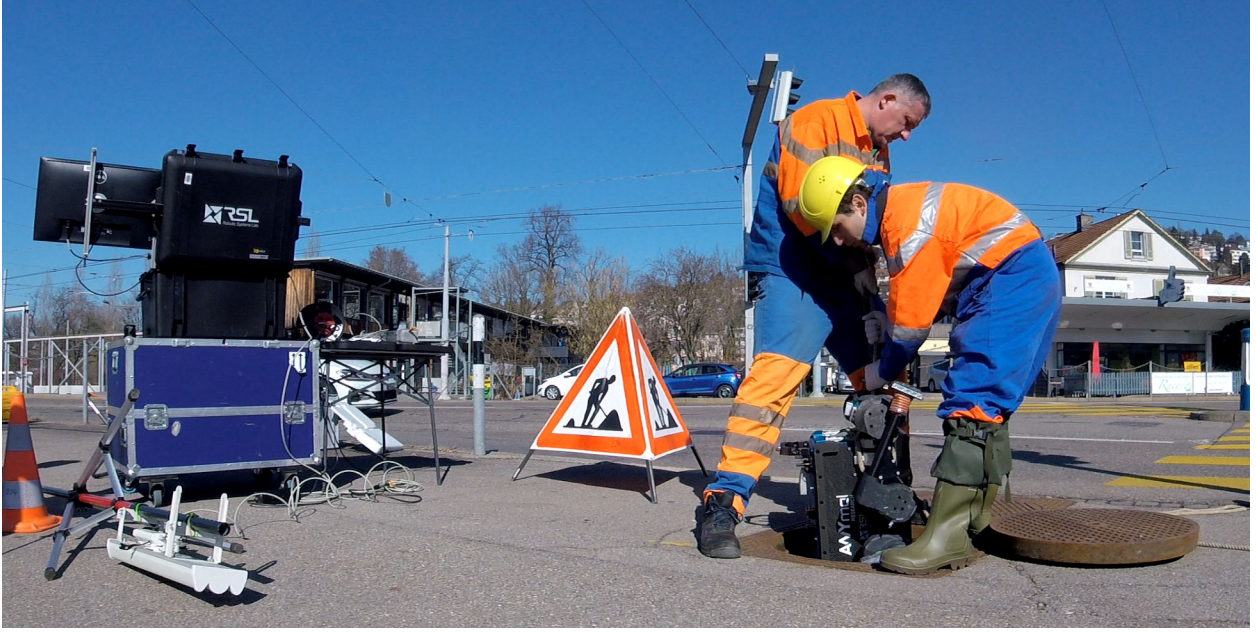
Figure 3: Depiction of the field test setup and the deployment of *ANYmal* into the sewer. The operator base station and warnings signs are visible in the background.

We conducted multiple field test campaigns in the sewage system of Zurich to iterate the hardware, practice operations, collect datasets, and execute inspection missions. The first test campaign with the robot took place during two days in February 2019 [Kolvenbach et al., 2019] and the second campaign took place on three days in December 2019. Generally, the robot can be easily deployed through a common utility hole ($d = 0.8$ m). To do so, the robot's legs are unpowered, tucked up, and the system is lowered into the sewer with a tether (Figure 3). During our tests, the robot was operated from a base station which was located outside the sewer, nearby the utility hole. The base station consists of the operator PC, an additional screen, and outlets for electricity and communication links to the robot. The base station is easy to transport and quick to set up. We installed a gazebo to shelter the robot operator and desk during rainy testing days. We deployed directional Wi-Fi antennas (Ubiquiti airMAX, HyperLink HG4958DP-19P) into the utility hole via a tripod with a reversed column to enable a reliable communication link to the robot. During the test, a safety operator stayed in the sewers with a professional inspector and communicated with the robot operator outside via two-way radios (Figure 4).

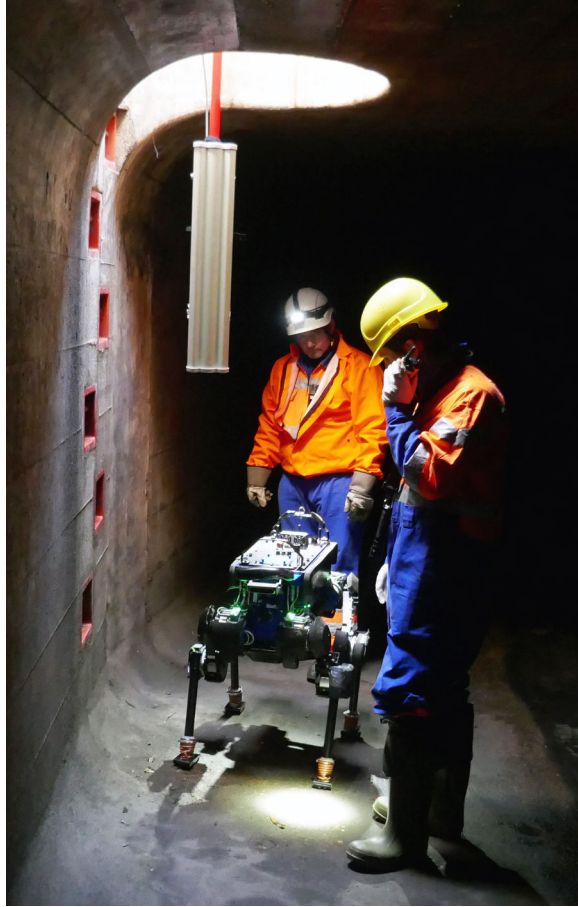
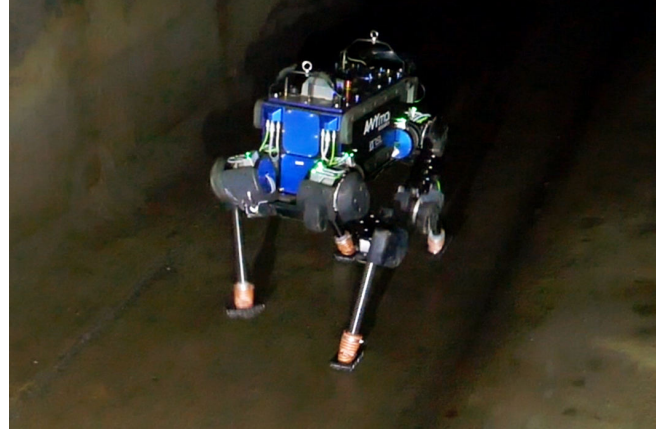
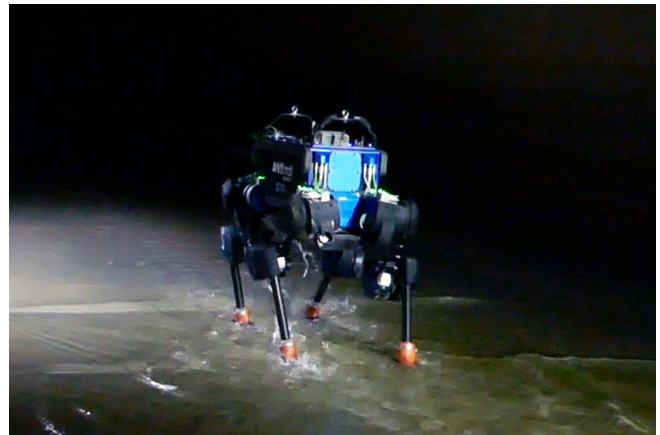
(a) *ANYmal* setup in the sewer

(b) Walking on biofilm

(c) Walking through wastewater

Figure 4: Depictions of *ANYmal* walking in the sewer. A professional sewer inspector accompanies the testing and assesses the state of the concrete.

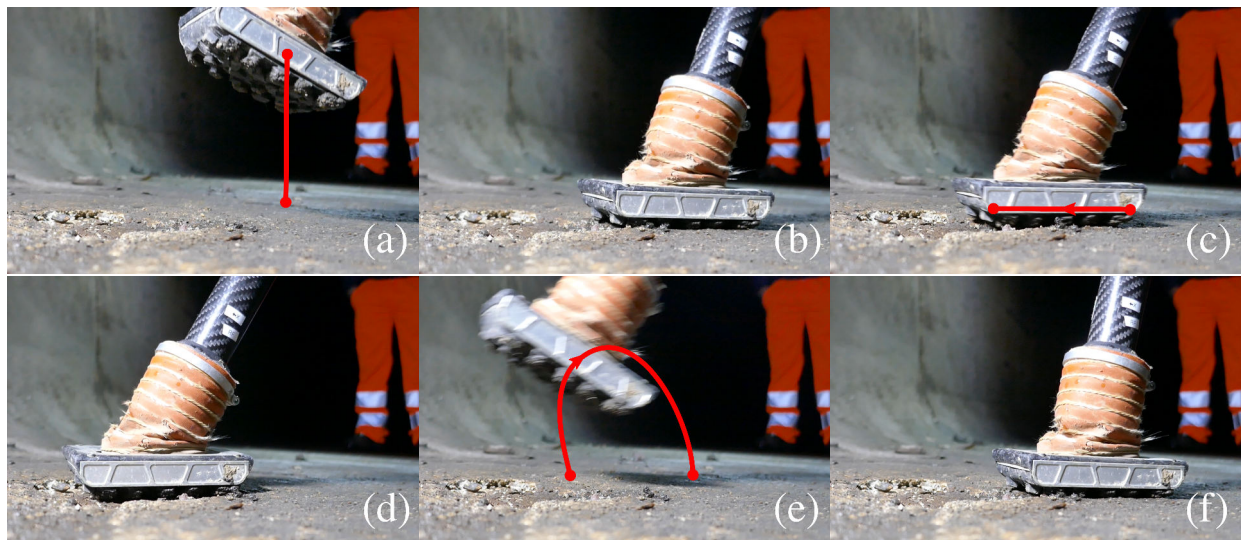
The full sequence of the inspection motion, shown in Figure 5, can be split into several phases. A predefined position relative to the three stance legs is approached in (a) and contact is established in (b). In (c), a straight line trajectory is followed until a target location (d). In (e) and (f), the foot is re-positioned to return to a nominal stance on four feet. For the part (c) of the inspection motion, where data is collected, the desired end-effector force is computed as seen in the following equation.

Figure 5: Picture sequence of the tactile inspection motion with the foot placement phase (a), inspection motion start location (b), main inspection phase (c), motion target (d), re-positioning movement (e), and final position (f).

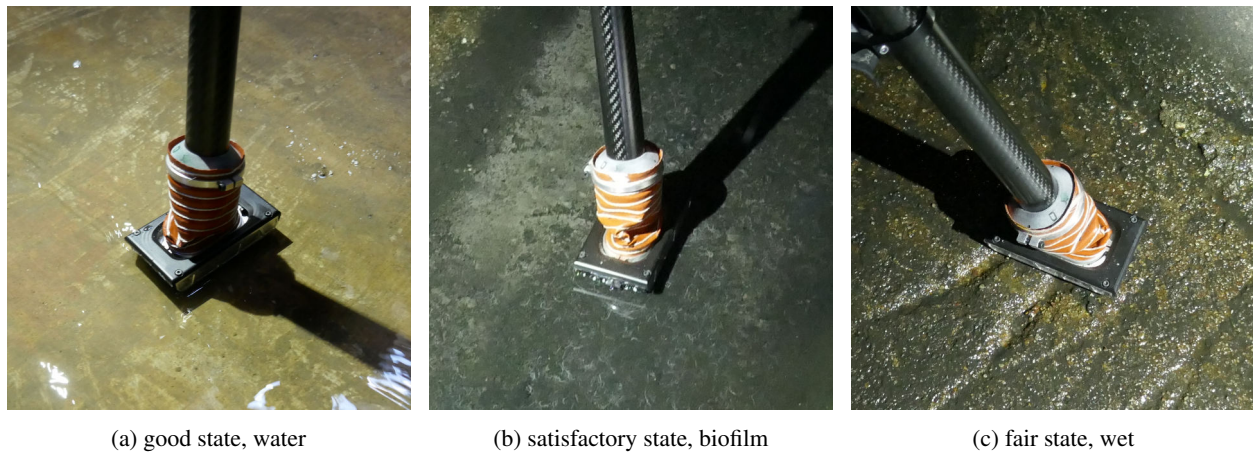
Figure 6: An exemplary set of pictures illustrating the various surface conditions encountered in the sewers.

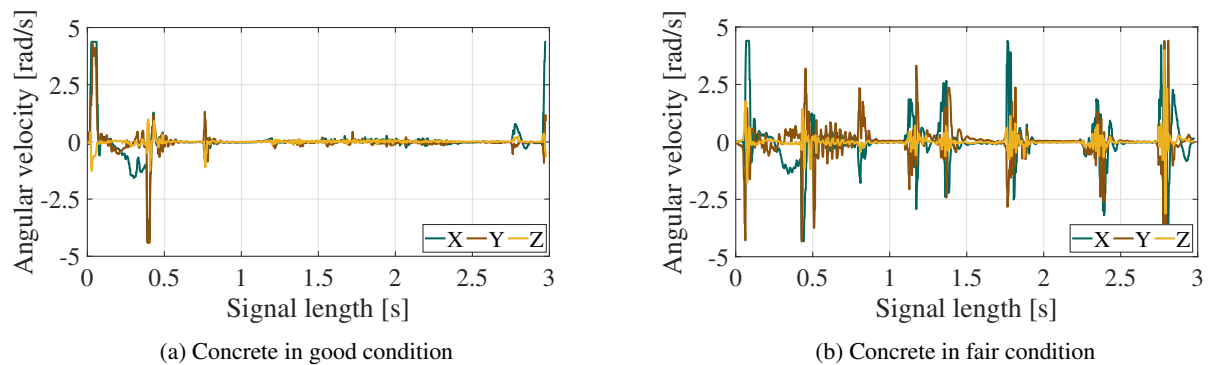
Figure 7: Comparing the angular velocities of two samples recorded by the foot sole IMU show a correlation between signal magnitudes and concrete deterioration (Complete sequence of the inspection motion).

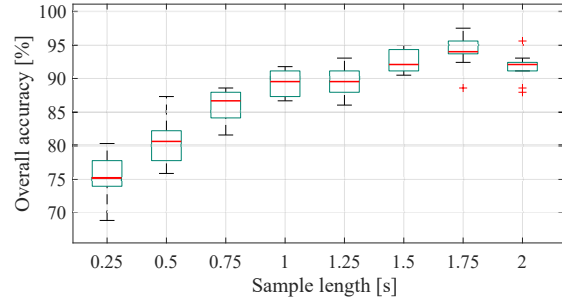
(b) Accuracy increase over signal duration

Figure 8: Few misclassification events occur between the *Satisfactory* and *Fair* class. Correlation between classification accuracy and signal length indicates that samples should be collected for at least a second after starting the scratching motion (Average performance over ten evaluations).

Investigating the sampling time shows that the signals should be captured for at least for one second for high classification accuracy. A small drop in performance is seen when taking the full sample length, which might be explained by small deviations in the duration of the scratching motion. Generally, an increase in performance might be realized by increasing the size of the dataset, further optimizing the feet for vibration response, or utilizing alternative classifiers, such as neural networks [Bednarek et al., 2019].

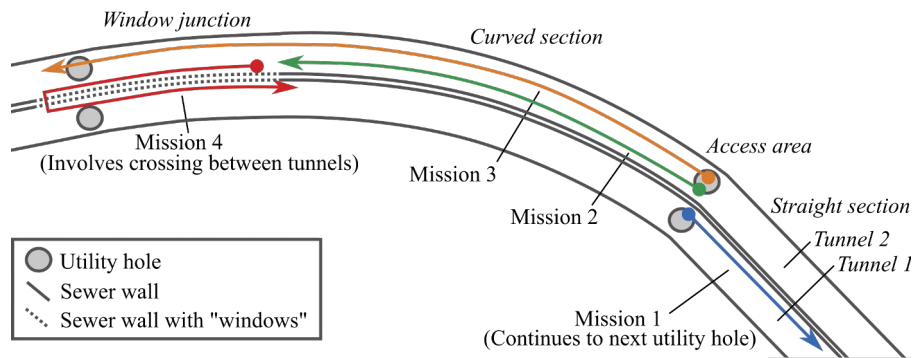
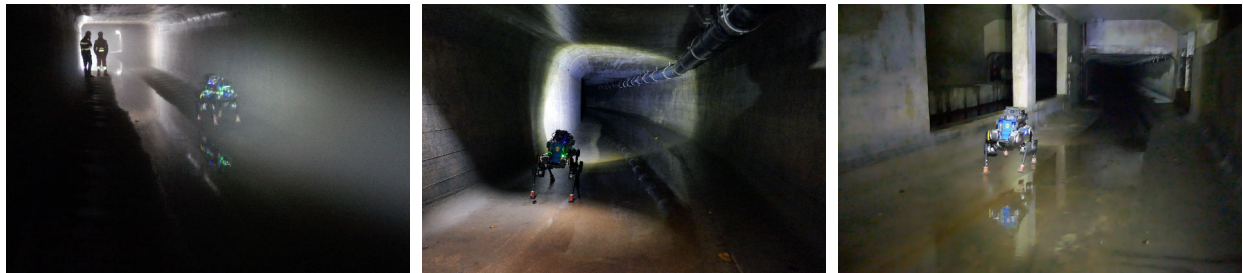
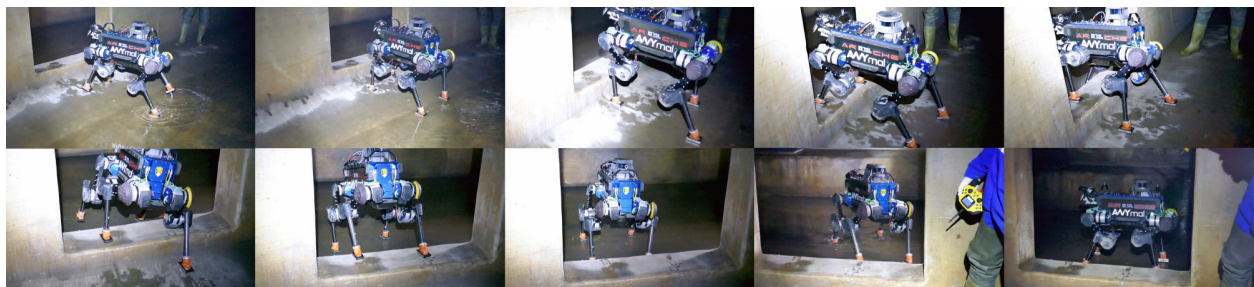
(a) Top-down diagram of the missions completed in the sewer.

(b) The robot during mission 1 as it walks down the straight featureless tunnel. Fog can be seen in front of the robot.

(c) Mission 2 in the second tunnel. Here the sewer is more curved and there is a large pipe suspended from the ceiling.

(d) View of second tunnel in direction of the window junction during mission 3. Two large windows are visible to the robot's left.

(e) The robot performing the crossing maneuver during mission 4. The robot has climbed onto the threshold and is transiting from tunnel two to tunnel one to continue the inspection.

Figure 10: Photos taken during each robot deployment.

Using the shared autonomy framework, we completed four missions as described in Figure 10a and Table 2. For missions 1-3, the robot was deployed through a utility hole and commanded to inspect a section of the tunnel (of length 145 m). The mission ended if either the final goal was reached or the robot slipped and could not recover. A safety operator was present at all times during the missions but did not intervene unless the robot fell. Mission 4 was designed to show the capabilities of using legged robots specifically.

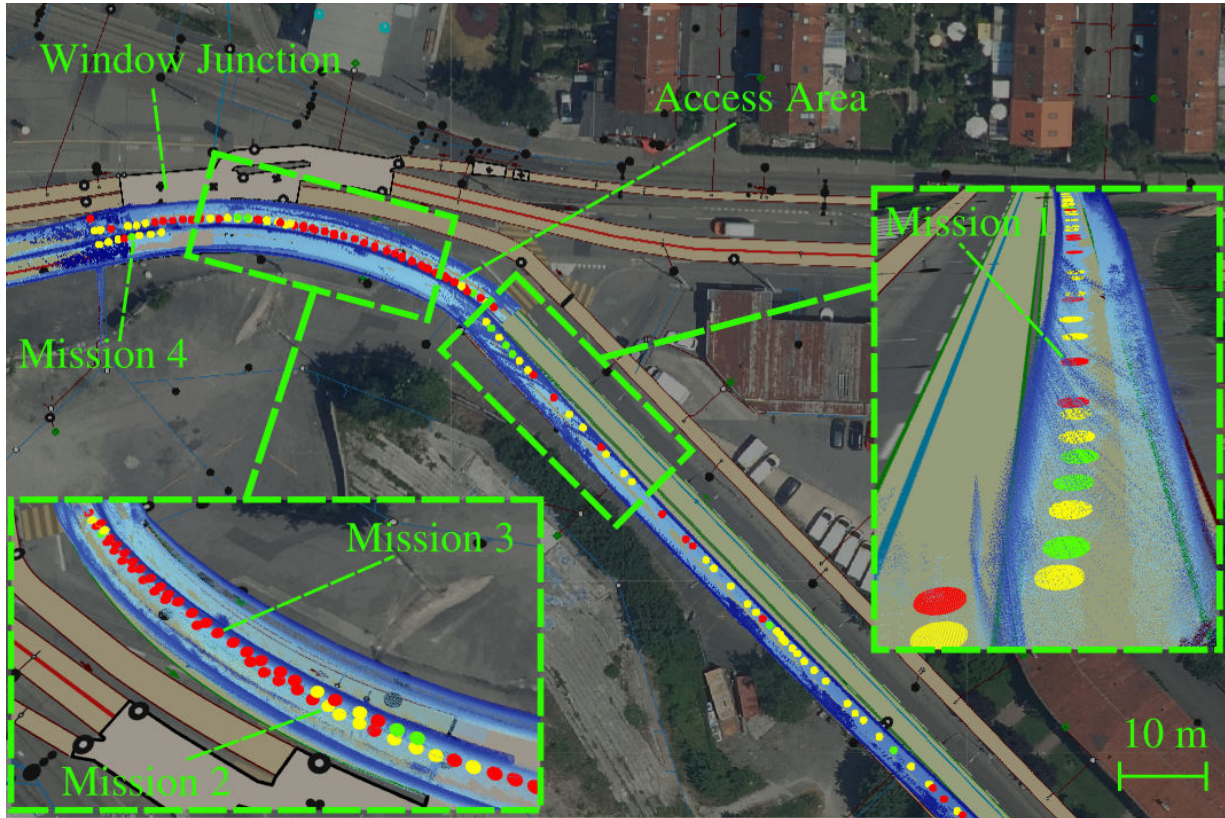
Figure 11: Overview of whole pointcloud map overlaid on sewer plans and satellite image. Blue points represent the map generated by the robot's LIDAR and the color intensity indicates height with dark blue being the sewer floor. Concrete classifications are colorized as: Red (*Fair*), Yellow (*Satisfactory*) and Green (*Good*). In green boxes we highlight two areas of interest: the curved section where missions 2 & 3 occurred and the straight section of mission 1. In the curved section we have raised the mission 3 contact maps above the ground to improve visibility.

The inspection mission results are displayed in Figure 11. In total, we were able to take 130 samples over 294 m to which we assigned a deterioration class in post-processing. There are several sections of the sewer with different levels of concrete degradation, which matched our qualitative impression. For example, the worst conditions were found in the second tunnel between the access area and window junction, while the straight part of the first tunnel was less degraded.

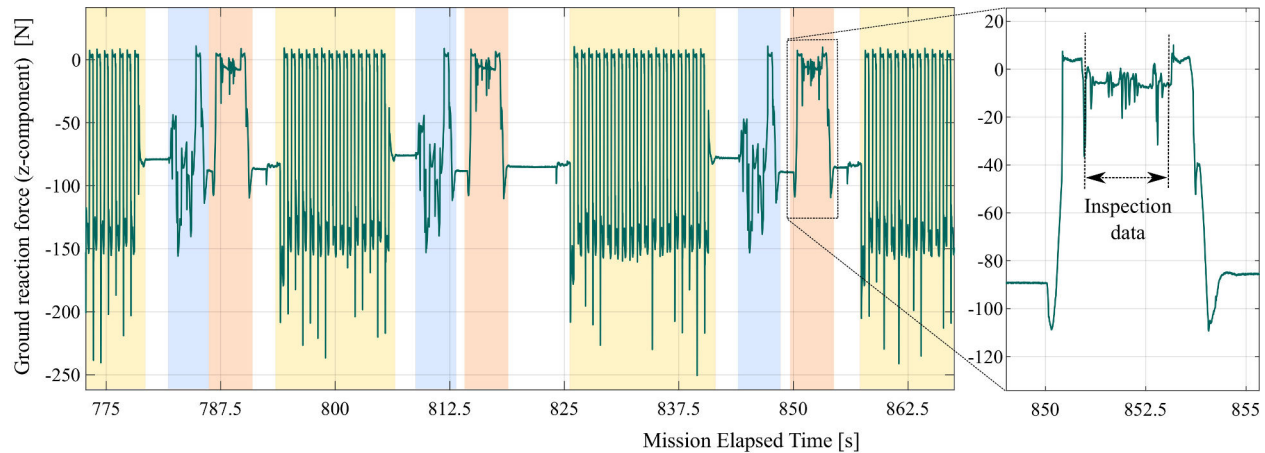
Figure 13: The vertical component of the ground reaction force of the front right foot as measured during mission 2. Walking episodes (yellow) can be easily distinguished from the “square up” reorientation maneuver (blue) and the tactile inspection motion (red). The inspection data is extracted from the sensor stream for classification.

An example of the raw data for contact classifications is provided in Figure 13, showing the vertical ground reaction force over three inspection motions. There is a clear pattern to the data, making it easy to distinguish between the three phases of the inspection task – walking, “square up”, and inspection motion. This shows the repeatability of the robot inspection, even during complex real-world missions.
