Petrinja, Croatia December 29, 2020, Mw 6.4 Earthquake Joint Reconnaissance Report (JRR)

PETRINJA, CROATIA DECEMBER 29, 2020, M_w 6.4 EARTHQUAKE

JOINT RECONNAISSANCE REPORT (JRR)

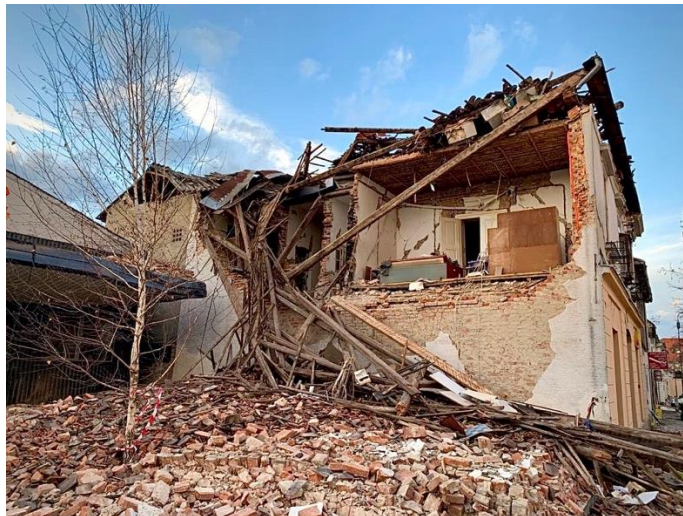
Collapsed unreinforced masonry building on Strossmayer St. in Petrinja, Photo by Damir Lazarević

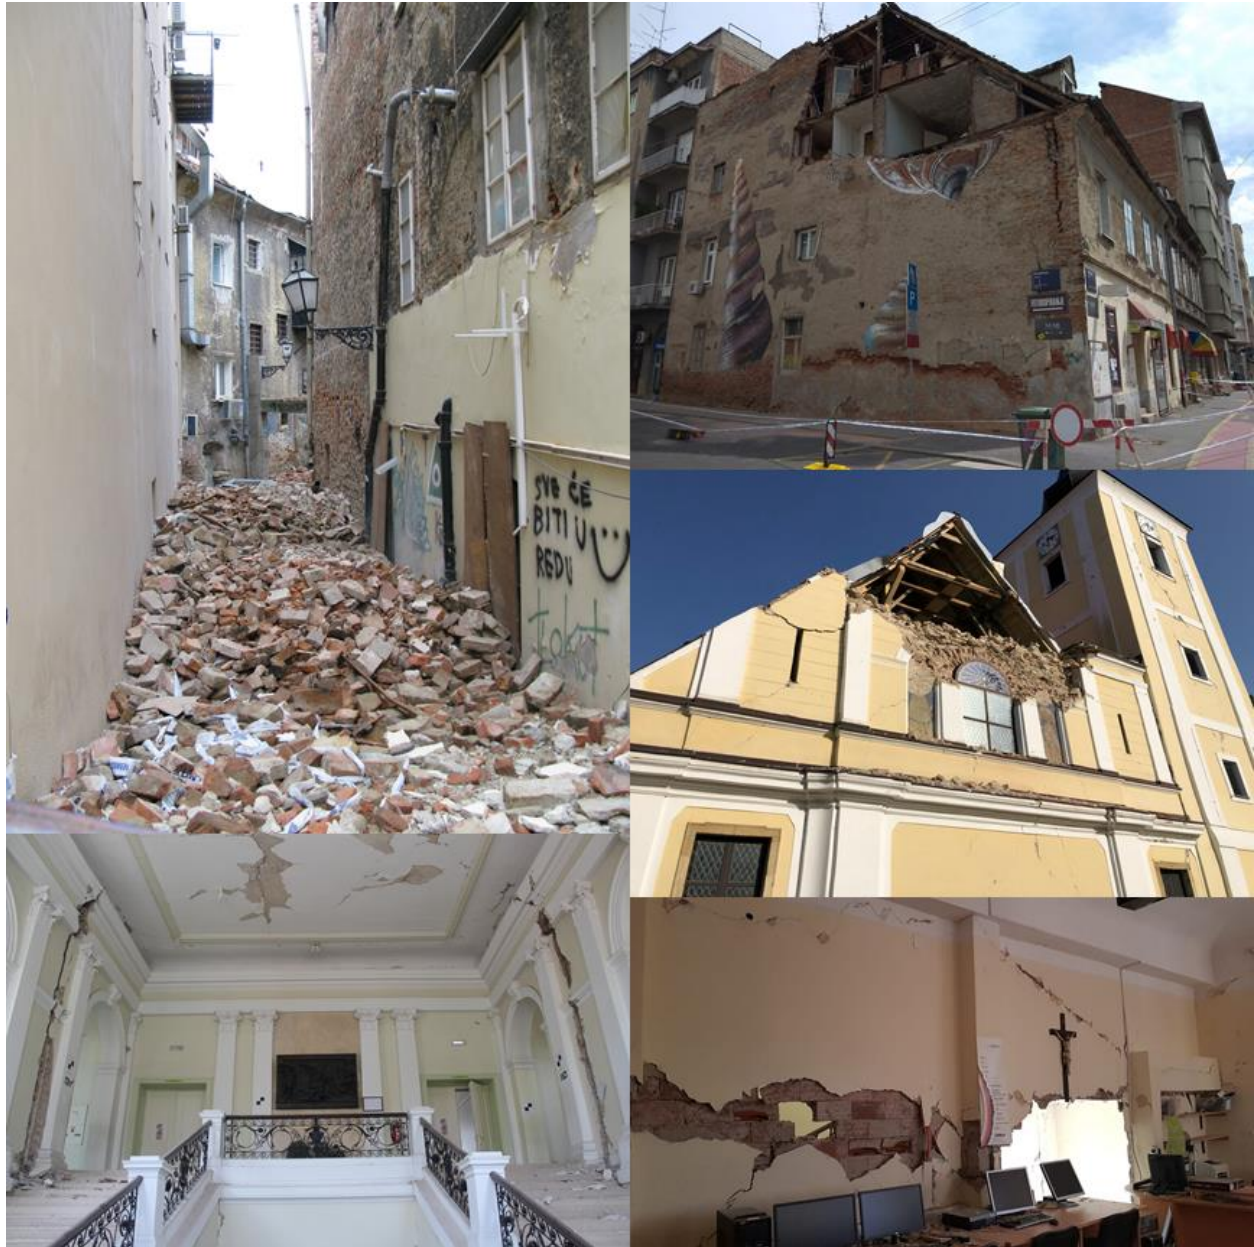
Figure 1.2. Photos of damage in Zagreb caused by the March 22, 2020 earthquake. (source: (1CroCEE 2021).

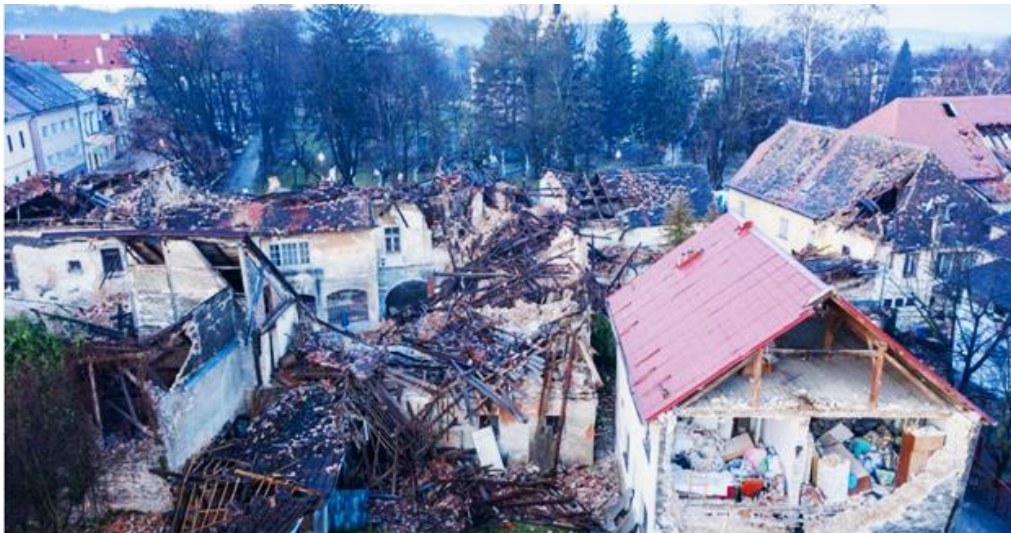
Figure 1.7. Aerial photo showing extent of damage in an area of Petrinja. Photo by Antonio Bronić (Reuters).

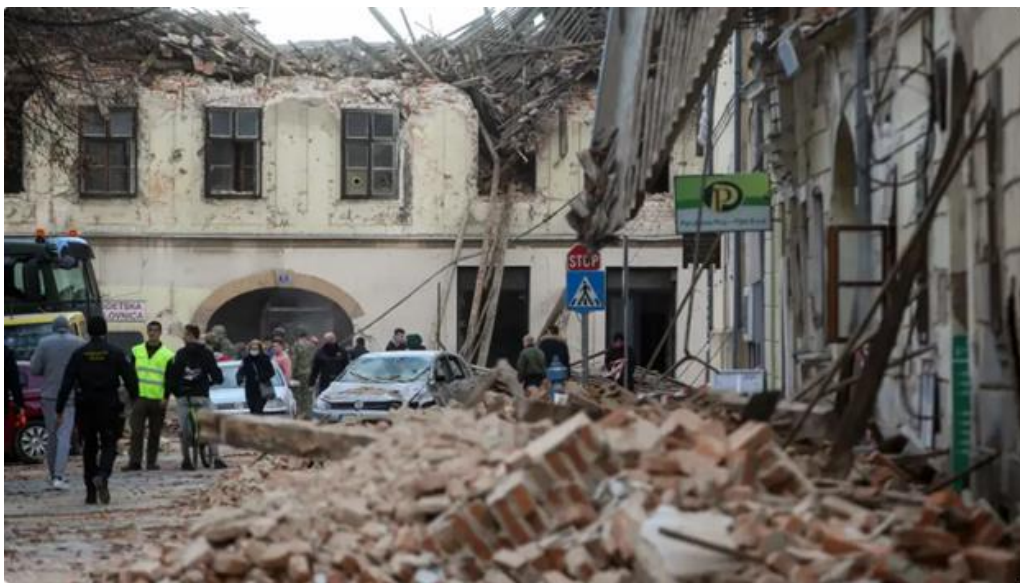
A significant portion of the Petrinja town was destroyed. As shown in Figure 1.12, many unreinforced masonry (URM) buildings experienced severe damage. Several schools were also damaged, in addition to the Petrinja hospital, as well as the St. Lawrence church and Petrinja Town Hall. Most houses in Majske Poljane, one of the most affected villages, were URM buildings constructed without seismic provisions and they experienced severe damage or collapse. Additionally, a majority of houses in Glina were damaged to varying extents, while in Sisak mostly older URM buildings located in the city center experienced damage. The damage was also observed in the nation's capital, Zagreb, where the Parliamentary building, the Cathedral, churches, and many other buildings experienced damage (Wikipedia 2021).

Figure 1.12. Croatian soldiers, firefighters, and residents next to heavily damaged buildings located in the center of Petrinja. Photo by Damir Senčar (Getty Images).

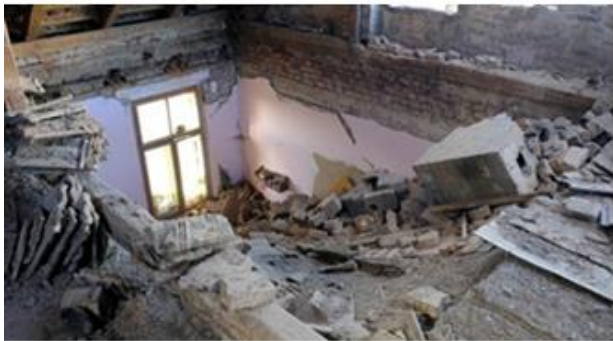
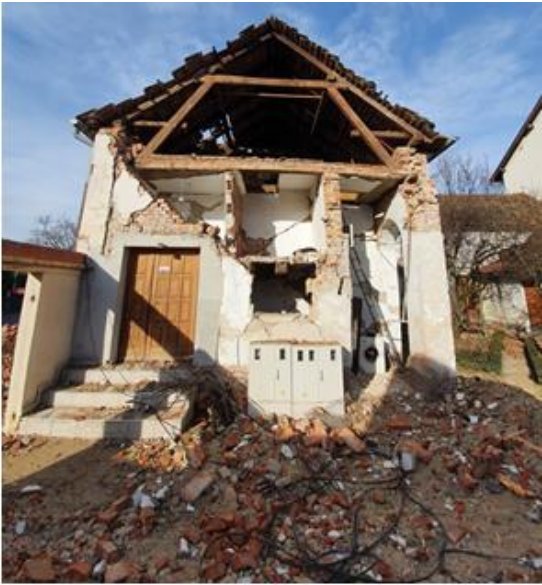
Figure 4.4. Details of older URM buildings: (a) floor-to-wall support area exposed due to floor collapse (source: Instagram account go.where.you.feel.most.alive) and (b) wooden roof truss structure with exposed wall-to-roof connection (source: Marko Bartolac).

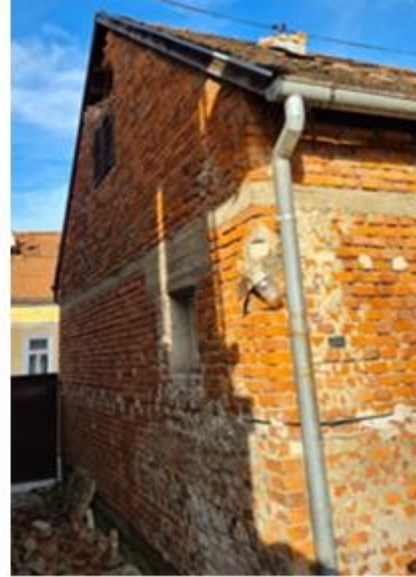
Figure 4.5. Modern masonry buildings in the earthquake-affected area: (a) two-story confined masonry building before the earthquake (source: Google Earth) and (b) single-story URM building with a rigid floor after the earthquake (source: Nenad Bijelić).

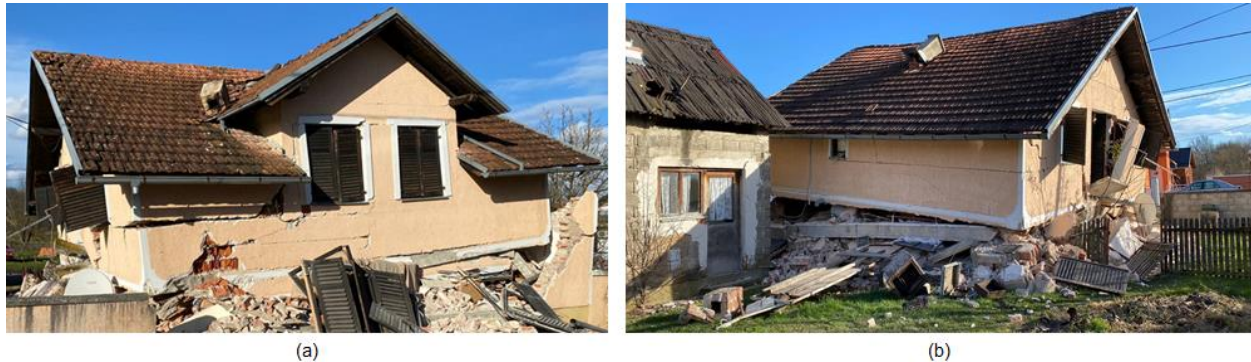
The ground floor of a 2-story masonry building in Prekope village collapsed, as shown in Figure 4.14. This is an example of a building with a vertical extension. The ground floor was constructed as an URM construction (solid clay bricks) whereas the upper floor was a partially confined structure constructed at a later stage. The photos show that the upper floor had a vertical confining element at the left corner, but was lacking such element at the other corner. It is interesting to observe that an adjacent unreinforced single-story masonry building did not experience any damage. Poor performance of this building can be attributed to the use of different masonry materials (i.e., bricks and hollow clay blocks) and construction technologies (unreinforced and confined masonry) at different floors.

Figure 4.14. Collapsed partially confined masonry building in Prekope village, close to Glina (sources: (a) Damir Sencar AFP Getty and (b) Krešimir Micić).

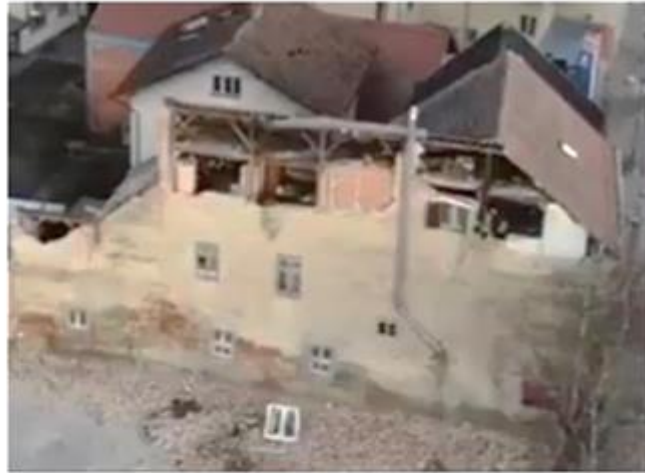
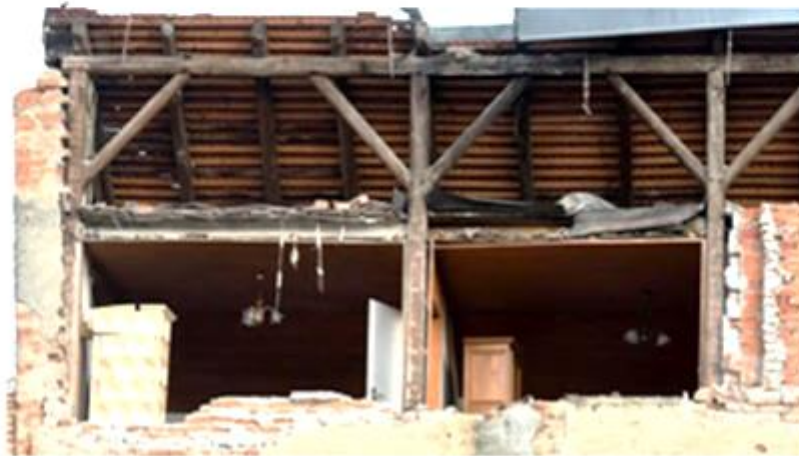
Figure 4.15. Collapse of exterior walls at the upper portion of a building in Petrinja: (a) before the earthquake (source: Google Earth), (b) damaged condition after the earthquake (source: Aeroklub Petrinja drone footage), and (c) detail of the exposed building interior and roof structure (source: Getty).

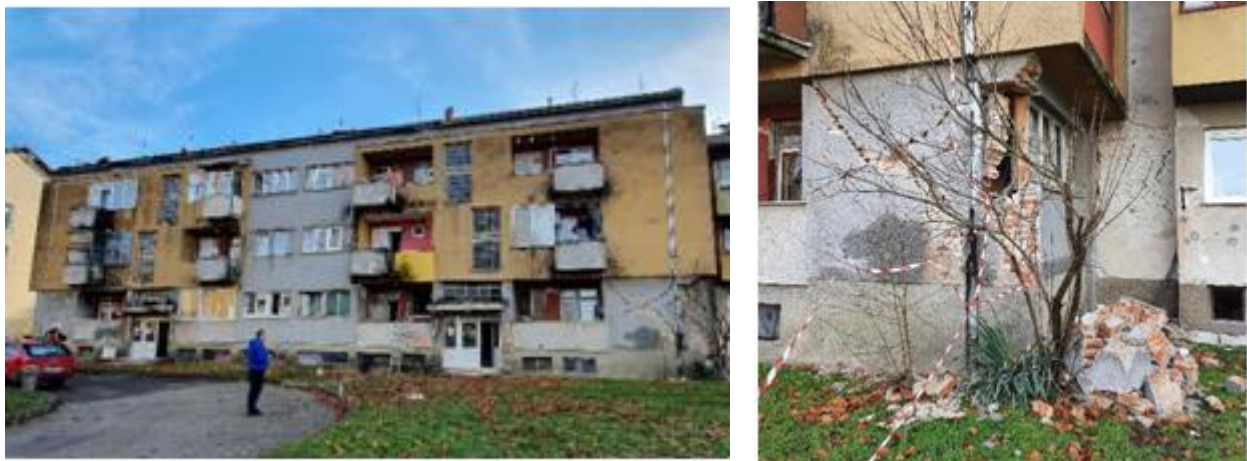
A 3-story apartment building located near the marketplace in Petrinja, an area where several low-rise URM buildings experienced heavy damage or collapse, is shown in Figure 4.16 (facade view in longitudinal direction). The building, which was probably constructed in the 1960s, had rigid floors and clay brick masonry walls (approximately 230 mm thick). The building experienced shear cracks in the walls at the ground floor level that were caused by high in-plane seismic demand and excessively high tensile stresses. The most extensive damage was observed at the right end of the building, where the connection between the longitudinal and transverse walls failed, causing crushing and falling out of masonry; this can be explained by inadequate structural integrity characteristic for URM buildings, and could have been prevented had RC tie-columns been provided.

Figure 4.16. Damage in a 3-story residential building in Petrinja (source: Marko Bartolac).

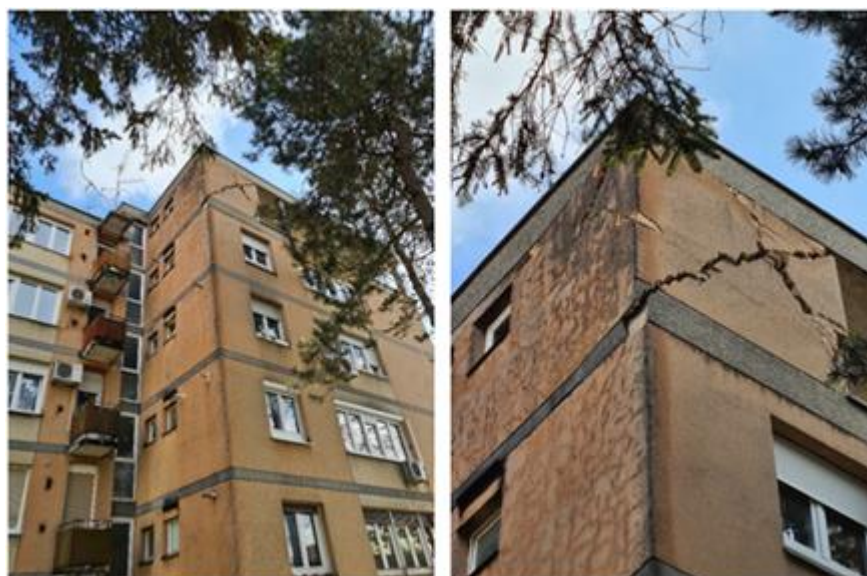
Figure 4.20. Extensive cracking experienced at the roof/terrace level of Building 2 (source: Nenad Bijelić).

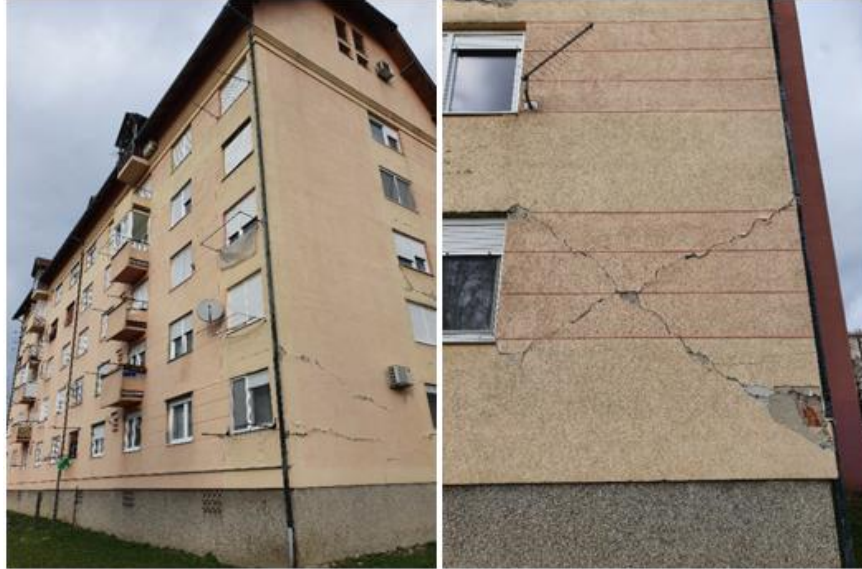
wall ends. Identical patterns of in-plane shear cracking were observed at the ground floor level in Buildings 1 and 2. Building 4 has a rectangular plan shape and 5 stories plus a vertical extension – the top story was added after the original construction was completed. The building experienced in-plane shear cracking in the transverse direction at the ground floor level (a similar pattern to that observed in Buildings 1 and 2) (Figure 4.21). It appears that other buildings in the vicinity of these 4 buildings did not experience significant damage, including an adjacent single-story URM building and some 10-story-plus high-rise buildings (Figure 4.22). The damage can be explained by low frequency content of the ground motions at this site.

Figure 4.21. Damage to Building 4, a 5-story building with a vertical extension (source: Marko Bartolac).

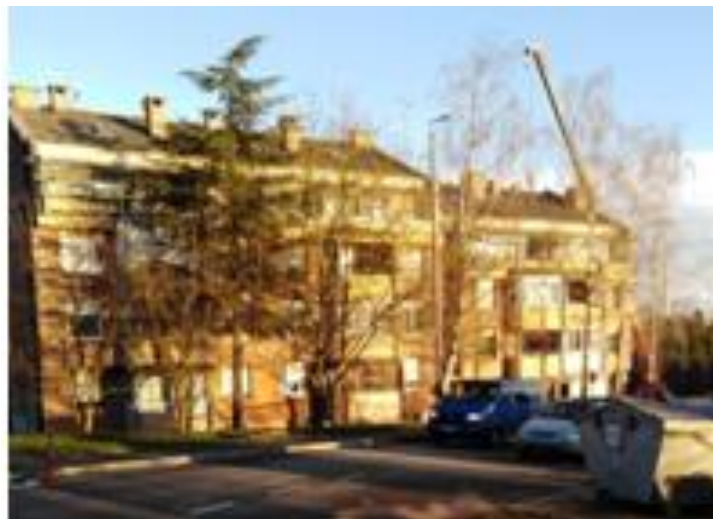
Figure 4.24. Removal of the chimneys from the roof of an RC building, "Brzaj" settlement in Sisak (source: Maja Freiberger).

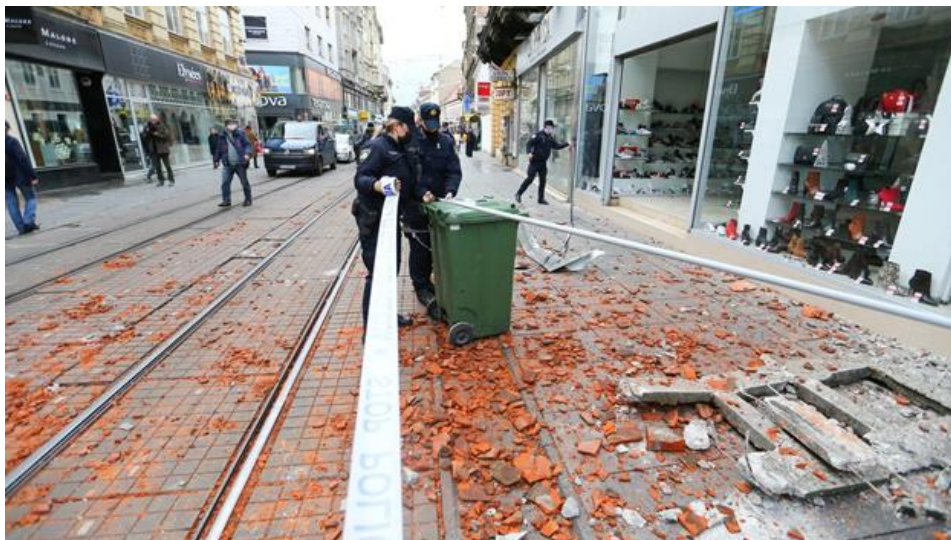
In Zagreb, there was little reported damage to store fronts. For example, Figure 4.25 shows a view looking east on Ilica Street in Zagreb, a large shopping area. Although fallen façades can be seen in the photo, there was no damage to glass store fronts.

Figure 4.25. Photo taken looking east on Ilica Street in Zagreb showing fallen debris (source: Santora and Orovic, 2020).

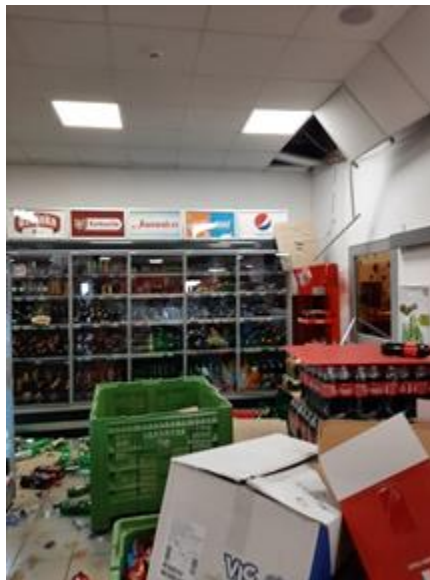
Damage was reported at the KTC supermarket, an RC structure located in downtown Petrinja, which is shown in Figure 4.26. There was damage to the hung ceiling assembly (Figure 4.27) and products fell off shelves (Figure 4.28); however, structural damage was not documented nor reported. The building also has an elevator that did not lose functionality due to the earthquake.

Figure 4.27. Damage to hung ceiling assembly in the KTC supermarket (source: Sonja Belovarac Radenovic).

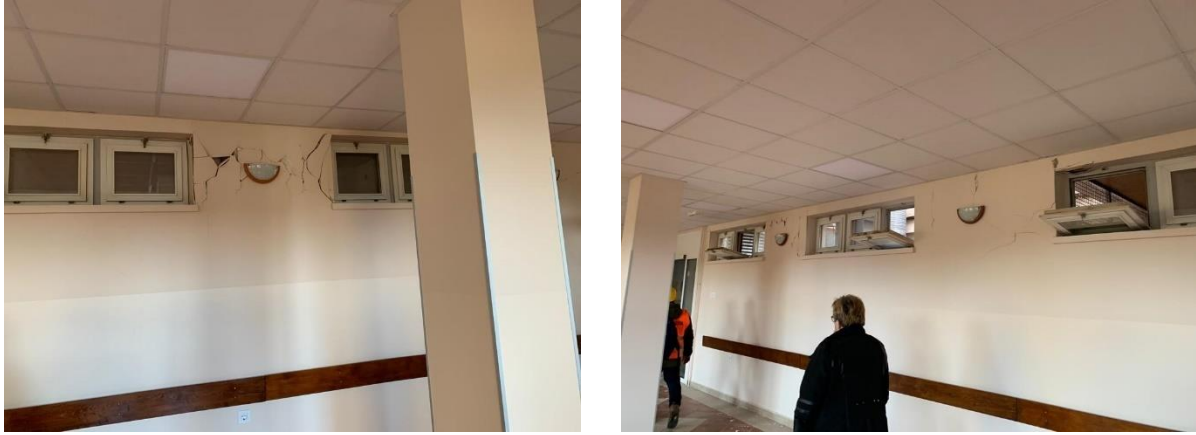
The observed damage in the retirement home was mostly to nonstructural elements such as interior masonry infills and partition walls, hung ceilings, tiles on the walls, and tiles on the floors. Shear cracks in masonry infill walls are common due to the stiffness and deformation incompatibility of the infills with the reinforced concrete frame. Several of these cracks occurred throughout the retirement facility in Petrinja. Figure 4.31 shows diagonal shear cracks originating from the corners of the windows in the infill walls of a hallway. Along the length of the hallway, large shear cracks originated from the corners of doorways and propagated through the single wythe partition walls, made of hollow clay blocks, as shown in Figure 4.32. Cracks along the interface between a masonry infill wall and a reinforced concrete column are seen in Figure 4.33. Besides large diagonal shear cracks in the plaster, cracks at the end of RC beams also occurred (Figure 4.34). Damage to other nonstructural components was also observed, such as hung ceiling assemblies in the form of exposed piping and fasteners for the hung ceiling (Figure 4.35) and cracks in wall and floor tiles (Figure 4.36).

Figure 4.31. Shear cracks in infill masonry walls of the retirement home in Petrinja (source: Damir Lazarević).

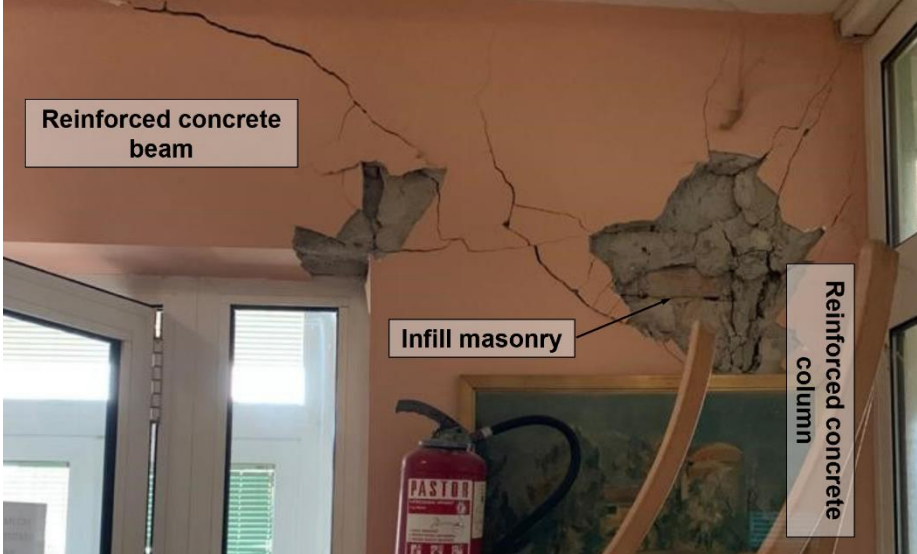
Figure 4.34. Damage to a reinforced concrete beam in the retirement home in Petrinja (source: Damir Lazarević).

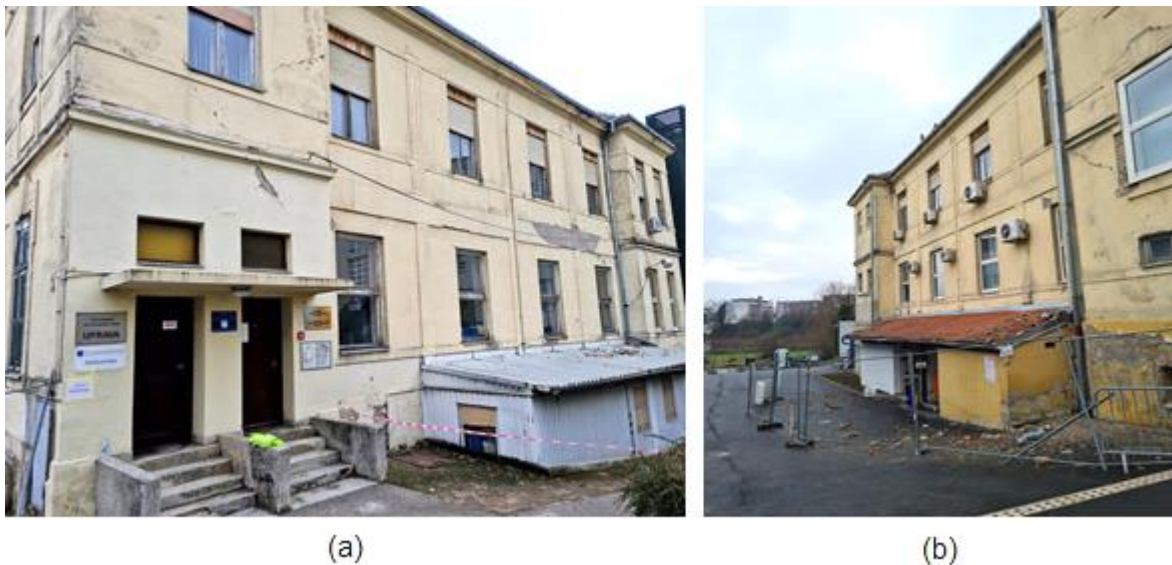
Building #4 (Administration) is an old rectangular three-story RC and masonry building with approximate plan dimensions of 25 m by 10 m. It presented cracking with different geometric patterns and fallen stucco facades, as shown in Figure 4.43, and was also declared unusable.

Figure 4.43. Building #4: (a) front view, and (b) back view (source: Nenad Bijelić).

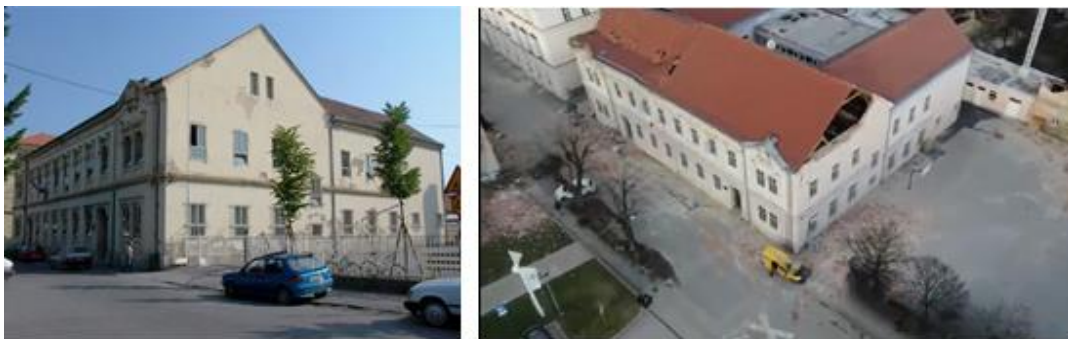
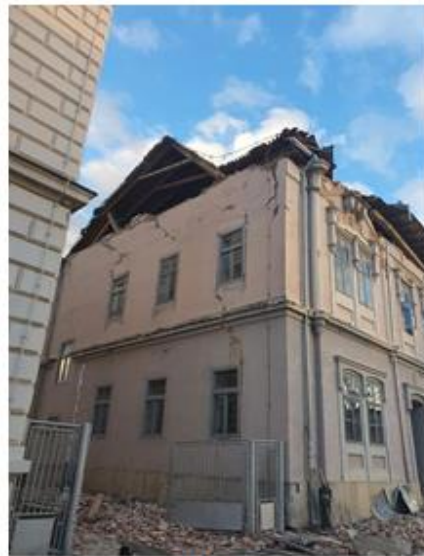
The First Primary School in Petrinja was originally built around 1860; however, it may have been expanded over time. The school is a U-shaped building, as shown in the plan view of Figure 4.46. The structural system of the building consists of URM walls and jack arch slabs. The roof is timber-framed with clay tiles and partially collapsed after the earthquake, as shown in Figure 4.47.

Figure 4.47. Exterior damage to the Primary School in Petrinja: exterior view (a) before and (b) after the earthquake, and (c) damage to the timber-framed roof, where masonry from the gable fell to the street (sources: (a) Google Earth; (b) Twitter 2021a and c) Nenad Bijelić).

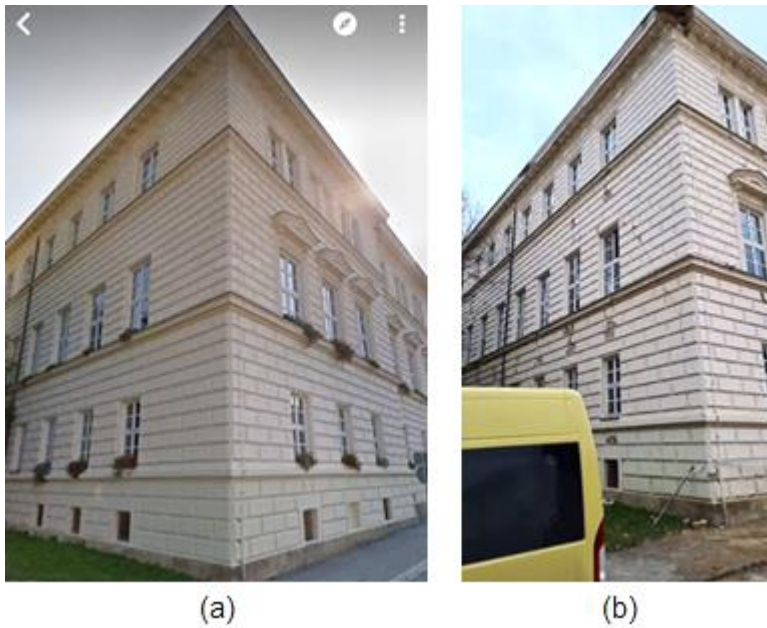
Figure 4.51. Transverse wall of Petrinja High School (a) before the earthquake (source: Google Street View) and (b) after the earthquake (source: Nenad Bijelić).

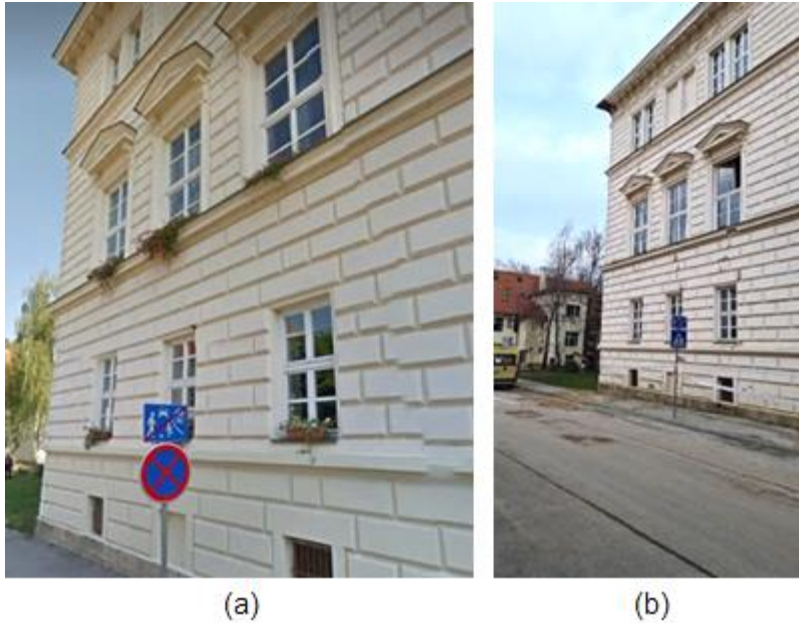
Figure 4.52. Longitudinal wall of Petrinja High School (a) before the earthquake (source: Google Street View) and (b) after the earthquake (source: Nenad Bijelić).

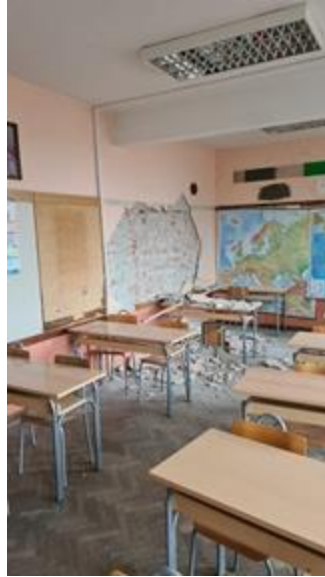
Figure 4.55. Plaster fell off of the wall exposing masonry infill (source: Nenad Bijelić and Damir Lazarević).

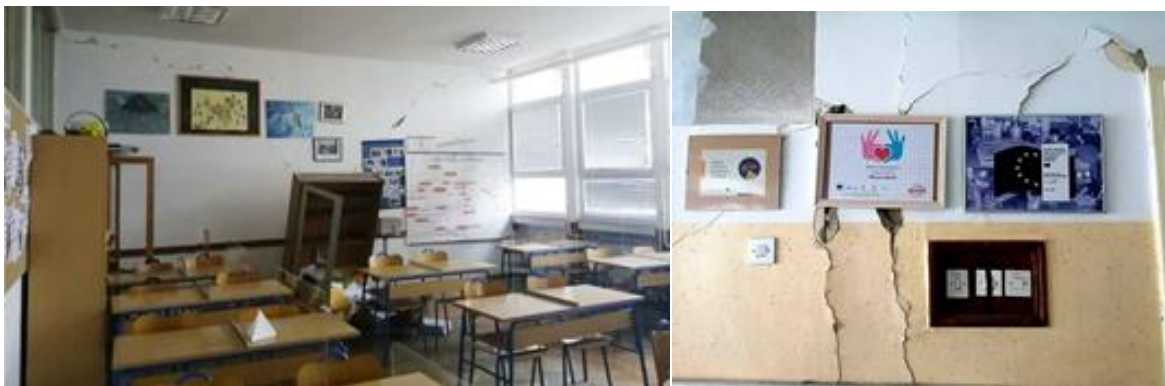
The Glina High School experienced damage to interior walls, as documented through the Facebook page of the school. Figure 4.59 shows the high school before the earthquake and Figure 4.60 shows damage to interior partition walls due to the earthquake. At this stage, it is not clear whether there was structural damage.

Figure 4.60. Earthquake damage in Glina High School (source: Facebook Page - Srednja škola Glina).

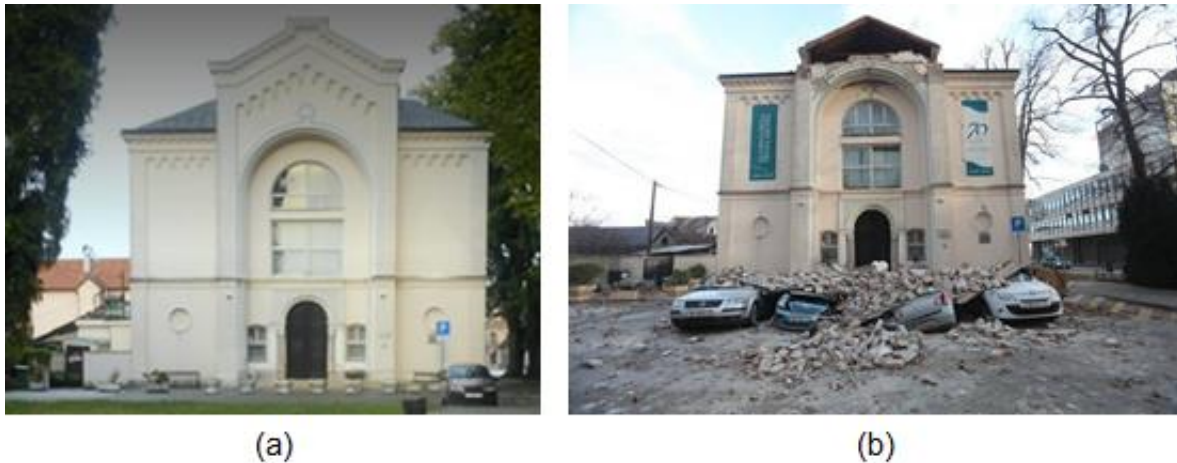
The building that houses the Fran Lhotka Music School in Sisak was originally a synagogue constructed around 1880 and converted into a music school in 1967 (Terbovc 2021). The building is shown before the earthquake in Figure 4.61a and after the earthquake in Figure 4.61b, which shows out-of-plane failure of the masonry in the gable. This masonry fell on top of cars parked in front of the building. There were no reports of casualties due to damage to this building. The interior of the building experienced damage to nonstructural components such as decorative ceiling and instruments, as shown in Figure 4.62. From this photograph, it appears that the floor diaphragms are made of timber and the walls are constructed of masonry.

Figure 4.61. Fran Lhotka Music School (a) before the earthquake (source: Google Maps) and (b) after the earthquake (source: Facebook page - Glazbena škola Frana Lhotke, Sisak).

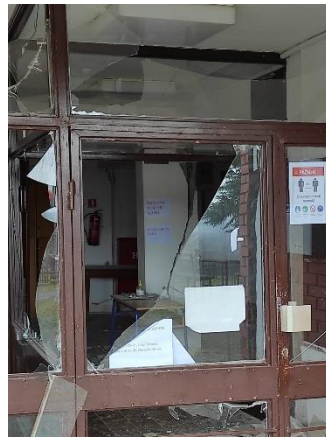
Figure 4.64. Broken glass in entryway door (source: Nina Čeh).

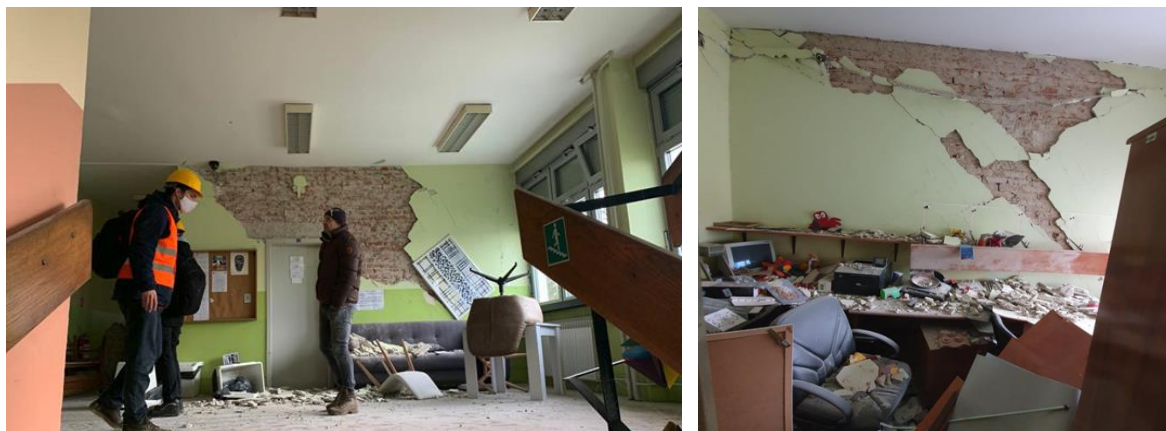
Figure 4.67. Plaster detached from the wall (source: Damir Lazarević and Marko Bartolac).

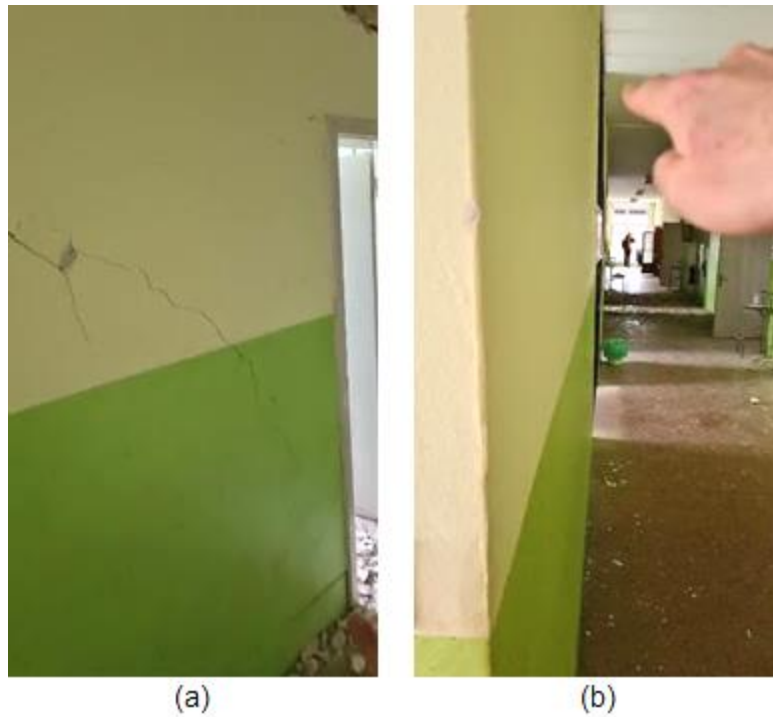
Figure 4.70. (a) Diagonal cracks due to in-plane loading and (b) out-of-plane infill failure due to in-plane/out-of-plane interaction (source: Nenad Bijelić and Damir Lazarević).

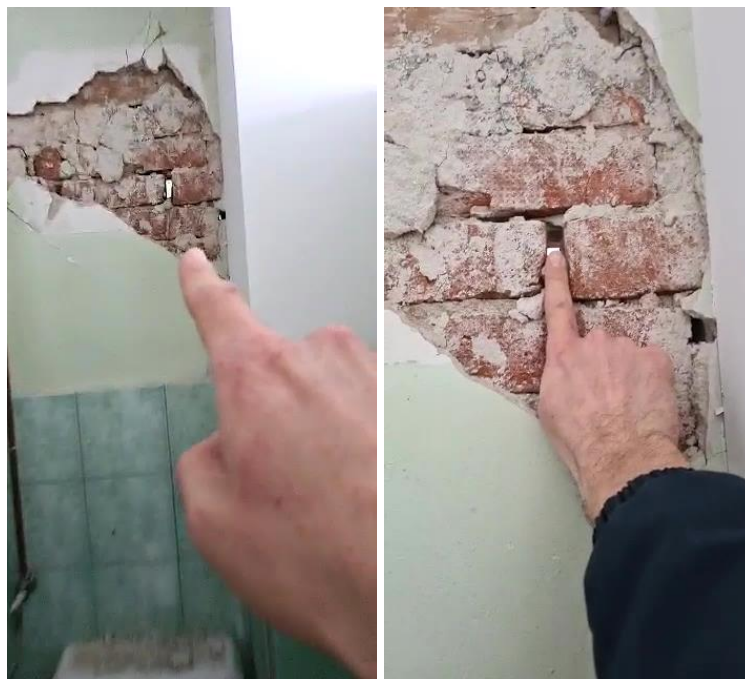
Figure 4.71. Gapping in head joints of infill walls (source: Nenad Bijelić).

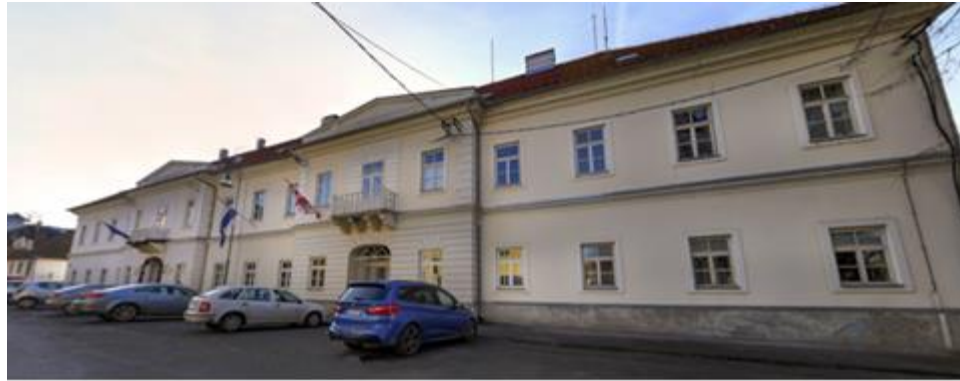
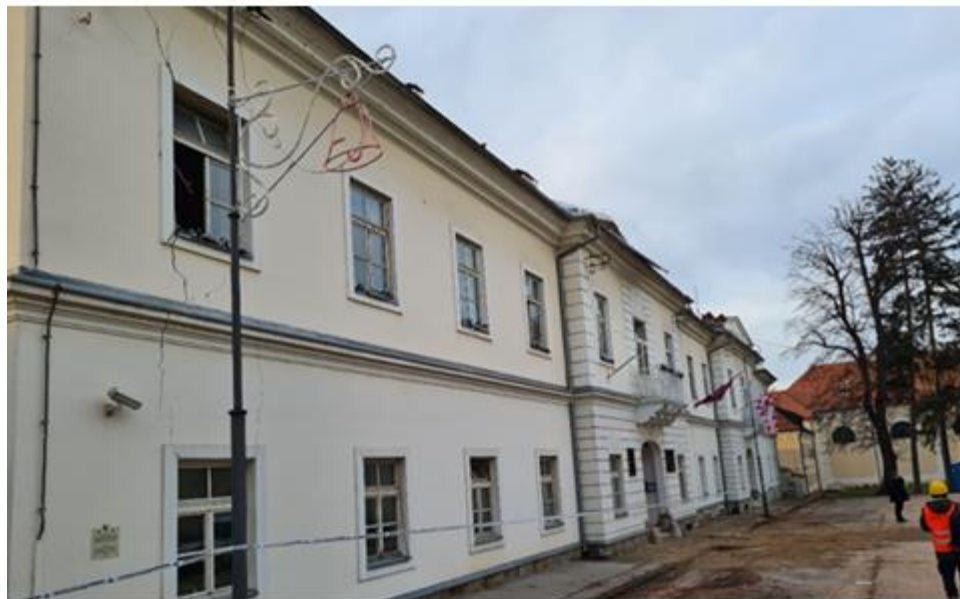
Figure 4.76. Petrinja town hall building: (a) Front façade before the earthquakes (source: Petrinja Virtual Tour) and (b) Front façade after the earthquakes (source: Nenad Bijelić).

The longitudinal direction of the building is aligned in north-south direction. Photos of the front façade before and after the earthquakes are shown in Figure 4.76. These photos show mainly cracking in the spandrels. Photos that were taken inside the building show extensive cracking of both the load bearing walls in the transverse direction (Figure 4.77a) and the masonry vaults of the first floor (Figure 4.77.b), which suggest that the masonry vault developed a mechanism. Similar damage has been observed throughout the building.

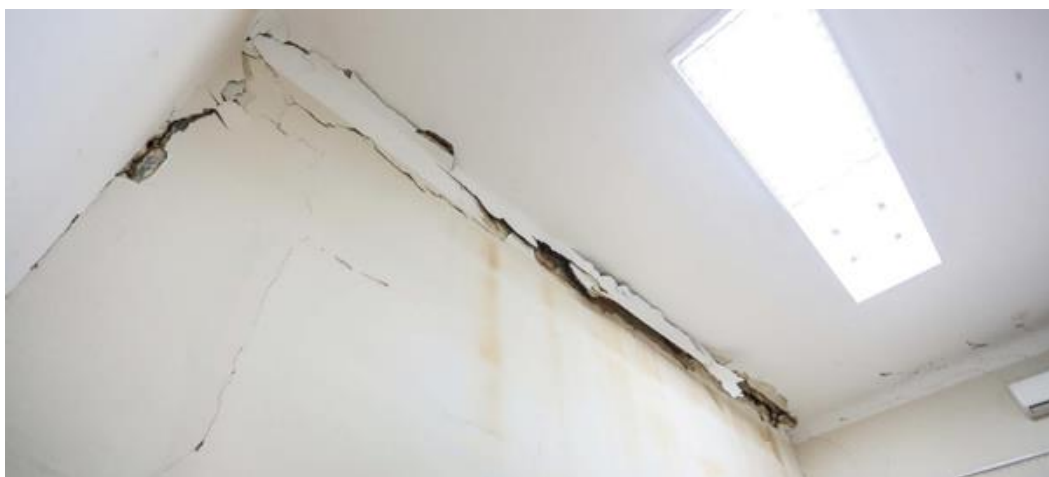
Damage was also detected at the floors of the 2nd story, where the cracks indicate that the floor beam had been sliding on the supports, shown in Figure 4.78.

Figure 4.78. Damage at a floor-wall connection at the 2nd story. The crack at the connection is potentially a result of beam sliding at supports (source <https://www.index.hr/vijesti/clanak/video-pogledajte-kako-izgleda-petrinja-ogromna-steta-na-zgradi-gradske-uprave/2242131.aspx>).

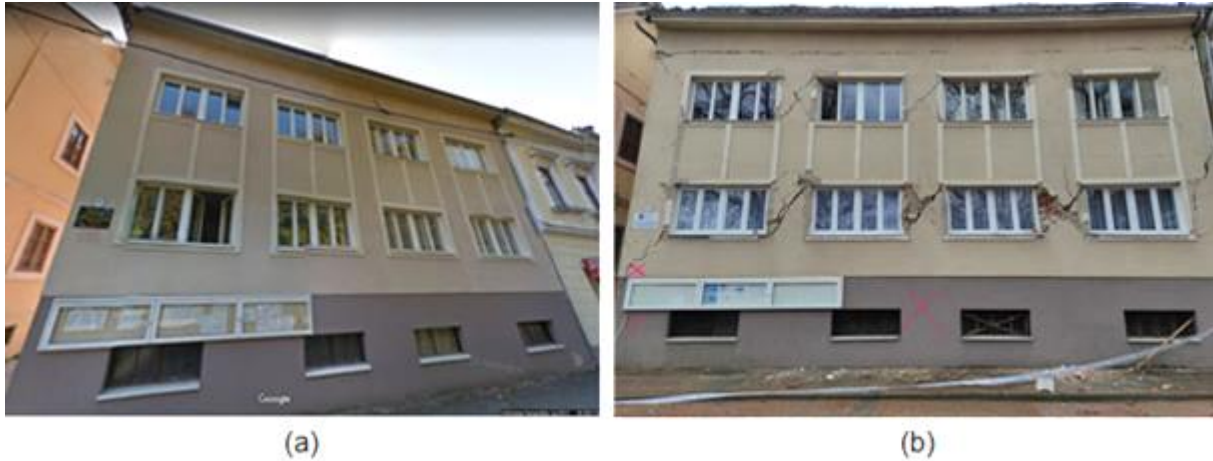
By the end of the 18th century, the so-called “Vojna krajina” (“War frontier”) region had lost its defensive purpose, becoming a burden for the central government in Vienna. To reform the region and make it more economically sustainable the central authorities supported the development of the crafts and trade. In turn, the towns such as Petrinja became attractive centers, leading to immigration from other parts of Habsburg Monarchy and wider. The largest stream of immigrants was arriving from Czechia, Italy, Germany and Austria. The immigrants brought their traditional craftsmanship skills leading to further development. The long tradition of craftsmanship is continued via the Chamber of Crafts whose building is located adjacent to the central park. The Chamber of Crafts of Petrinja building has a rectangular shape with approximate outer dimensions of 14 m x 10 m. It consists of a high basement and two floors. The building before and after the earthquakes can be seen in Figure 4.80. The Building suffered extensive damage, mostly marked by the characteristic in-plane shear failure of the piers, and

the horizontal crack at the roof level. Considering the fact that the building suffered extensive in-plane damage, and considering the position of the building shown in Figure 4.81, we can note that the location of the building in-plane damaged façade is perpendicular to the façades of the buildings that suffered the out-of-plane collapse. This suggests that the strong motion direction was in the direction of the damaged façade, being approximately east-west.

Figure 4.80. Chamber of Crafts building: (a) before the earthquakes (source: Google Maps) and (b) after the earthquakes. All central piers developed deep in-plane shear cracks. A wide continuous horizontal crack extends throughout the façade at the roof level (source: Nina Čeh).

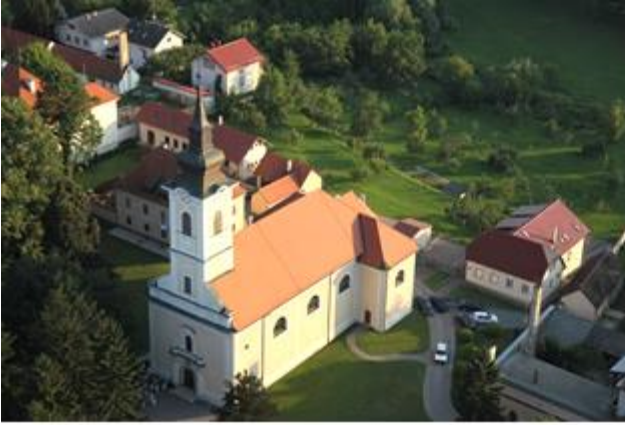
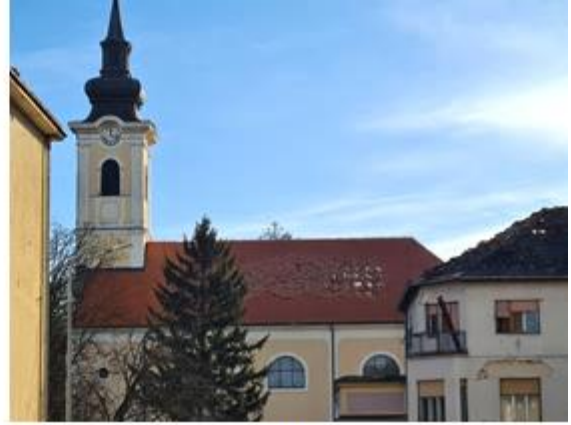
Figure 4.85. (a) St. Lawrence Church before the earthquake (source: petrinjaturizam.hr/upoznaj-petrinju/kultura) and (b) after the earthquake, roof tiles were displaced (source: Nenad Bijelić).

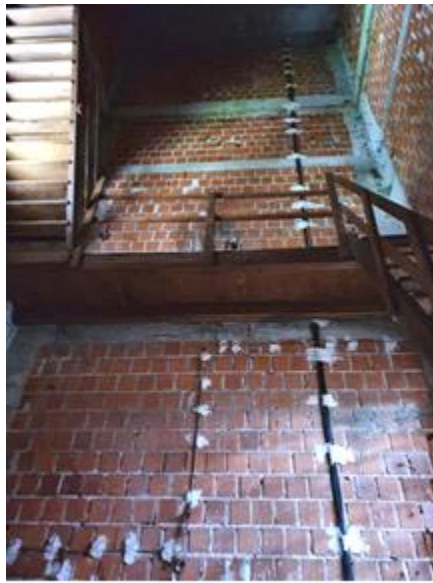
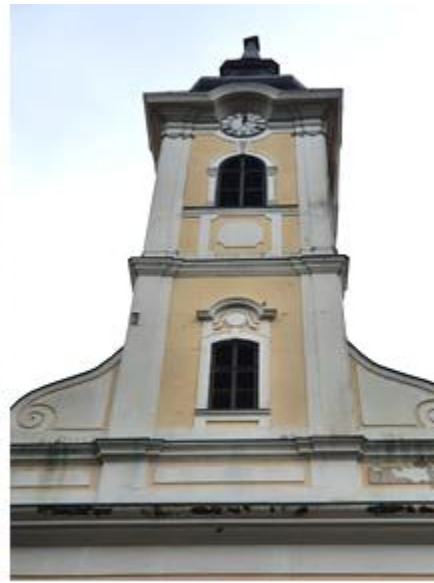
Figure 4.86. (a) Inside the campanile - confined masonry and (b) thin cracks in the exterior of the bell tower (source: Marko Bartolac).

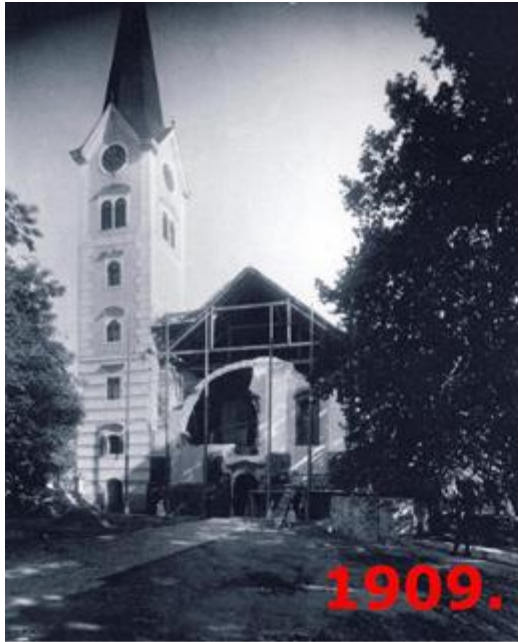
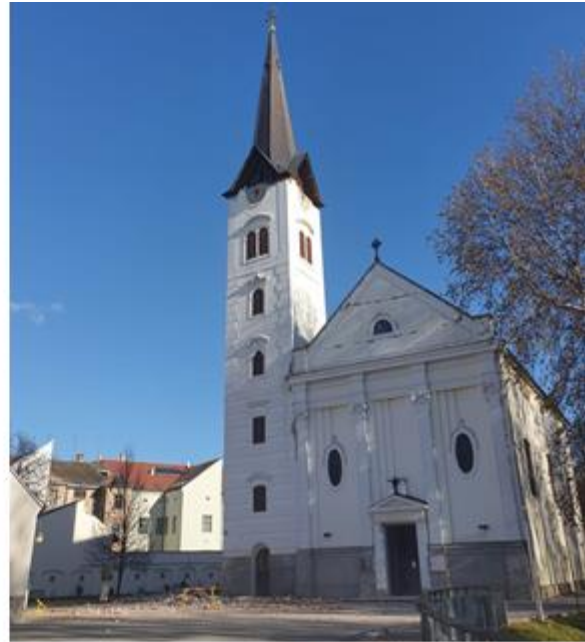
Figure 4.88. Sisak Cathedral: (a) after the earthquake in 1909 (source: svetikrizsisak.hr/i/141/zupa/zupna-crkva/) and (b) after the earthquake in 2020, local out-of-plane failure of gables at the top of the bell tower (source: Damir Lazarević).

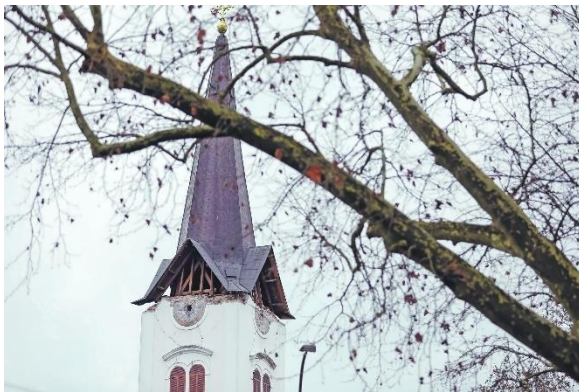
Figure 4.89. Sisak Cathedral after the earthquake in 2020: (a) a detail of the top of the bell tower showing local out-of-plane failure of gables (source: Marko Todorov/CROPIX) and (b) after the bell tower was removed (source: Nina Čeh)

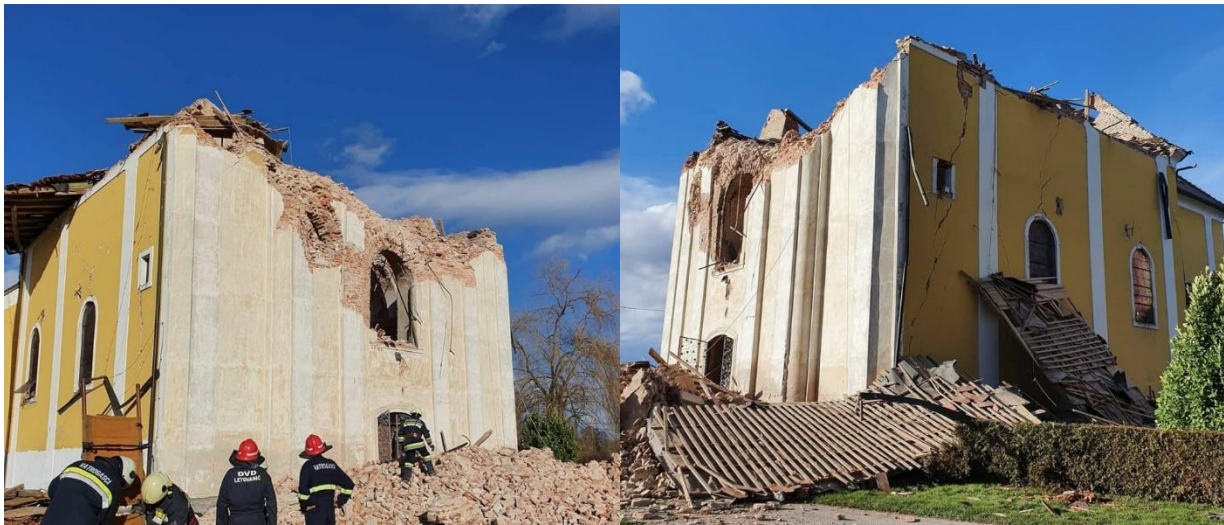
Figure 4.92. Church of St. Nikola and Vid in the village of Žažina after it suffered the collapse of a campanile and roof structure (source: Instagram account visitlekenik).
