Petrinja, Croatia December 29, 2020, Mw 6.4 Earthquake Joint Reconnaissance Report (JRR)

PETRINJA, CROATIA DECEMBER 29, 2020, M_w 6.4 EARTHQUAKE

JOINT RECONNAISSANCE REPORT (JRR)

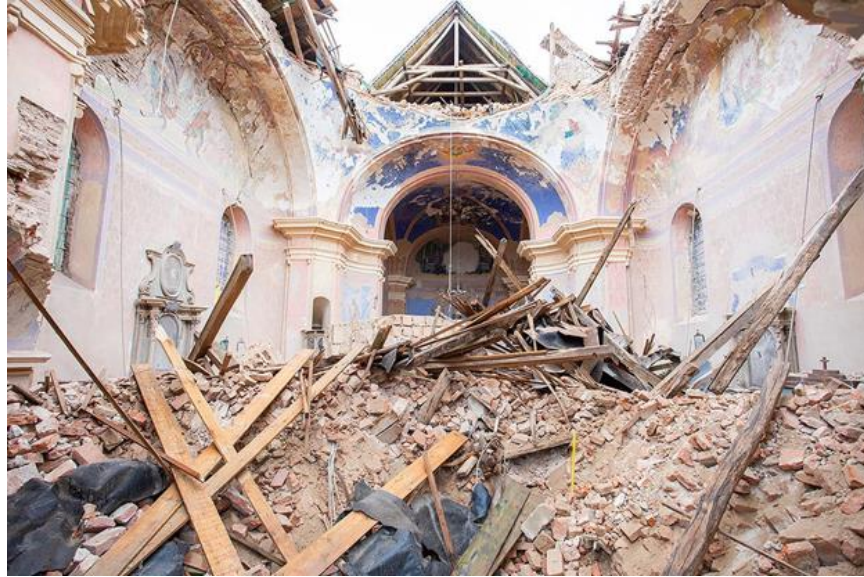
Figure 4.93. Interior of the Church of St. Nikola and Vid in the village of Žažina after the earthquake (source: Facebook Page - Sisačka biskupija).

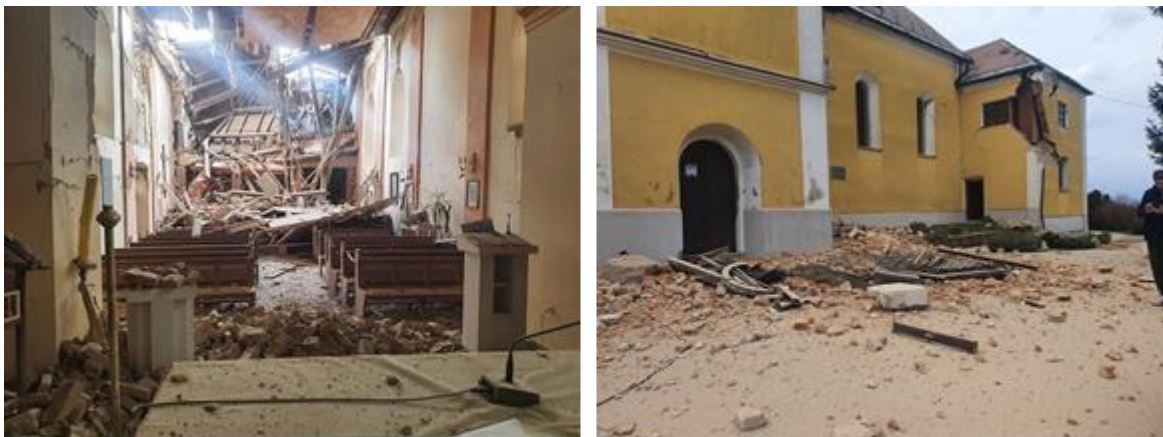
The Church of the Exaltation of the Holy Cross is located on the main route Zagreb-Pokupsko-Glina. The first church built in this area was in Gothic style. Demolished and rebuilt in 1847 on the site of the older one, the new church was severely damaged by German bombing during World War II and then rebuilt in 1969 as it is nowadays (Župa uzvišenja Svetoga Križa Kravarsko 2021). The recent earthquake has significantly damaged the structure. Part of the bell tower and the roof of the church have collapsed, and major damage appears also on the side walls (Figure 4.97). The church is out of function (Figure 4.98a).

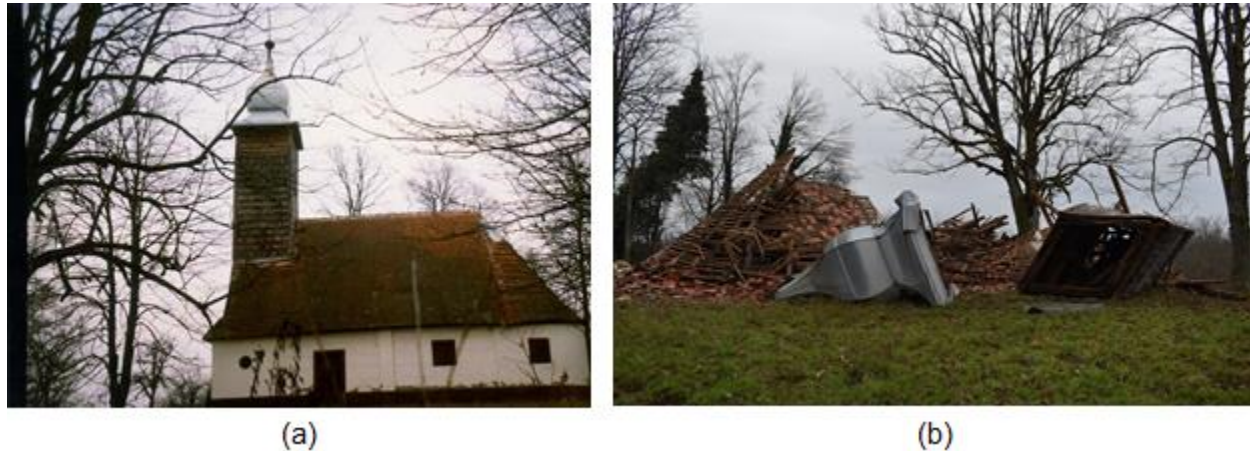
A small village of Majske Poljane, located near Glina, was a home to one of the two Orthodox timber churches in this area. The original church was built in 1820. This church survived the wars in the past century but exhibited a complete collapse under the earthquake on December 29, 2020 (Figure 4.99).

Figure 4.99. (a) Church in Majske Poljane (Hram Vaskrsenja Gospodnjeg) before the earthquake (source: Eparhija Gornjokarlovacka) and (b) Complete collapse of the Church (source: Eparhija Gornjokarlovacka).

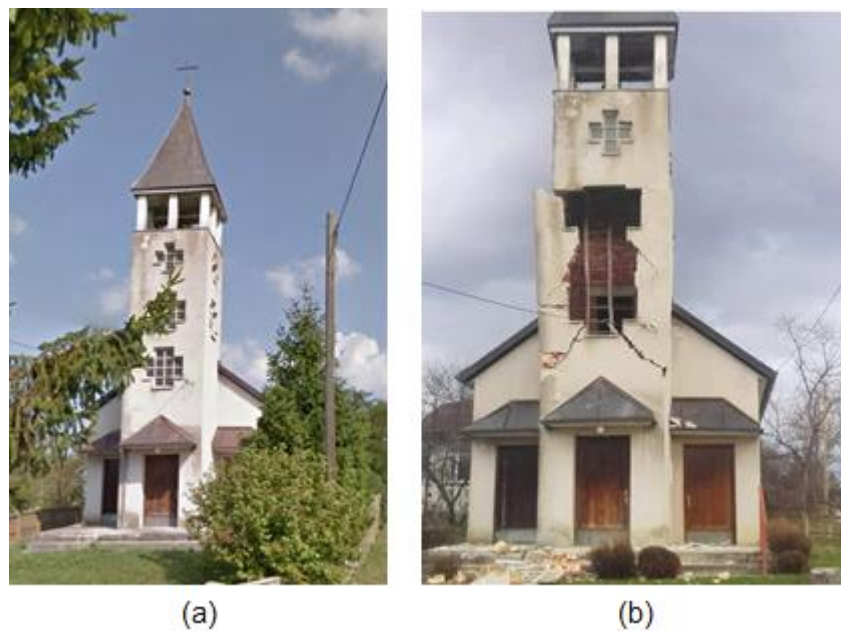
Figure 4.101. (a) Church St. Vid in Hotnja before the seismic event (source: Google); (b) Collapsed windows on the bell tower of the church (source: Facebook Page - Sisačka biskupija).

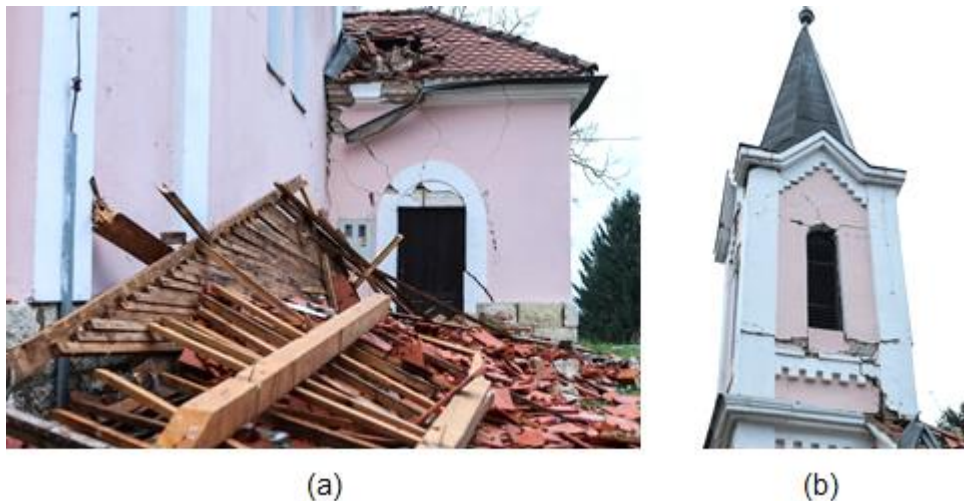
Figure 4.103. Church in Mračaj, near village Majur: (a) heavy cracking in the interface between adjacent shorter unit and the main nave (source: Marko Pripic/PIXSELL) and (b) severe cracking of the bell tower (source: Marko Pripic/PIXSELL).

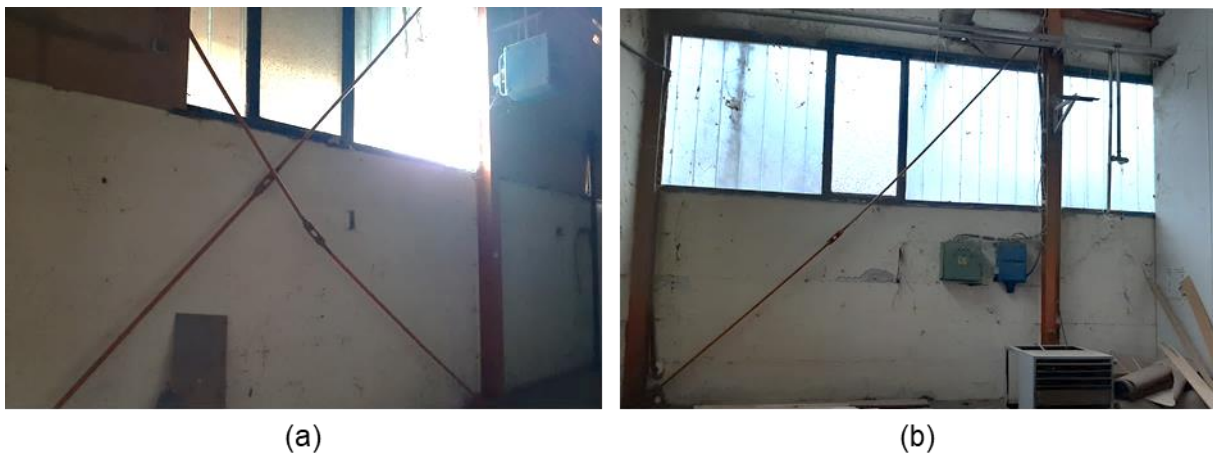
tension-only bracings (see Figure 4.107) a number of connection fractures were observed. Figure 4.107a shows one of the braces that was bent and stayed in place after fracture of its top left bracing connection. Moreover, Figure 4.107b illustrates another bay of the same structure where one of the two braces completely fell to the ground whereas the one standing exhibited flexural buckling during the earthquake. Failures of the same nature were observed in low ductility steel industrial facilities in prior earthquakes (e.g., Cruz and Valdivia 2011; Okazaki et al. 2013). Moreover, considering the fairly poor performance of precast low-ductility industrial buildings in past earthquakes in Europe (e.g., Sezen and Whittaker 2006, Belleri et al. 2015), special attention should be paid to other industrial facilities of similar nature in this and other seismically prone regions.

Figure 4.107. Fracture of tension-only steel bracings in an industrial facility in Sisačka ul. 116, 44250, Petrinja (source: Marko Bartolac).

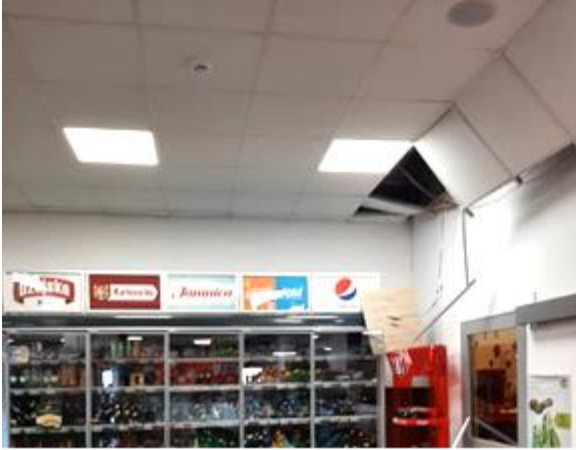
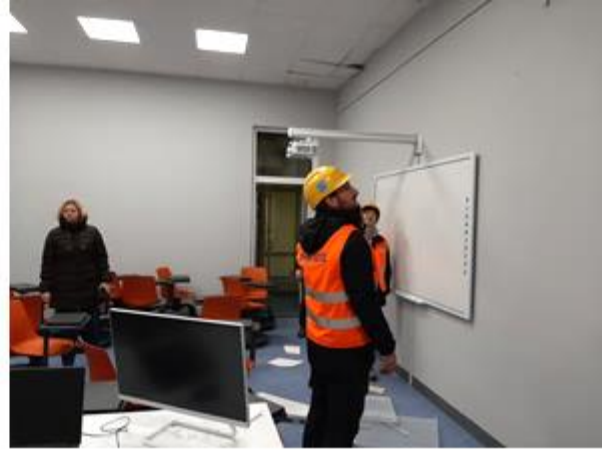
Besides structural damage to an old chimney, overall, the building behaved really well without any visible signs of structural damage. Some minor nonstructural damage was observed in the perimeter of a ceiling system (see Section 4.10.1, Figure 4.109b). However, all classrooms (Figure 4.74a) and corridors (Figure 4.74b) were operational after the earthquake. Opposite to

While damage of fallen ceiling tiles / panels was not as extensive as in prior earthquakes (e.g., Miranda et al. 2012), this was related to the fact that the damage was mostly observed in low-rise commercial buildings (i.e., single story) (Figure 4.109a). The elementary school in Ul. Mirka Antolića 18, 44250, Petrinja, which was a mixed wood-steel-reinforced concrete concrete structure also experienced damage of the same nature (Figure 4.109b). Preliminary evaluation of the ceiling systems did not seem to comply with seismic requirements of EN13964 (EN 2014) neither for moderate nor high seismic hazard ceiling systems. Figure 4.109 indicates that damage was mostly initiated in the perimeter and around columns due to ceiling supports slipping of the clips over the perimeter trim. It appears that this occurred due to lack of suspension wire in the initial span. While failure of ceiling systems was not extensive in this case, it still caused partial functionality disruption in the commercial store.

Figure 4.109. Damage to: (a) ceiling systems in a single-story commercial store and (b) Elementary School Mate Lovraka in Ul. Mirka Antolića 18, 44250, Petrinja (source: Sonja Belovarac Radenović (a), Marko Bartolac (b)).

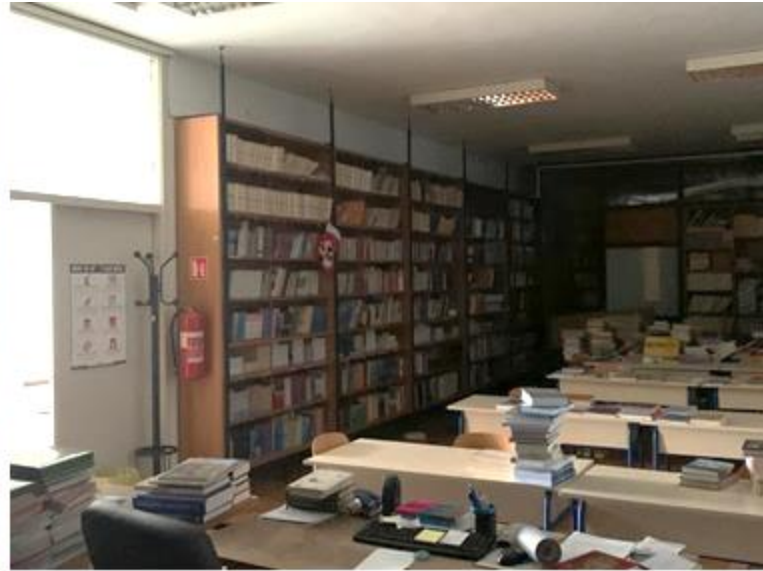
In many cases, the falling of building contents was due to lack of, or inadequate, anchorage. In general, contents such as bookcases shown in Figure 4.111 were fairly slender. Therefore, the seismic excitation resulted in a rocking-dominated response that eventually caused overturning, as shown in Figure 4.111a. On the other hand, fully loaded bookcases which were properly anchored to walls and/or partitions remained standing (see Figure 4.111b). The above observations corroborate prior work on the rocking response of unanchored building contents (e.g., Filiatrault et al. 2004).

Figure 4.111. Comparisons of (a) inadequate and (b) sufficient (b) anchorage of building content in 1962 university building (Učiteljski fakultet) (source: Marko Bartolac).

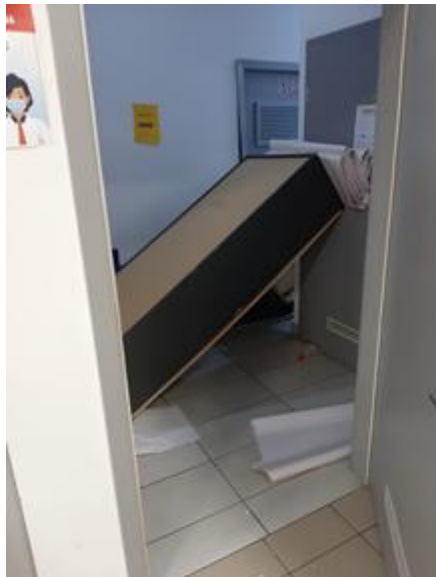
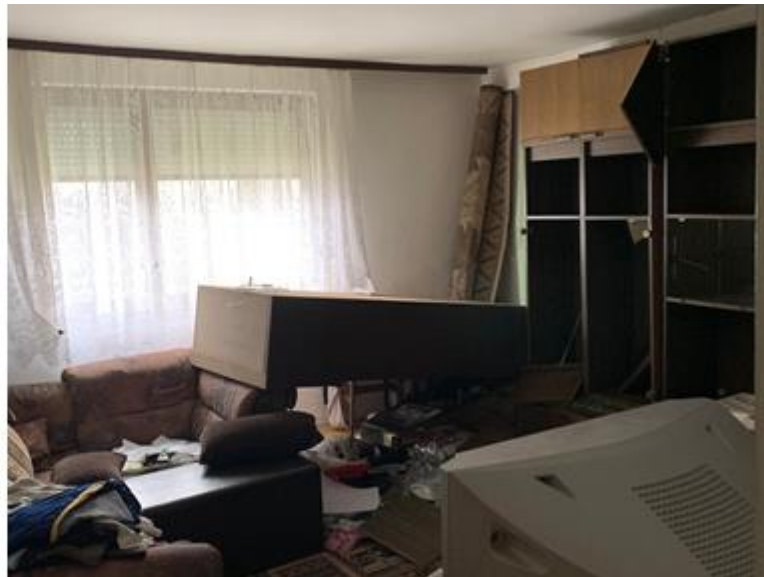
Overturning of unanchored slender contents often caused blocking of emergency exits in commercial stores, university buildings as well as residential houses as depicted in Figures 4.112. During the inspection of the building of the Faculty of Education (Učiteljski fakultet) in one classroom a detachment and collapse of the school board was observed (Figure 4.113).

Figure 4.112. Examples of unanchored slender contents blocking emergency exits and doors in commercial stores and residential houses (Otona Kučere 90, Petrinja) (source: Nenad Bijelić (a) and Damir Lazarević (b)).

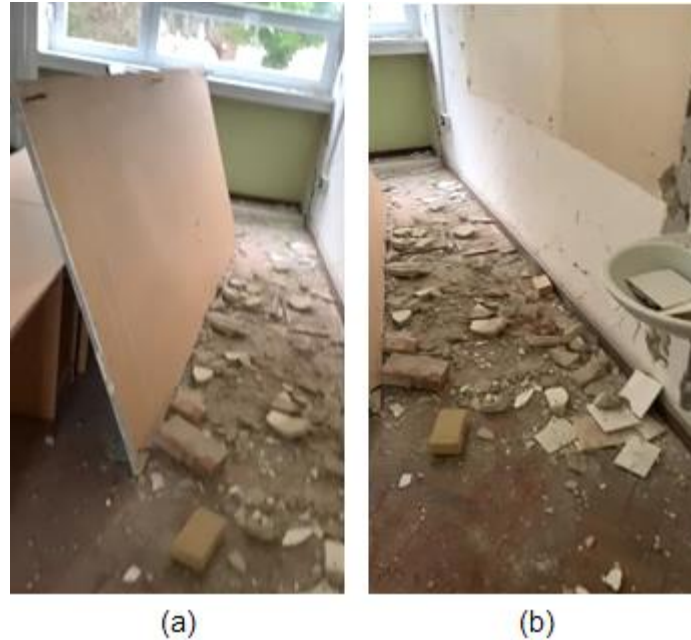
Figure 4.113. Detachment and collapse of the school board in one classroom (Faculty of Education - Učiteljski fakultet) (source: Marko Bartolac).

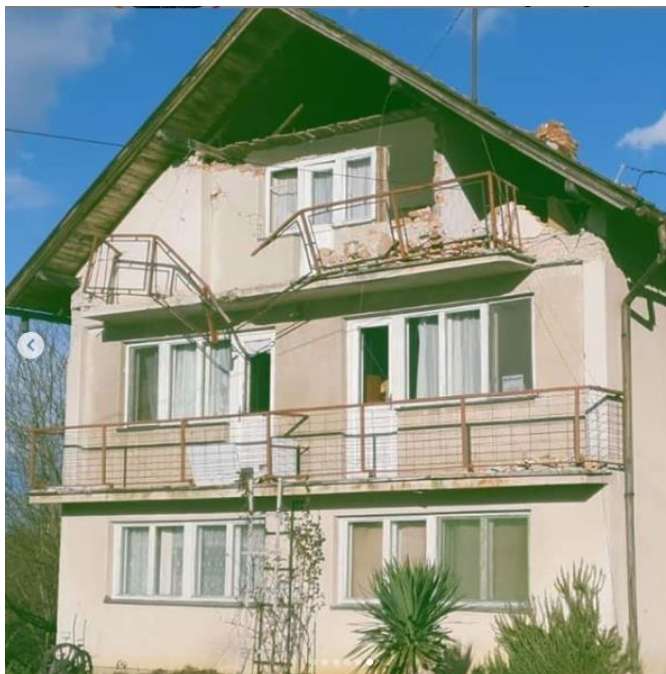
Moreover, in the area close to the Faculty of Education, a complete collapse of a URM balcony guardrail was observed (Figure 4.116). The heavy masonry wall probably fell due to lack of adequate reinforcement and connection to the slab. The guardrail on a residential balcony was damaged due to collapse of a gable end wall (Figure 4.117)

Figure 4.117. Damaged balcony guardrail in a family house in Sisak due to collapse of the gable end wall above (source: Instagram account on_a_binge_art).

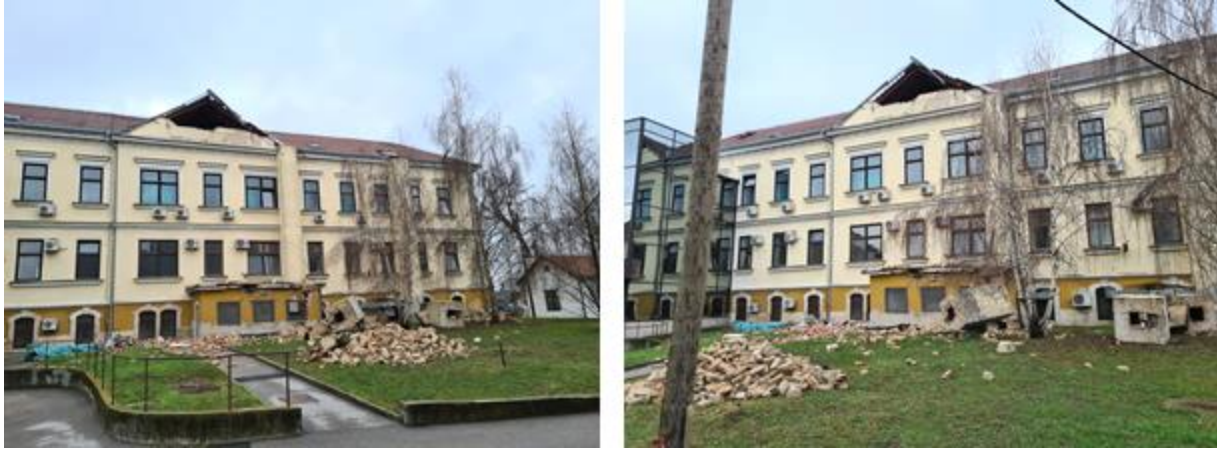
During the site visits frequent failure of chimneys was observed. Falling of the chimneys to the street as well as through the roof can endanger people in and adjacent to the buildings. Figures 4.118 to 4.121 present some examples of collapsed and damaged chimneys.

Figure 4.119. Fallen chimneys and gable end wall in hospital Dr. Ivo Pedišić in Sisak (source: Nenad Bijelić and Marko Bartolac).

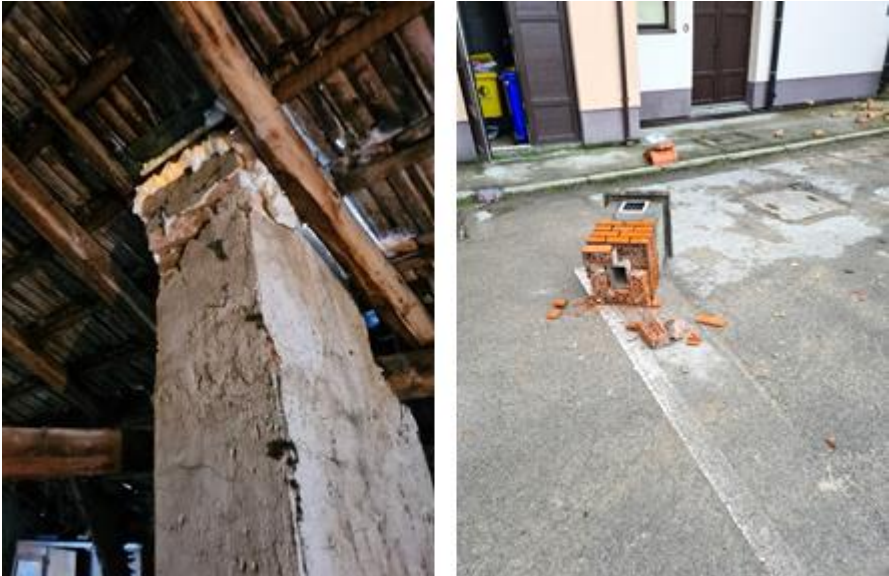
Figure 4.120. (a) Damaged chimney, (b) chimney fallen on the street (source: Nenad Bijelić and Damir Lazarević).

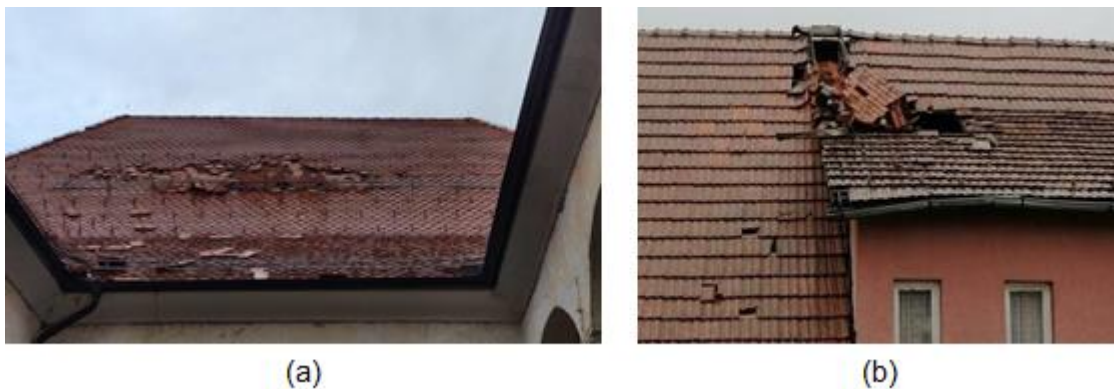
A significant number of roofs were damaged during this earthquake event. Besides failure of the roof construction, roof tiles often fell on the street and around the perimeter of the structures. Figures 4.122 and 4.123 show some examples seen during the site visits.

Figure 4.122. Damaged roof tiles (source: rtvslo.si).

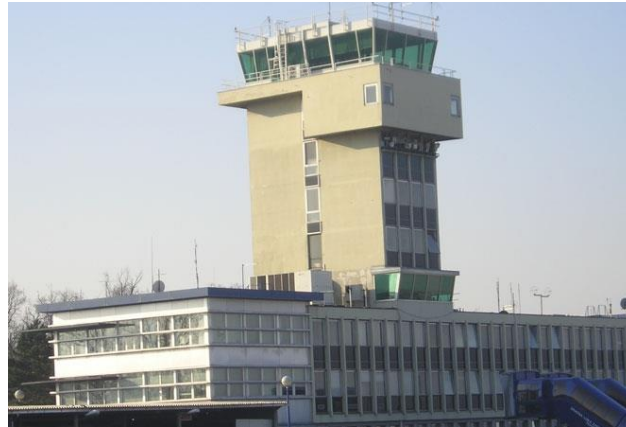
Zagreb International Airport (Figure 5.3) is located south of Zagreb and approximately 40 km northwest of the epicenter. According to the Croatian Air Navigation Services, the control tower suffered minor damage due to the earthquake, which led to an interruption of air traffic for a few hours (Dubrovnik Times 2020).

Figure 5.3. Control tower at the Zagreb International Airport experienced minor damage (source: DubrovnikTimes).

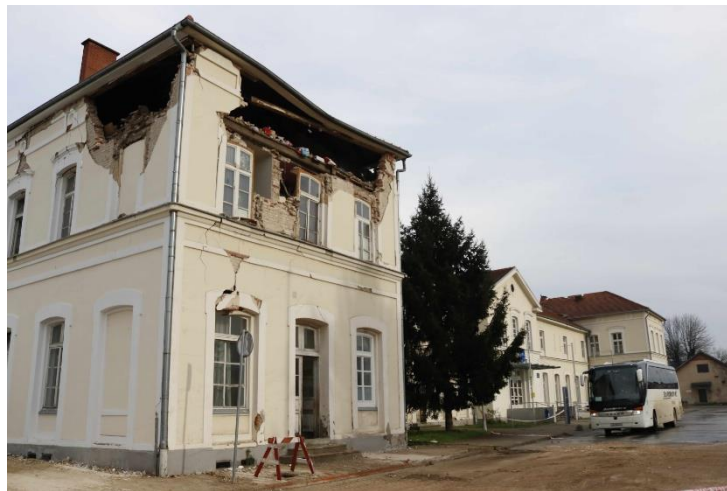
The Sisak Railway Station experienced severe damage during the event (Figure 5.4) but railway tracks were not damaged and railway transportation was not disrupted (CroatiaWeek 2020).

Figure 5.4. Significant damage of the Sisak Railway Station building (source: CroatiaWeek).

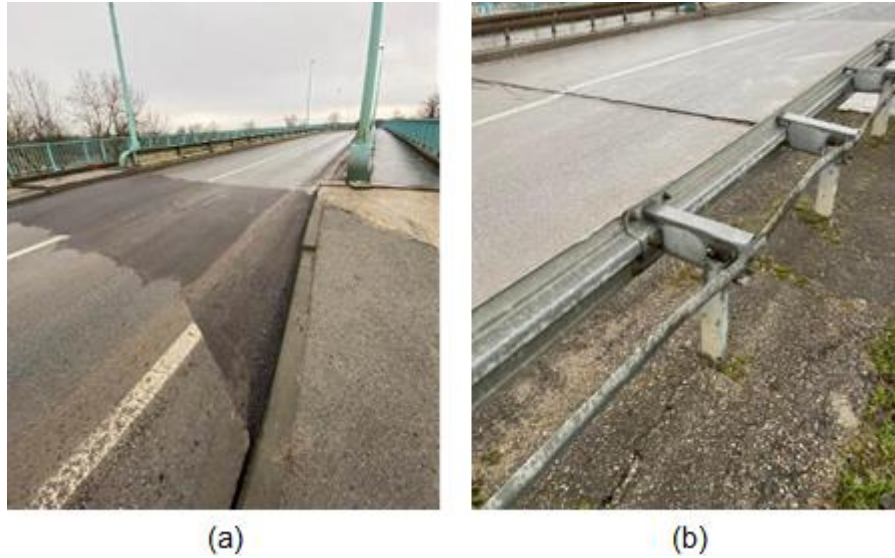
The "asphalt wedge" constructed between the bridge structure and the transition slab must be refilled to make the transition to the bridge as smooth as possible. Currently, the vehicles approaching the bridge impose large dynamic loads on the bridge structure (Figure 5.5 right-hand side and Figure 5.7). A transverse crack in the transition slab was also observed at the left-hand side of the bridge, but no denivelation was observed as on the opposite abutment (Figure 5.7).

Figure 5.7. Asphalt at right-hand side abutment (a) and asphalt at left-hand side of abutment (b) of the Brest Bridge (source: Mate Baričević).

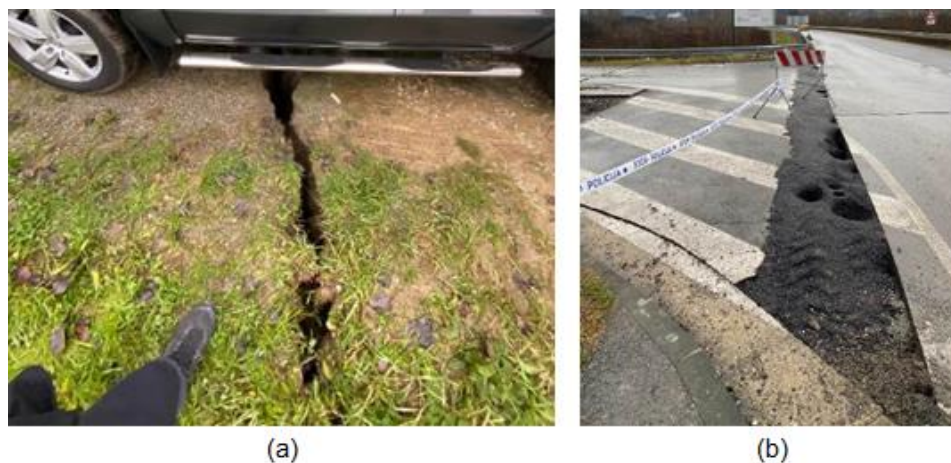
Wide ground fissures (up to 10 cm wide) were observed on the embankments leading to the bridge (Figure 5.8a). The asphalt curtain partially collapsed at the intersection with the access road to the center of Petrinja, as shown in Figure 5.8b.

Figures 5.8. (a) Wide cracks at the bridge embankment and (b) collapsed portion of the asphalt curtain at the intersection with the access road to the center of Petrinja (source: Mate Baričević).

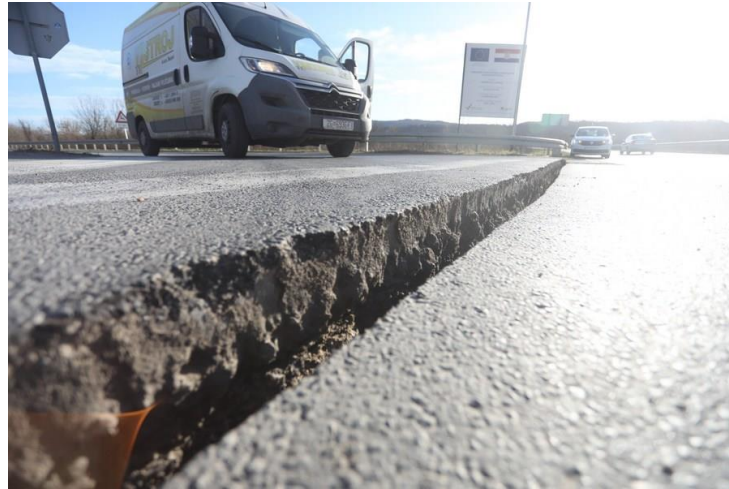
Due to the proximity to the epicenter, the roads close to Brest Bridge experienced differential settlements, which caused a decrease of the ground bearing capacity and resulted in ground and pavement failure. Iron railings were also damaged. These damages to roadways are shown in Figures 5.14 through 5.19.

Figure 5.14. A major fissure in the road in Sisak was observed after the December 29, 2020 earthquake (source: Marin Tironi/Pixsell via Xinhua).

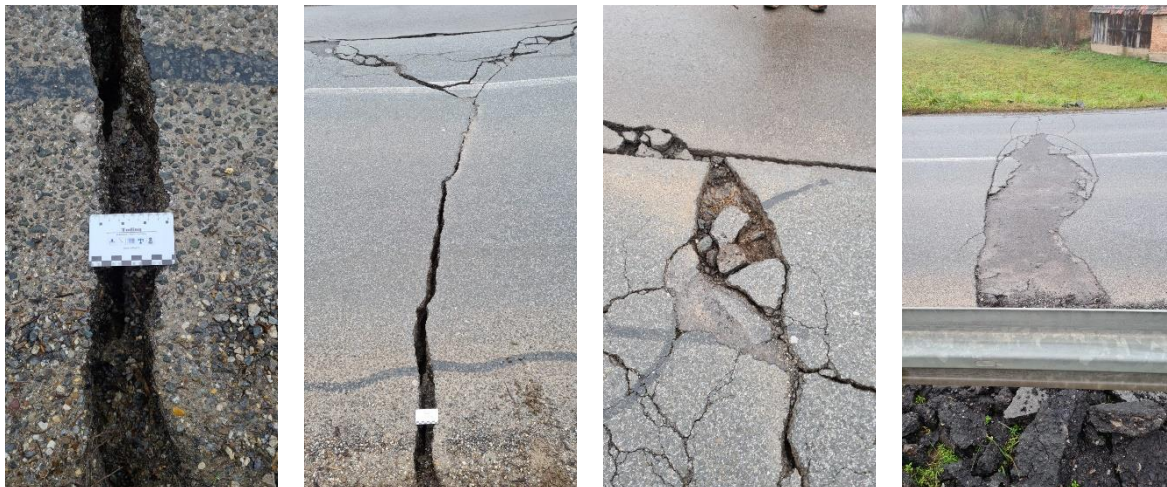
Figure 5.15. Damage to roads in Brest, north of Petrinja (source: Nenad Bijelić).

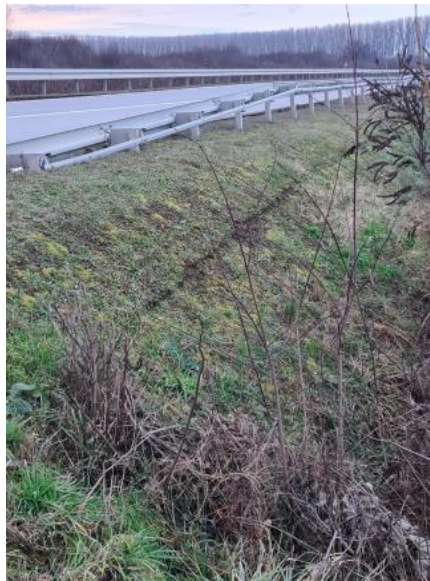
Figure 5.19. Partial lateral ground slide close to Brest Bridge (source: Nenad Bijelić).

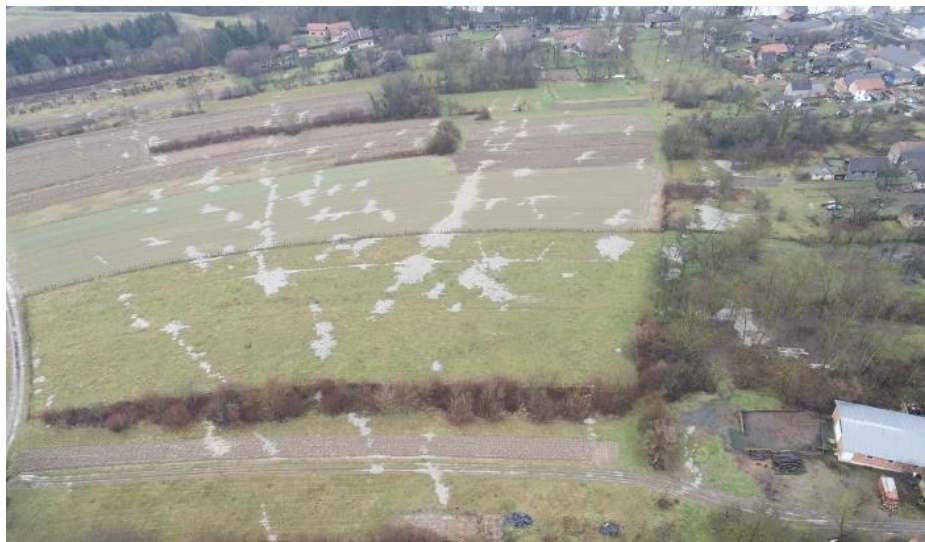
Figure 6.7. Aerial image of liquefaction ejecta at (45°30'41.988"N,16°24'37.632"E, source: Vedran Damjanović).

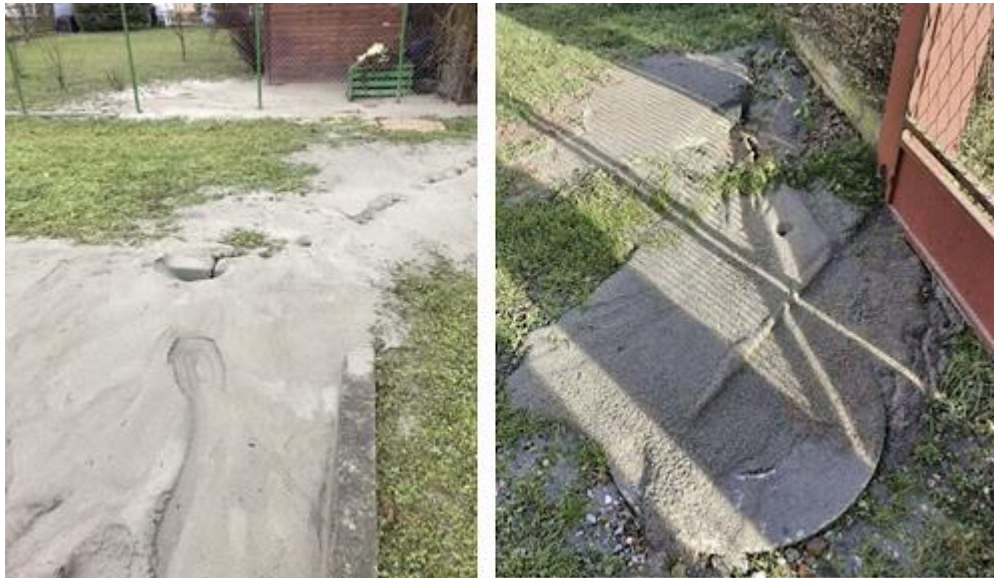
Figure 6.10. Liquefaction ejecta in Petrinja (Location: 45° 26' 38.6694"N, 16° 16' 33.5238"E, photo: Marko Bartolac).

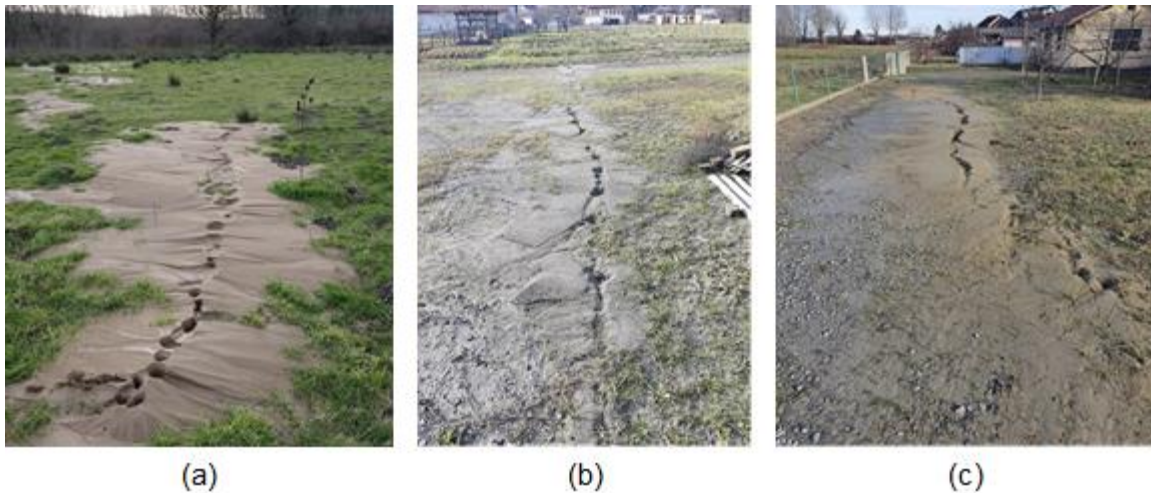
Figure 6.11. Liquefaction ejecta in Petrinja ((b) and (c): 45° 26' 39.447"N, 16° 16' 31.188"E, photo: Marko Bartolac, (a) photo: unknown location, Željko Arbanas).

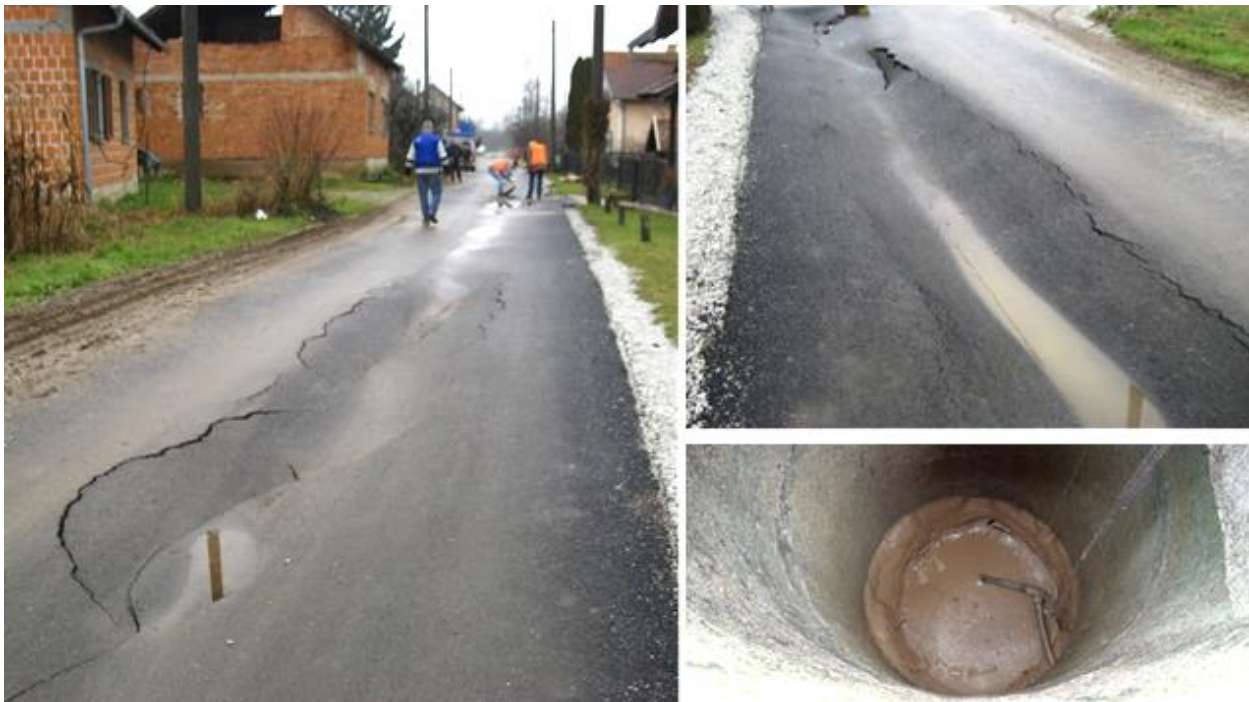
Figure 6.20. Settlement of the road along which the sewage system was renovated recently. It is possible that the material around the pipes was not compacted properly during construction, but liquefaction might have been the main reason for the settlements as a nearby well (45.4562, 16.3164) was filled with sandy material. Nova Drenčina, Drenačka ulica. (source Sonja Zlatović).

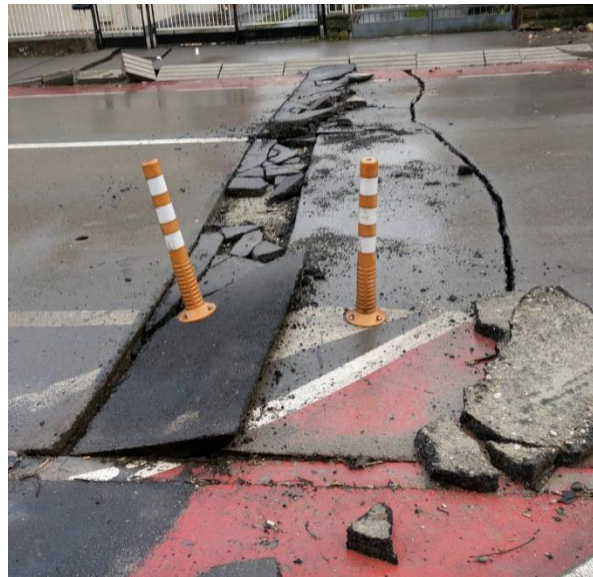
Figure 6.23. Road pavement cracking (45°29'45.108"N,16°22'36.888"E, source Zeljko Arbanas).

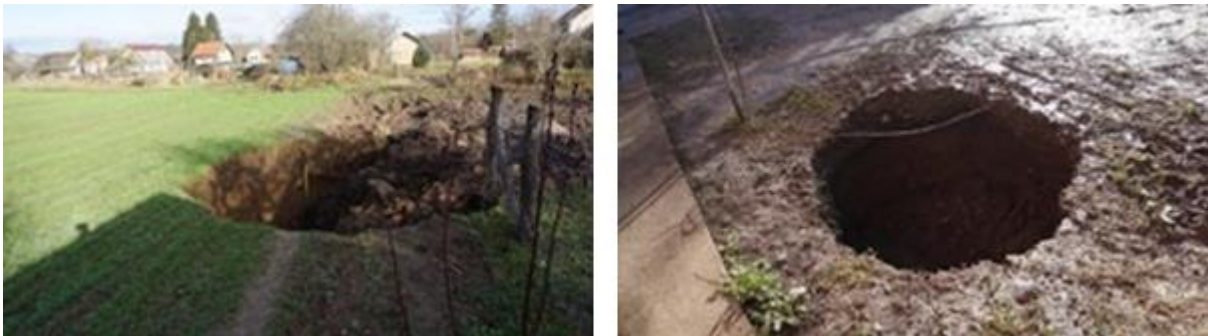
In the area of the village Mečenčani, on Friday December 31st a dozen sinkholes appeared, as shown in Figures 6.24 to 6.27. The location is approximately 30 km southeast of Petrinja, and it can be seen on the map that the village is located very close to or directly on the fault.

Similar sinkholes were known to appear occasionally in this area after individual communications with the local community. Many of the sinkholes appeared in the aftermath of the earthquake. Part of these sinkholes may be connected with abandoned mines. However, some of them are probably karst phenomena. It seems that new sinkholes continued appearing. Additionally, as seen in the photos, the slopes of the soil are quite steep, so widening of these holes may be expected with new rains, earthquakes etc.

Figure 6.24. Sinkholes (source: Index.hr news portal).

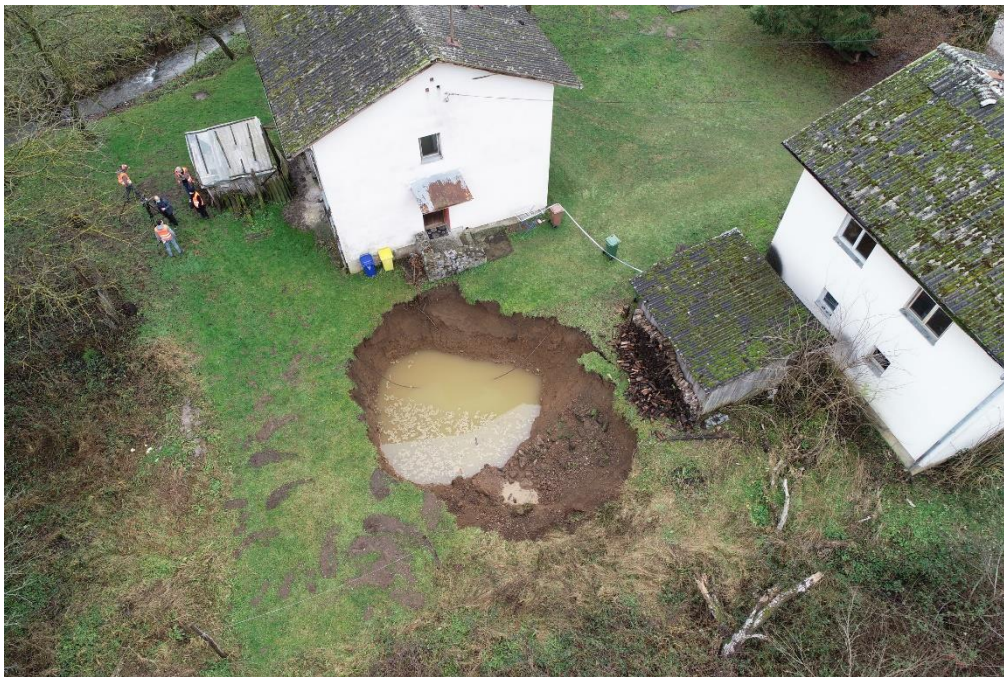
Figure 6.27. One of sinkholes in Mečenčani (45.2829,16.4299, source: Marijan Car; Mario Bačić and Josip Terzić, 2021).

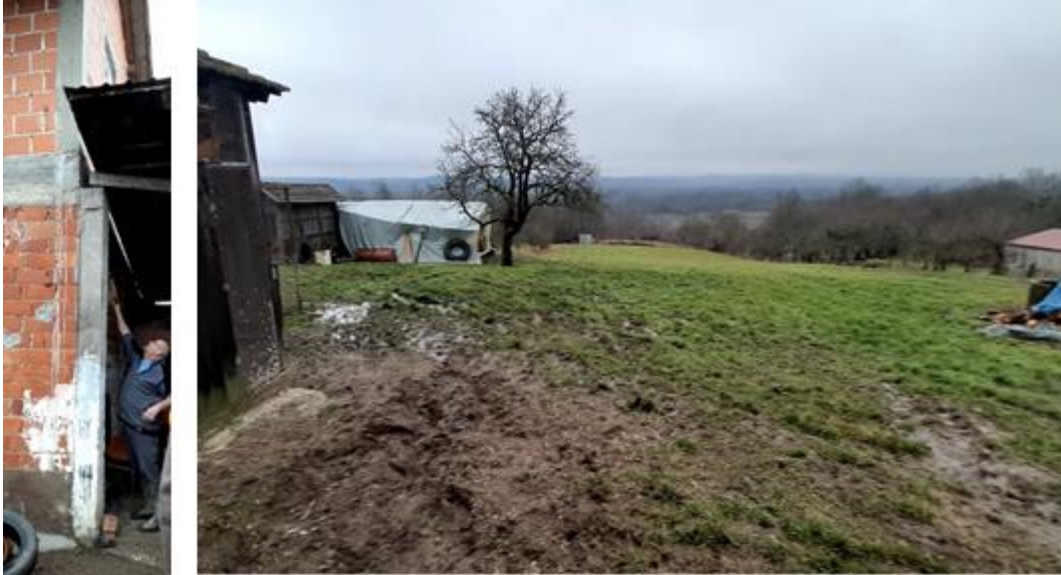
Figure 6.29. Neighboring the previously known landslide in Hadžar, is a small farm where various houses started moving down the slope, in different directions. The figure on the left shows a gap opening after the earthquake. The grass covered slope, usually firm even in rainy days, as rain would quickly run off, suddenly became wet and soft - maybe due to liquefaction in the shallow layer, which released water to the upper surface layer (45.3795,16.1199, source Sonja Zlatović).
