Petrinja, Croatia December 29, 2020, Mw 6.4 Earthquake Joint Reconnaissance Report (JRR)

Report

Joint Reconnaissance Team Leaders: Eduardo Miranda, Stanford University Svetlana Brzev, University of British Columbia / SUZI-SAEE Nenad Bijelić, Swiss Federal Institute of Technology Lausanne (EPFL) Field Assessment Structural Team (FAST) Authors: (in alphabetical order) Željko Arbanas, University of Rijeka Marko Bartolac, University of Zagreb Nenad Bijelić, Swiss Federal Institute of Technology Lausanne (EPFL) Vedran Jagodnik, University of Rijeka Damir Lazarević, University of Zagreb Snježana Mihalić Arbanas, University of Zagreb Sonja Zlatović, Zagreb University of Applied Sciences Virtual Assessment Structural Team (VAST) Authors: (in alphabetical order) Andrés Acosta, Stanford University Dimitrios Lignos, EPFL Jorge Archbold, UC Berkeley Ting Lin, Texas Tech University James Bantis, Stanford University Marko Marinković, University of Belgrade Jovana Borozan, SUZI-SAEE Armando Messina, Stanford University Ivana Božulić, EPFL Sebastián Miranda, Univ. del Desarrollo Nikola Blagojević, ETH Zurich Alan Poulos, Stanford University Cristian Cruz, Univ. Técnica Federico Santa María Giuli

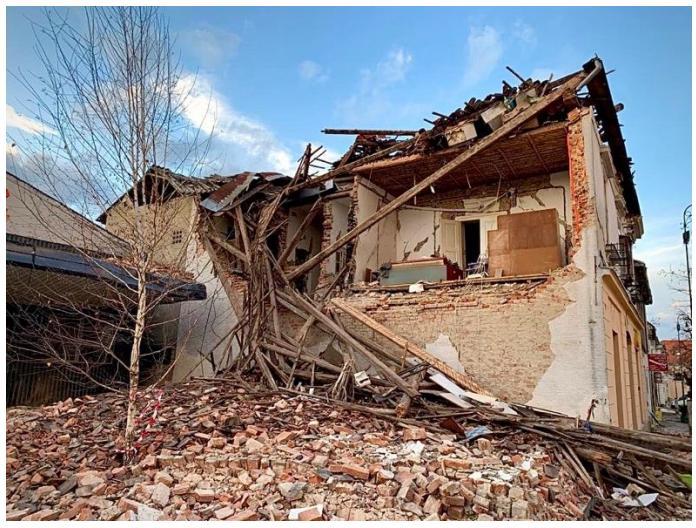
Collapsed unreinforced masonry building on Strossmayer St. in Petrinja, Photo by Damir Lazarević

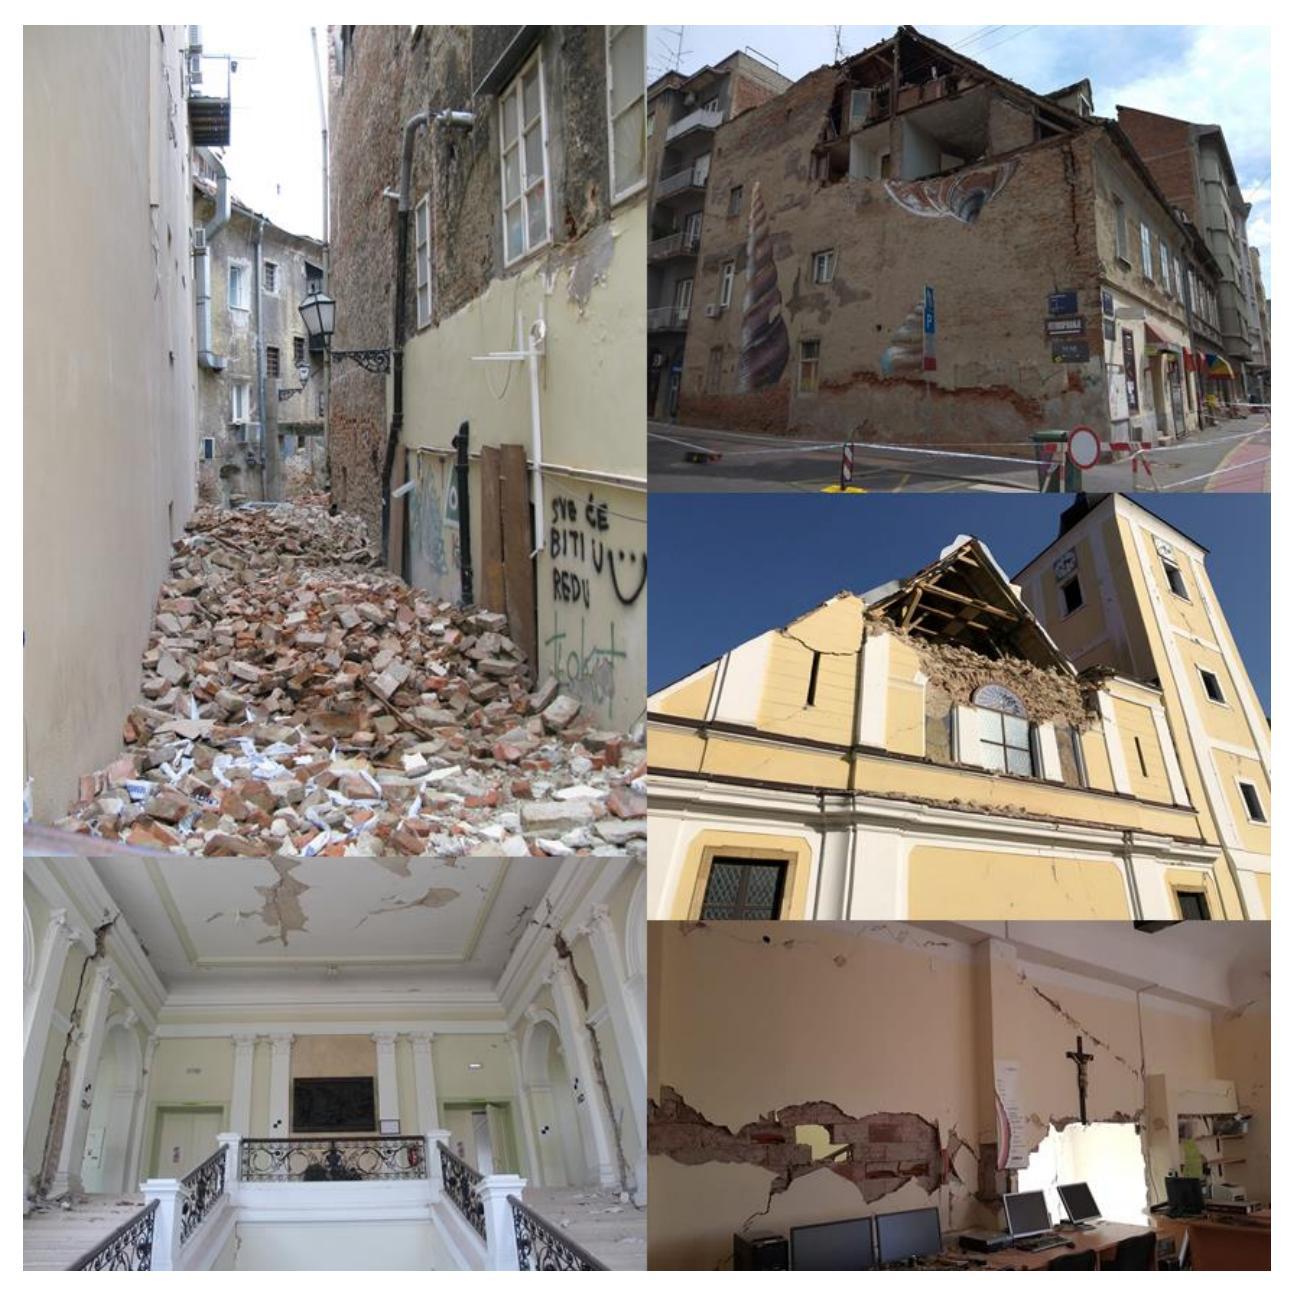
Figure 1.2. Photos of damage in Zagreb caused by the March 22, 2020 earthquake. (source: (1CroCEE 2021).

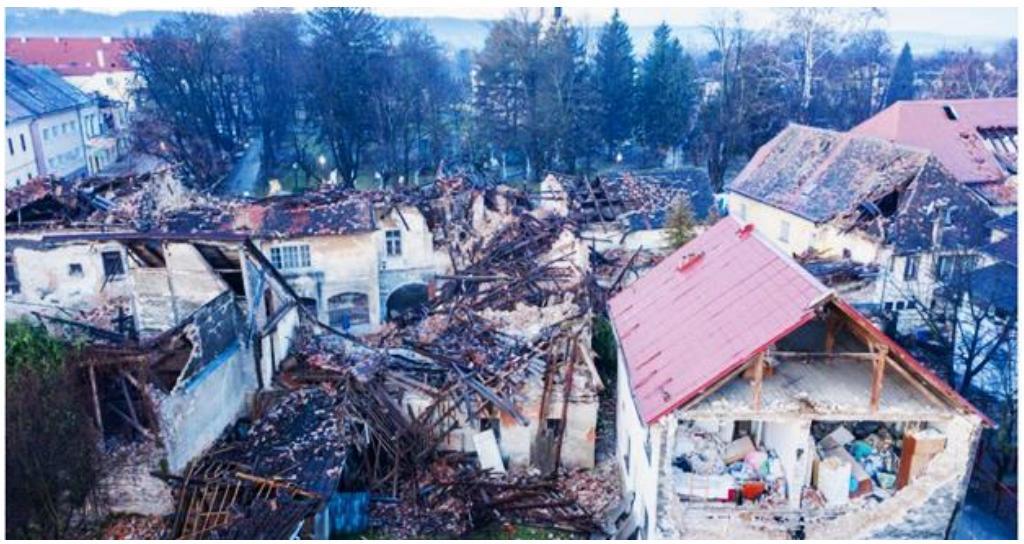
Figure 1.7. Aerial photo showing extent of damage in an area of Petrinja. Photo by Antonio Bronić (Reuters).

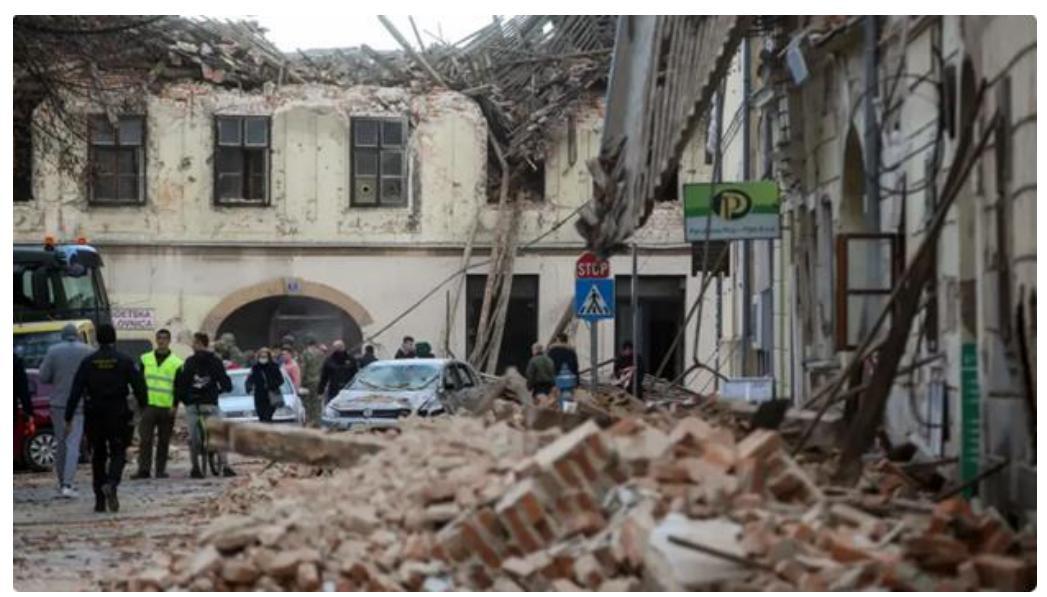
A significant portion of the Petrinja town was destroyed. As shown in Figure 1.12, many unreinforced masonry (URM) buildings experienced severe damage. Several schools were also damaged, in addition to the Petrinja hospital, as well as the St. Lawrence church and Petrinja Town Hall. Most houses in Majske Poljane, one of the most affected villages, were URM buildings constructed without seismic provisions and they experienced severe damage or collapse. Additionally, a majority of houses in Glina were damaged to varying extents, while in Sisak mostly older URM buildings located in the city center experienced damage. The damage was also observed in the nation's capital, Zagreb, where the Parliamentary building, the Cathedral, churches, and many other buildings experienced damage (Wikipedia 2021).

Figure 1.12. Croatian soldiers, firefighters, and residents next to heavily damaged buildings located in the center of Petrinja. Photo by Damir Senčar (Getty Images).

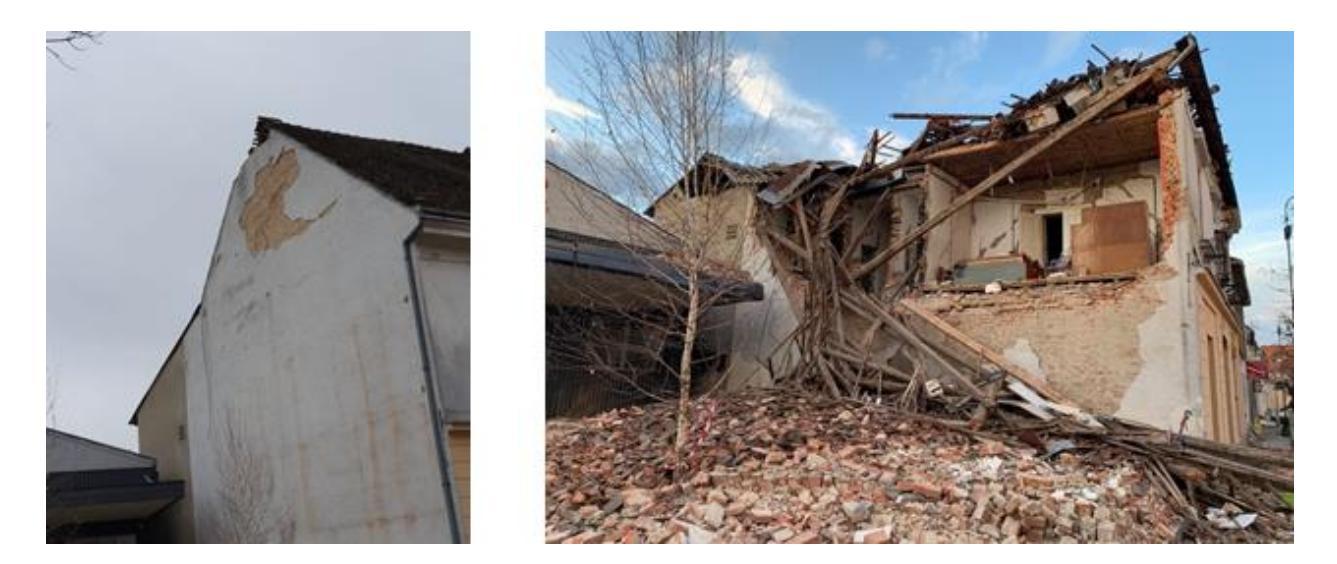
Figure 4.3. Typical wall and floor construction in older URM buildings, characterized by thick clay brick masonry walls, timber floors, and roofs. This building in Petrinja (adjacent to the KTC supermarket) was not significantly damaged in the December 28 M_w 5.2 earthquake but experienced gable wall and roof collapse in the December 29 M_w 6.4 earthquake (source: Joško Krolo).

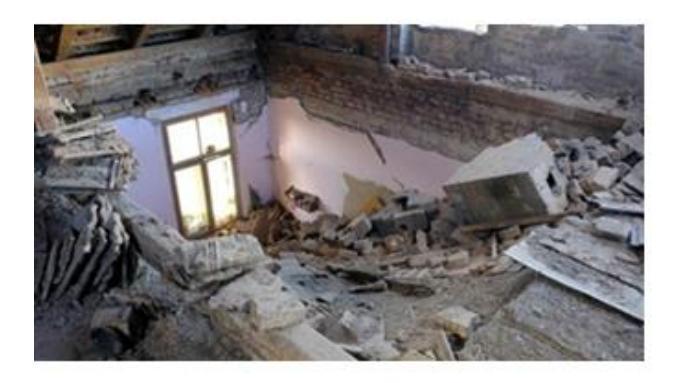
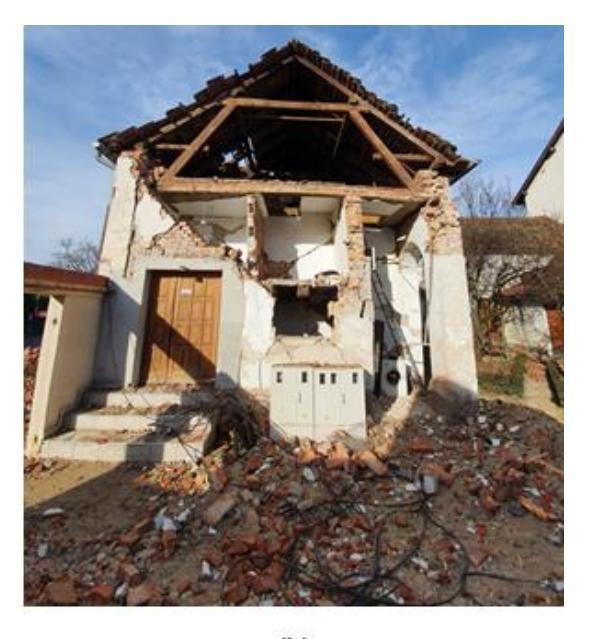
Figure 4.4. Details of older URM buildings: (a) floor-to-wall support area exposed due to floor collapse (source: Instagram account go.where.you.feel.most.alive) and (b) wooden roof truss structure with exposed wall-to-roof connection (source: Marko Bartolac).

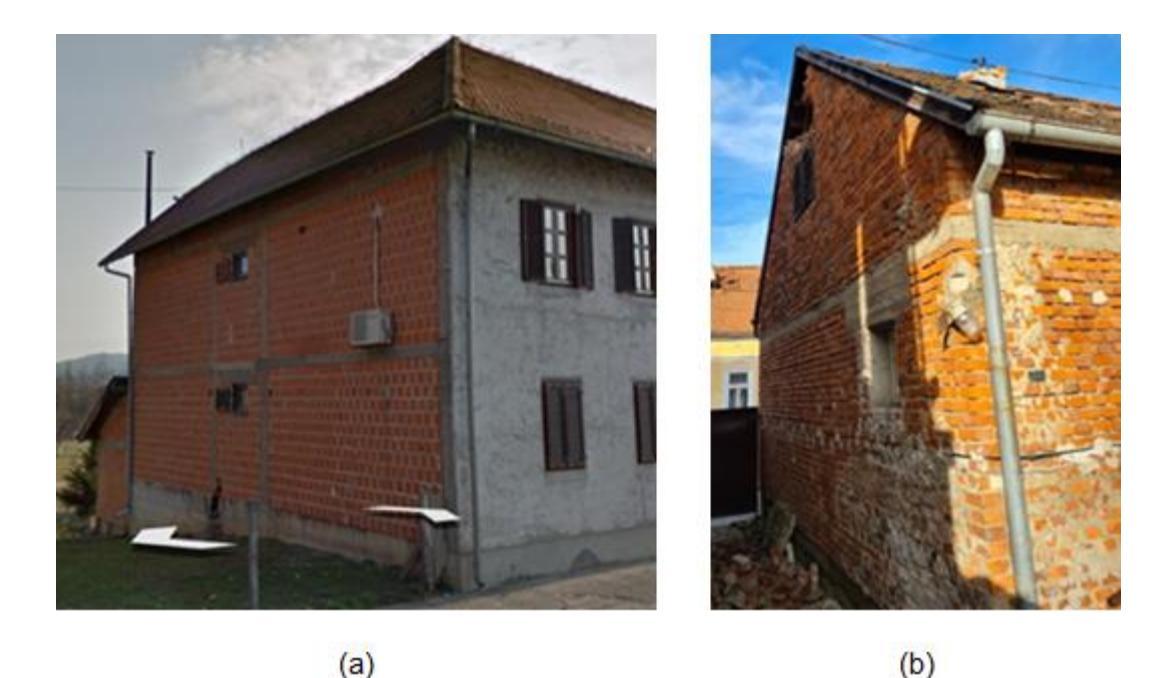
Figure 4.5. Modern masonry buildings in the earthquake-affected area: (a) two-story confined masonry building before the earthquake (source: Google Earth) and (b) single-story URM building with a rigid floor after the earthquake (source: Nenad Bijelić).

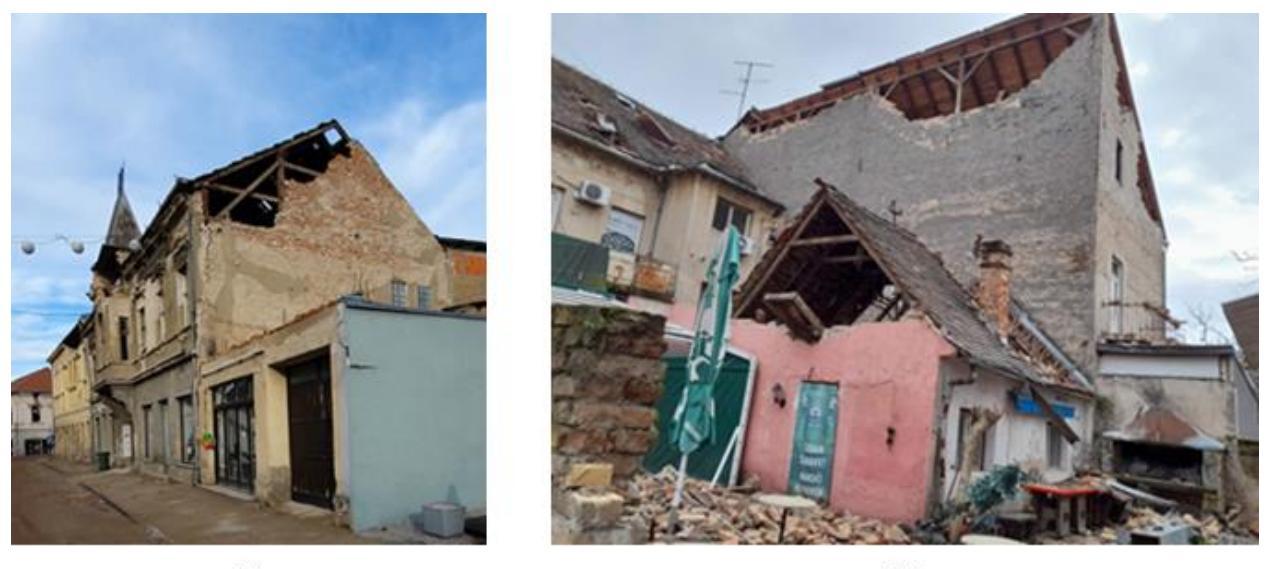
In many cases exterior walls at the top floors of buildings with wooden floors and roofs collapsed, as happened in the buildings shown in Figure 4.7.

Figure 4.7. Out-of-plane failure of walls at the upper portion of buildings with wooden floors and roofs due to flexible diaphragm and the absence of adequate wall-to-floor connections: (a) older 2-story URM building in downtown Petrinja (source: Nenad Bijelić) and (b) rear wall of a 2-story building in Sisak (source: Kristijan Freiberger).

- Out-of-plane damage or failure of exterior masonry walls at the upper/top floors of older URM buildings (constructed before the Second World War) were caused by excessive lateral displacements of flexible wooden floors. In most cases, these walls acted as vertical cantilevers due to inadequate wall-to-floor and wall-to-roof connections, and were prone to collapse due to out-of-plane inertial forces. In some instances, wall failures triggered roof failure.

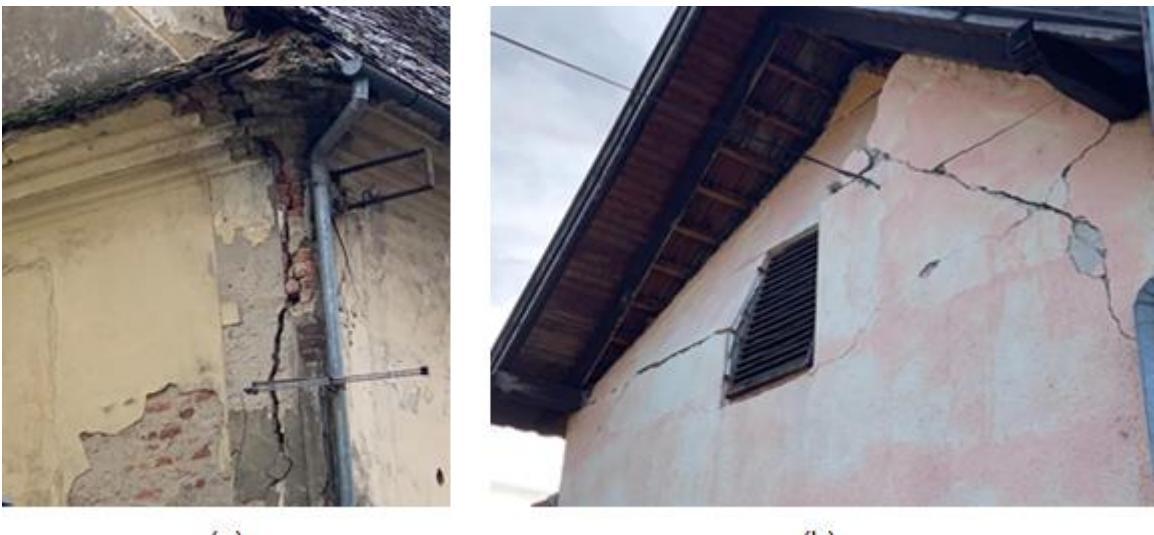
JRR: Petrinja December 29, 2020 Earthquake PRJ-2959 | Released: Jan 22, 2021 Building Resilience through Reconnaissance Figure 4.8 shows different stages of out-of-plane failure mechanism, from the development of vertical cracks at wall intersections to cracking in the gable wall.

Figure 4.8. Out-of-plane damage of masonry walls: (a) vertical cracks (source: Damir Lazarević) and (b) cracking and onset of failure in gable walls (source: Nenad Bijelić).

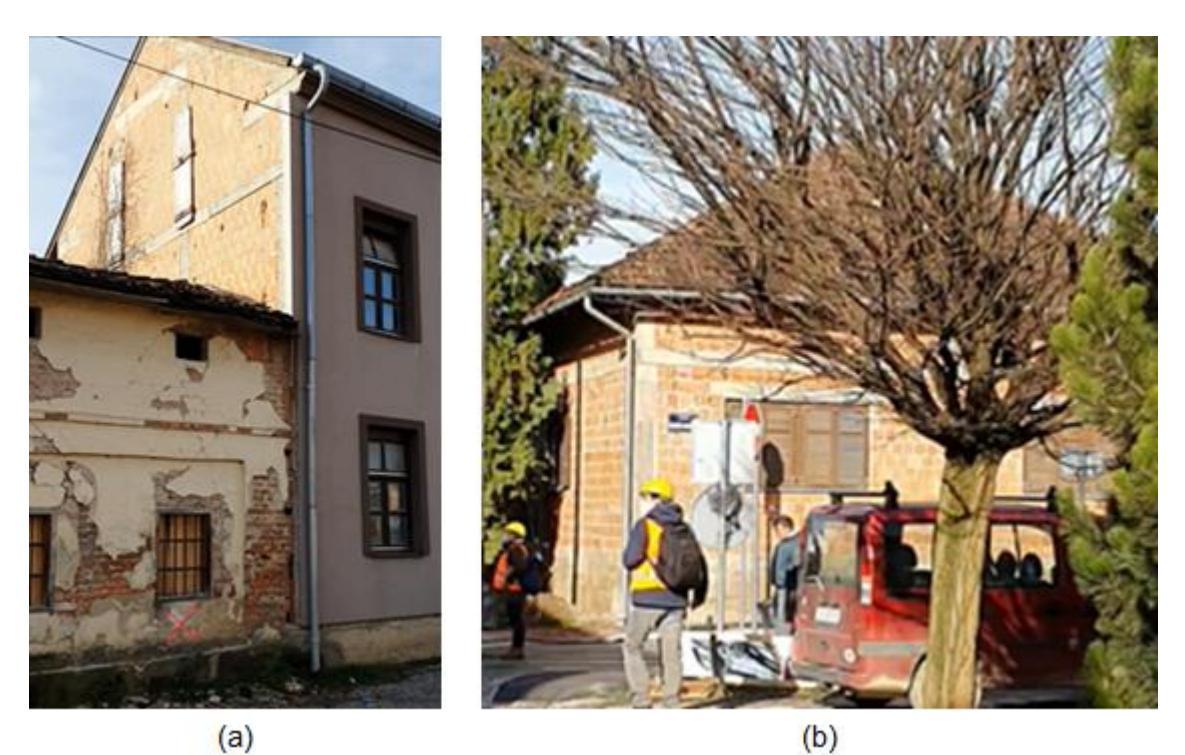
Properly constructed confined masonry buildings performed very well in the earthquake, particularly in comparison with URM buildings, as illustrated in Figures 4.10 and 4.11.

Figure 4.10. Examples of good performance of confined masonry buildings in Petrinja: (a) a two-story confined masonry building remained undamaged while an adjacent older URM building experienced severe damage; and (b) an undamaged single-story confined masonry building (source: Marko Bartolac).

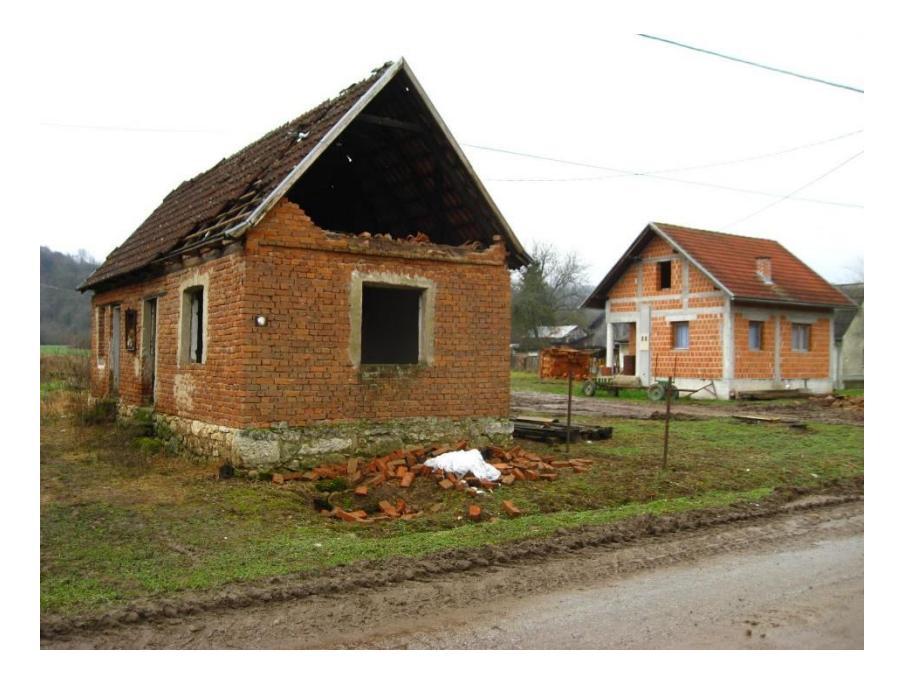
Figure 4.11. Performance comparison between confined masonry and URM buildings in Mečenčani village. The URM building with brick masonry walls (left) experienced damage in the earthquake while a similar confined masonry building (right) remained intact (source: Sonja Zlatović).

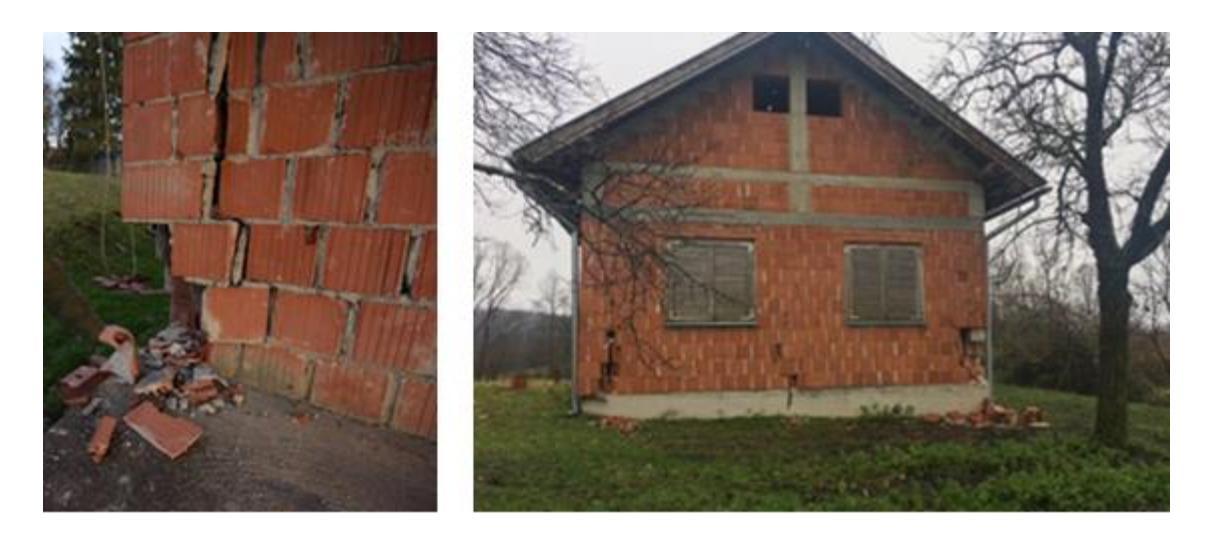
Figure 4.12. Damage of a partially confined masonry building due to the absence of RC tiecolumns at the ground floor level (sources: J. Miskovic/Cropix (left) Hrvatska Danas 2021 (right)).

- 2. Masonry buildings of more recent construction have rigid floors, but also experienced damage due to the absence of vertical reinforcement at the ground floor level. The inplane damage pattern was in the form of diagonal tension cracks in the walls due to excessively high seismic demand. Earthquake-induced principal tensile stresses in the walls exceeded the masonry tensile strength and caused the development of inclined cracks (diagonal tension cracks). The quality of masonry materials and construction appears to be inadequate in some cases, and is also a cause of damage.

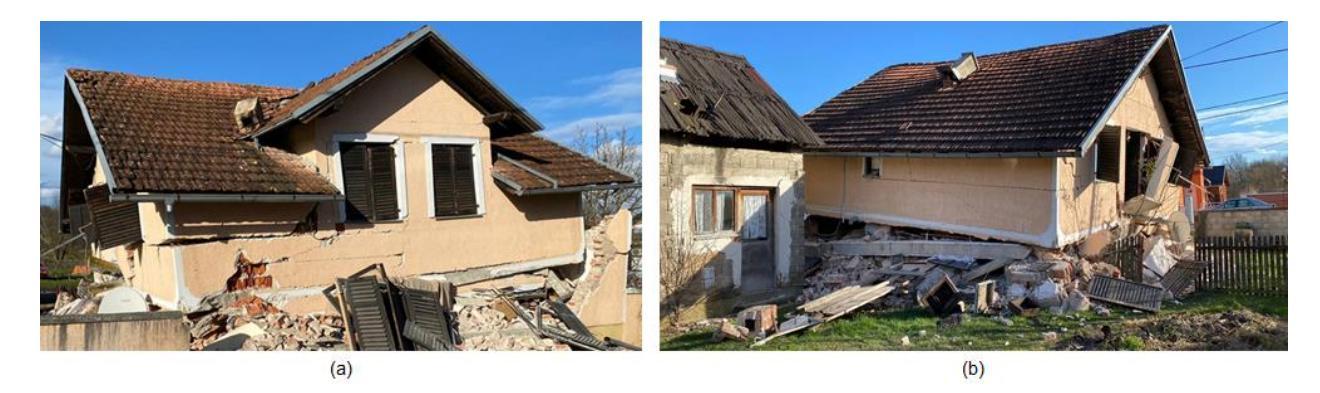
The ground floor of a 2-story masonry building in Prekope village collapsed, as shown in Figure 4.14. This is an example of a building with a vertical extension. The ground floor was constructed as an URM construction (solid clay bricks) whereas the upper floor was a partially confined structure constructed at a later stage. The photos show that the upper floor had a vertical confining element at the left corner, but was lacking such element at the other corner. It is interesting to observe that an adjacent unreinforced single-story masonry building did not experience any damage. Poor performance of this building can be attributed to the use of different masonry materials (i.e., bricks and hollow clay blocks) and construction technologies (unreinforced and confined masonry) at different floors.

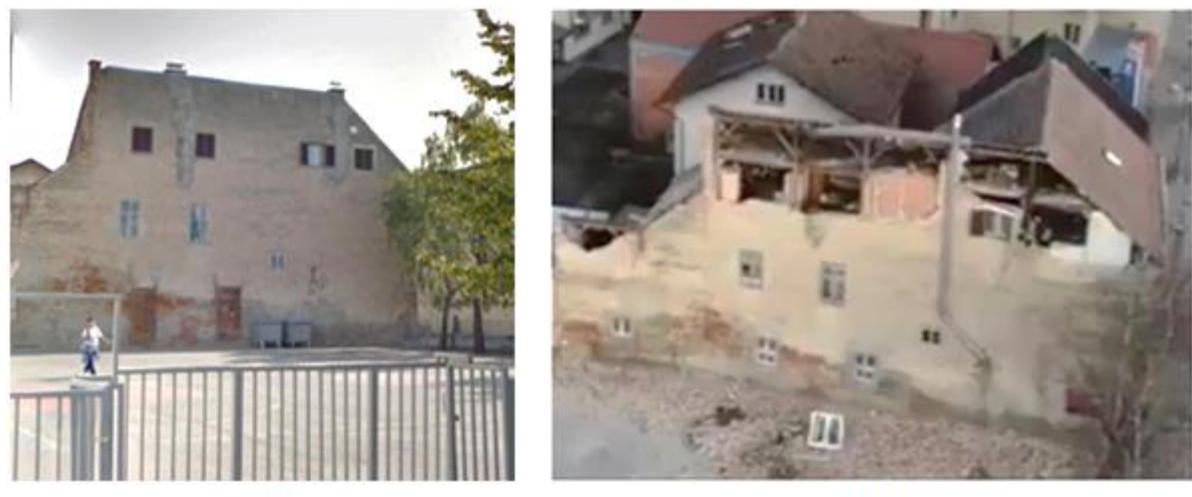
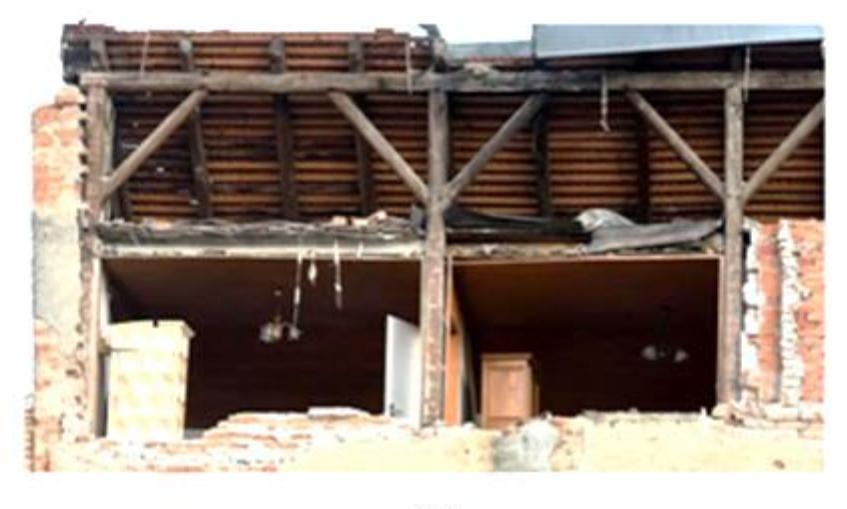
This section provides an overview of the seismic performance of mid-rise apartment buildings. Most of these buildings were constructed after World War II, either as individual buildings in urban areas or within settlements which were systematically developed as urban development projects after the 1960s. However, it should be noted that older mid-rise apartment buildings also exist in the earthquake-affected area. In most cases, these buildings were originally owned by one family, but over time they were converted into multi-family residential buildings. These are URM buildings with wooden floors and roofs, and their structural features and damage patterns are similar to the low-rise residential buildings described in Section 4.1. Figure 4.15 shows the collapse of exterior walls at the top floors of a 4-story building in Petrinja and the appearance of the facade prior to the earthquake (see Figure 4.15a).

Figure 4.15. Collapse of exterior walls at the upper portion of a building in Petrinja: (a) before the earthquake (source: Google Earth), (b) damaged condition after the earthquake (source: Aeroklub Petrinja drone footage), and (c) detail of the exposed building interior and roof structure (source: Getty).

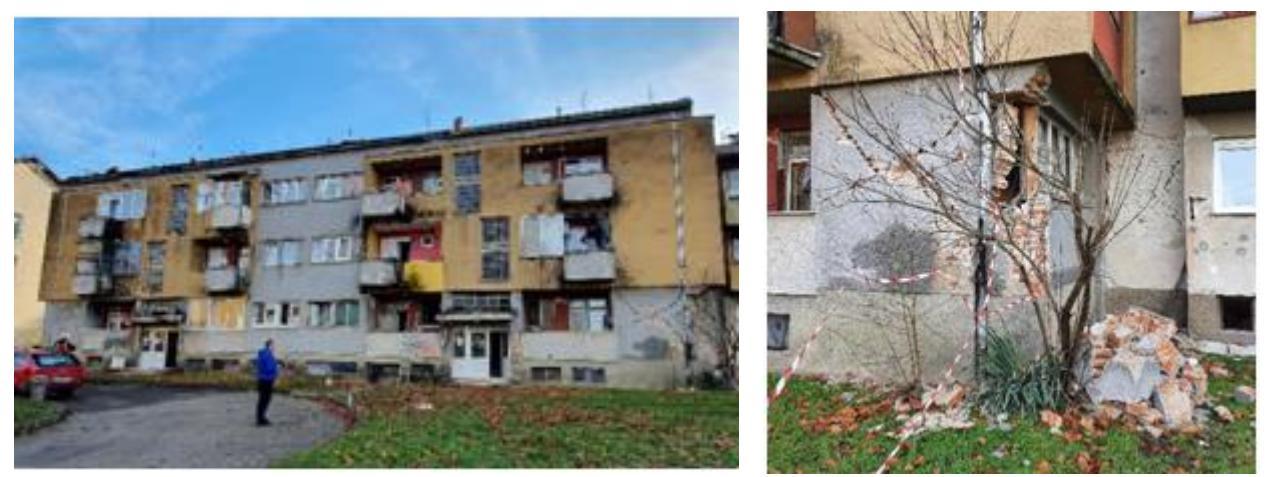
A 3-story apartment building located near the marketplace in Petrinja, an area where several low-rise URM buildings experienced heavy damage or collapse, is shown in Figure 4.16 (facade view in longitudinal direction). The building, which was probably constructed in the 1960s, had rigid floors and clay brick masonry walls (approximately 230 mm thick). The building experienced shear cracks in the walls at the ground floor level that were caused by high inplane seismic demand and excessively high tensile stresses. The most extensive damage was observed at the right end of the building, where the connection between the longitudinal and transverse walls failed, causing crushing and falling out of masonry; this can be explained by inadequate structural integrity characteristic for URM buildings, and could have been prevented had RC tie-columns been provided.

Figure 4.16. Damage in a 3-story residential building in Petrinja (source: Marko Bartolac).

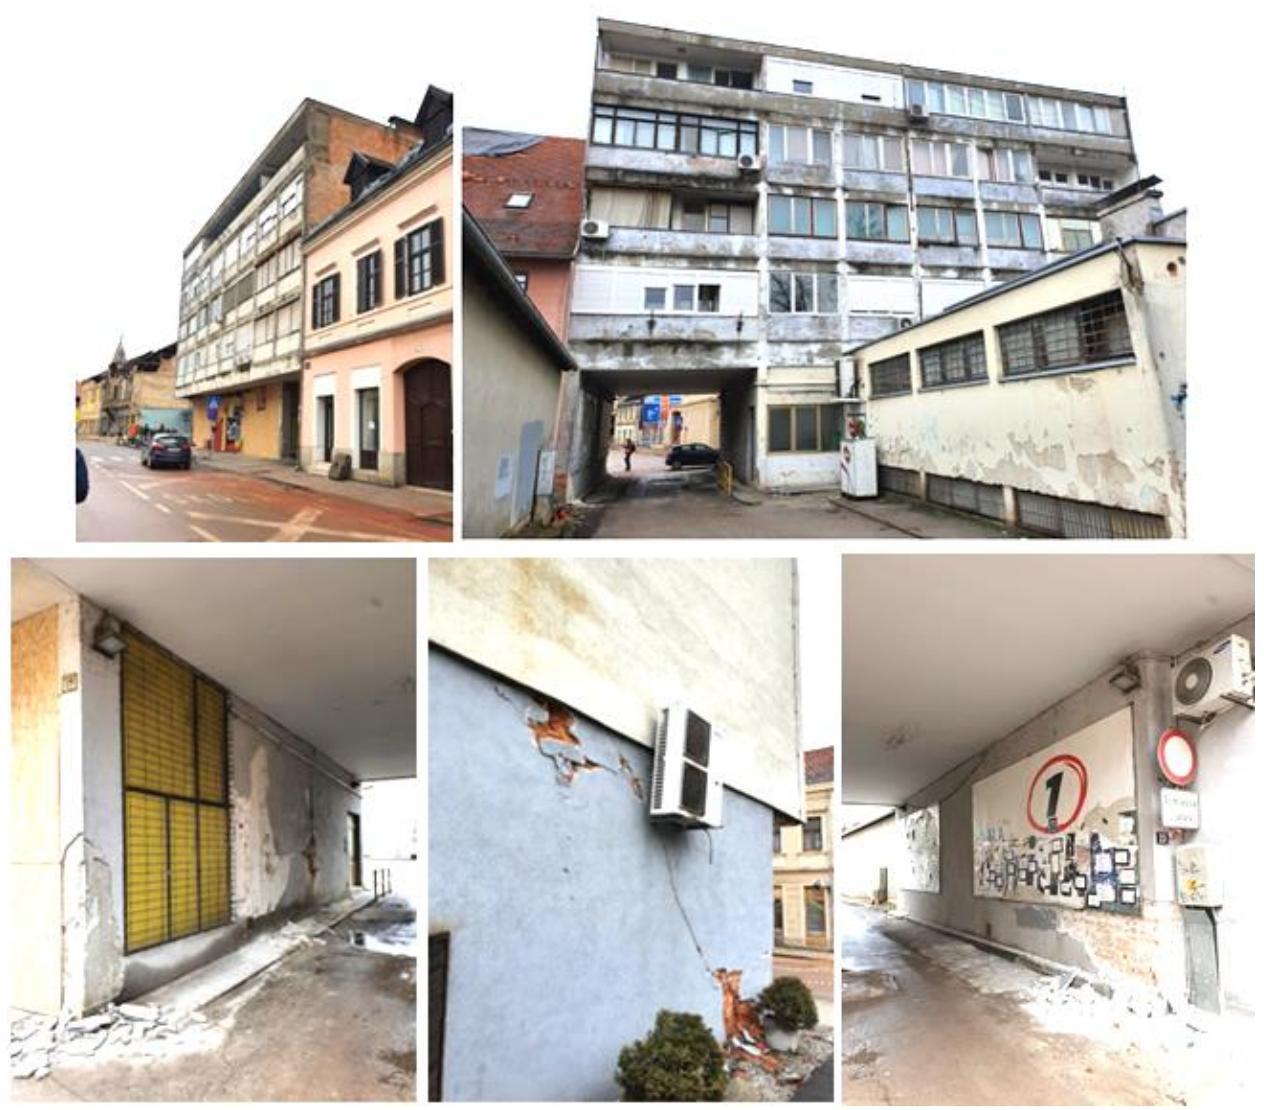
A five-story apartment building at Vladimira Nazora Street in Petrinja is an example of an older apartment building that was affected by the earthquake (Figure 4.17). Based on the architectural style, it appears that the building was constructed in the 1960s, hence it was most likely designed without any seismic provisions. This is the tallest building in downtown Petrinja and is located close to several damaged two-story URM buildings. The building has a rectangular plan with a length of 25 m and a width of 15 m (approximately). It is a load-bearing wall structure with brick masonry walls and rigid floor and roof slabs. A few RC columns were constructed at the ground floor level, which was intended for commercial use. There is also a passage for vehicles, which causes a decrease in strength and stiffness at the ground floor level and can be characterized as a vertical irregularity. At the rear side there is an adjacent single-story building and another adjacent two-story URM building at the street level. Based on a survey of the building exterior, it was observed that wide in-plane shear cracks developed in the transverse direction at the ground floor level.

Figure 4.17. Five-story apartment building in the center of Petrinja (source: Nenad Bijelić and Marko Bartolac).

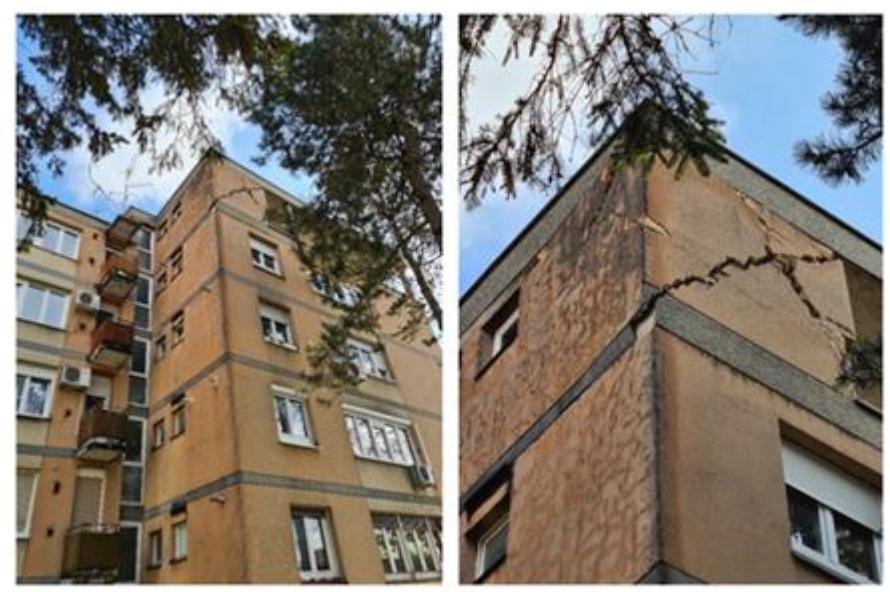
Figure 4.20. Extensive cracking experienced at the roof/terrace level of Building 2 (source: Nenad Bijelić).

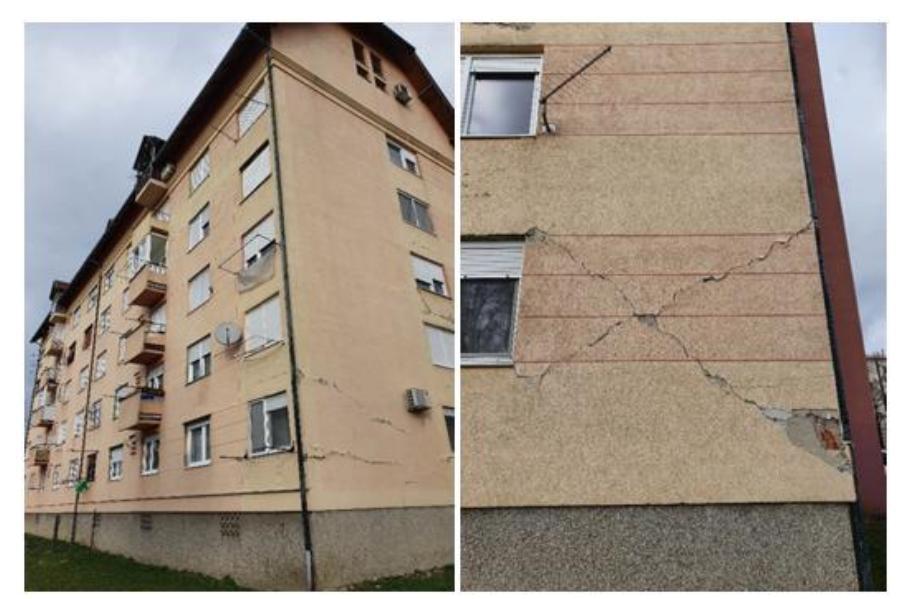
wall ends. Identical patterns of in-plane shear cracking were observed at the ground floor level in Buildings 1 and 2. Building 4 has a rectangular plan shape and 5 stories plus a vertical extension – the top story was added after the original construction was completed. The building experienced in-plane shear cracking in the transverse direction at the ground floor level (a similar pattern to that observed in Buildings 1 and 2) (Figure 4.21). It appears that other buildings in the vicinity of these 4 buildings did not experience significant damage, including an adjacent single-story URM building and some 10-story-plus high-rise buildings (Figure 4.22). The damage can be explained by low frequency content of the ground motions at this site.

Figure 4.21. Damage to Building 4, a 5-story building with a vertical extension (source: Marko Bartolac).

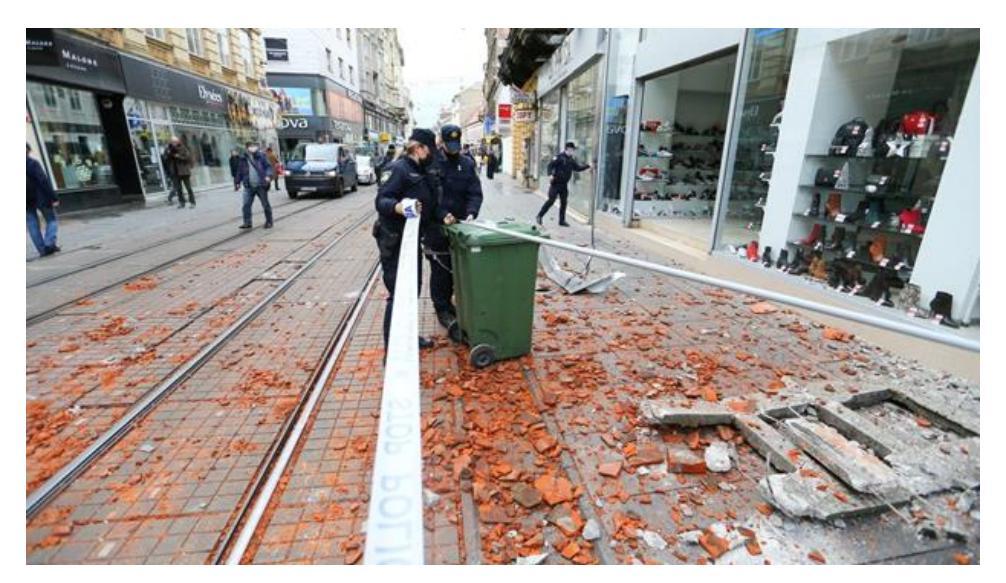
In Zagreb, there was little reported damage to store fronts. For example, Figure 4.25 shows a view looking east on Ilica Street in Zagreb, a large shopping area. Although fallen façades can be seen in the photo, there was no damage to glass store fronts.

Figure 4.25. Photo taken looking east on Ilica Street in Zagreb showing fallen debris (source: Santora and Orovic, 2020).

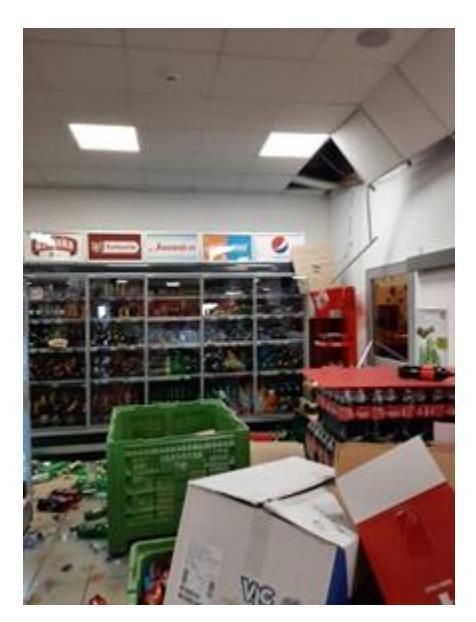
Damage was reported at the KTC supermarket, an RC structure located in downtown Petrinja, which is shown in Figure 4.26. There was damage to the hung ceiling assembly (Figure 4.27) and products fell off shelves (Figure 4.28); however, structural damage was not documented nor reported. The building also has an elevator that did not lose functionality due to the earthquake.

Figure 4.27. Damage to hung ceiling assembly in the KTC supermarket (source: Sonja Belovarac Radenovic).

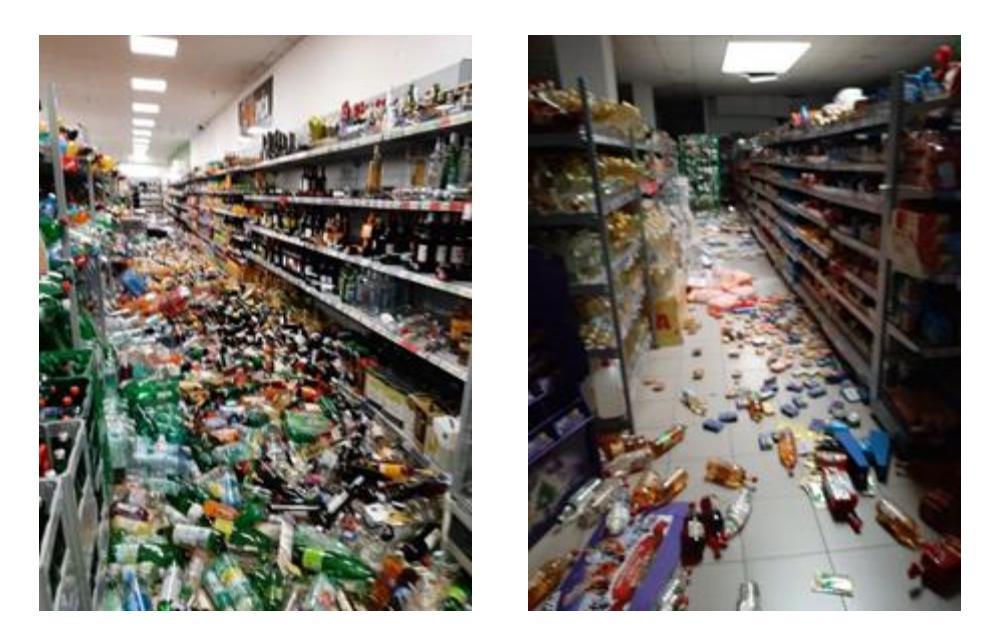
Figure 4.28. Products on the floor of the KTC supermarket due to the earthquake (source: Sonja Belovarac Radenovic).

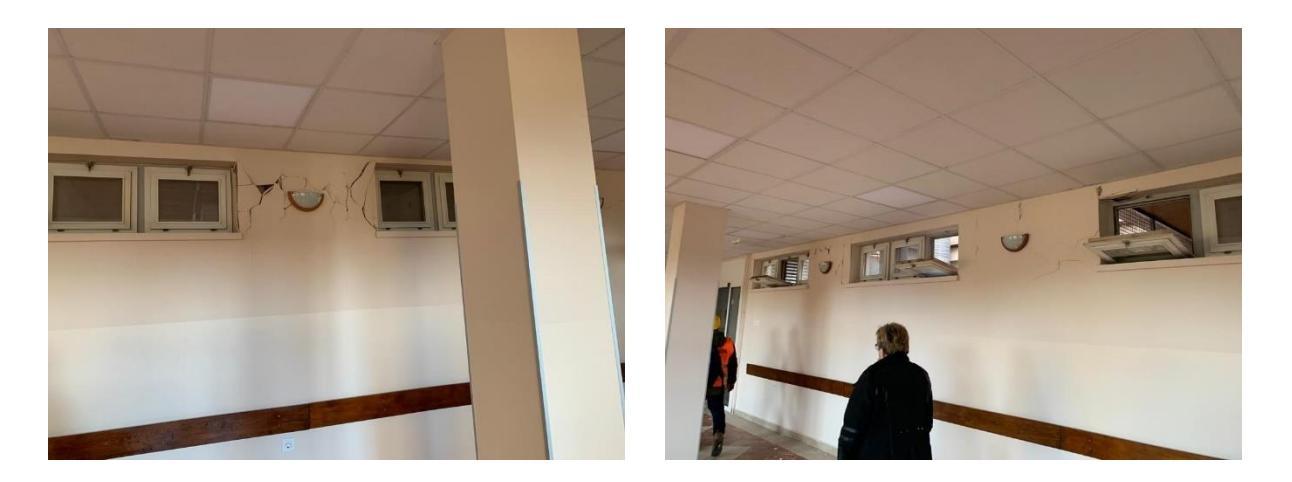
The observed damage in the retirement home was mostly to nonstructural elements such as interior masonry infills and partition walls, hung ceilings, tiles on the walls, and tiles on the floors. Shear cracks in masonry infill walls are common due to the stiffness and deformation incompatibility of the infills with the reinforced concrete frame. Several of these cracks occurred throughout the retirement facility in Petrinja. Figure 4.31 shows diagonal shear cracks originating from the corners of the windows in the infill walls of a hallway. Along the length of the hallway, large shear cracks originated from the corners of doorways and propagated through the single wythe partition walls, made of hollow clay blocks, as shown in Figure 4.32. Cracks along the interface between a masonry infill wall and a reinforced concrete column are seen in Figure 4.33. Besides large diagonal shear cracks in the plaster, cracks at the end of RC beams also occurred (Figure 4.34). Damage to other nonstructural components was also observed, such as hung ceiling assemblies in the form of exposed piping and fasteners for the hung ceiling (Figure 4.35) and cracks in wall and floor tiles (Figure 4.36).

Figure 4.31. Shear cracks in infill masonry walls of the retirement home in Petrinja (source: Damir Lazarević).

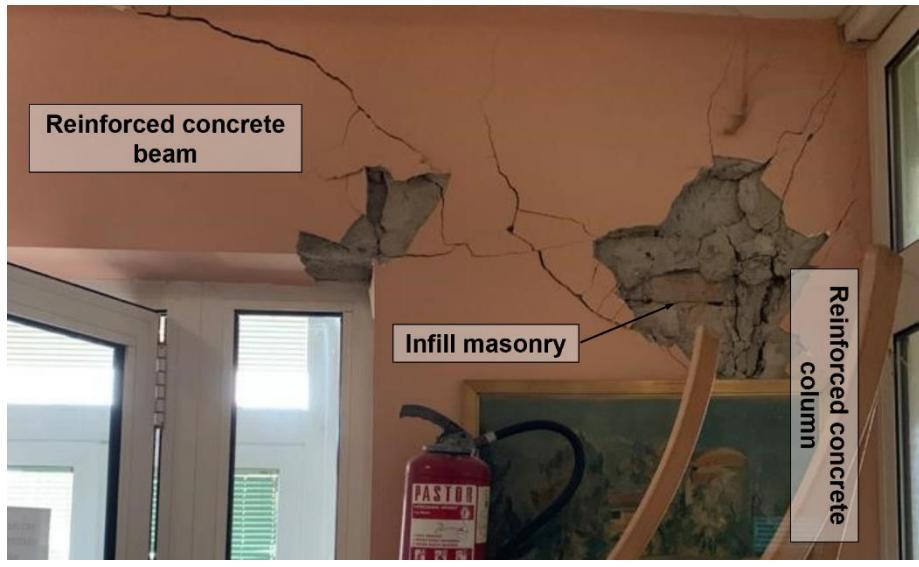
Figure 4.34. Damage to a reinforced concrete beam in the retirement home in Petrinja (source: Damir Lazarević).

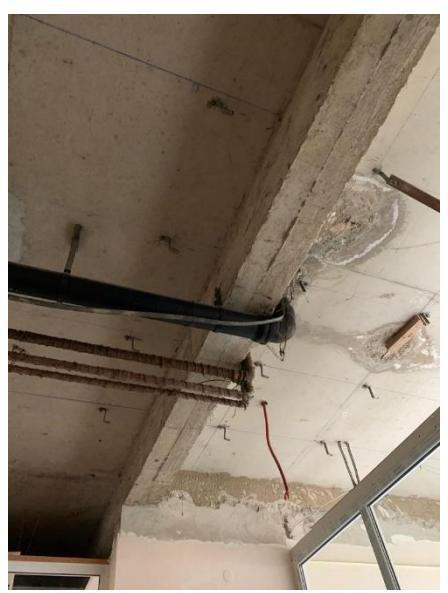
Figure 4.35. Exposed piping and fasteners for the hung ceiling (source: Damir Lazarević).

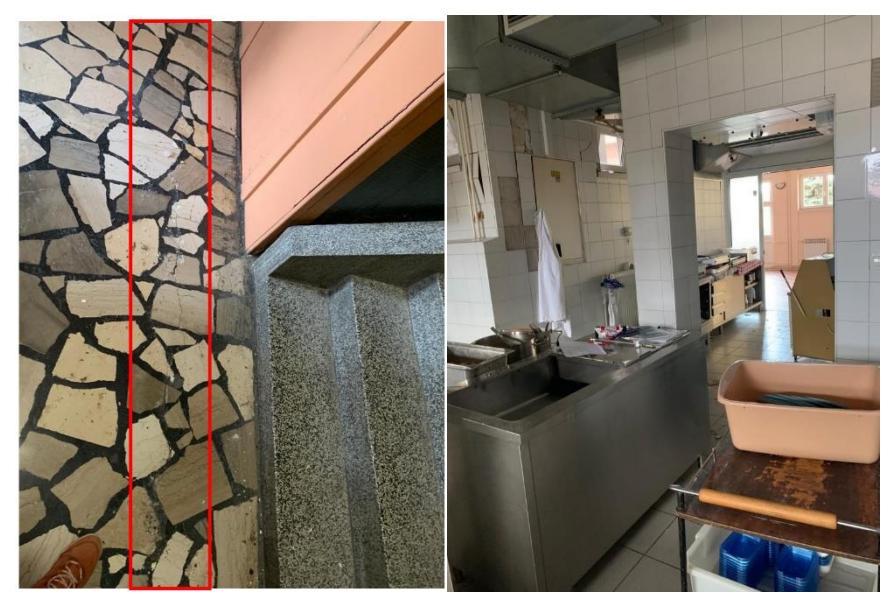
Figure 4.36. Cracks in the floor tiles (left) and tiles detached from the kitchen walls (right) (source: Damir Lazarević).

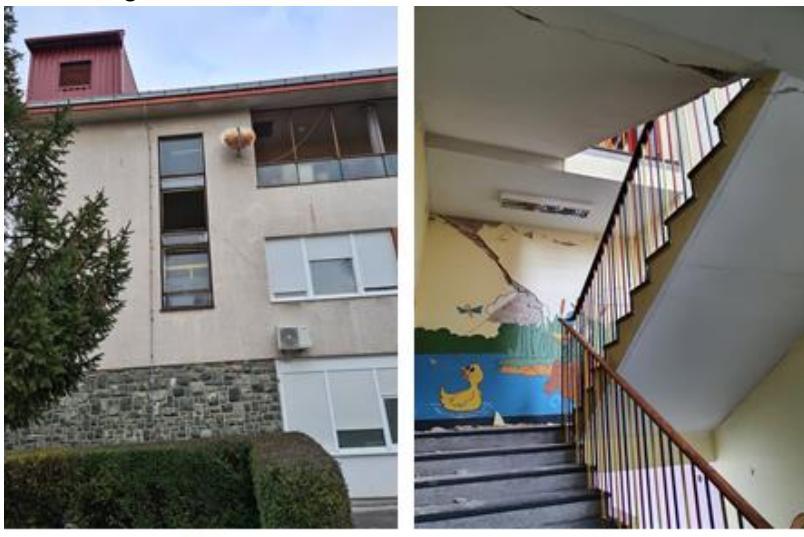
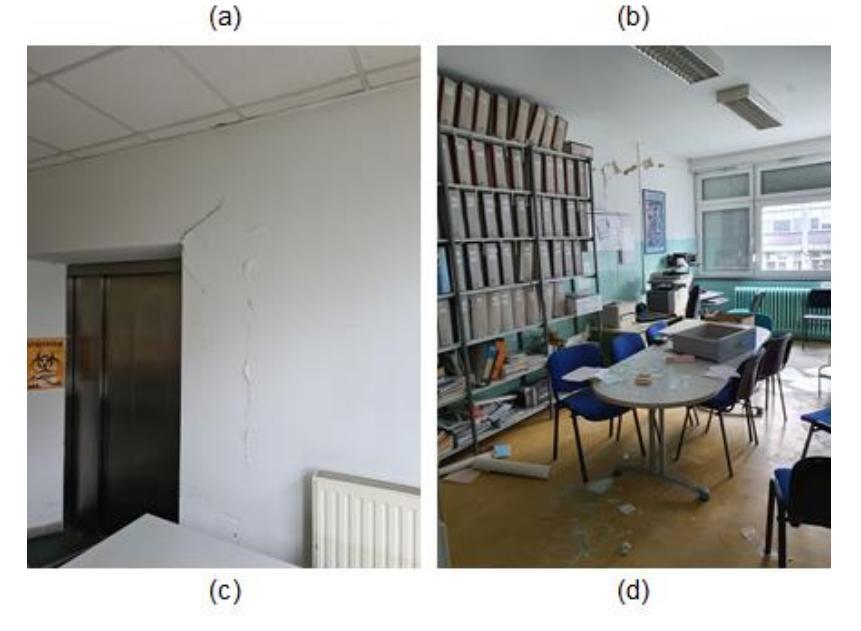
masonry infills presented cracks with horizontal and diagonal patterns, usually due to incompatibility between the deformation capabilities of concrete and masonry. Damage also occurred in the elevator shafts and stairs. The 2nd and 3rd floor of this building were declared unusable due to this damage.

Figure 4.41. Building #1: (a) external view, (b) diagonal cracks in masonry infills, (c) cracks near elevator shafts, and (d) horizontal cracks along masonry-concrete joints (source: Nenad Bijelić).

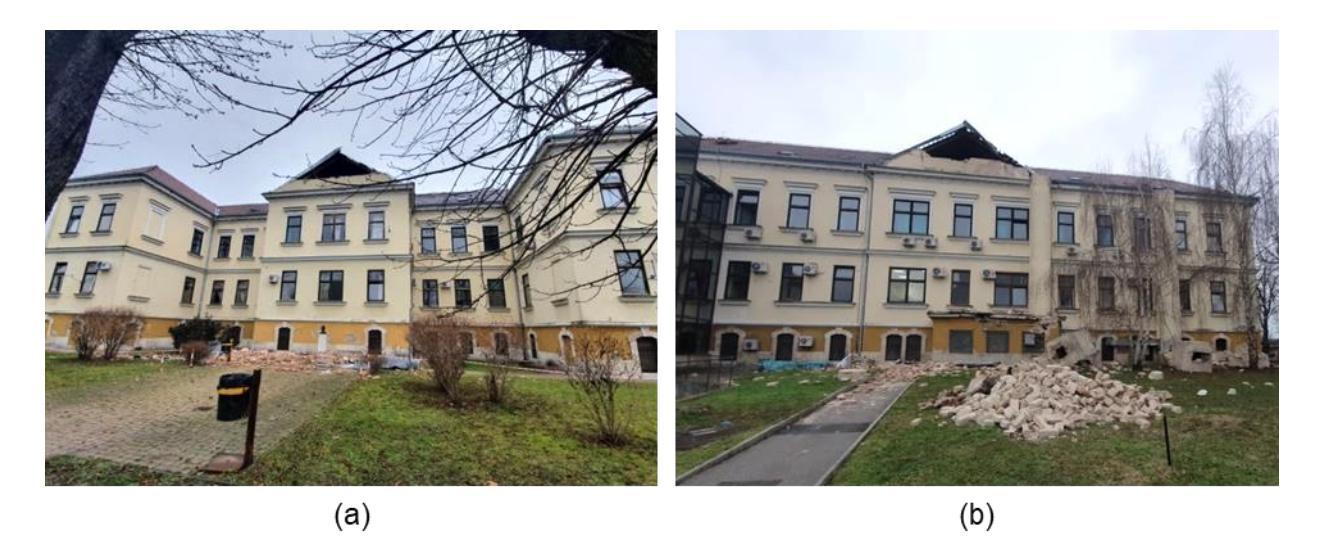
Building #2 (Internal Medicine) is an old C-shaped three-story RC and masonry building with main plan dimensions of 42 m by 17 m. The roof of this building partially collapsed, as shown in Figure 4.42. The building also presented massive cracking in different areas and was, therefore, declared unusable.

Figure 4.42. Building #2: (a) front view and (b) back view (source: Croatia Week 2021, Jan 5).
