Petrinja, Croatia December 29, 2020, Mw 6.4 Earthquake Joint Reconnaissance Report (JRR)

Report

Joint Reconnaissance Team Leaders: Eduardo Miranda, Stanford University Svetlana Brzev, University of British Columbia / SUZI-SAEE Nenad Bijelić, Swiss Federal Institute of Technology Lausanne (EPFL) Field Assessment Structural Team (FAST) Authors: (in alphabetical order) Željko Arbanas, University of Rijeka Marko Bartolac, University of Zagreb Nenad Bijelić, Swiss Federal Institute of Technology Lausanne (EPFL) Vedran Jagodnik, University of Rijeka Damir Lazarević, University of Zagreb Snježana Mihalić Arbanas, University of Zagreb Sonja Zlatović, Zagreb University of Applied Sciences Virtual Assessment Structural Team (VAST) Authors: (in alphabetical order) Andrés Acosta, Stanford University Dimitrios Lignos, EPFL Jorge Archbold, UC Berkeley Ting Lin, Texas Tech University James Bantis, Stanford University Marko Marinković, University of Belgrade Jovana Borozan, SUZI-SAEE Armando Messina, Stanford University Ivana Božulić, EPFL Sebastián Miranda, Univ. del Desarrollo Nikola Blagojević, ETH Zurich Alan Poulos, Stanford University Cristian Cruz, Univ. Técnica Federico Santa María Giuli

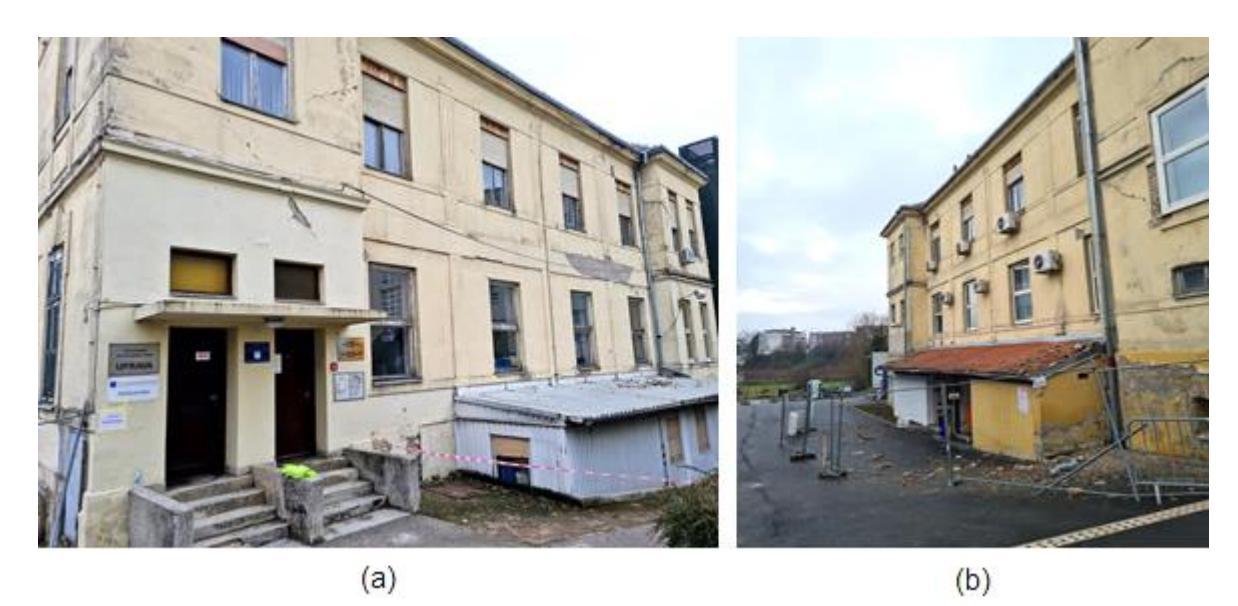
Building #4 (Administration) is an old rectangular three-story RC and masonry building with approximate plan dimensions of 25 m by 10 m. It presented cracking with different geometric patterns and fallen stucco facades, as shown in Figure 4.43, and was also declared unusable.

Figure 4.43. Building #4: (a) front view, and (b) back view (source: Nenad Bijelić).

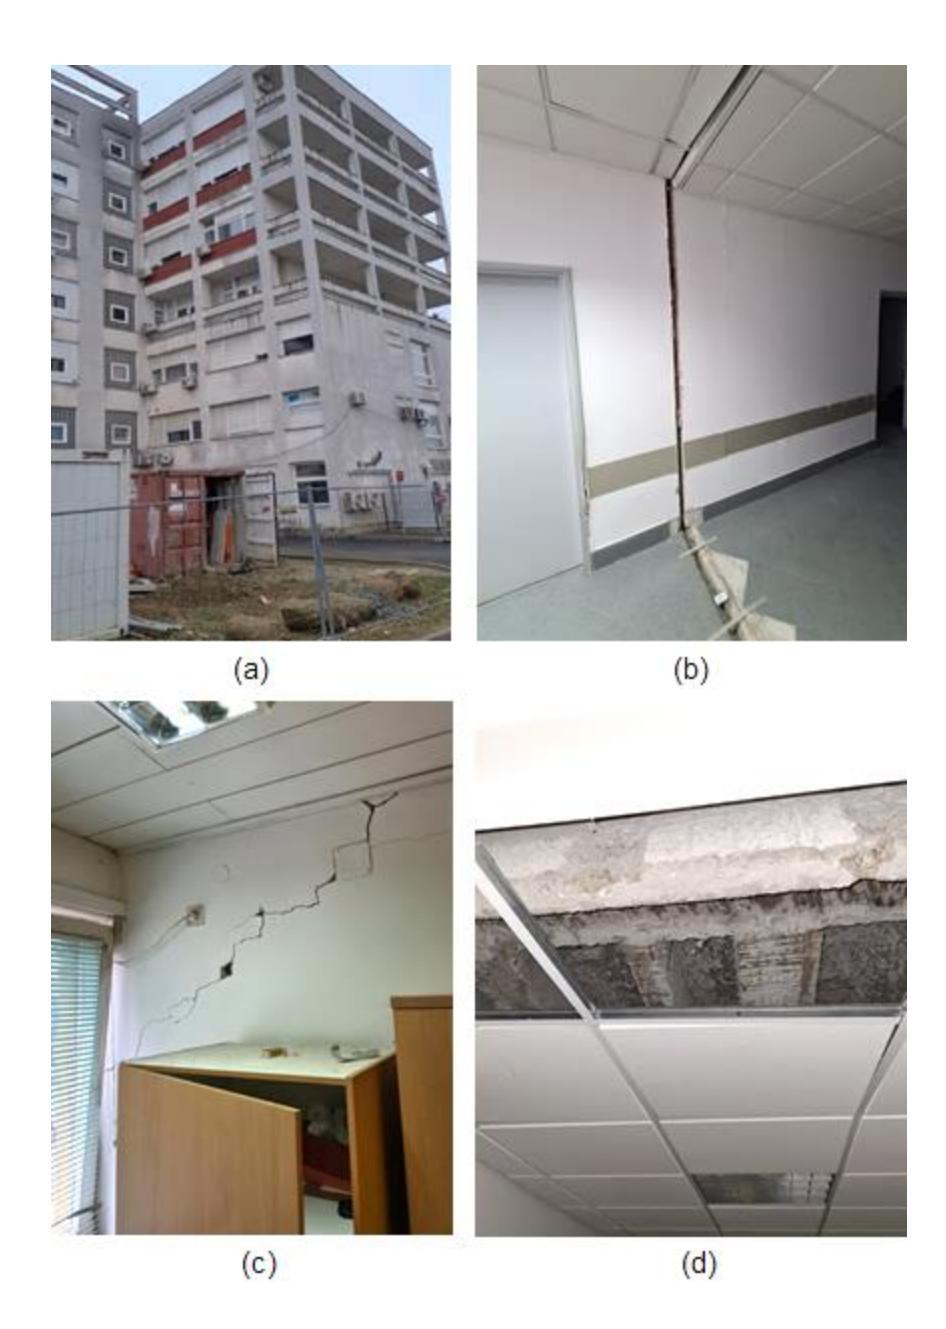
Building #5 (Surgery) is a seven-story RC structure with plan dimensions of approximately 63 m by 14 m. The building exhibited different types of damage, including construction joint openings, tiles detaching, fallen ceiling tiles, and broken windows, some of which are presented in Figure 4.44. The sterilization equipment was also damaged. However, the building remained operational.

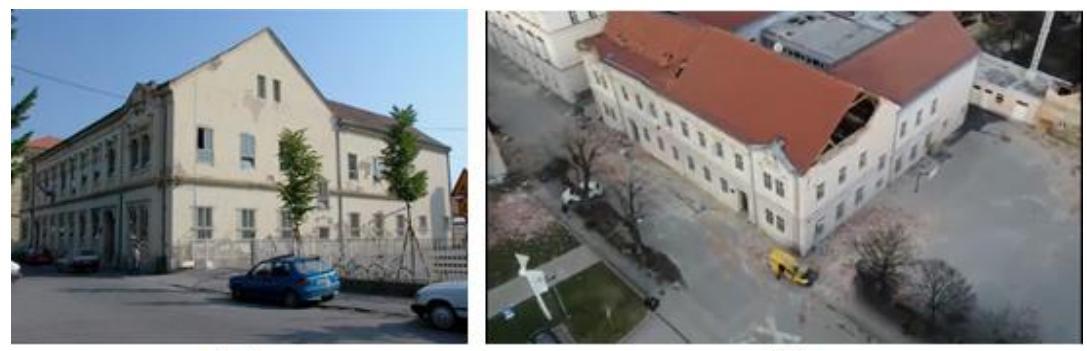
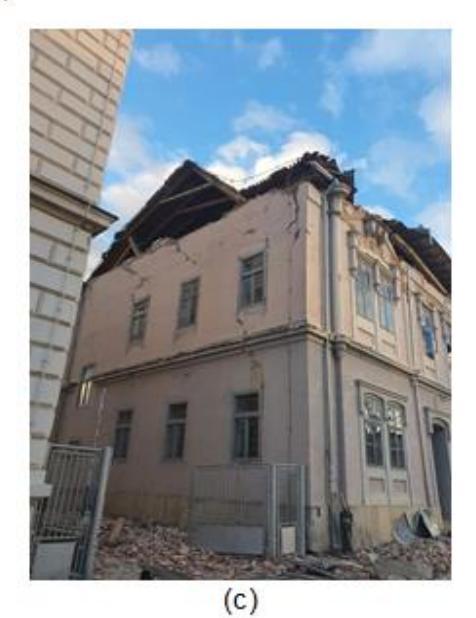
The First Primary School in Petrinja was originally built around 1860; however, it may have been expanded over time. The school is a U-shaped building, as shown in the plan view of Figure 4.46. The structural system of the building consists of URM walls and jack arch slabs. The roof is timber-framed with clay tiles and partially collapsed after the earthquake, as shown in Figure 4.47.

Figure 4.47. Exterior damage to the Primary School in Petrinja: exterior view (a) before and (b) after the earthquake, and (c) damage to the timber-framed roof, where masonry from the gable fell to the street (sources: (a) Google Earth; (b) Twitter 2021a and c) Nenad Bijelić).

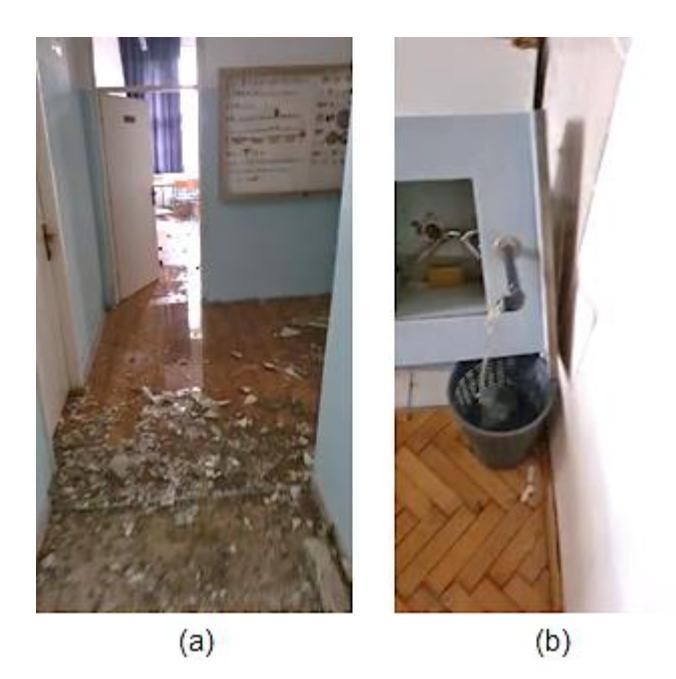
The First Primary School in Petrinja also experienced significant nonstructural damage, especially to interior partition walls, which were apparently constructed recently. These walls are hollow clay tiles, as shown in Figure 4.48a. The observed damage included partial or total collapses likely due to out-of-plane seismic effects and the lack of connection between the walls and the floor structure, such as seen, for example, in Figure 4.48a where the tile fell out of the wall. Some cracks were also observed at the interface of the wall tiles and structural elements, as shown in Figures 4.48b and 4.48c. Moreover, a water pipe was damaged causing water leakage, which can be seen in Figure 4.49.

Figure 4.49. Leaking water pipe in the First Primary School in Petrinja: (a) water on the floor and (b) broken water pipe (source: Nenad Bijelić).

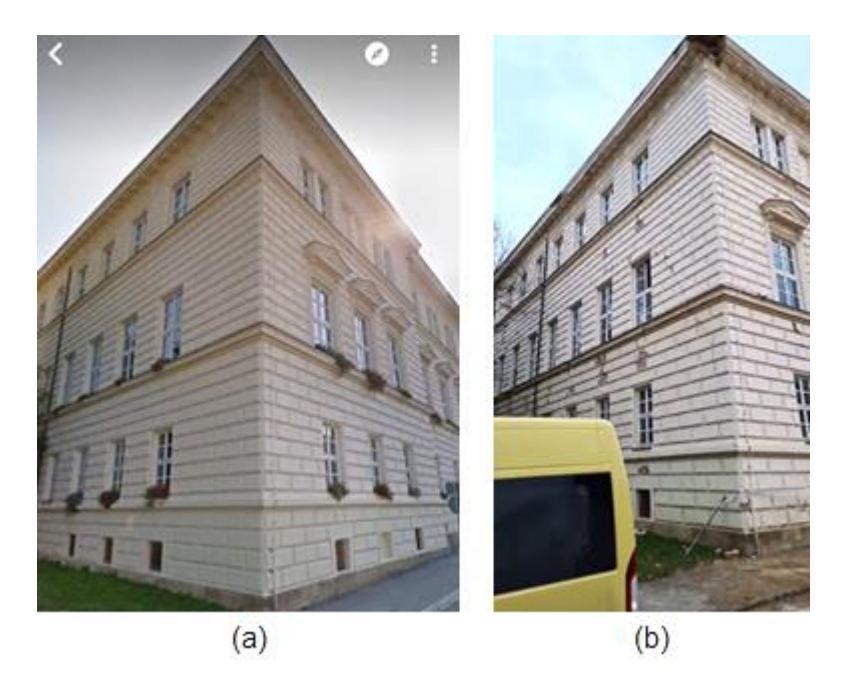
Figure 4.51. Transverse wall of Petrinja High School (a) before the earthquake (source: Google Street View) and (b) after the earthquake (source: Nenad Bijelić).

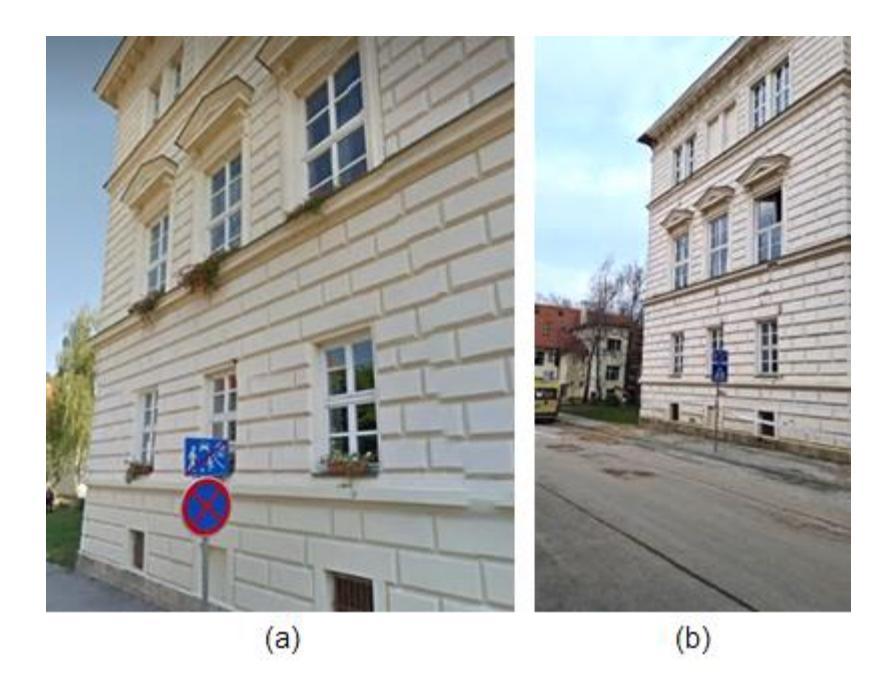
Figure 4.52. Longitudinal wall of Petrinja High School (a) before the earthquake (source: Google Street View) and (b) after the earthquake (source: Nenad Bijelić).

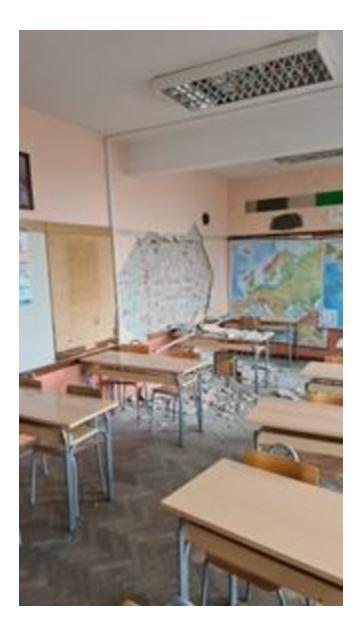
Figure 4.55. Plaster fell off of the wall exposing masonry infill (source: Nenad Bijelić and Damir Lazarević).

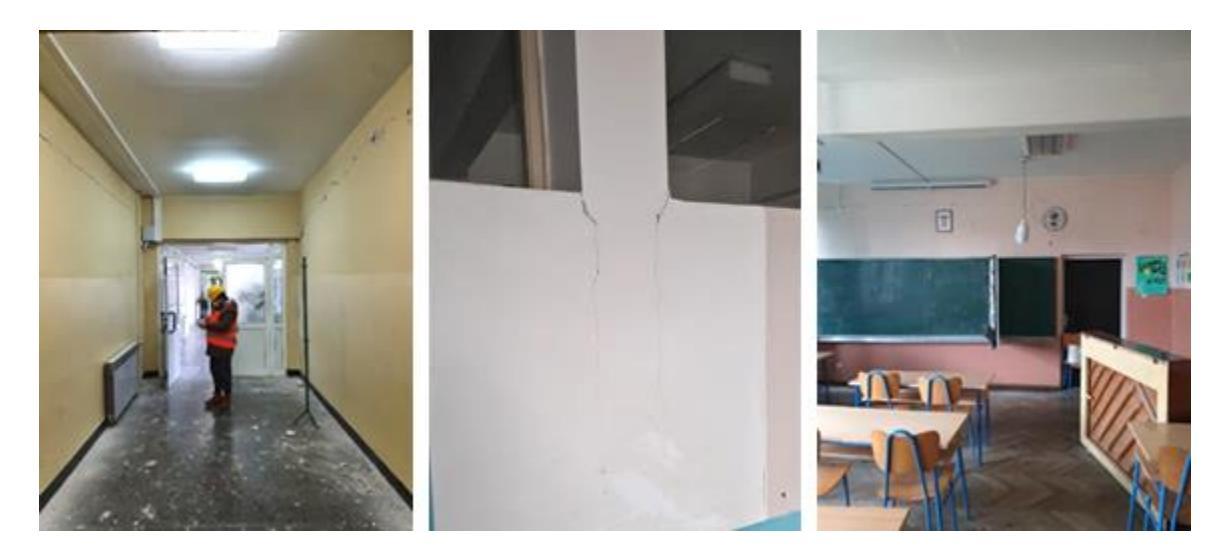
Figure 4.56. Cracks forming at the contact between reinforced concrete frames and masonry infills (source: Nenad Bijelić and Damir Lazarević).

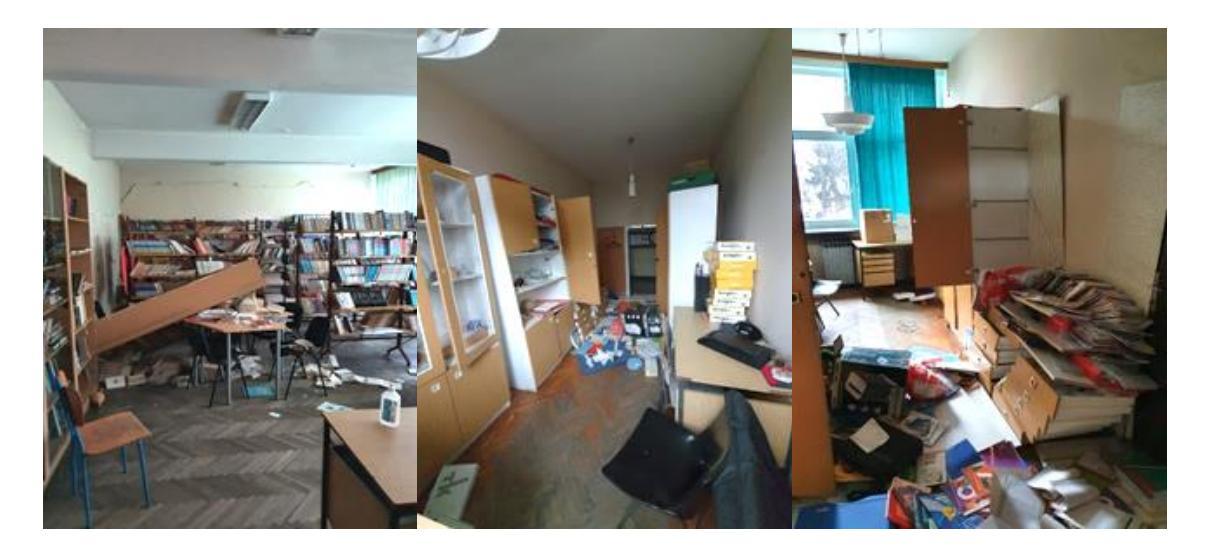
Figure 4.57. Items that fell off shelves and out of cabinets (source: Nenad Bijelić and Damir Lazarević).

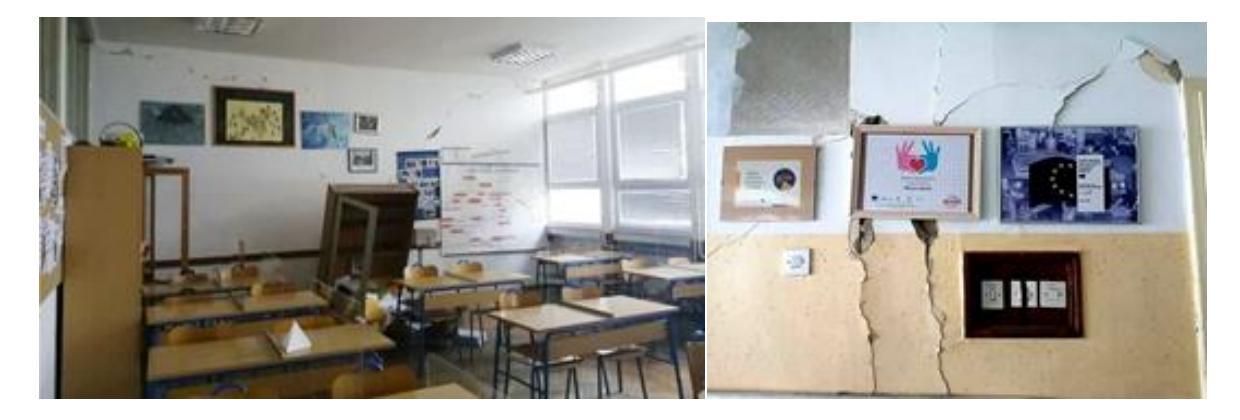
The Glina High School experienced damage to interior walls, as documented through the Facebook page of the school. Figure 4.59 shows the high school before the earthquake and Figure 4.60 shows damage to interior partition walls due to the earthquake. At this stage, it is not clear whether there was structural damage.

Figure 4.60. Earthquake damage in Glina High School (source: Facebook Page - Srednja škola Glina).

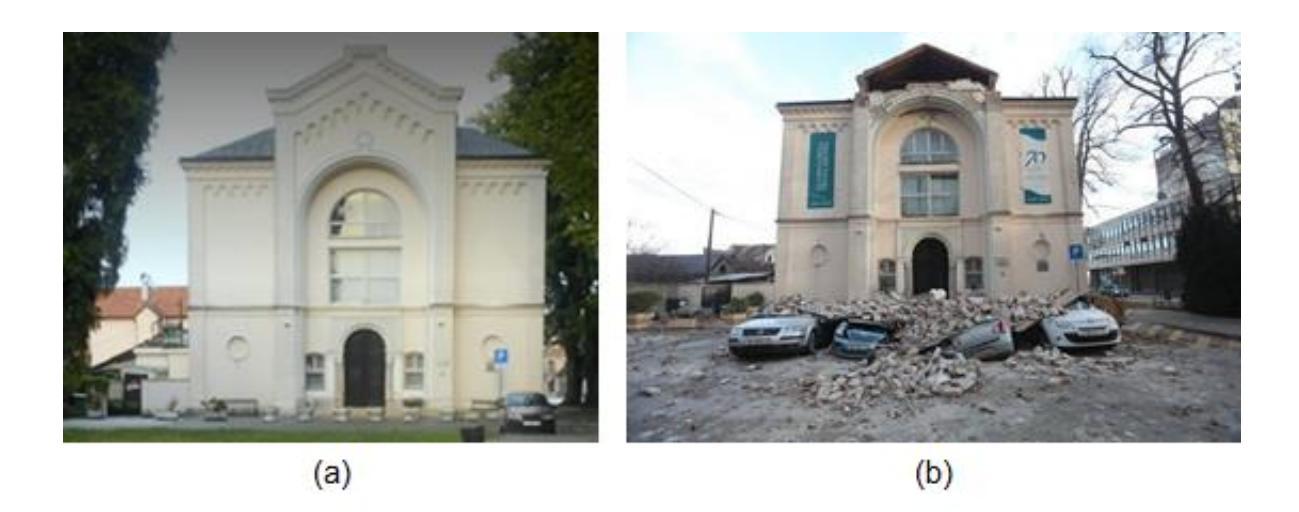
The building that houses the Fran Lhotka Music School in Sisak was originally a synagogue constructed around 1880 and converted into a music school in 1967 (Terbovc 2021). The building is shown before the earthquake in Figure 4.61a and after the earthquake in Figure 4.61b, which shows out-of-plane failure of the masonry in the gable. This masonry fell on top of cars parked in front of the building. There were no reports of casualties due to damage to this building. The interior of the building experienced damage to nonstructural components such as decorative ceiling and instruments, as shown in Figure 4.62. From this photograph, it appears that the floor diaphragms are made of timber and the walls are constructed of masonry.

Figure 4.61. Fran Lhotka Music School (a) before the earthquake (source: Google Maps) and (b) after the earthquake (source: Facebook page - Glazbena škola Frana Lhotke, Sisak).

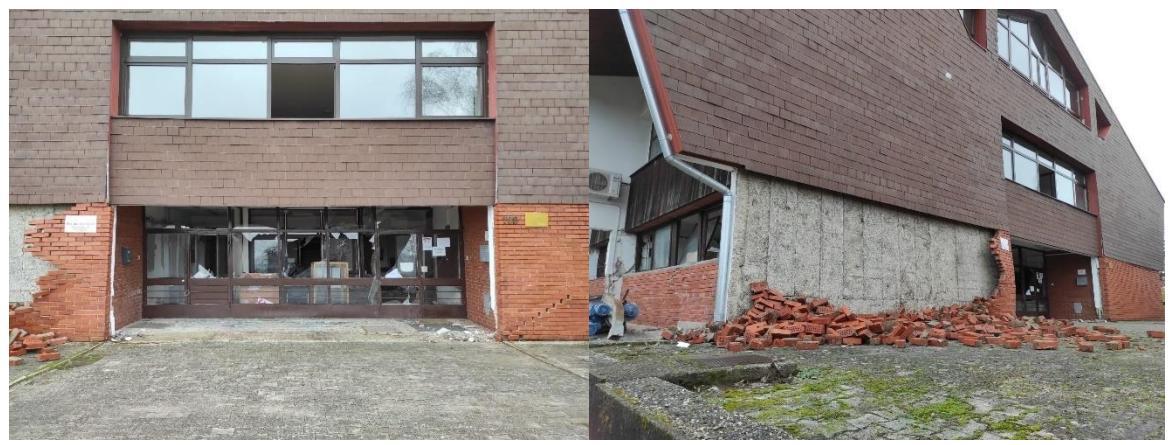
Figure 4.63. Brick facade detached from building (source: Nina Čeh).

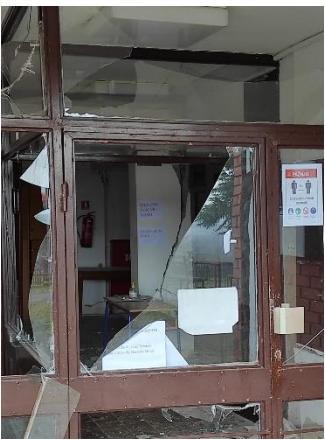
Figure 4.64. Broken glass in entryway door (source: Nina Čeh).

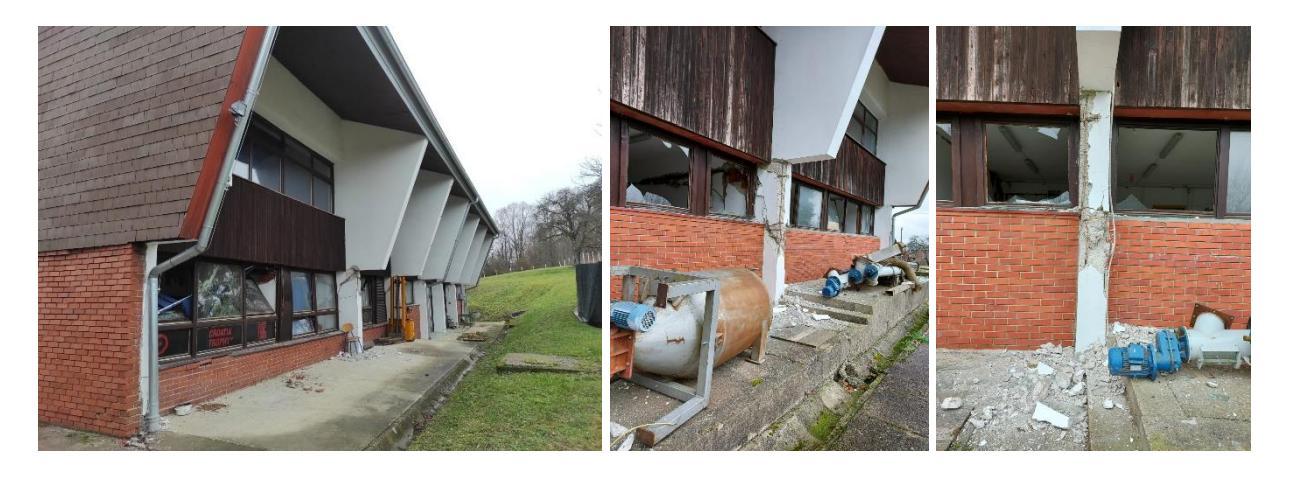
Figure 4.65. Shear cracks to exterior RC columns (source: Nina Čeh).

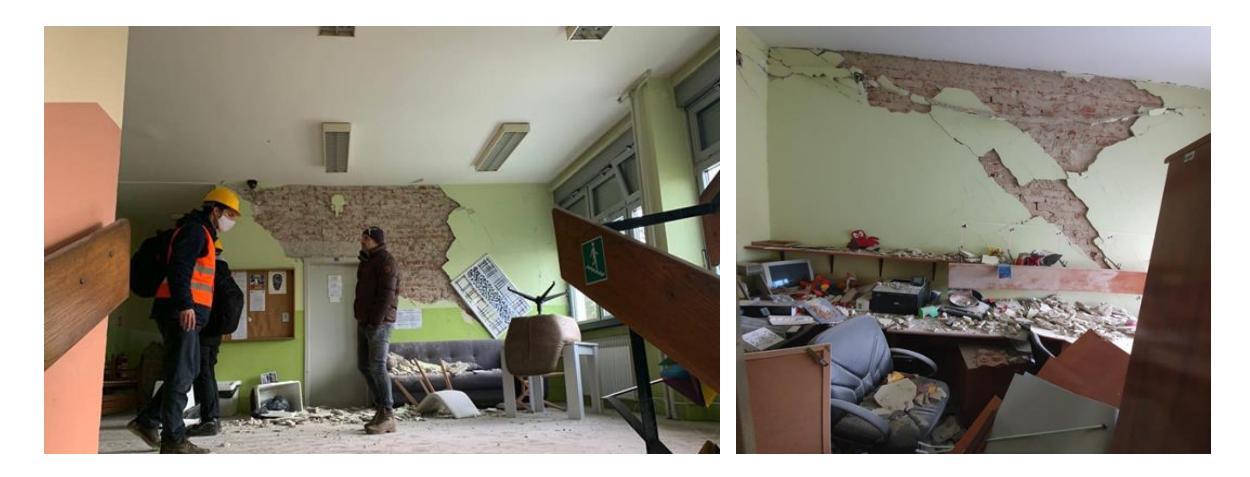
Figure 4.67. Plaster detached from the wall (source: Damir Lazarević and Marko Bartolac).

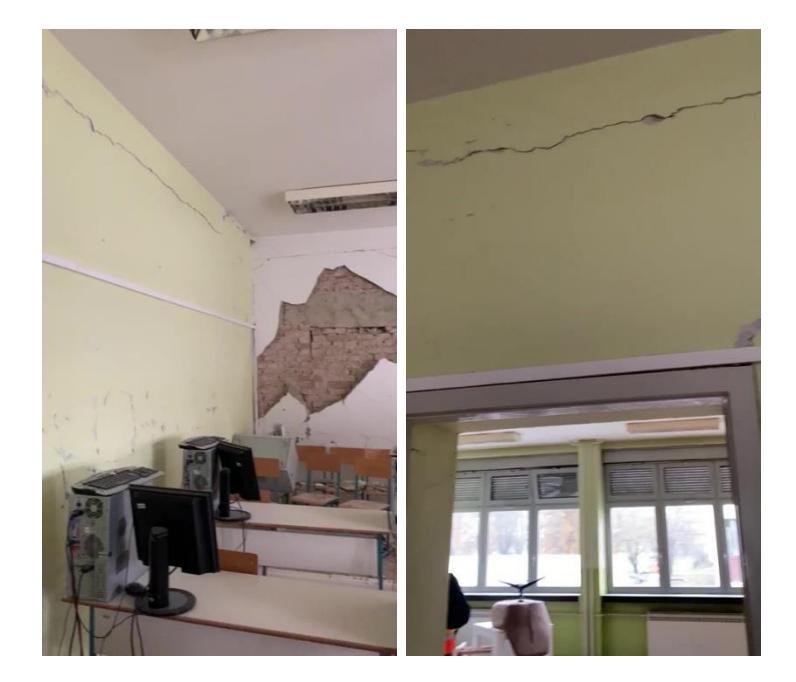
Figure 4.69. Horizontal cracks between the RC beams and the top of infill walls (source: Damir Lazarević).

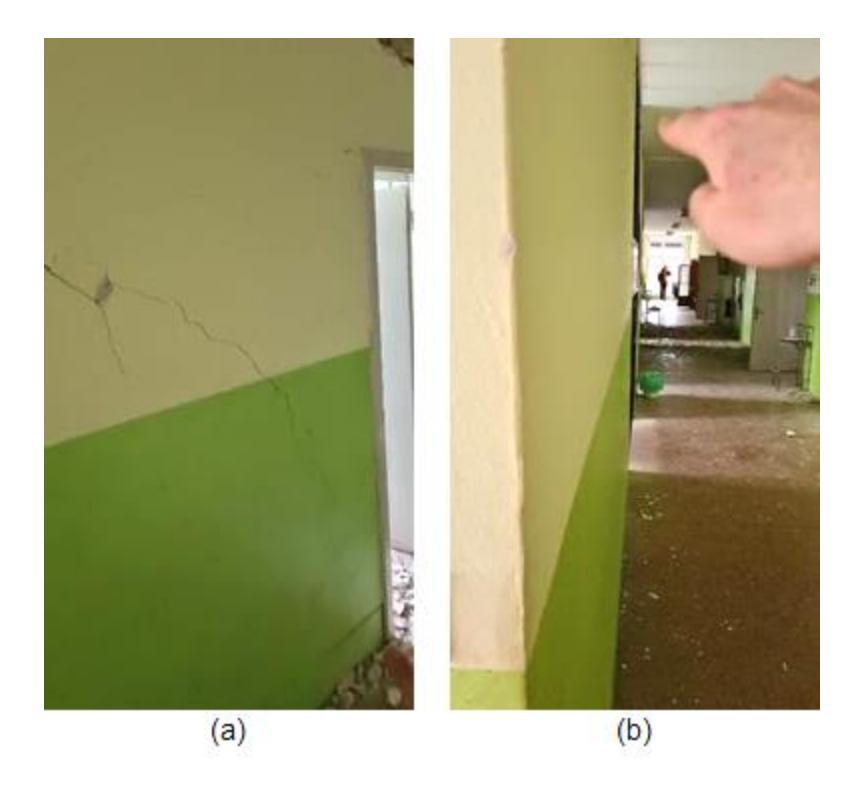
Figure 4.70. (a) Diagonal cracks due to in-plane loading and (b) out-of-plane infill failure due to in-plane/out-of-plane interaction (source: Nenad Bijelić and Damir Lazarević).

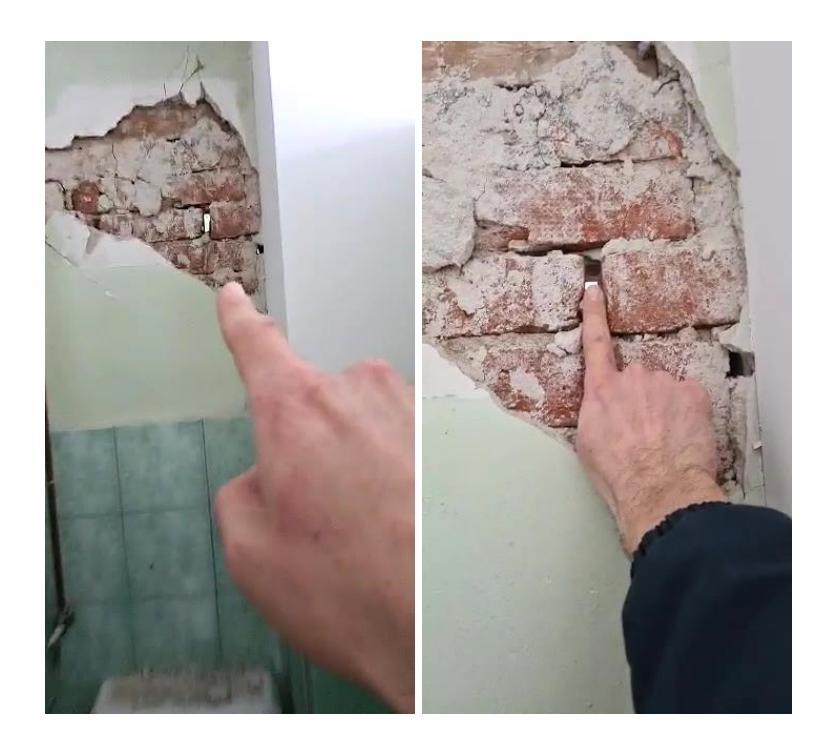
Figure 4.71. Gapping in head joints of infill walls (source: Nenad Bijelić).

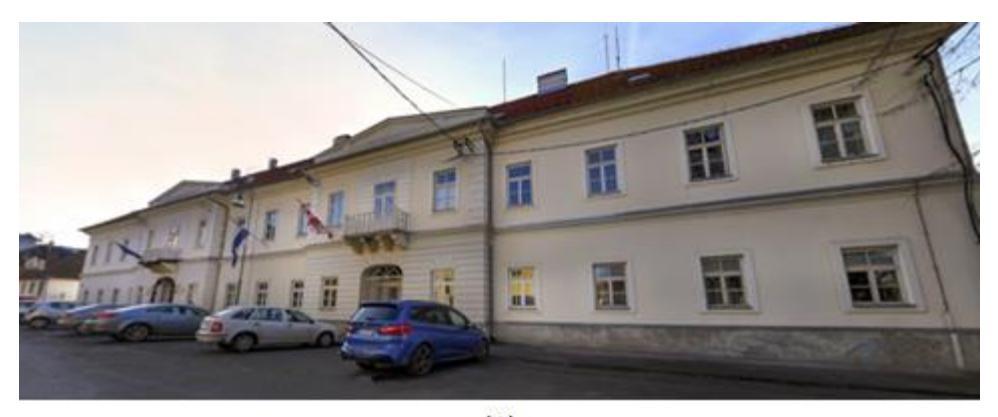
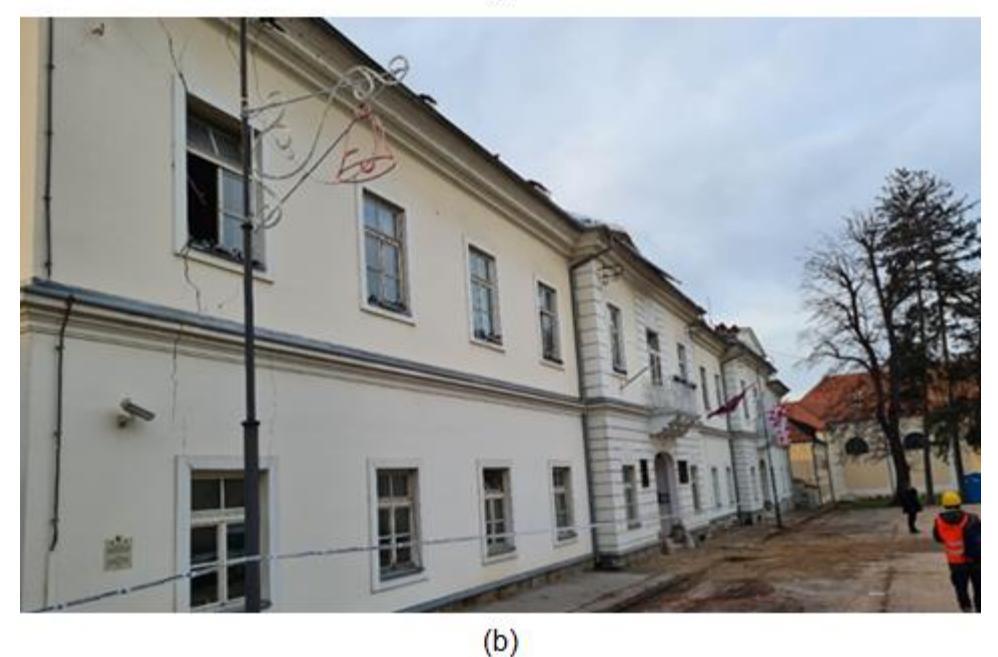
Figure 4.76. Petrinja town hall building: (a) Front façade before the earthquakes (source: Petrinja Virtual Tour) and (b) Front façade after the earthquakes (source: Nenad Bijelić).

The longitudinal direction of the building is aligned in north-south direction. Photos of the front façade before and after the earthquakes are shown in Figure 4.76. These photos show mainly cracking in the spandrels. Photos that were taken inside the building show extensive cracking of both the load bearing walls in the transverse direction (Figure 4.77a) and the masonry vaults of the first floor (Figure 4.77.b), which suggest that the masonry vault developed a mechanism. Similar damage has been observed throughout the building.

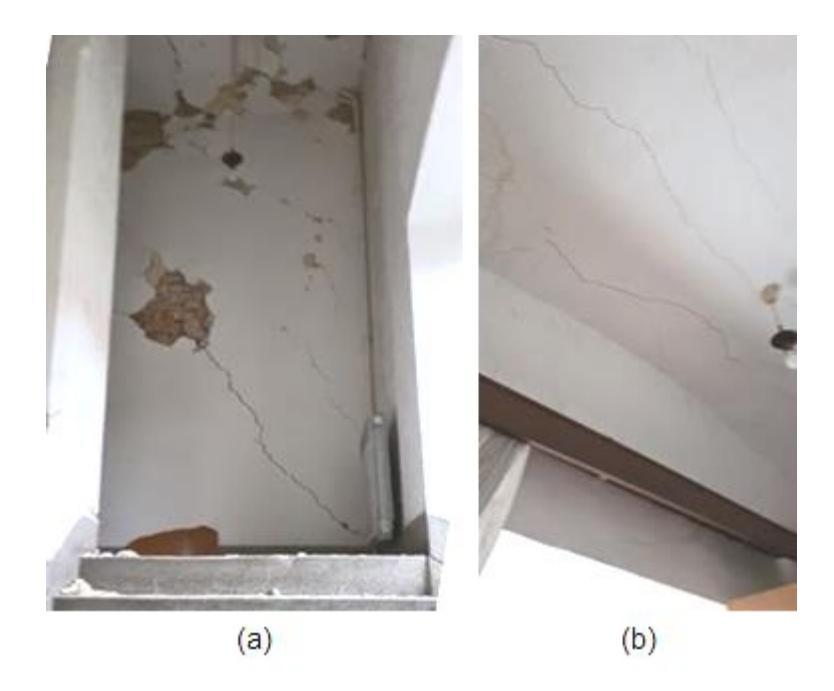
Figure 4.77. Details of Town Hall building damage: (a) In-plane shear crack in a load-bearing wall in the transverse direction (source: Nenad Bijelić) and (b) Cracking of a masonry vault, indicating a potential formation of an arch mechanism (source: Nenad Bijelić).

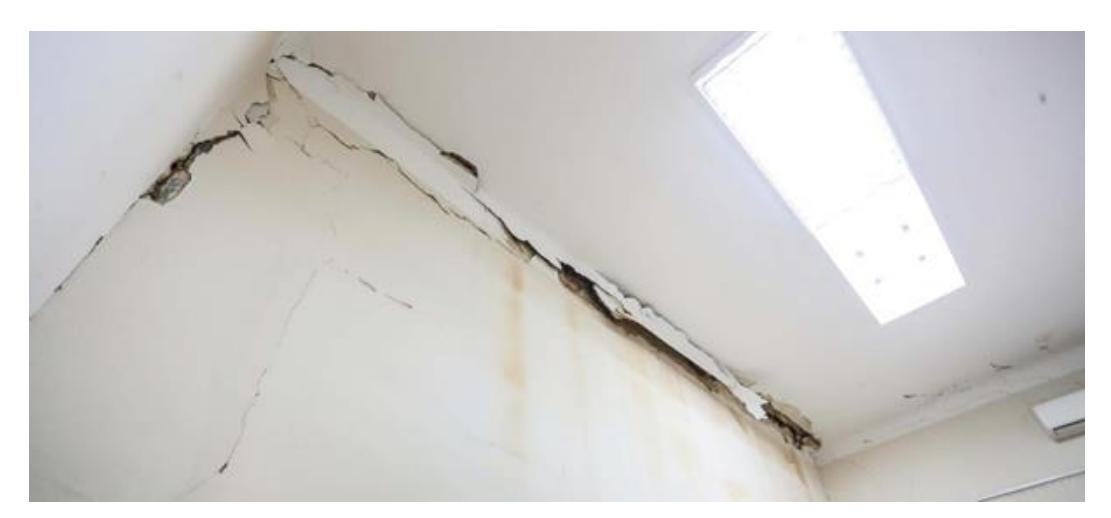
Damage was also detected at the floors of the 2nd story, where the cracks indicate that the floor beam had been sliding on the supports, shown in Figure 4.78.

Figure 4.78. Damage at a floor-wall connection at the 2nd story. The crack at the connection is potentially a result of beam sliding at supports (source https://www.index.hr/vijesti/clanak/video-pogledajte-kako-izgleda-petrinja-ogromna-steta-na-zgradi-gradske-uprave/2242131.aspx).

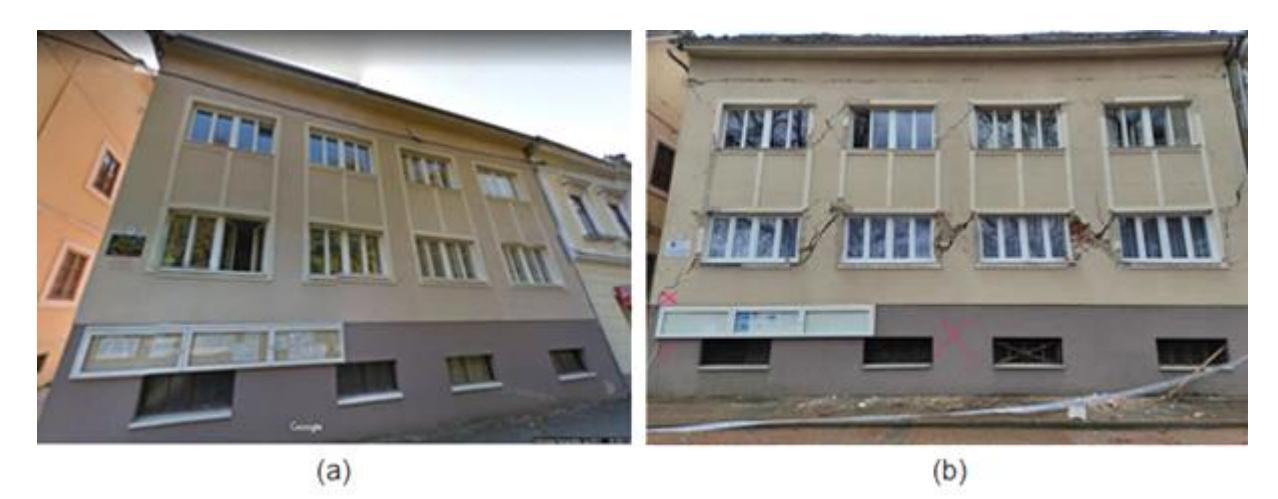
the horizontal crack at the roof level. Considering the fact that the building suffered extensive inplane damage, and considering the position of the building shown in Figure 4.81, we can note that the location of the building in-plane damaged façade is perpendicular to the façades of the buildings that suffered the out-of-plane collapse. This suggests that the strong motion direction was in the direction of the damaged façade, being approximately east-west.

Figure 4.80. Chamber of Crafts building: (a) before the earthquakes (source: Google Maps) and(b) after the earthquakes. All central piers developed deep in-plane shear cracks. A wide continuous horizontal crack extends throughout the façade at the roof level (source: Nina Čeh).

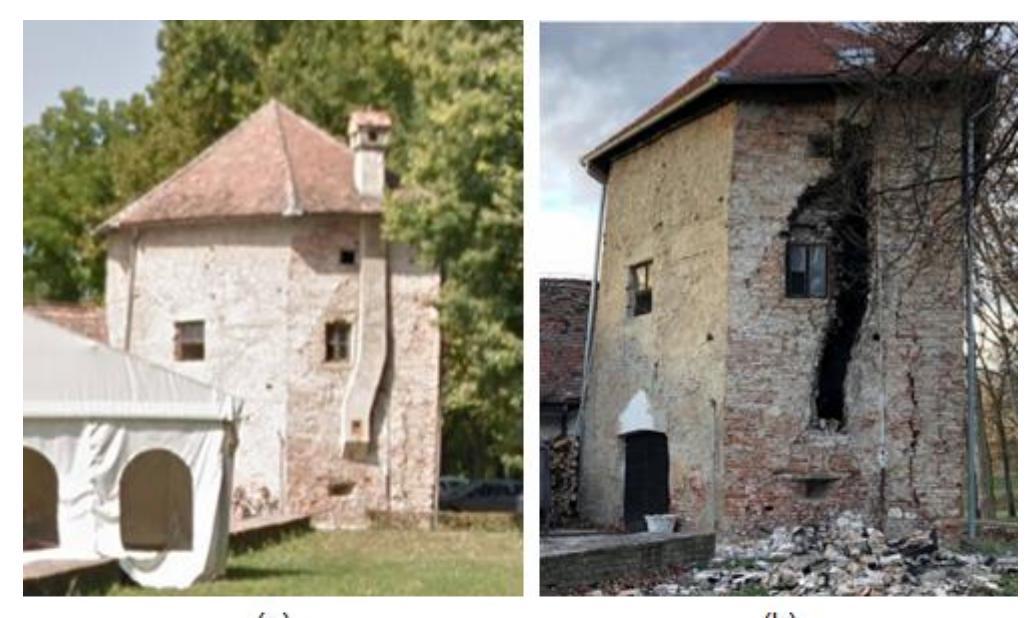
The main damage is concentrated in the structure connected to the fortress and in particular in the small tower. Figure 4.83a shows the structure in 2011 (Google). In Figure 4.83b and 4.83c, it is possible to observe the collapse of the entire chimney probably added to the original construction later and the presence of cracks in the masonry structure. Some cracks were already present before the earthquake. The fortress reported damage to the tiles of the conical roof.

Figure 4.83. (a) Small tower connected to the Sisak fortress in 2011 (source: Google), (b, c) collapsed chimney in the small tower, and (d) damage to the tiles of the conical roof of one of the tower of the fortress (source: Instagram account starigradsisak and dvorcistarigardovi).

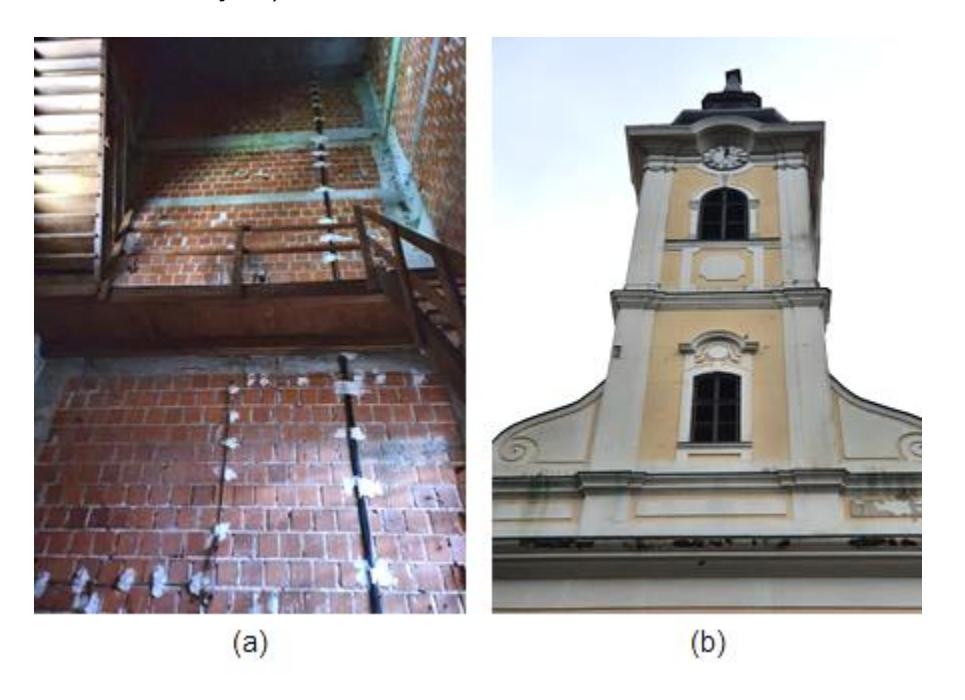
The dominating building on the main square in Petrinja is the Church of St Lovre, originally built in 1780 under the rule of Maria Theresa and Austro-Hungarian Empire. It was destroyed during the war in the 1990s. On its foundations, the new Church was built in 2000, replicating fully the original architectural design and the decorations. Figure 4.86a depicts that during the earthquake on December 29, 2020, it did not suffer any damage of structural elements mostly due to the good seismic behavior of confined masonry. However, the roof tiles are displaced, as indicated in Figure 4.85b, as well as the cross from the top of the Church. Plaster inside is cracked and statues are damaged. Cracks in the plaster are visible in the exterior of the bell tower.

Figure 4.86. (a) Inside the campanile - confined masonry and (b) thin cracks in the exterior of the bell tower (source: Marko Bartolac).

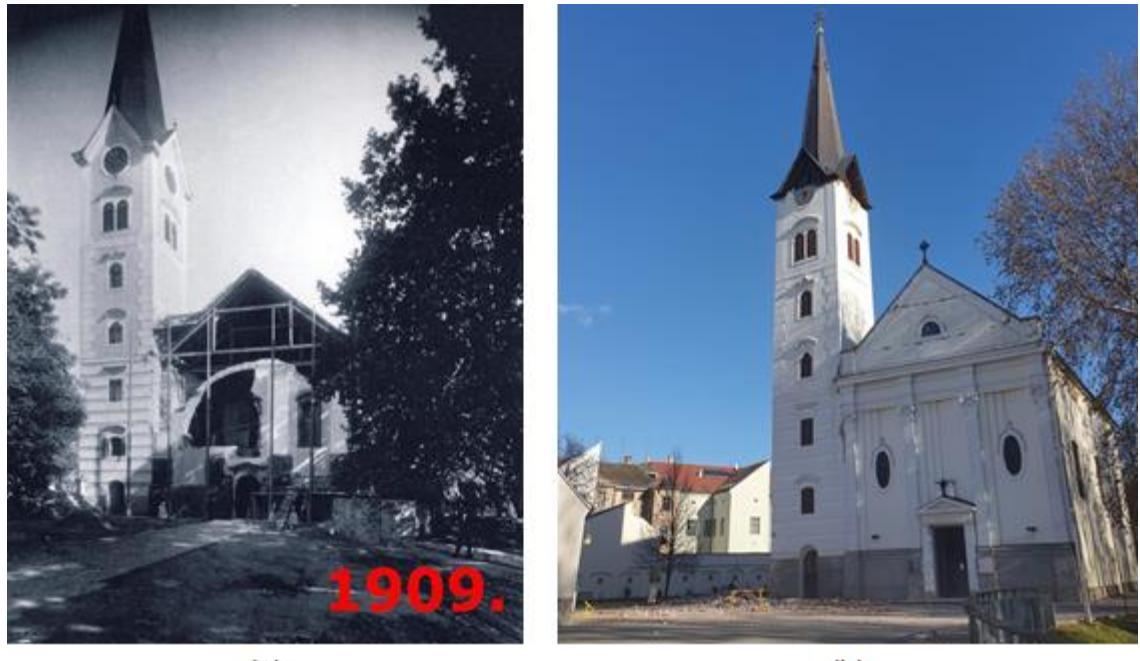
The Cathedral in Sisak was built during the first half of the 18th century. The bell tower was erected in 1760, and the church was consecrated in 1765. In 1909, an earthquake hit the Cathedral, leaving extensive damage. As a consequence, the old baroque façade was replaced by a neoclassical one, with elements of secession. The Cathedral suffered damage during both World War II and War in the 1990s and it was repaired afterwards. Reinforced concrete horizontal ring beams were added in the 1990s. After the earthquake on December 29, 2020, triangular gables at the top of the bell tower collapsed out-of-plane, as shown in Figures 4.88b and 4.89. The roof above the entrance to the choir and the connection between façade and the bell tower are also damaged but to a lesser extent. Moreover, the interior of the Cathedral showed numerous cracks and plaster detachment. The ceiling above the sanctuary and the sacristy was damaged as well as the connection between the bell tower and the portal, which had already been damaged during the earthquake in 1909.

Figure 4.88. Sisak Cathedral: (a) after the earthquake in 1909 (source: svetikrizsisak.hr/i/141/zupa/zupna-crkva/) and (b) after the earthquake in 2020, local out-of-plane failure of gables at the top of the bell tower (source: Damir Lazarević).

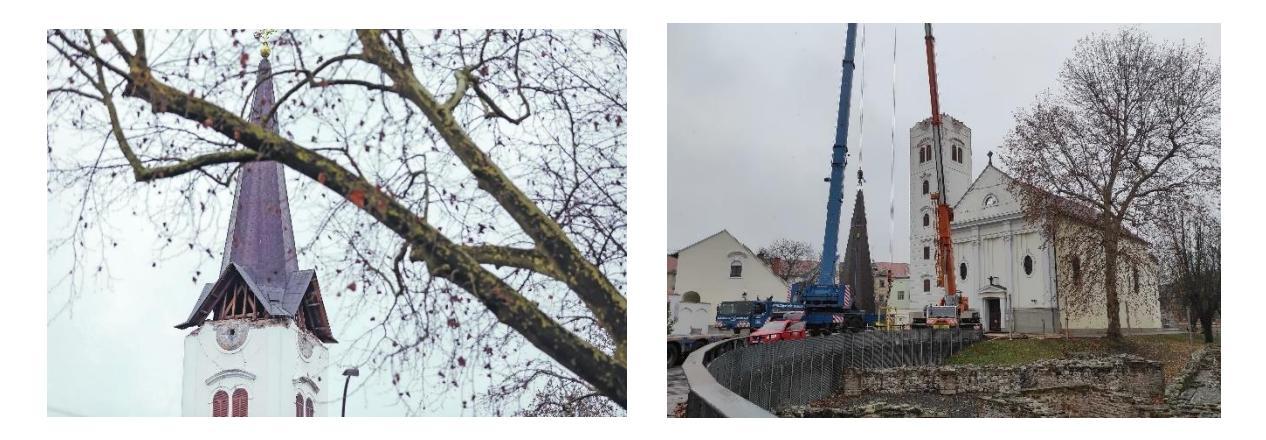
Figure 4.89. Sisak Cathedral after the earthquake in 2020: (a) a detail of the top of the bell tower showing local out-of-plane failure of gables (source: Marko Todorov/CROPIX) and (b) after the bell tower was removed (source: Nina Čeh)

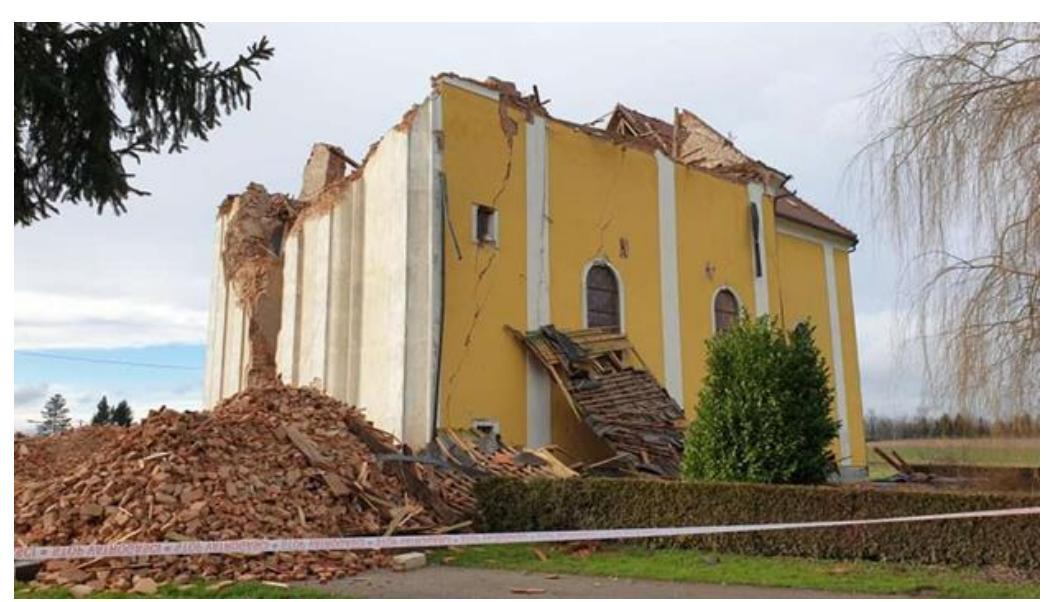
shape of a square, dominates the Church. An arch separates the nave from a narrower sanctuary and shallow elliptoid apse. After severe damage in World War II, the exterior of the Church was renovated. However, the bell tower remained in poor static condition and strengthening was necessary. The earthquake on December 29, 2020 affected the Church severely, leading to the collapse of the bell tower, as seen in Figure 4.90. Thick load bearing unreinforced masonry walls remained standing, but they are heavily cracked. A church organist was found dead in the wreckage of the collapsed St. Nikola and Vid Church in the village of Žažina. Media reported that three other people were in the church during the earthquake but managed to escape with only minor injuries.

Figure 4.90 Church of St. Nikola and Vida in the village of Žažina after the earthquake exhibited severe collapse of the bell tower and extensive cracking of load bearing walls (source: Total Croatia News 2021).

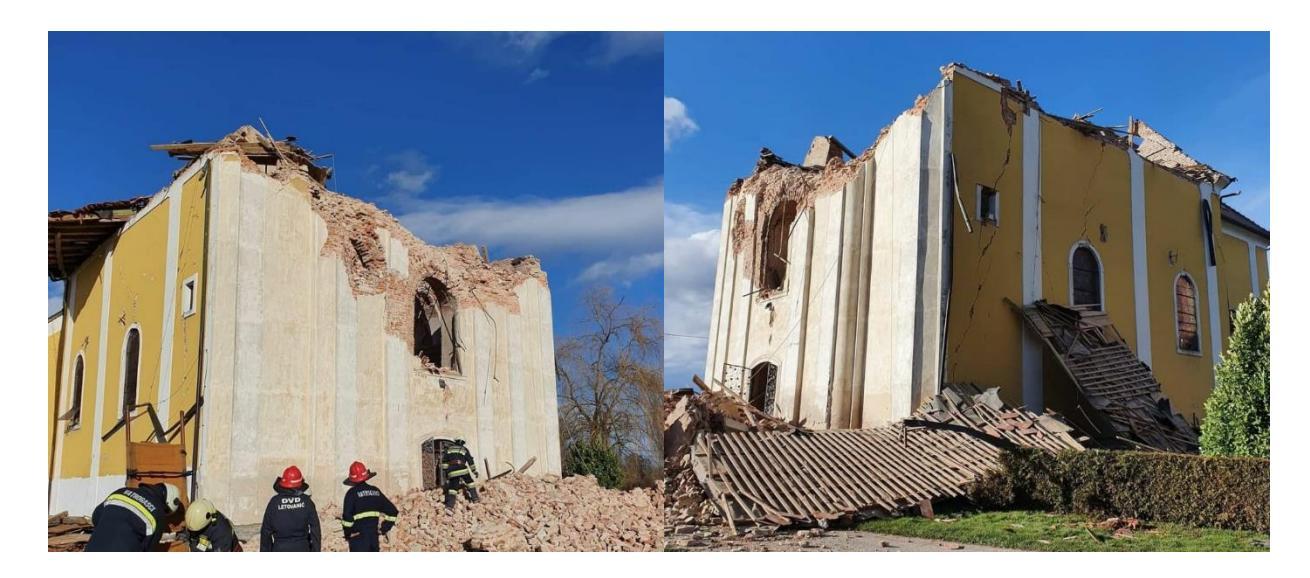
Figure 4.92. Church of St. Nikola and Vid in the village of Žažina after it suffered the collapse of a campanile and roof structure (source: Instagram account visitlekenik).

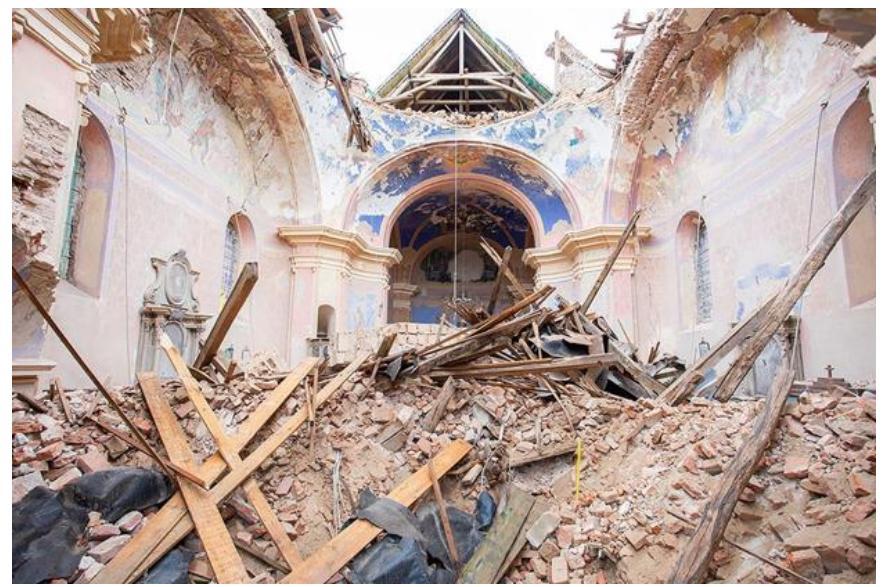
Figure 4.93. Interior of the Church of St. Nikola and Vid in the village of Žažina after the earthquake (source: Facebook Page - Sisačka biskupija).

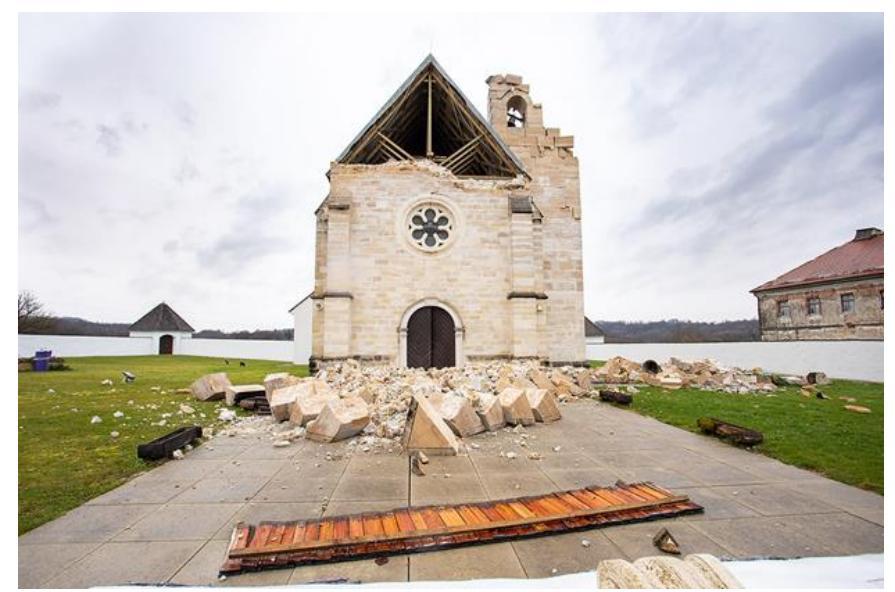
The parish Church in Gora is a reconstructed early Gothic Templar structure with some architectural forms taken from its Baroque period. After devastation during the war in the 1900s, the Church was rebuilt. The finalization of works and consecration of the Church took place in 2015. The Church was made of properly carved stone blocks, smaller in the façade and larger in the bell tower. The roof is covered with larch shingles. In 2016, one year after completion of the reconstruction, it was noted that the stone is not sufficiently weather resistant since some stone blocks showed horizontal cracks. Furthermore, some stones of the base on the north façade of the central buttress were missing, as well as the stones of the cornice. This pre-existing issue with stone and inadequate design possibly had influence on the poor behavior of the top of the facade, where the lack of connections and support led to out-of-plane failure, as presented in Figure 4.95.

Figure 4.95. Church of Our Lady of the Mountain in the village Gora after its triangular gable suffered out-of-plane failure and the part of the bell tower collapsed (source: Facebook Page - Sisačka biskupija).
