Petrinja, Croatia December 29, 2020, Mw 6.4 Earthquake Joint Reconnaissance Report (JRR)

Report

Joint Reconnaissance Team Leaders: Eduardo Miranda, Stanford University Svetlana Brzev, University of British Columbia / SUZI-SAEE Nenad Bijelić, Swiss Federal Institute of Technology Lausanne (EPFL) Field Assessment Structural Team (FAST) Authors: (in alphabetical order) Željko Arbanas, University of Rijeka Marko Bartolac, University of Zagreb Nenad Bijelić, Swiss Federal Institute of Technology Lausanne (EPFL) Vedran Jagodnik, University of Rijeka Damir Lazarević, University of Zagreb Snježana Mihalić Arbanas, University of Zagreb Sonja Zlatović, Zagreb University of Applied Sciences Virtual Assessment Structural Team (VAST) Authors: (in alphabetical order) Andrés Acosta, Stanford University Dimitrios Lignos, EPFL Jorge Archbold, UC Berkeley Ting Lin, Texas Tech University James Bantis, Stanford University Marko Marinković, University of Belgrade Jovana Borozan, SUZI-SAEE Armando Messina, Stanford University Ivana Božulić, EPFL Sebastián Miranda, Univ. del Desarrollo Nikola Blagojević, ETH Zurich Alan Poulos, Stanford University Cristian Cruz, Univ. Técnica Federico Santa María Giuli

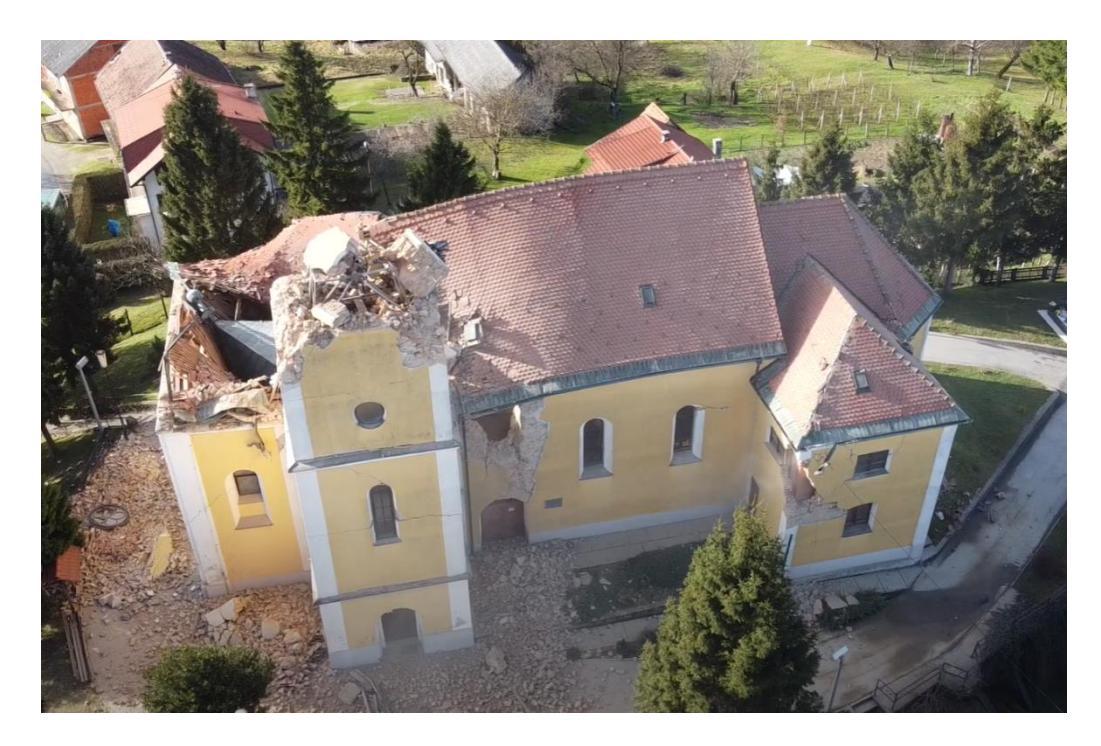
The Church of the Exaltation of the Holy Cross is located on the main route Zagreb-Pokupsko-Glina. The first church built in this area was in Gothic style. Demolished and rebuilt in 1847 on the site of the older one, the new church was severely damaged by German bombing during World War II and then rebuilt in 1969 as it is nowadays (Župa uzvišenja Svetoga Križa Kravarsko 2021). The recent earthquake has significantly damaged the structure. Part of the bell tower and the roof of the church have collapsed, and major damage appears also on the side walls (Figure 4.97). The church is out of function (Figure 4.98a).

Figure 4.97. Aerial view of the Church of the Exaltation of the Holy Cross (Crkva Uzvišenja Sv. Križa) in Kravarsko (source: Youtube 2021).

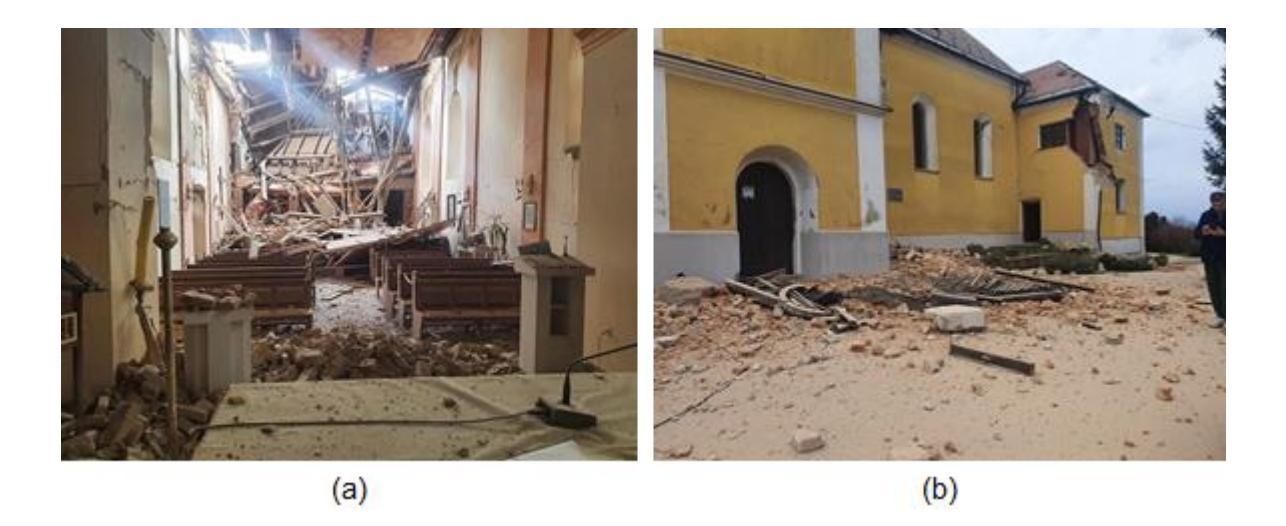
Figure 4.98. (a) Devastated interior of the Church in Kravarsko (source: Brnada 2021) and (b) Expulsion of the wall corner (source: Brnada 2021).

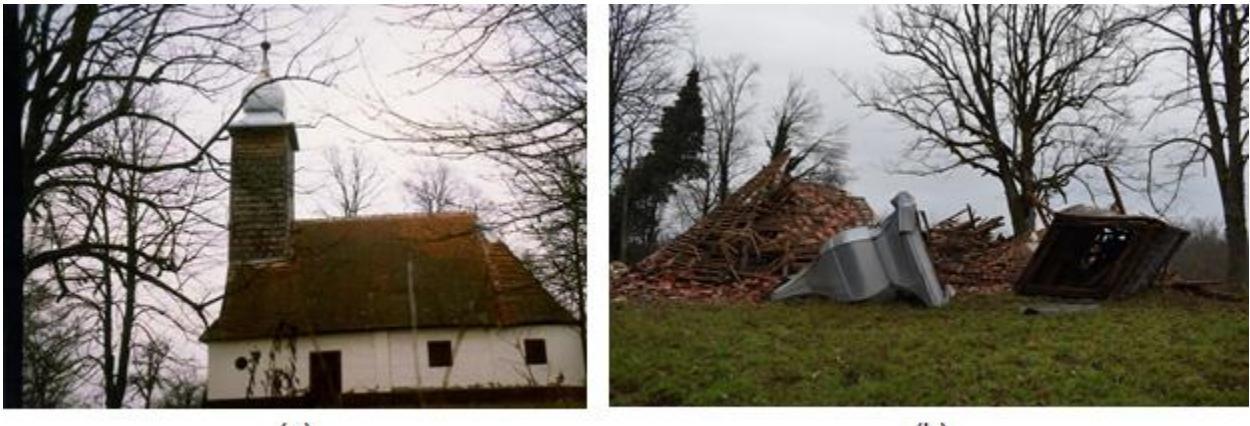
A small village of Majske Poljane, located near Glina, was a home to one of the two Orthodox timber churches in this area. The original church was built in 1820. This church survived the wars in the past century but exhibited a complete collapse under the earthquake on December 29, 2020 (Figure 4.99).

Figure 4.99. (a) Church in Majske Poljane (Hram Vaskrsenja Gospodnjeg) before the earthquake (source: Eparhija Gornjokarlovacka) and (b) Complete collapse of the Church (source: Eparhija Gornjokarlovacka).

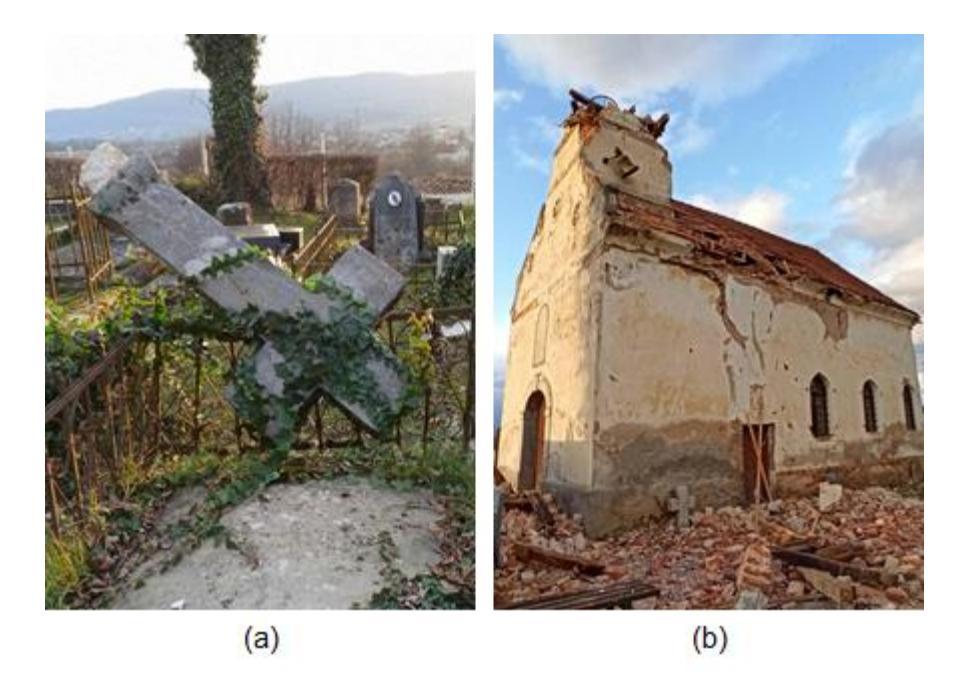
Many other churches throughout Croatia experienced light to heavy damage during the earthquake. Images showing the damage to just a few of them are included below. Figure 4.100 shows the damage reported to the masonry structure of the St. Nicholas Chapel in Petrinja and its cemetery. The bell tower collapsed causing heavy damage also to the roof and tombstones and crosses were damaged in the nearby cemetery. Another church suffered damage to the bell tower in the village of Hotnja: the cross windows on the bell tower and part of its structure fell down during the seismic event (Figure 4.101). The church in Mracaj, near the village Majur (Figures 4.102 and 4.103) suffered an almost complete collapse of the timber roof structure and cover. the severely cracked bell tower represents a danger, and it will have to be removed.

Figure 4.100. (a) Overturned cross at the cemetery in Petrinja and (b) St. Nicholas Chapel in Petrinja after severe damage due to the earthquake (source: Service of the Serbian Orthodox Church 2021).

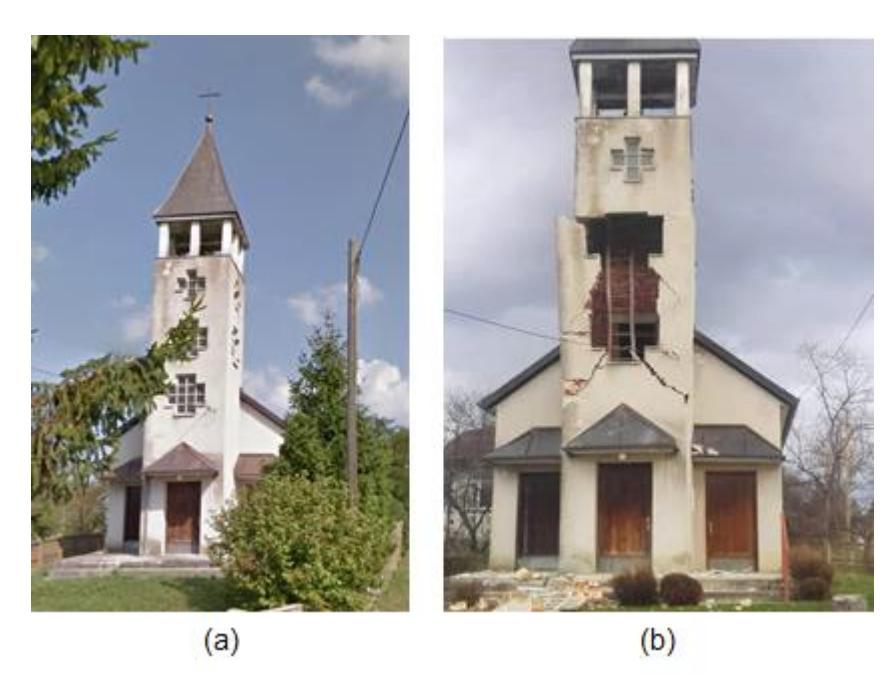
Figure 4.101. (a) Church St. Vid in Hotnja before the seismic event (source: Google); (b) Collapsed windows on the bell tower of the church (source: Facebook Page - Sisačka biskupija).

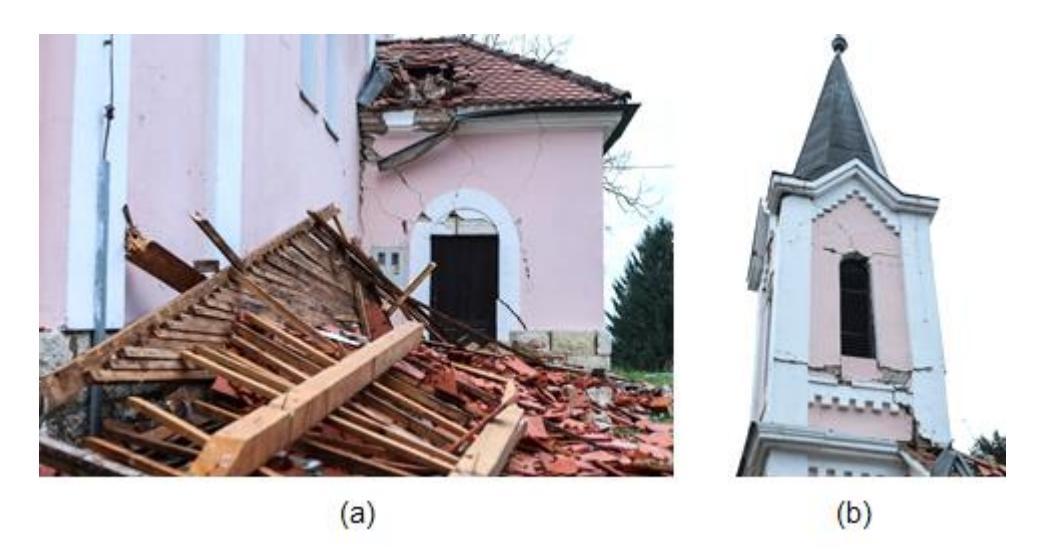
Figure 4.103. Church in Mračaj, near village Majur: (a) heavy cracking in the interface between adjacent shorter unit and the main nave (source: Marko Pripic/PIXSELL) and (b) severe cracking of the bell tower (source: Marko Pripic/PIXSELL).

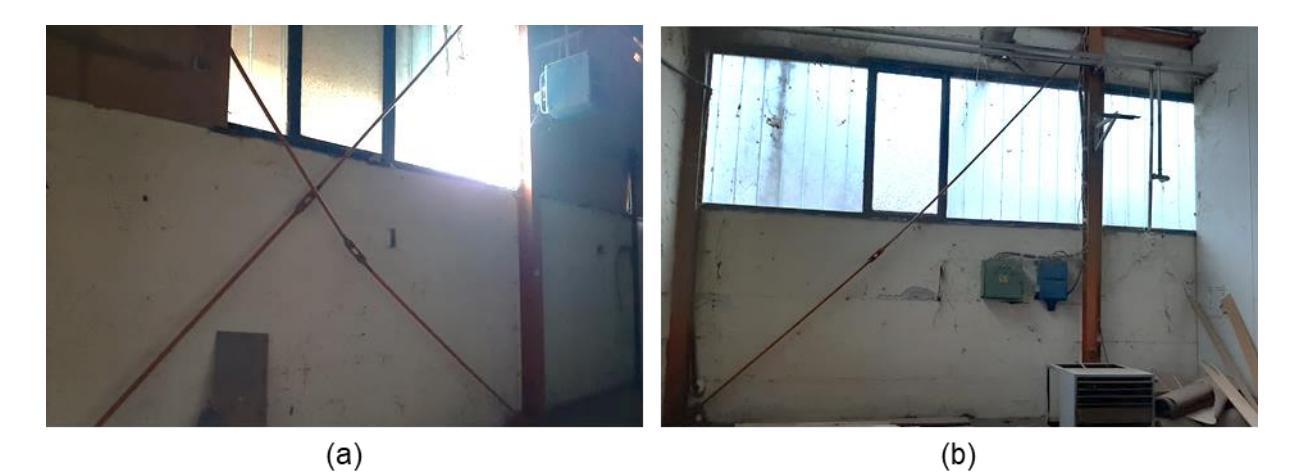
tension-only bracings (see Figure 4.107) a number of connection fractures were observed. Figure 4.107a shows one of the braces that was bent and stayed in place after fracture of its top left bracing connection. Moreover, Figure 4.107b illustrates another bay of the same structure where one of the two braces completely fell to the ground whereas the one standing exhibited flexural buckling during the earthquake. Failures of the same nature were observed in low ductility steel industrial facilities in prior earthquakes (e.g., Cruz and Valdivia 2011; Okazaki et al. 2013). Moreover, considering the fairly poor performance of precast low-ductility industrial buildings in past earthquakes in Europe (e.g., Sezen and Whittaker 2006, Belleri et al. 2015), special attention should be paid to other industrial facilities of similar nature in this and other seismically prone regions.

Figure 4.107. Fracture of tension-only steel bracings in an industrial facility in Sisačka ul. 116, 44250, Petrinja (source: Marko Bartolac).

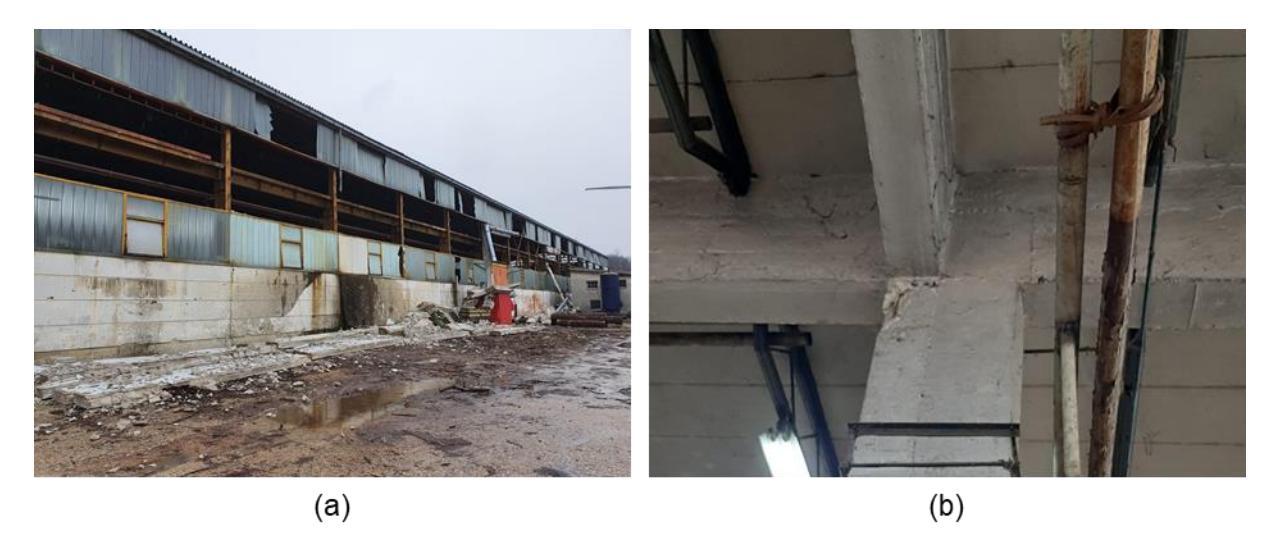
Finally, the primary industrial facility shown in Figure 4.108 experienced complete collapse of its exterior cladding. Some of the reinforced concrete columns inside the older part of the building also experienced cracking during the earthquake.

Figure 4.108. Damage to exterior cladding and concrete columns in an industrial facility in Sisačka ul. 116, 44250, Petrinja (source: Marko Bartolac).

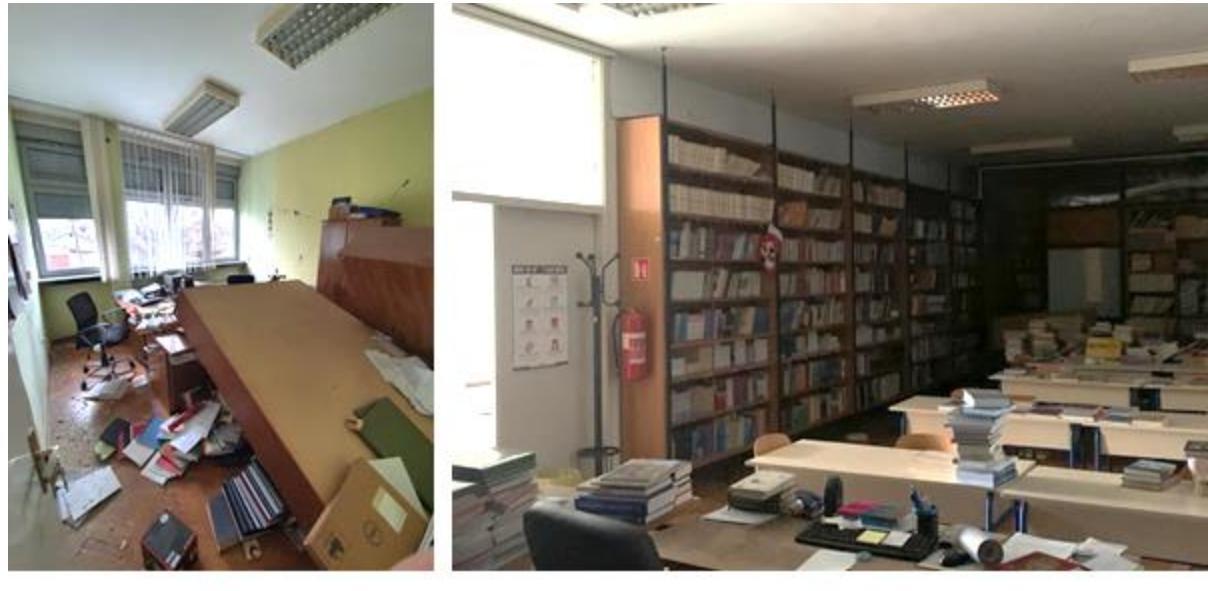
In many cases, the falling of building contents was due to lack of, or inadequate, anchorage. In general, contents such as bookcases shown in Figure 4.111 were fairly slender. Therefore, the seismic excitation resulted in a rocking-dominated response that eventually caused overturning, as shown in Figure 4.111a. On the other hand, fully loaded bookcases which were properly anchored to walls and/or partitions remained standing (see Figure 4.111b). The above observations corroborate prior work on the rocking response of unanchored building contents (e.g., Filiatrault et al. 2004).

Figure 4.111. Comparisons of (a) inadequate and (b) sufficient (b) anchorage of building content in 1962 university building (Učiteljski fakultet) (source: Marko Bartolac).

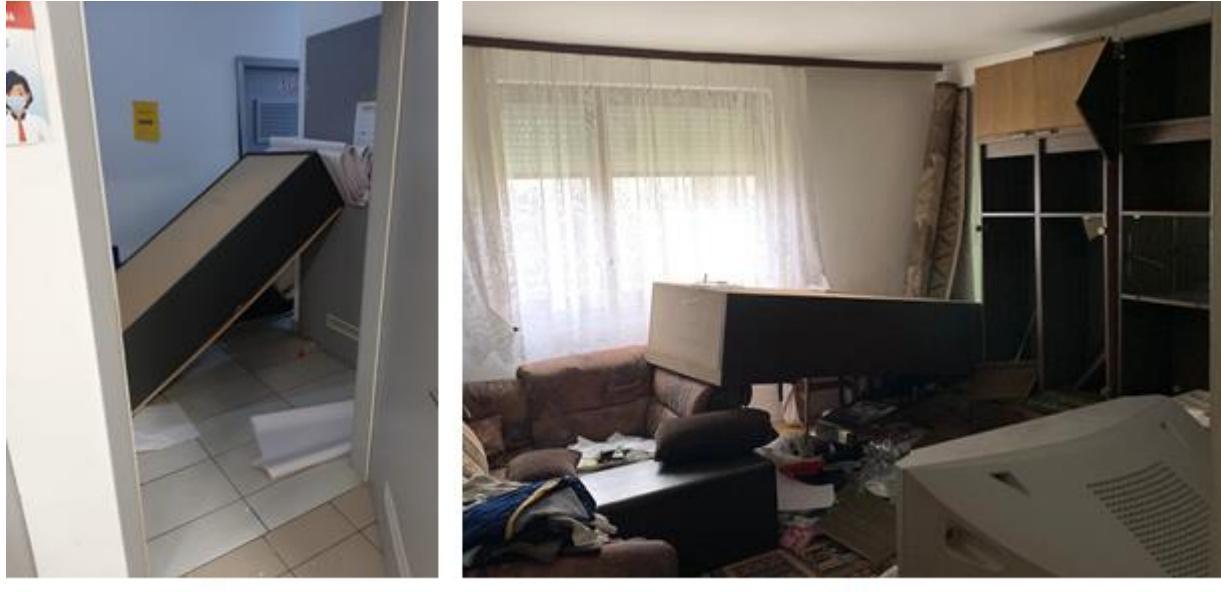
Overturning of unanchored slender contents often caused blocking of emergency exits in commercial stores, university buildings as well as residential houses as depicted in Figures 4.112. During the inspection of the building of the Faculty of Education (Učiteljski fakultet) in one classroom a detachment and collapse of the school board was observed (Figure 4.113).

Figure 4.112. Examples of unanchored slender contents blocking emergency exits and doors in commercial stores and residential houses (Otona Kučere 90, Petrinja) (source: Nenad Bijelić (a) and Damir Lazarević (b)).

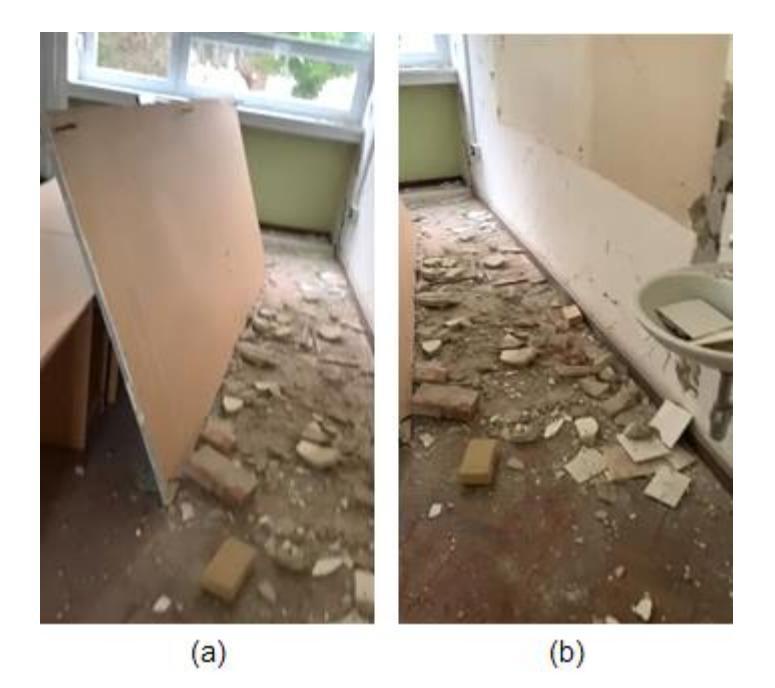
Figure 4.113. Detachment and collapse of the school board in one classroom (Faculty of Education - Učiteljski fakultet) (source: Marko Bartolac).

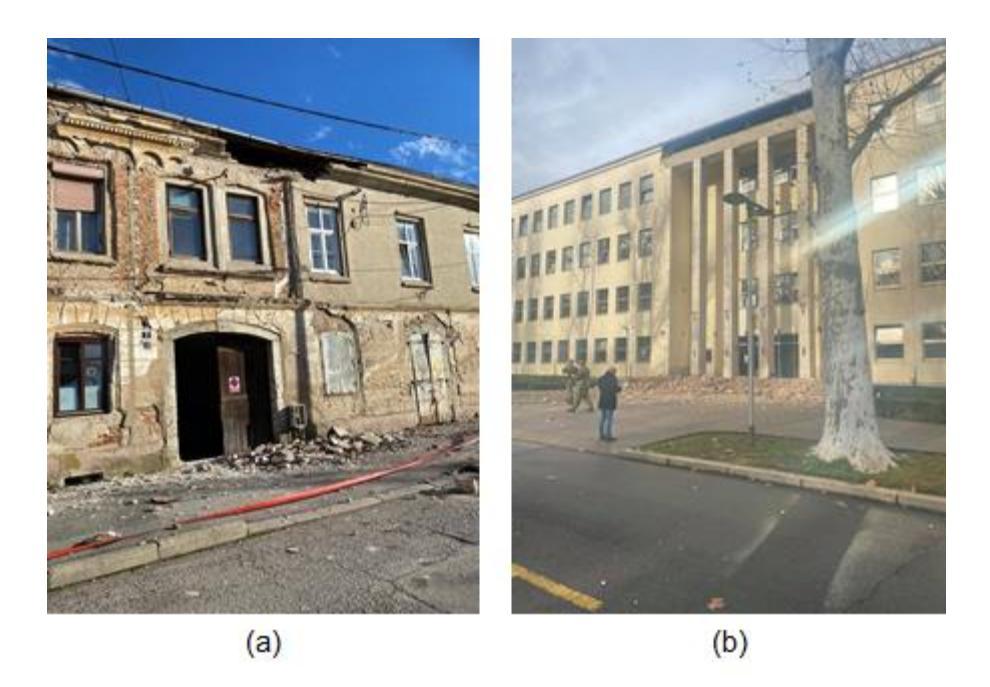
Figure 4.115. Fallen façades and parapets (source: 24sata.hr).

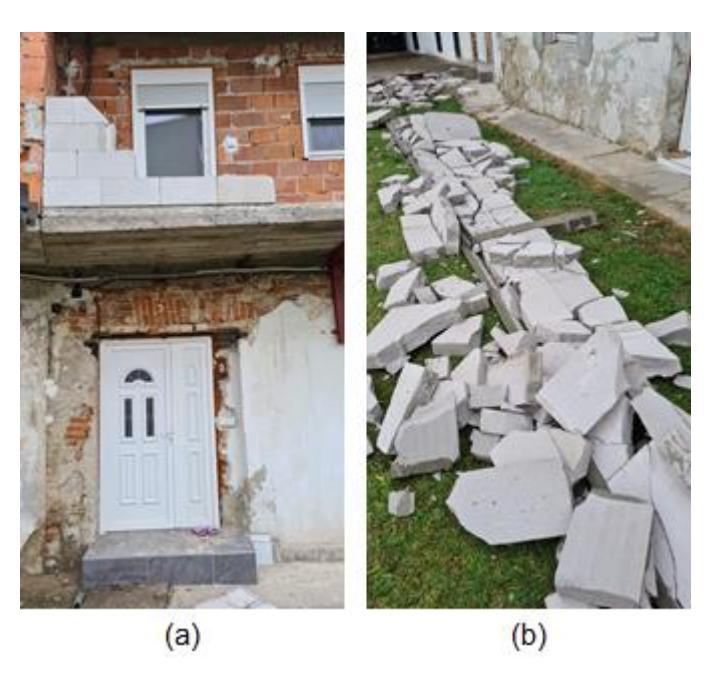
Moreover, in the area close to the Faculty of Education, a complete collapse of a URM balcony guardrail was observed (Figure 4.116). The heavy masonry wall probably fell due to lack of adequate reinforcement and connection to the slab. The guardrail on a residential balcony was damaged due to collapse of a gable end wall (Figure 4.117)

Figure 4.116. Collapsed unreinforced masonry balcony guardrail (source: Nenad Bijelić and Damir Lazarević).

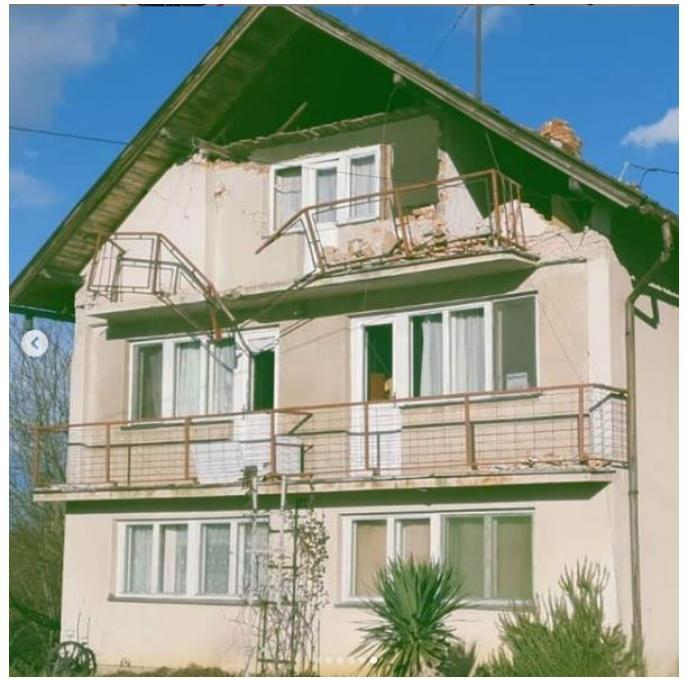
Figure 4.117. Damaged balcony guardrail in a family house in Sisak due to collapse of the gable end wall above (source: Instagram account on_a_binge_art).

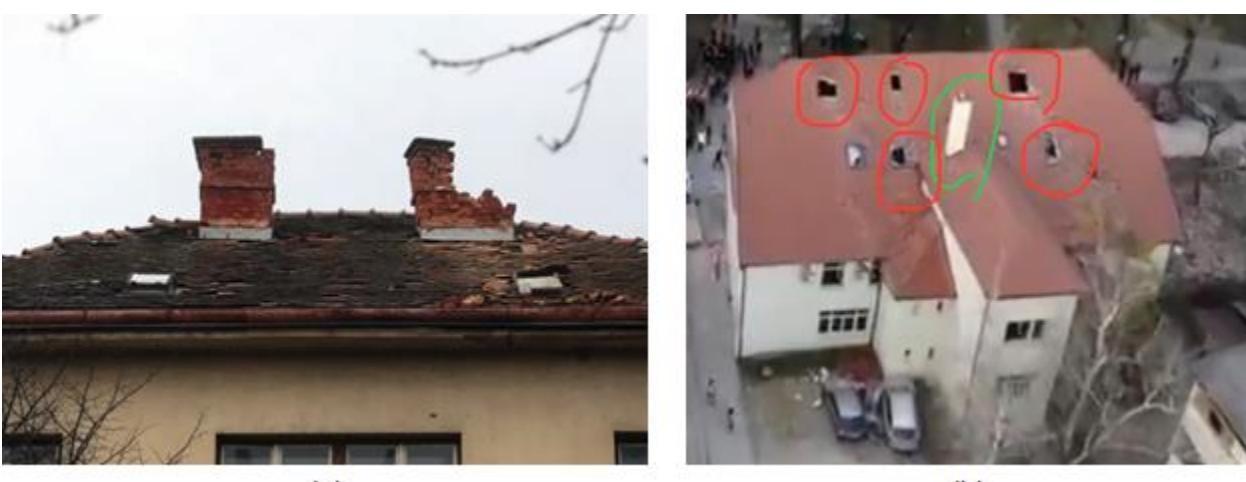
Figure 4.118. Damaged chimneys (source: (a) Getty and (b) Twitter 2021).

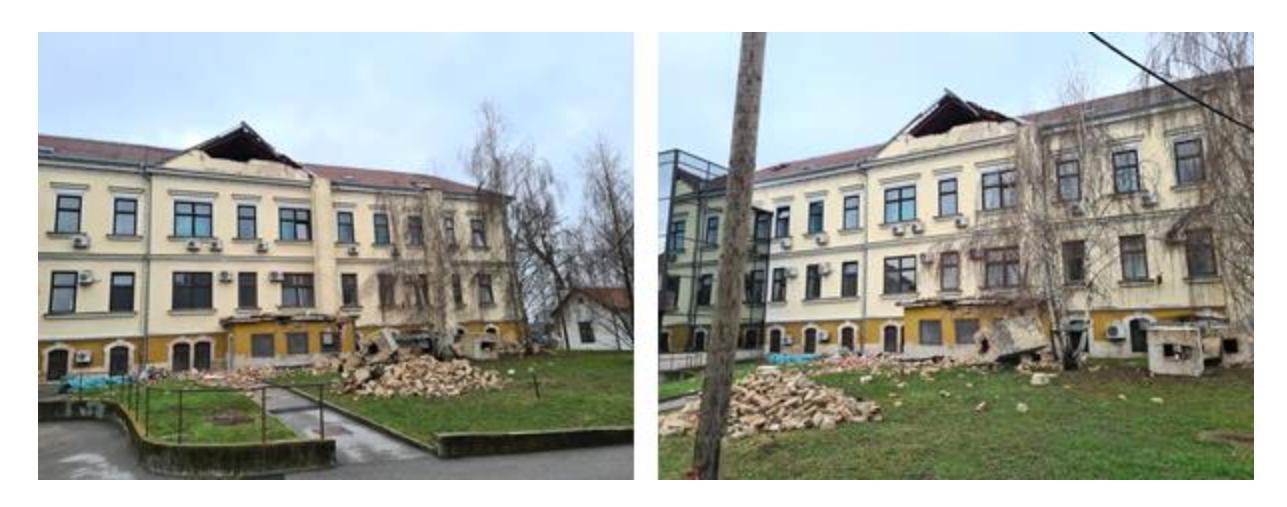
Figure 4.119. Fallen chimneys and gable end wall in hospital Dr. Ivo Pedrišić in Sisak (source: Nenad Bijelić and Marko Bartolac).

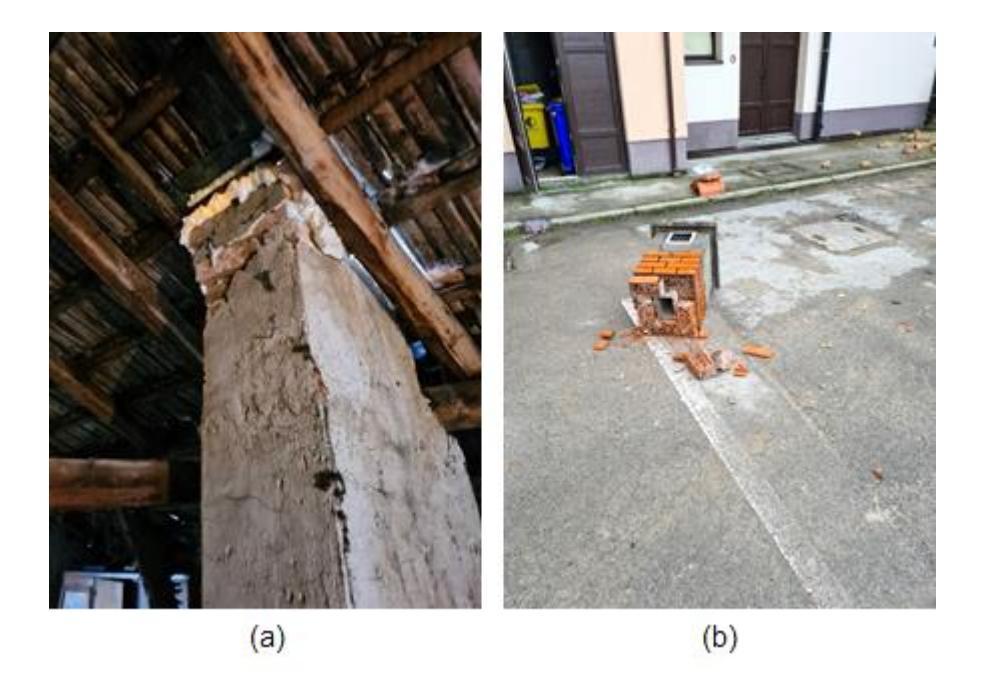
Figure 4.120. (a) Damaged chimney, (b) chimney fallen on the street (source: Nenad Bijelić and Damir Lazarević).

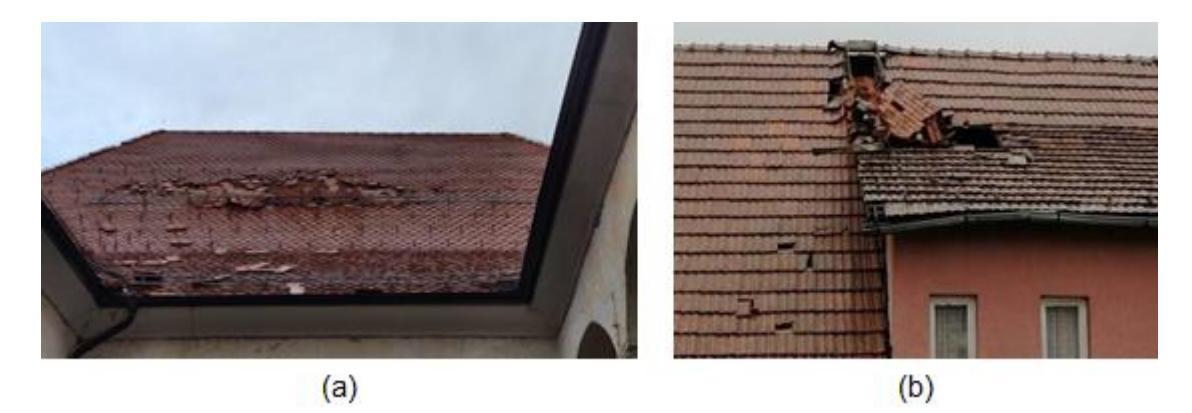
Figure 4.122. Damaged roof tiles (source: rtvslo.si).

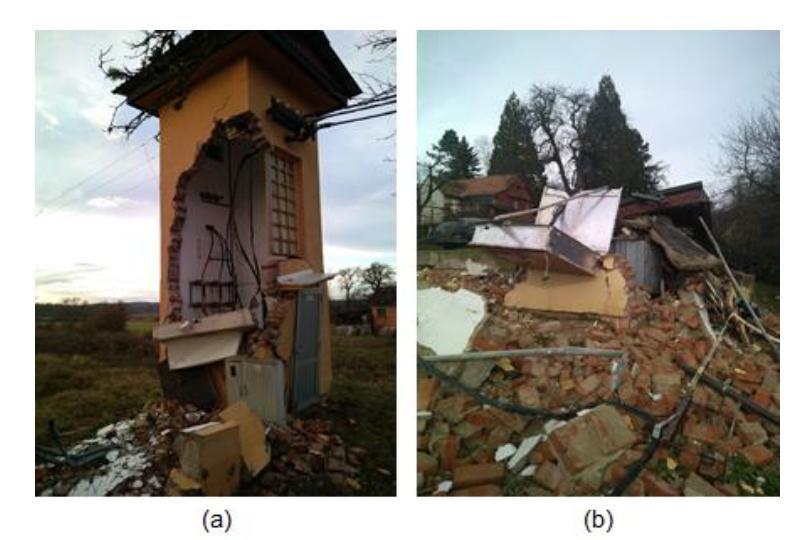
Damage to transmission and distribution infrastructure was also reported in the epicentral area, including Petrinja, Glina, and Sisak. Approximately 130 substations suffered damage, of which 10 were completely destroyed (Figure 5.2). In Petrinja and the neighboring villages 3 transmission lines and 79 substations went out of operation (Index.hr 2020b), among which 35 substations were reported as heavily damaged. The damaged equipment from the substations is planned to be fully replaced (Štajdohar Mladen, 2021). HEP noted that it continued to receive reports of individual breakdowns of the low-voltage distribution network in the areas of Sisak, Petrinja, and Glina. As a result the number of users without power supply varied on an hourly basis (Jutarnji list 2020).

Figure 5.2. Severely damaged (a) and collapsed (b) substations in the Petrinja area. The size of substation structure on the left is 2.5 m square in plan and 8 m high (source: Mladen Štajdohar).

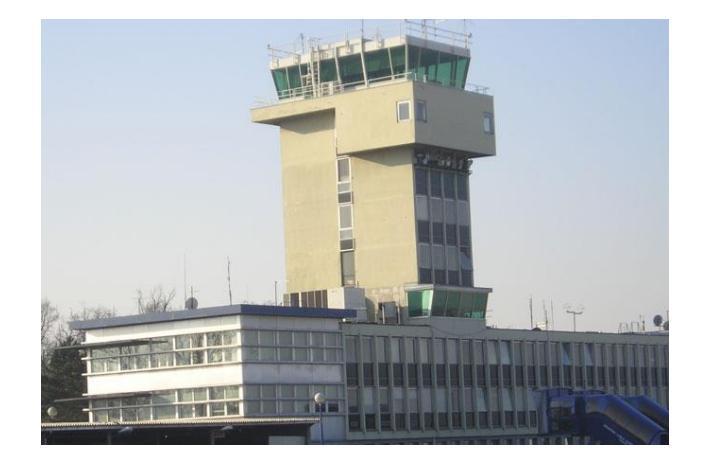
Zagreb International Airport (Figure 5.3) is located south of Zagreb and approximately 40 km northwest of the epicenter. According to the Croatian Air Navigation Services, the control tower suffered minor damage due to the earthquake, which led to an interruption of air traffic for a few hours (Dubrovnik Times 2020).

Figure 5.3. Control tower at the Zagreb International Airport experienced minor damage (source: DubrovnikTimes).

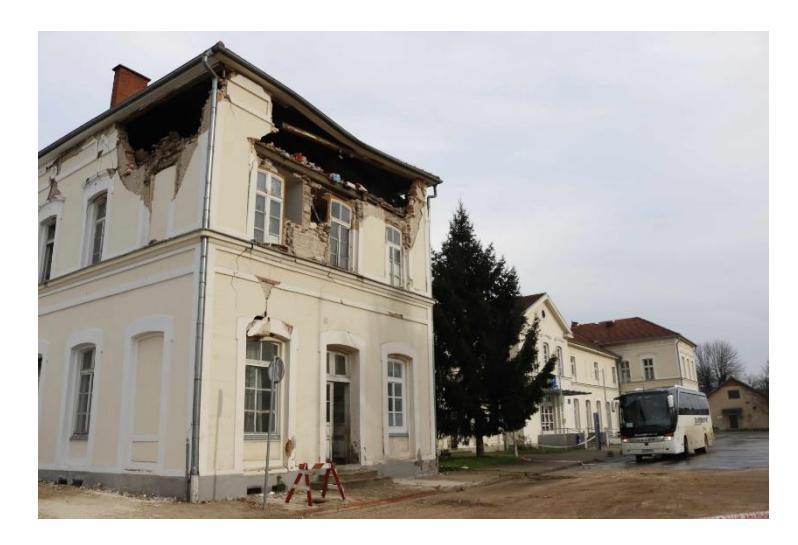
The Sisak Railway Station experienced severe damage during the event (Figure 5.4) but railway tracks were not damaged and railway transportation was not disrupted (CroatiaWeek 2020).

Figure 5.4. Significant damage of the Sisak Railway Station building (source: CroatiaWeek).

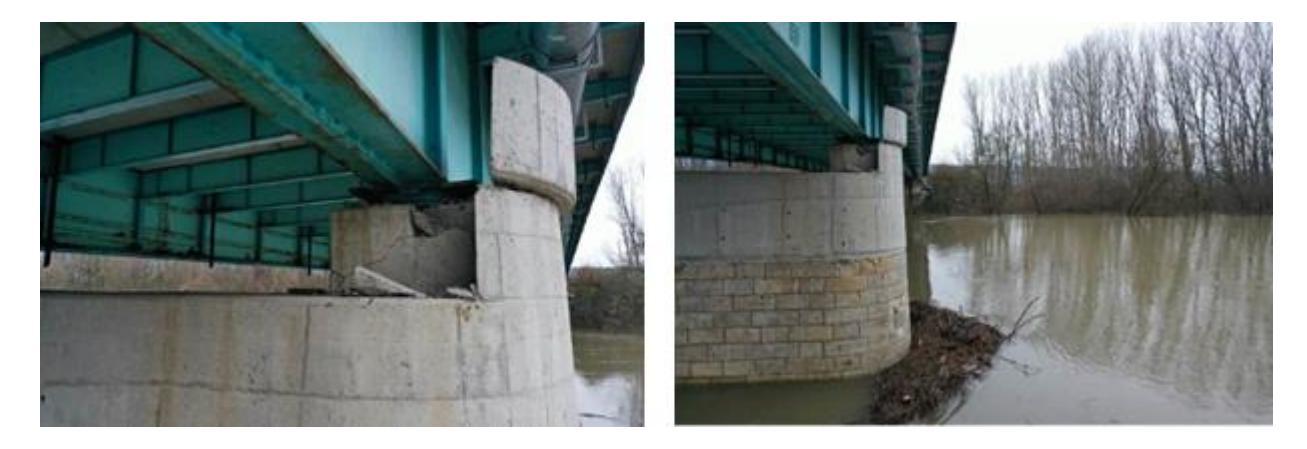
Based on the visual inspection, it was determined that the concrete bearing pads forming both vertical and lateral supports were severely damaged. Figure 5.6 shows deep cracks in the base bearing pad and lateral shifting of the lateral pad at the upstream side of the river bed.

Figure 5.6. Damaged bearing supports of the Brest Bridge (source: Mate Baričević).

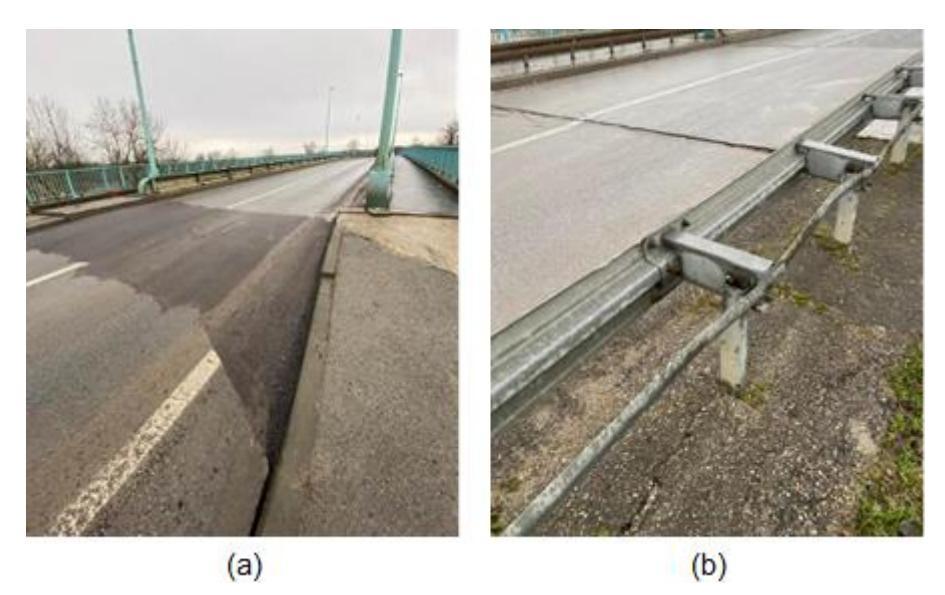
JRR: Petrinja December 29, 2020 Earthquake PRJ-2959 | Released: Jan 22, 2021 Building Resilience through Reconnaissance
The "asphalt wedge" constructed between the bridge structure and the transition slab must be refilled to make the transition to the bridge as smooth as possible. Currently, the vehicles approaching the bridge impose large dynamic loads on the bridge structure (Figure 5.5 right-hand side and Figure 5.7). A transverse crack in the transition slab was also observed at the left-hand side of the bridge, but no denivelation was observed as on the opposite abutment (Figure 5.7).

Figure 5.7. Asphalt at right-hand side abutment (a) and asphalt at left-hand side of abutment (b) of the Brest Bridge (source: Mate Baričević).

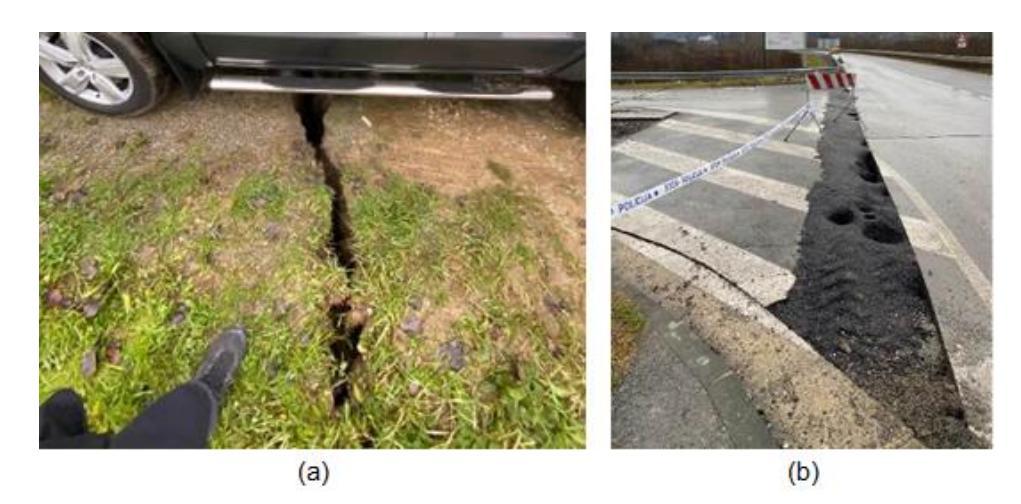
Wide ground fissures (up to 10 cm wide) were observed on the embankments leading to the bridge (Figure 5.8a). The asphalt curtain partially collapsed at the intersection with the access road to the center of Petrinja, as shown in Figure 5.8b.

Figures 5.8. (a) Wide cracks at the bridge embankment and (b) collapsed portion of the asphalt curtain at the intersection with the access road to the center of Petrinja (source: Mate Baričević).

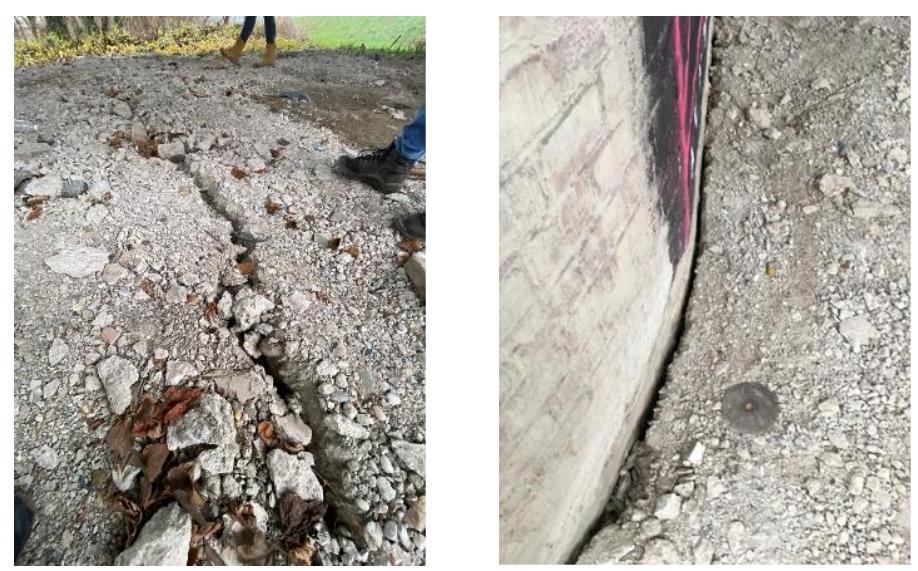
Figure 5.13. The displacement of the platform is visible on the ground, Galdovo Bridge (source: Mate Baričević).

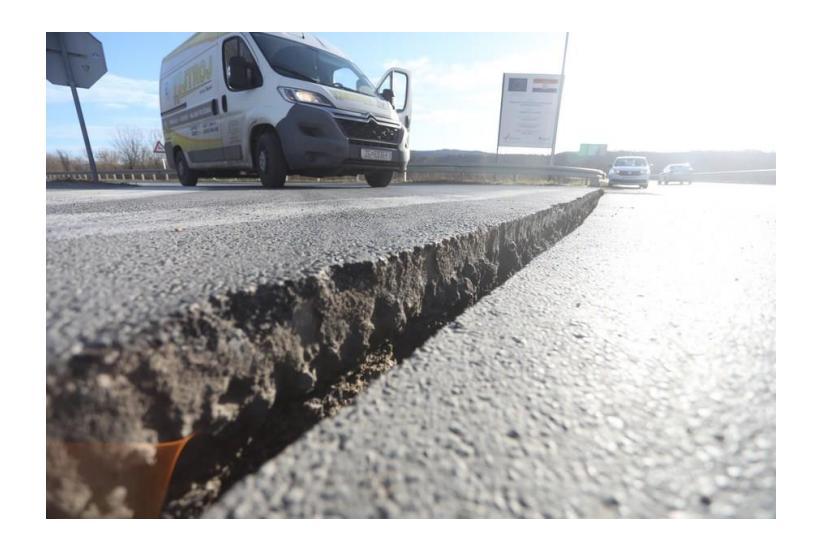
Due to the proximity to the epicenter, the roads close to Brest Bridge experienced differential settlements, which caused a decrease of the ground bearing capacity and resulted in ground and pavement failure. Iron railings were also damaged. These damages to roadways are shown in Figures 5.14 through 5.19.

Figure 5.14. A major fissure in the road in Sisak was observed after the December 29, 2020 earthquake (source: Marin Tironi/Pixsell via Xinhua).

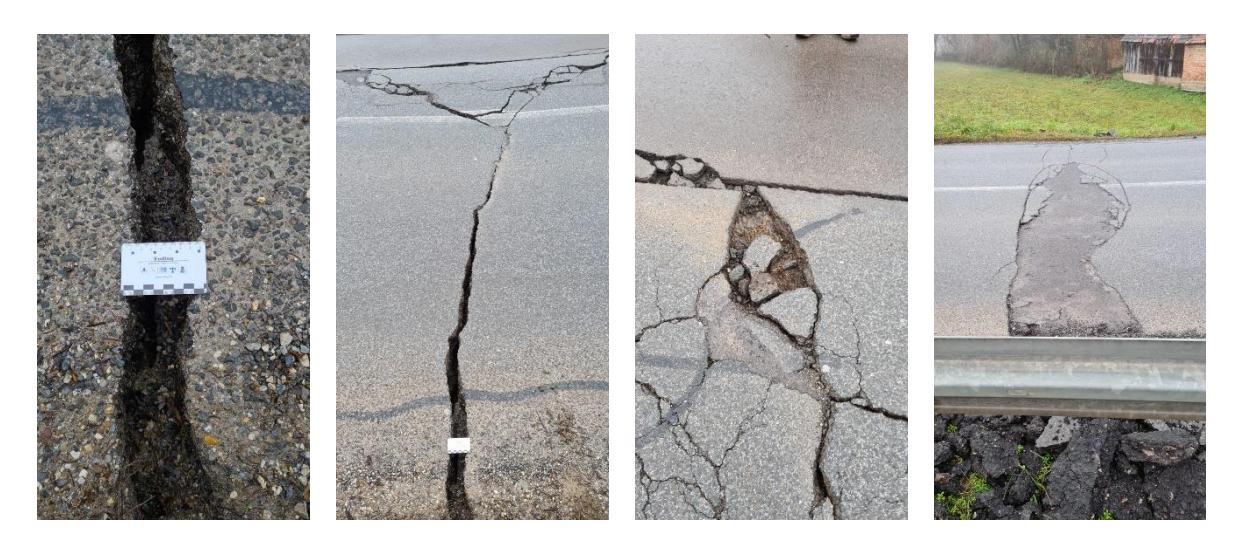
Figure 5.15. Damage to roads in Brest, north of Petrinja (source: Nenad Bijelić).

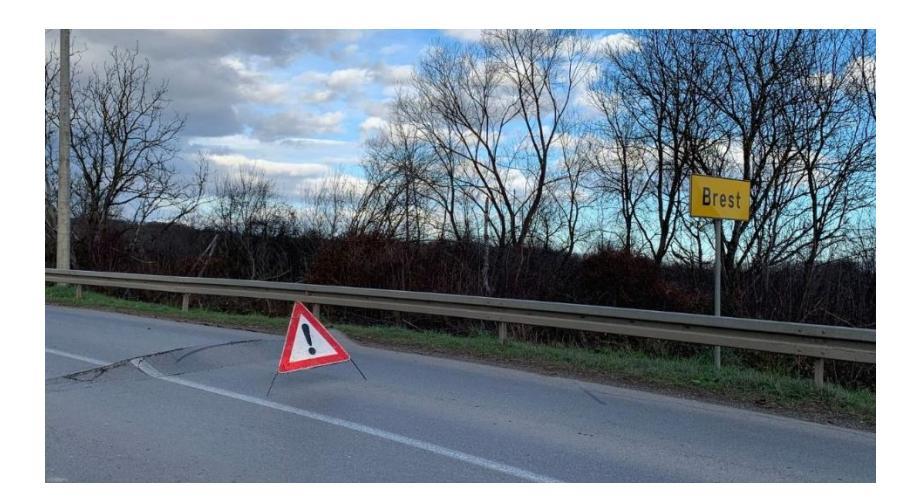
Figure 5.16. Ground failure of the road close to the Brest Bridge (source: Index.hr 2020d).

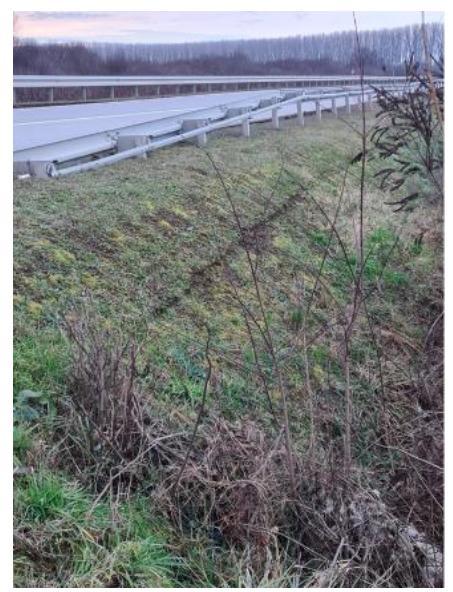
Figure 5.19. Partial lateral ground slide close to Brest Bridge (source: Nenad Bijelić).

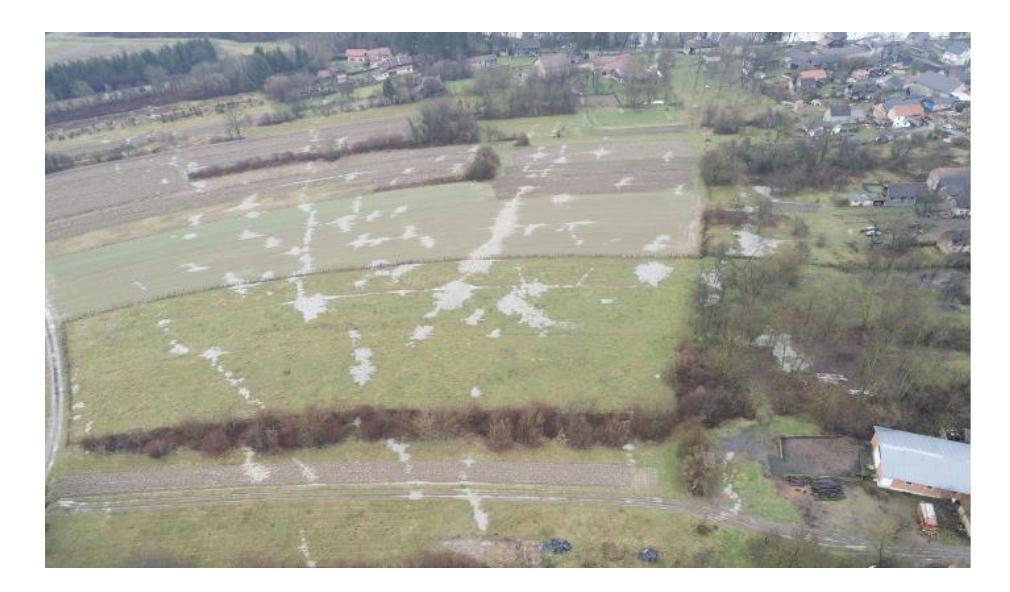
Figure 6.7. Aerial image of liquefaction ejecta at (45°30'41.988"N,16°24'37.632"E, source: Vedran Damjanović).

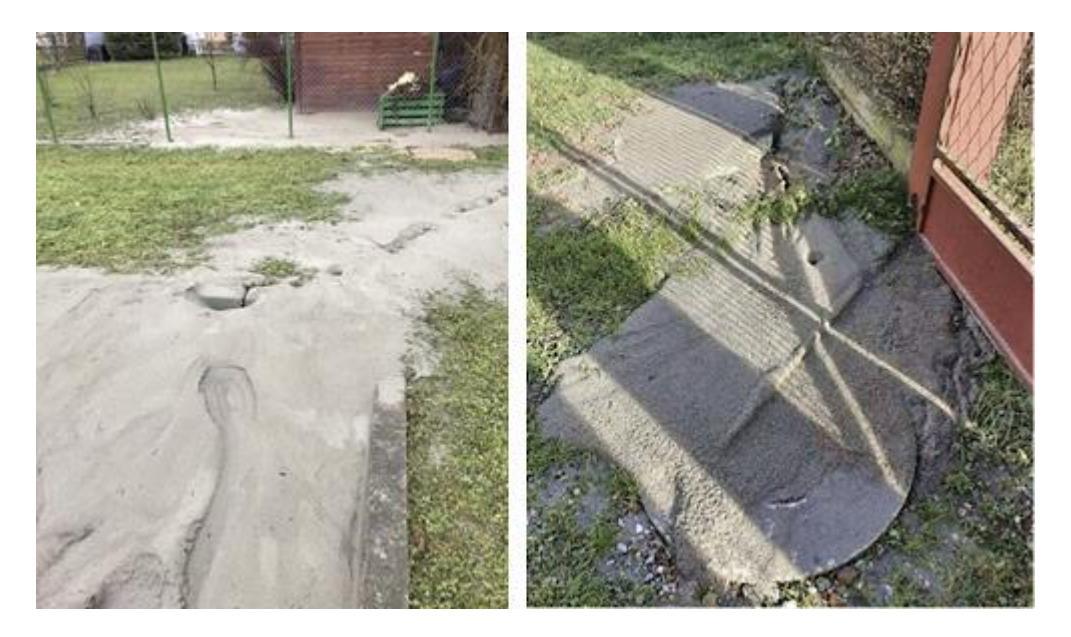
Figure 6.10. Liquefaction ejecta in Petrinja (Location: 45° 26' 38.6694"N, 16° 16' 33.5238"E, photo: Marko Bartolac).

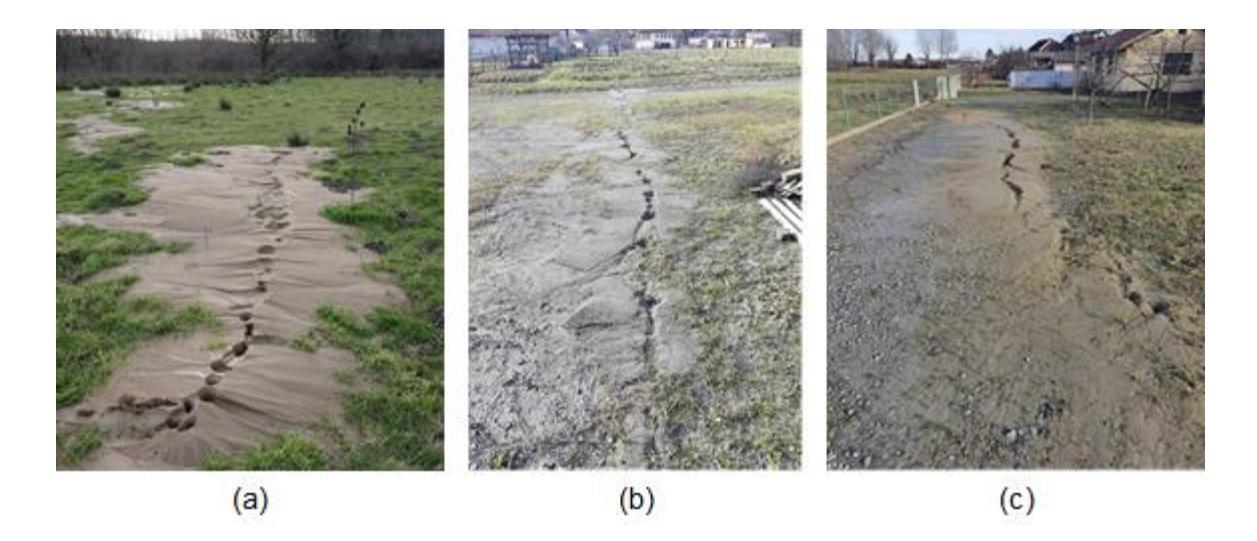
Figure 6.11. Liquefaction ejecta in Petrinja ((b) and (c): 45° 26' 39.447"N, 16° 16' 31.188"E, photo: Marko Bartolac, (a) photo: unknown location, Željko Arbanas).

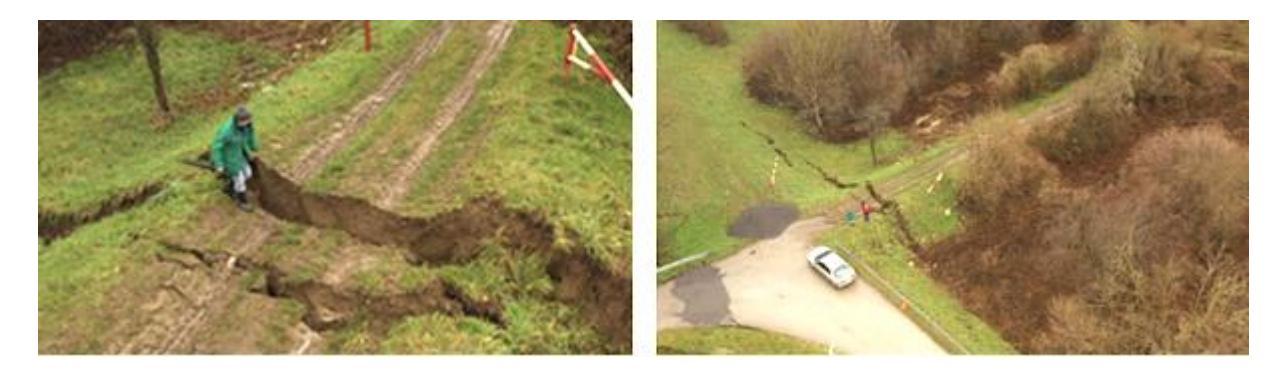
Rivers Sava and Kupa flow through highly populated areas, thus over the years a system of embankments was built for flood protection. Embankments are built, but also retrofitted in stages and their quality varies. Embankments on the left riverbank of Sava ruptured perpendicularly (Figure 6.13). Ruptures parallel to the longitudinal axis of the embankment, in the soil left and right from the embankment core in near Hrastelnica and in Galdovo depict another failure mechanism, which is probably a deep and gradual slope stability failure or lateral

spreading. This is characterized by parallel long fractures on the surface (Figs. 6.13, 6.14). Given the extensive liquefaction in the same areas and the proximity of the levees, this is very plausible. Local faculty indicated that this type of failure has not been observed before in Croatia (Professor Arbanas).

Figure 6.13. Rupture of the left riverbank of Sava (source: Croatian Waters Archive).
