Petrinja, Croatia December 29, 2020, Mw 6.4 Earthquake Joint Reconnaissance Report (JRR)

Report

Joint Reconnaissance Team Leaders: Eduardo Miranda, Stanford University Svetlana Brzev, University of British Columbia / SUZI-SAEE Nenad Bijelić, Swiss Federal Institute of Technology Lausanne (EPFL) Field Assessment Structural Team (FAST) Authors: (in alphabetical order) Željko Arbanas, University of Rijeka Marko Bartolac, University of Zagreb Nenad Bijelić, Swiss Federal Institute of Technology Lausanne (EPFL) Vedran Jagodnik, University of Rijeka Damir Lazarević, University of Zagreb Snježana Mihalić Arbanas, University of Zagreb Sonja Zlatović, Zagreb University of Applied Sciences Virtual Assessment Structural Team (VAST) Authors: (in alphabetical order) Andrés Acosta, Stanford University Dimitrios Lignos, EPFL Jorge Archbold, UC Berkeley Ting Lin, Texas Tech University James Bantis, Stanford University Marko Marinković, University of Belgrade Jovana Borozan, SUZI-SAEE Armando Messina, Stanford University Ivana Božulić, EPFL Sebastián Miranda, Univ. del Desarrollo Nikola Blagojević, ETH Zurich Alan Poulos, Stanford University Cristian Cruz, Univ. Técnica Federico Santa María Giuli

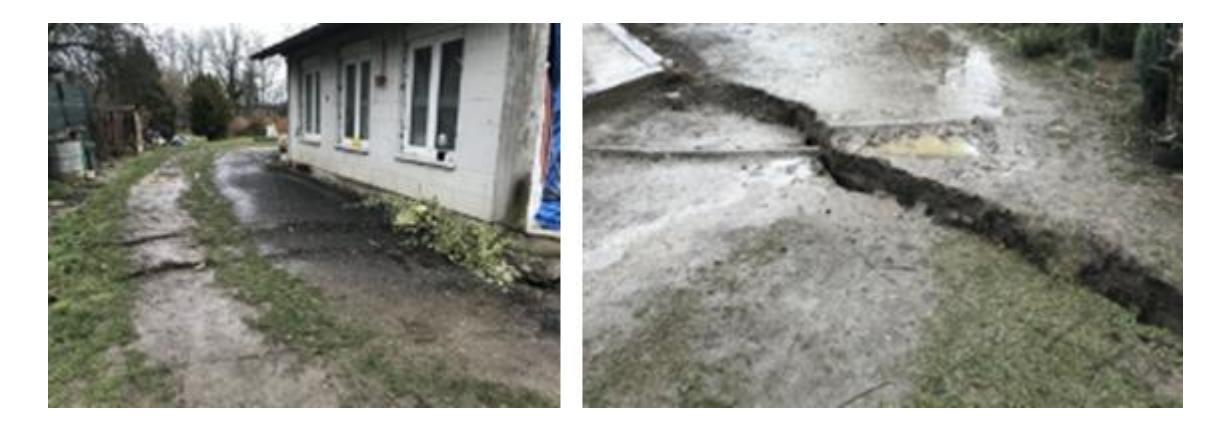
Figure 6.17. Building settlement due to lateral spreading, Bok Palanječki (photo: Vedran Jagodnik, 45°30'36.21"N,16°24'38.892"E).

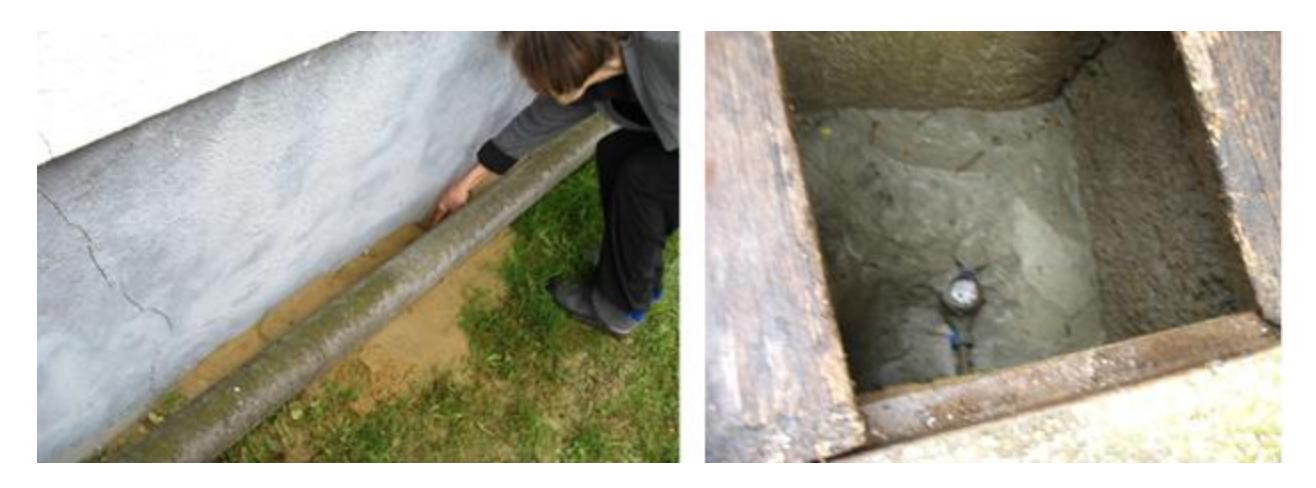
Figure 6.19. Liquefaction under a residential building with sandy soil ejected next to the structure and filling the underground space, Petrinja, Ulica Slavka Kolara (45.4349,16.2683, source Sonja Zlatović).

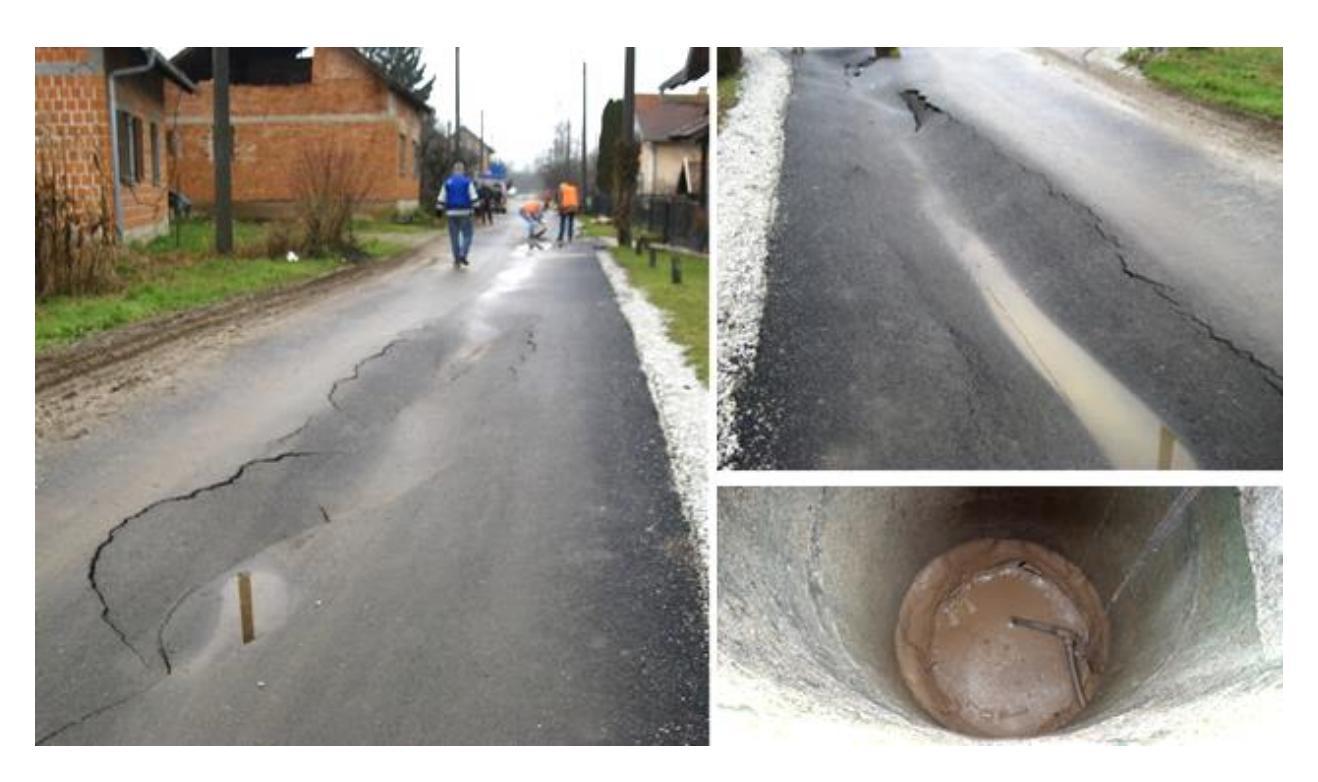
Figure 6.20. Settlement of the road along which the sewage system was renovated recently. It is possible that the material around the pipes was not compacted properly during construction, but liquefaction might have been the main reason for the settlements as a nearby well (45.4562, 16.3164) was filled with sandy material. Nova Drenčina, Drenačka ulica. (source Sonja Zlatović).

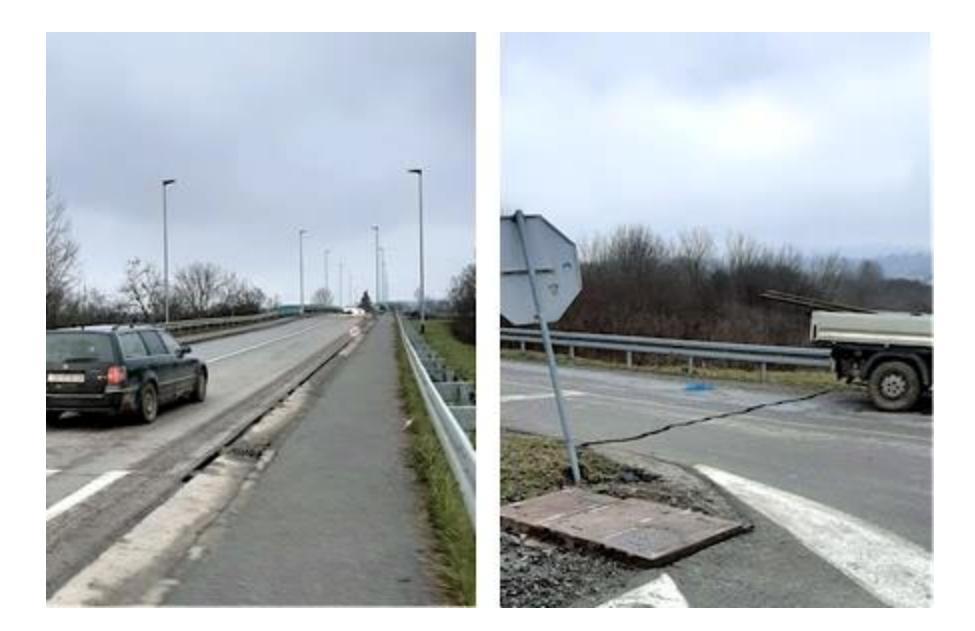
Figure 6.22. Bridge Brest, from Petrinja for Brest Pokupski (45.4461, 16.2628, source Sonja Zlatović).

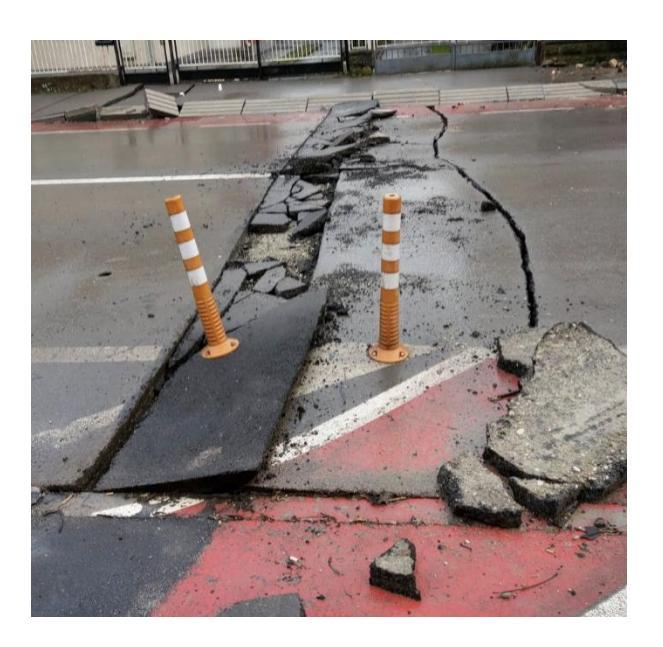
Figure 6.23. Road pavement cracking (45°29'45.108"N,16°22'36.888"E, source Zeljko Arbanas).

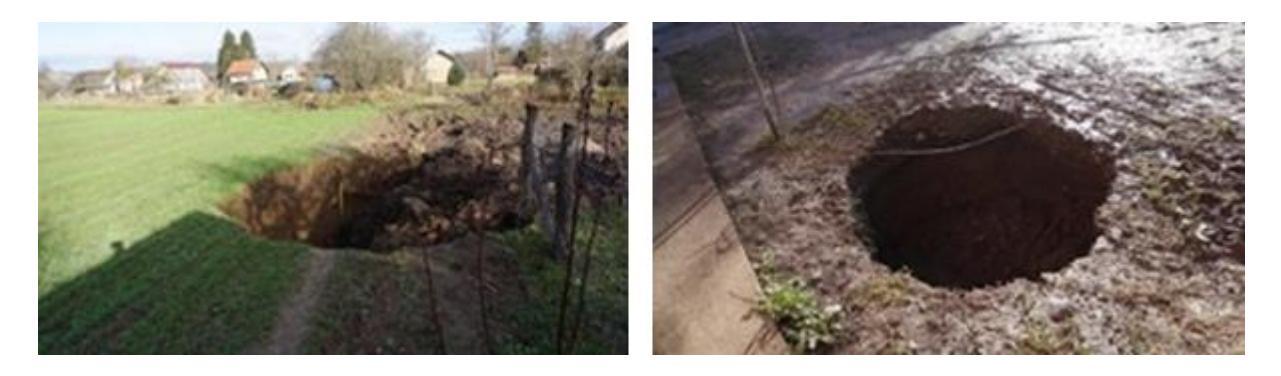
In the area of the village Mečenčani, on Friday December 31st a dozen sinkholes appeared, as shown in Figures 6.24 to 6.27. The location is approximately 30 km southeast of Petrinja, and it can be seen on the map that the village is located very close to or directly on the fault.

Similar sinkholes were known to appear occasionally in this area after individual communications with the local community. Many of the sinkholes appeared in the aftermath of the earthquake. Part of these sinkholes may be connected with abandoned mines. However, some of them are probably karst phenomena. It seems that new sinkholes continued appearing. Additionally, as seen in the photos, the slopes of the soil are quite steep, so widening of these holes may be expected with new rains, earthquakes etc.

Figure 6.24. Sinkholes (source: Index.hr news portal).

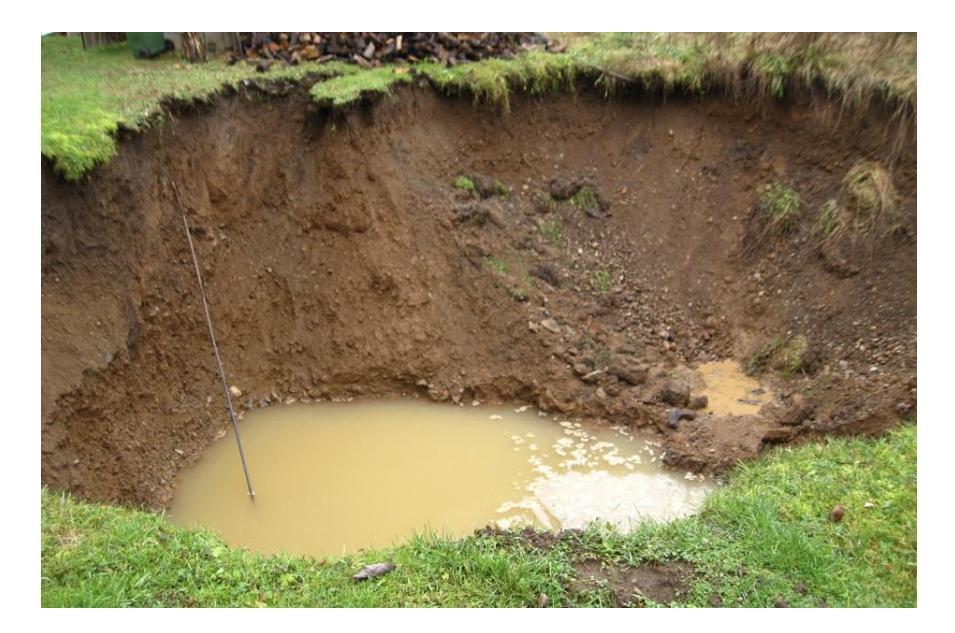
Figure 6.26. Sinkhole in Mečenčani (45.2829,16.4298, source Sonja Zlatović).

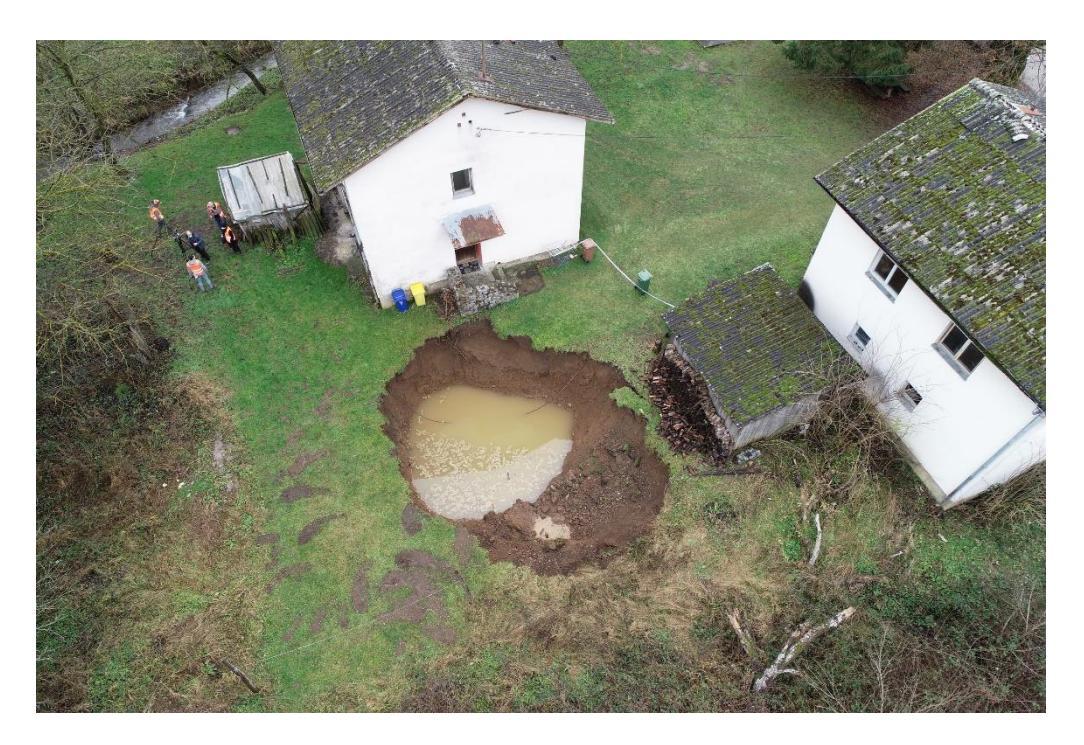
Figure 6.27. One of sinkholes in Mečenčani (45.2829,16.4299, source: Marijan Car; Mario Bačić and Josip Terzić, 2021).

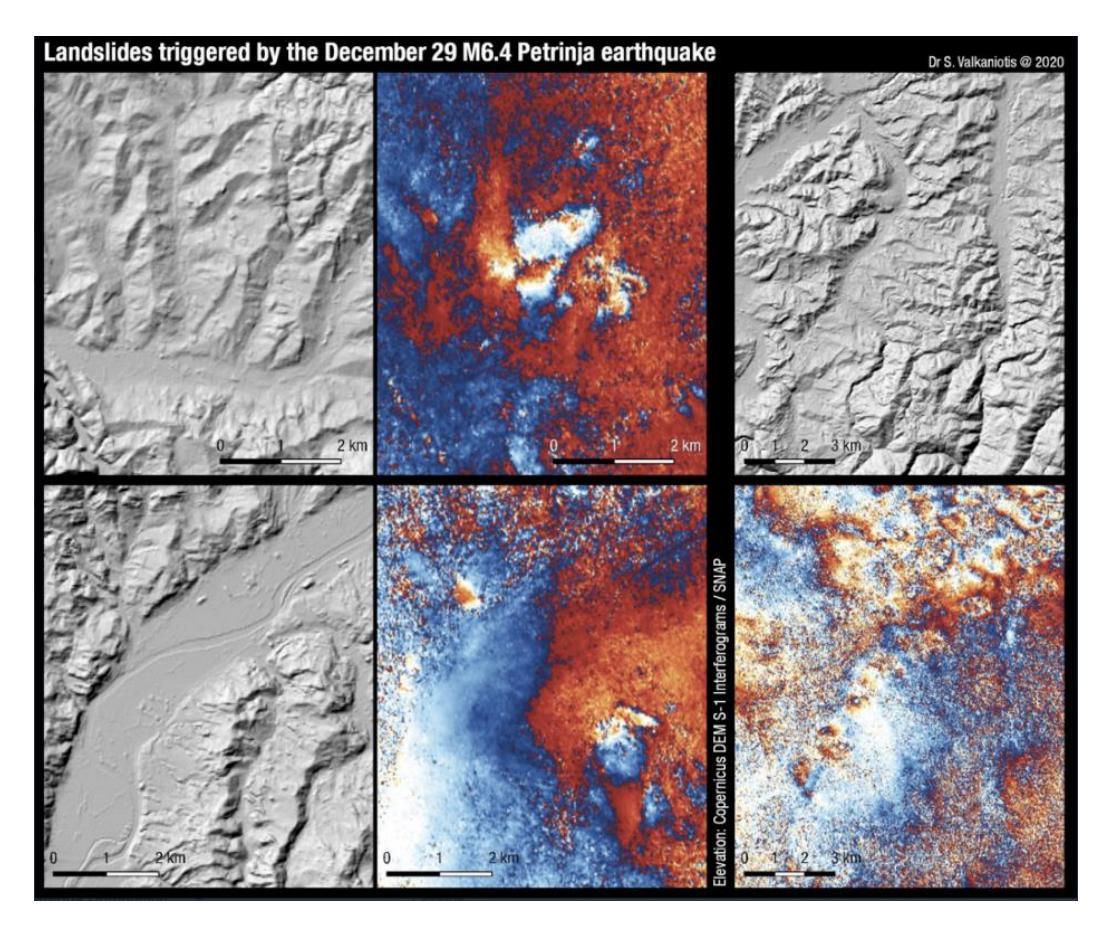
A series of landslides were analyzed before the earthquake. Various colors of the asphalt on the roads in the hilly area suggest that many small landslides happened often. Figure 6.28 illustrates the Sentinel1 interferogram in distances as far as 30 km from the earthquake rupture, showing that a number of large landslides were triggered (with a few cm of displacement) by the M_w 6.4 Petrinja earthquake (S. Valkaniotis 2021).

Figure 6.28. Sentinel1 interferogram showing the landslides triggered by the M_w 6.4 Petrinja earthquake. Color images show the phase difference (displacement) for a pair of radar images. Each color fringe from blue to red represents 2.8 cm of ground displacement (relative to satellite position). Gray-scale images show topography (image source and explanation by Dr. Sotiris Valkaniotis 2020).

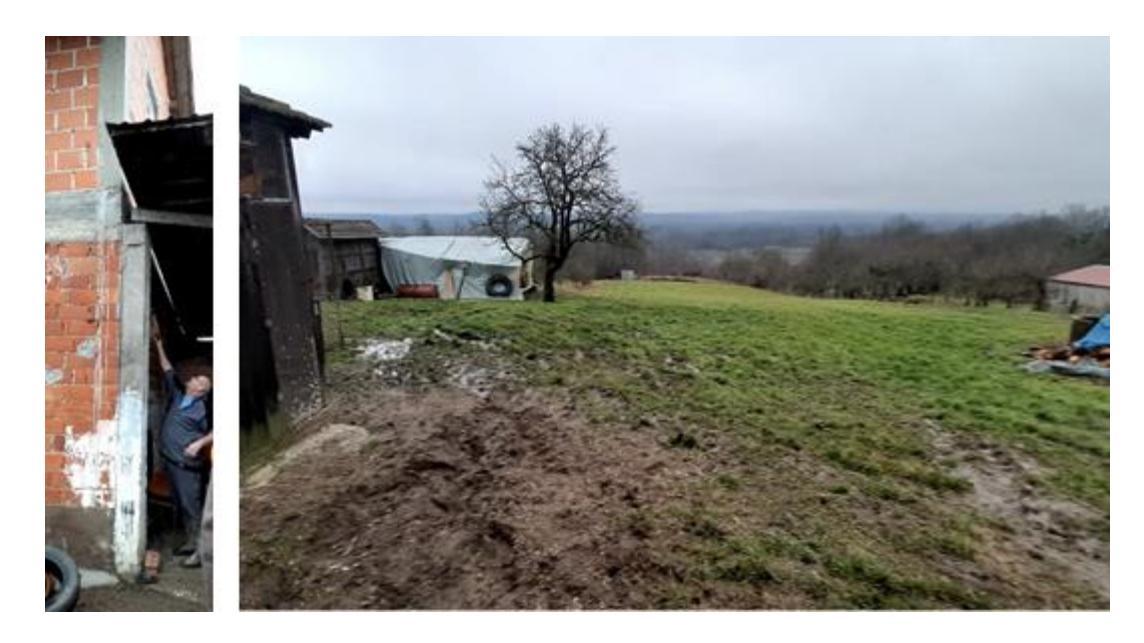
Figure 6.29. Neighboring the previously known landslide in Hadžar, is a small farm where various houses started moving down the slope, in different directions. The figure on the left shows a gap opening after the earthquake. The grass covered slope, usually firm even in rainy days, as rain would quickly run off, suddenly became wet and soft - maybe due to liquefaction in the shallow layer, which released water to the upper surface layer (45.3795,16.1199, source Sonja Zlatović).

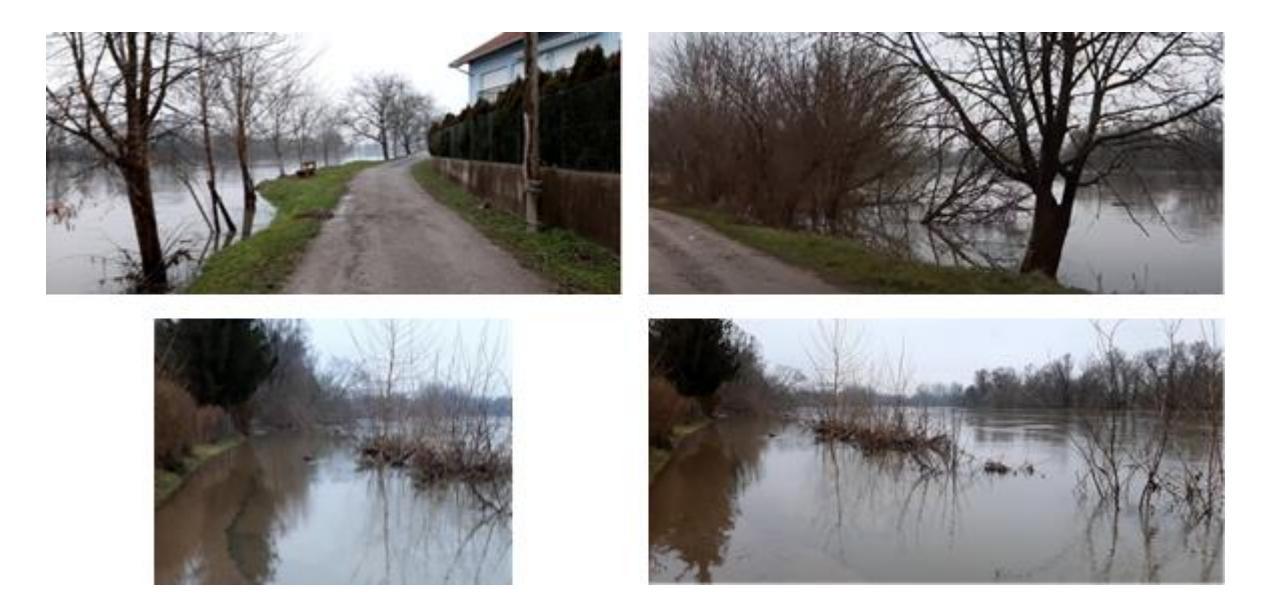
Figure 6.30. Landslide on the coast of the river Kupa, Letovanić (45.5082,16.2118, source Sonja Zlatović).

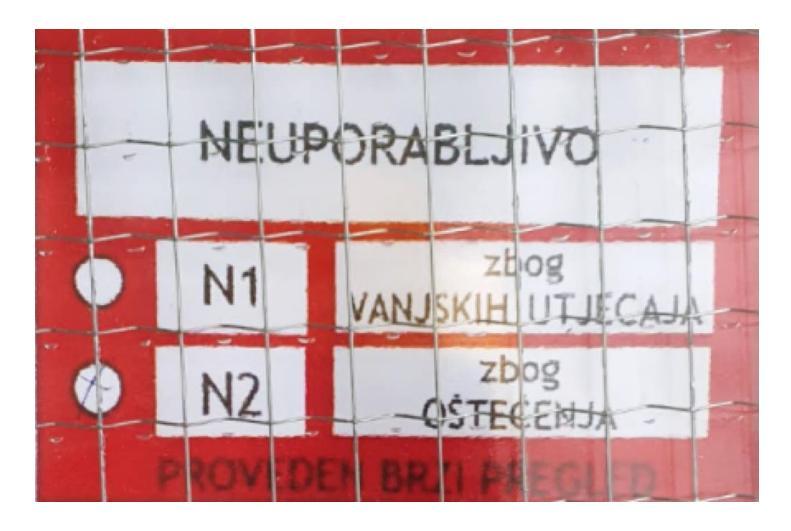
Figure 7.6. Example of red tags used by HCPI during their post-earthquake safety evaluations (Source: Damir Lazerevic).
