StEER-EERI: 2023 Mw 7.8 Kahramanmaras, Türkiye Earthquake Sequence Joint Preliminary Virtual Reconnaissance Report (PVRR)

JOINT PRELIMINARY VIRTUAL RECONNAISSANCE REPORT (PVRR)

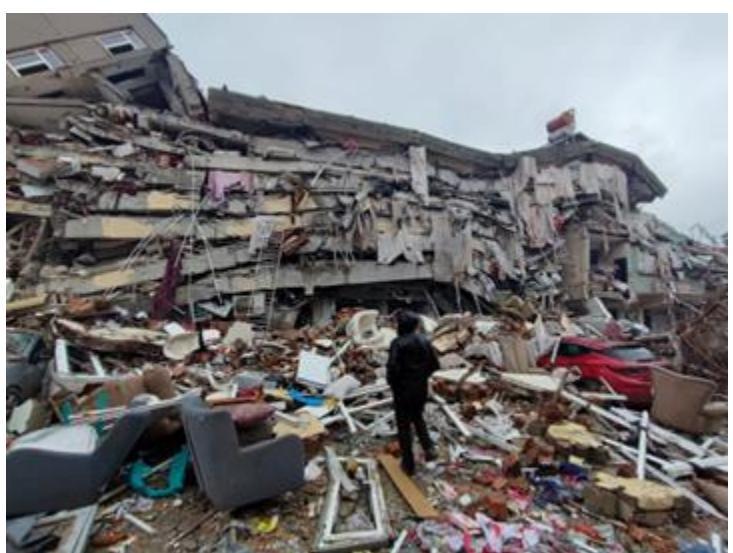
Damage to personal property is expected to be significant, particularly given the number of complete collapses that result in not only significant threats to life safety, but also total loss of contents (Figure 1.5). Unfortunately, insured losses may be only around \$1 billion (USD) due to low insurance coverage in the affected regions (Fitch 2023). The Turkish Catastrophe Insurance Pool (TCIP) was created after the 1999 Izmit earthquake to cover damage to residential buildings, but it does not cover human loss, liability claims, or business interruptions.

Figure 1.5. Collapsed multi-family residential building in Kahramanmaras. The photograph illustrates how observed collapse scenarios lead to complete loss of contents and the inability to recover personal possessions (Source: <u>Reuters via CNN</u>).

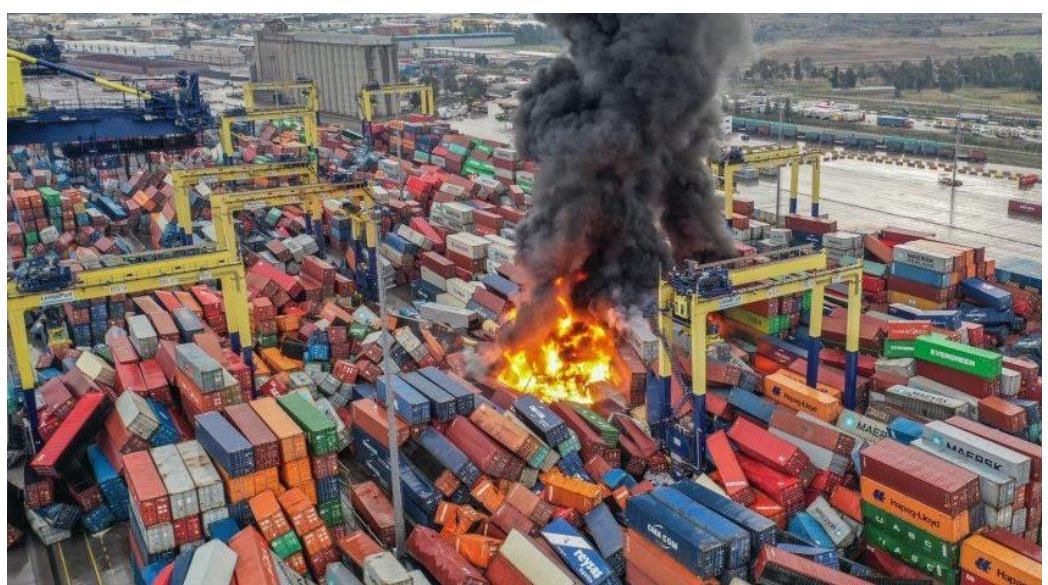
Iskenderun is home to heavy industries, e.g., steel production, and two major container hubs on Türkiye's Southeastern coast. A fire occurred at one of these ports, Türkiye's southern international shipping port, after the earthquake sequence (Figure 1.6) (Daily Sabah 2023a). The fire began at 1400 GMT on February 6 and was eventually extinguished via military helicopters and planes two days later. Reportedly, hundreds of shipping containers were ablaze. A leading global container shipping group, AP Moller Maersk, said that there had been significant damage

to logistics and transport infrastructure specifically around the Port of Iskenderun, requiring that company and other shipping lines to divert containers to nearby ports and hubs.

Figure 1.6. While gantry cranes appear unaffected by the earthquake, primary and secondary effects from fire after the earthquake compounded losses and downtime at the Iskenderun Port (Source: <u>Odessa Journal</u>).

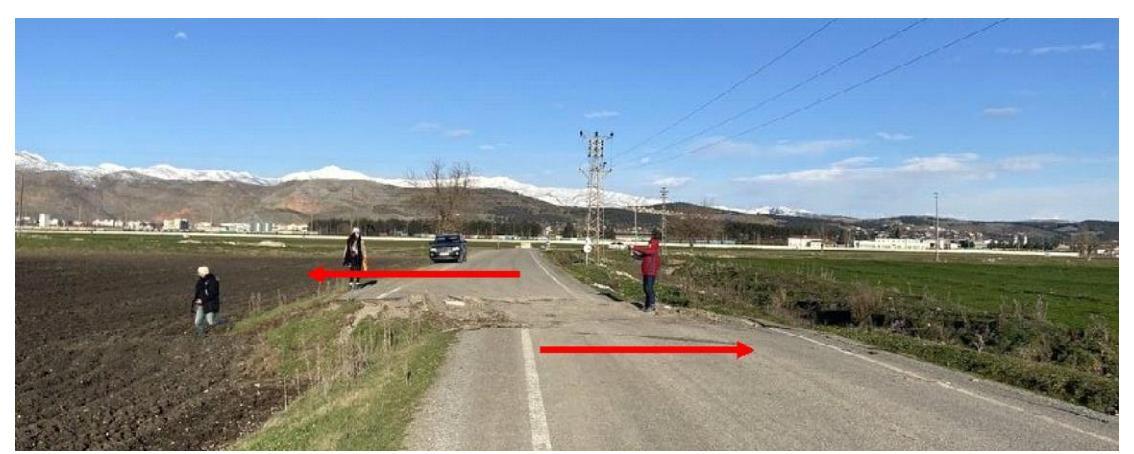
Figure 2.8. Fault slip of 3.0 to 3.5 m at the Anatolian plate from the February 6, 2023 earthquake sequence (adapted from reddit post by <u>u/kebabG 2023a</u>, last accessed 2-20-2023).

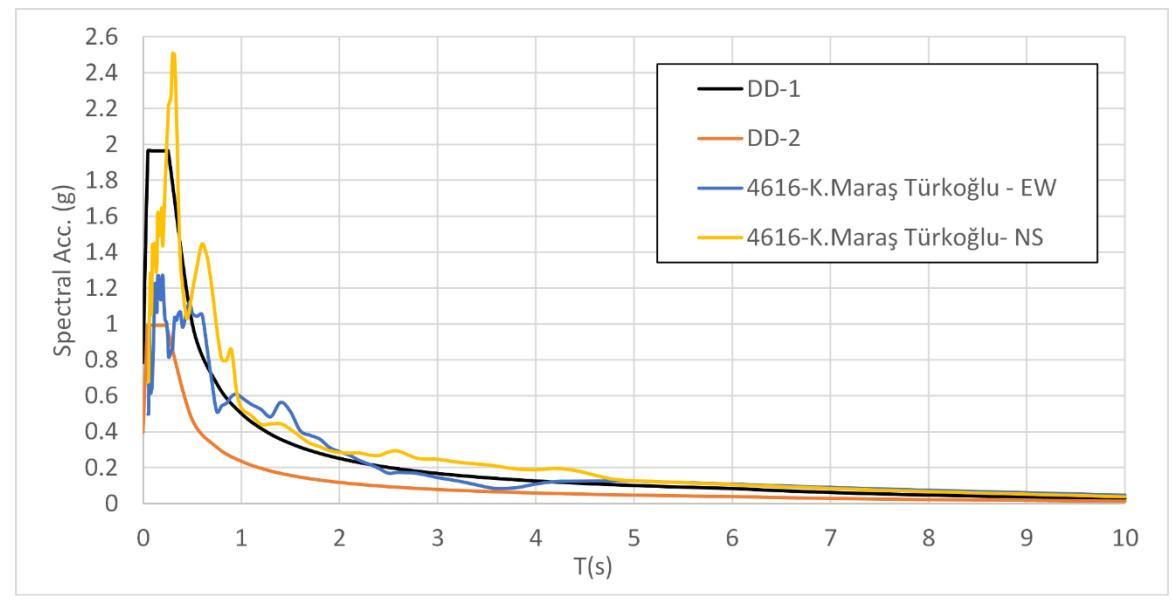
Figure 2.22 shows the response spectra at station TK.4616 (20.5 km from the epicenter, and 4 km away from the fault rupture) for the Mw 7.7 event at 01:17 UTC. This station is located in Türkoğlu district of Kahramanmaraş, and the soil characteristics are class ZB according to Eurocode 8 (shear wave velocity Vs30=390 m/s). The highest spectral accelerations of 2.5g and

1.38g are observed in the N-S direction at periods of 0.32 s and 0.65 s, respectively. Due to strong spectral content at short periods, a building at this location with a period of 0.1 to 0.75 s (typically 1 to 7 stories) will experience very intense shaking (larger than 1g). Additionally, there is strong spectral content (>1g) in the E-W direction at periods of 0.10 to 0.60 s.

Comparison of the response spectra for both horizontal components of this ground motion against the DBE and MCE indicates that except for the short period region (T<0.1 s), the response spectra at this location clearly exceed the design levels. For structures with periods larger than 0.4 s, it exceeds the MCE levels as well. Even in cases when the seismic hazard is accurately characterized, the current design philosophy of ductility-based design, adopted in the current and earlier versions of the Turkish Building Seismic Code (TBSC) and the seismic regulations of similar codes and standards around the world (including capacity design, confinement, and adequate detailing), aims at ensuring collapse prevention due to brittle failures and ensuring large levels of ductile response at damaged locations before failure. However, when the shaking experienced significantly exceeds the design levels, the provided ductility and energy dissipation capacity delivered by these principles of seismic design may not be sufficient and can lead to collapse. Based on judgment informed by benchmark studies of several code-conforming building systems, a maximum tolerable collapse risk of 10% is specified in FEMA P695 under MCE ground motions, and a collapse risk of 1% in 50 years is specified in the ASCE 07-22 provisions to define the seismic design parameters. Therefore, even code-compliant buildings could collapse when subjected to this intense motion.

Furthermore, it is possible that seismic detailing required by the code might not have been followed in the actual construction. For earthquake-resistant buildings, some degree of damage is expected when they are subjected to the design earthquake intensity, and this damage is generally repairable. However, when the shaking level significantly exceeds the design levels, such seismic design details may not be adequate to prevent collapse. This may explain the collapse of several mid-rise buildings in Kahramanmaras.

Finally, around 50% of the building stock in this area was constructed before 2000 and are more vulnerable under the experienced excessive levels of shaking. Another important factor related to the observed collapses is the demand that resulted from a Mw 7.7 earthquake followed by another earthquake (Mw 7.6) of a comparable size, and the high intensity aftershocks in between.

Figure 2.22. Spectral acceleration of the Mw 7.7 earthquake in comparison with the design spectra of DBE (DD-2) and MCE (DD-1) for horizontal components at station TK.4616.

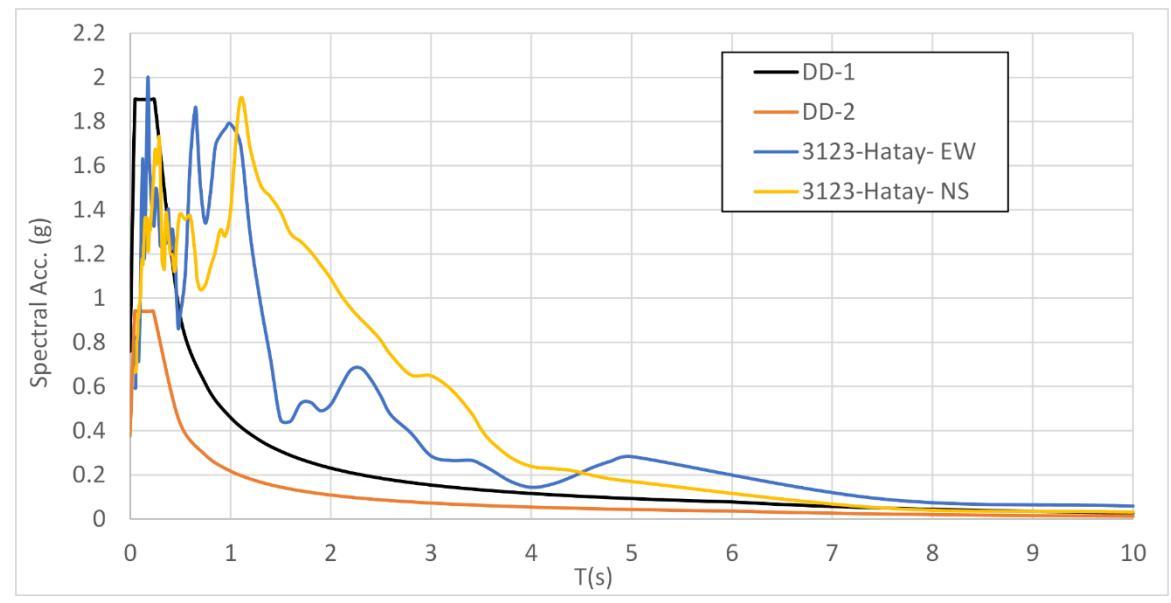
Figure 2.23 shows the response spectra at station TK.3123, which has R_{epi} =143 km and R_{rup} =20 km for the Mw 7.7 earthquake. This station is located in Hatay city center, and the soil characteristics are given as class ZB according to Eurocode 8, based on the shear wave velocity Vs30=470 m/s. Spectral accelerations larger than 1g and up to 2g are observed in both N-S and E-W directions at periods up to 2.00 s. Moreover, strong spectral content (larger than 0.5g) is observed for longer periods between 1.50 and 3.50 s. Mid- to high-rise buildings typically have natural periods in this range, and hence experienced severe shaking in both N-S and E-W directions. As mentioned above, the discussion on the possible reasons for the extensive destruction seems to be valid for buildings in this location as well.

Figure 2.23. Spectral acceleration of Mw 7.7 earthquake compared with the design spectra of DBE (DD-2) and MCE (DD-1) for horizontal components at station TK.3123.

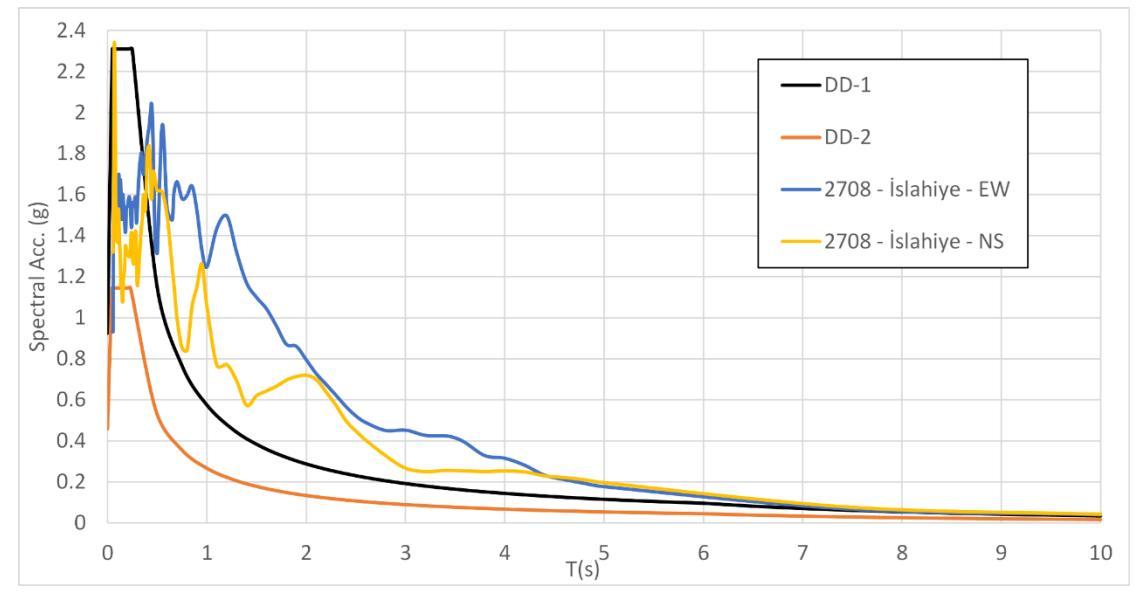
Two more response spectra comparisons with the corresponding design spectra at the site are presented in Figures 2.24 and 2.25 for stations TK.2708 and TK.3138, respectively. TK.2708 is in Islahiye district of Gaziantep (R_{epi} =41 km and R_{rup} =2 km) and TK.3138 is in Hassa district of Hatay (R_{epi} =72 km and R_{rup} =1.3 km). The soil characteristics are given as class ZB according to Eurocode 8 for both stations with Vs30=523 m/s and 618 m/s for Islahiye and Hassa stations, respectively. High spectral accelerations > 1g and as large as 2g are observed in N-S and E-W directions at periods up to 1.7 s, for both stations. The peak spectral acceleration reached 2.9g at a period of 0.85 s at Hassa station (N-S direction). Moreover, strong spectral content (>0.5g) exists for long periods up to 2.50 and 3.00 s. Without exception, the response spectra are significantly larger than the design spectra. As discussed above, spectral accelerations are significantly larger than DBE and even MCE levels for roughly the full range of possible natural periods of buildings in the region. The high spectral content at periods larger than 1.00 s observed in Figures 2.23 to 2.25 suggest potential significant local site amplification and potential basin effects.

Figure 2.24. Spectral acceleration of Mw 7.7 earthquake compared with the design spectra of DBE (DD-2) and MCE (DD-1) for horizontal components at TK.2708.

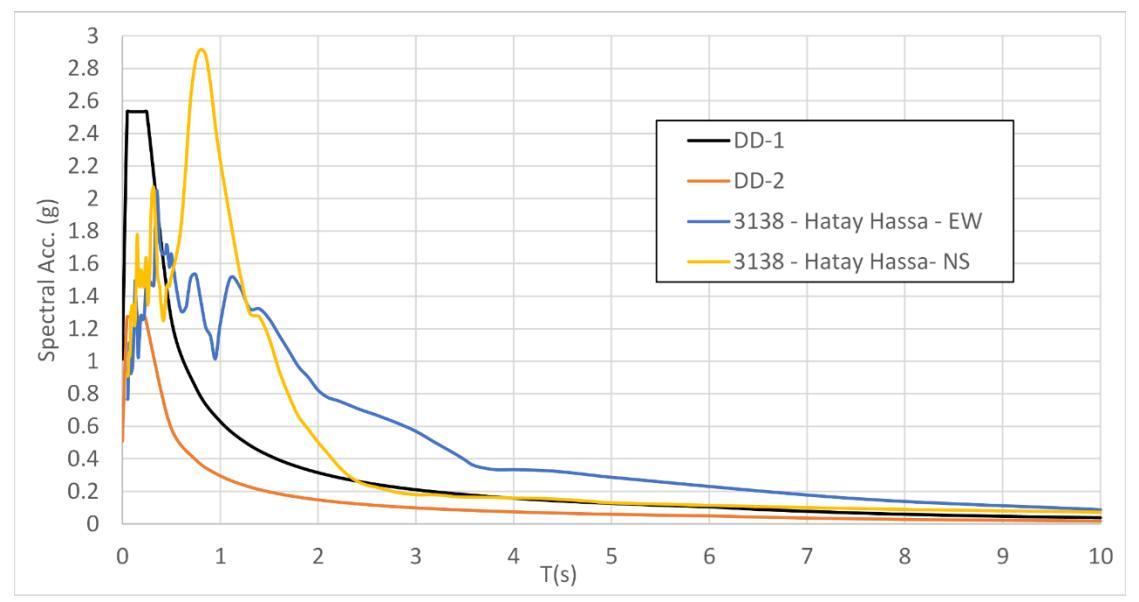
Figure 2.25. Spectral acceleration of Mw 7.7 earthquake compared with the design spectra of DBE (DD-2) and MCE (DD-1) for horizontal components at TK.3138.

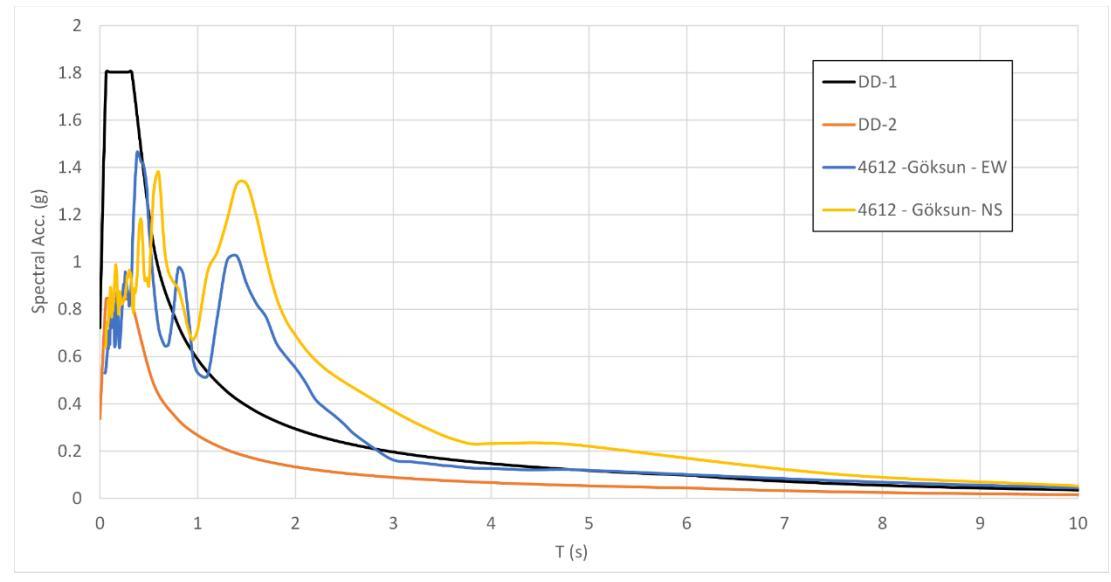
The strong motion duration D5-95 at this station are 25.91 s (E-W) and 20.15 s (N-S) [https://tadas.afad.gov.tr/waveform-detail/275963]. The Vs30 at TK.4612 (Göksun seismometer location) indicates soft soil which has a tendency of higher shaking at longer periods. Figure 2.27 shows large spectral content at longer periods (> 0.3 s) in both directions. In the N-S direction, the spectral accelerations exceed 1g for periods of 1.00 to 2.00 s with the potential of causing heavy damage in high-rise buildings (10 stories and higher). This aligns with reports that "the downtown district with taller buildings was hit particularly hard, while residential areas outside the city center had less apparent destruction" (Abraham et al. 2023).

Comparing the response spectra at TK.4612 with the hazard spectra indicates that observed shaking exceeds the DBE level hazard spectra (10% exceedance in 50 years, or 475-year return period) at almost all periods and exceeds the MCE level hazard spectra (2% exceedance in 50 years, or 2475-year return period) at all periods above about 0.50 s. Engineered structures that are designed to resist seismic forces are typically designed to prevent collapse at MCE-level shaking. As a result, tall buildings at this location that would have been engineered to prevent collapse at MCE levels could experience heavy damage or collapse in this earthquake given that the shaking exceeded the MCE levels by a factor of 2 to 3 for certain periods.

Figure 2.27. Spectral acceleration of Mw 7.6 earthquake in comparison with the design spectra of DBE (DD-2) and MCE (DD-1) for horizontal components at station TK.4612.

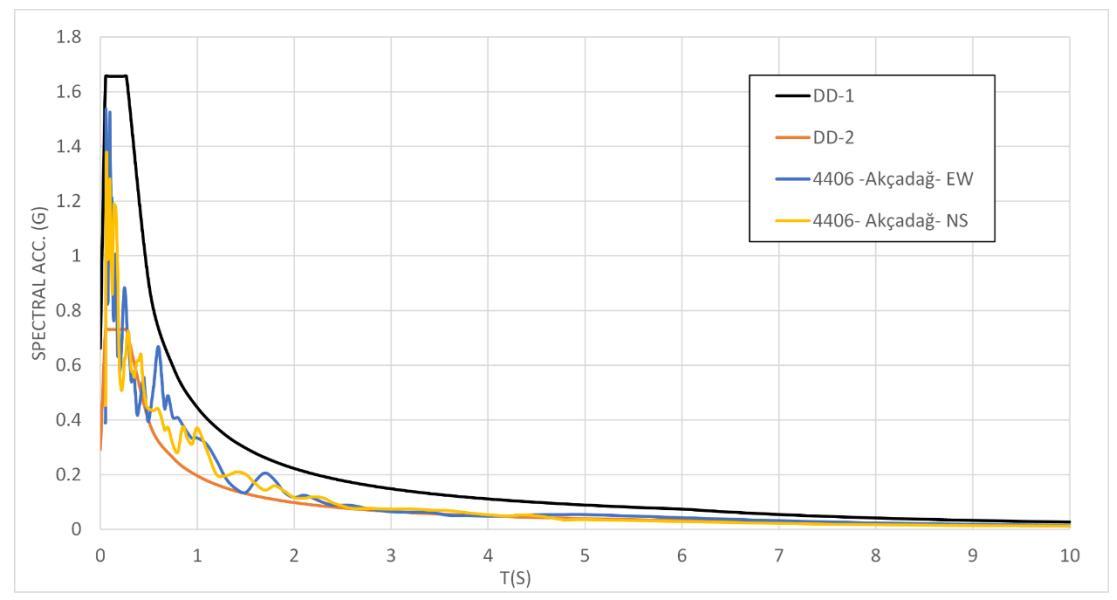
The impact of the earthquake sequence on buildings is clearly location dependent. For the same earthquake, the observed response spectra at station TK.4406 in Akçadağ (Figure 2.27) do not exceed the MCE levels at any value of natural period. However, the DBE level is exceeded by the observed response spectra. As a result, engineered buildings at this location may be able to withstand this shaking without collapse, albeit while sustaining moderate to heavy damage.

Figure 2.28. Spectral acceleration of Mw 7.6 earthquake in comparison with the design spectra of DBE (DD-2) and MCE (DD-1) for horizontal components at station TK.4406.

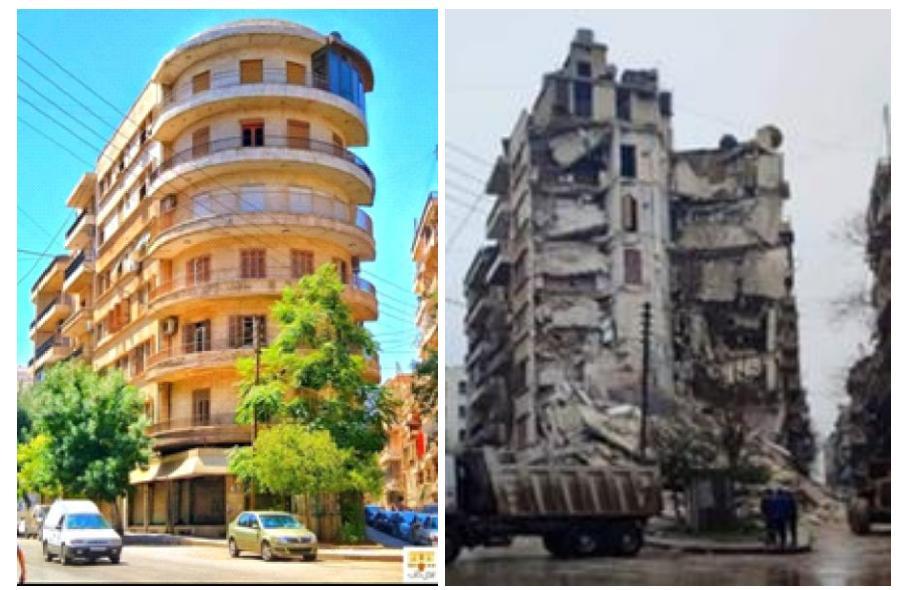
Figure 3.2 shows an example of common flawed practices in non-engineered buildings promoted through a local "Reconciliation Law", which allowed building owners to register the building with little or no structural review or building inspection/assessment. Furthermore, permits were granted to recently registered buildings of less than 6 stories to allow construction of additional stories (up to 6) despite being non-engineered buildings with unknown column and foundation capacity. Those additional floors were built completely from hollow concrete block bearing walls, and solid slabs that are 60 to 80 mm thick with no beams and insufficient reinforcing bars.

Figure 3.2. An Aleppo City mid-rise non-engineered building before and after the earthquakes, (Source: Salah Haj Ismail personal Archive).

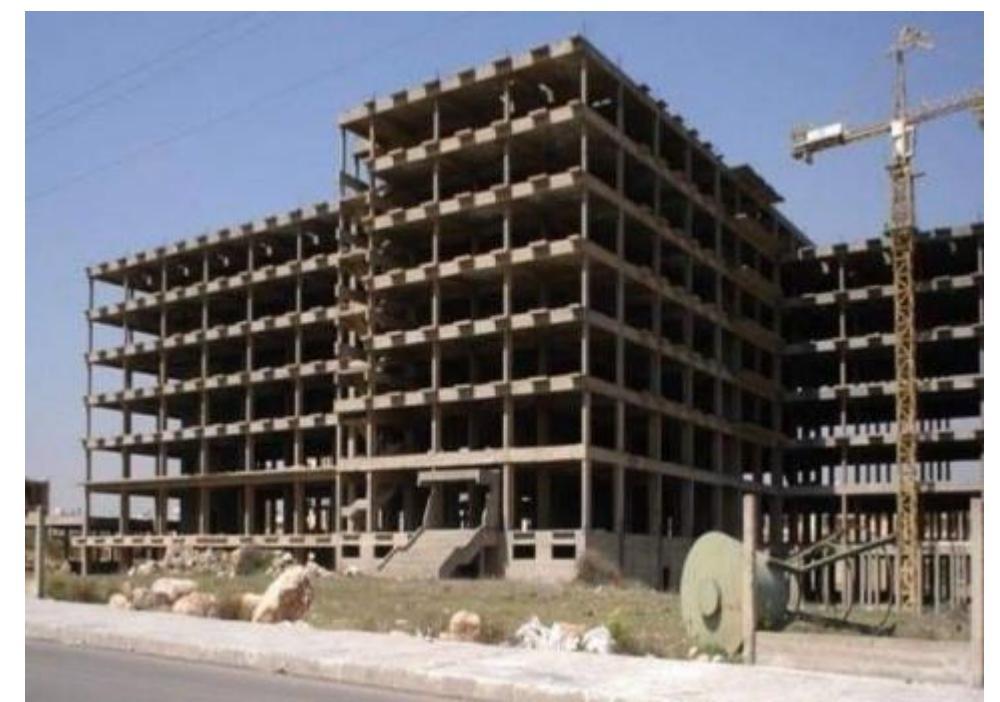
Another example is related to earthquake-resistant designed public buildings and hospitals. In this case, as-built conditions were substantially different from the structural drawings. For instance, the local special moment frames were usually built with substandard quality, reinforcement quantity and details, such as using smaller diameter reinforcing bars or even removing the reinforcement totally from some members.

Figure 3.3. The structure of Aleppo military Hospital, Aleppo City - Construction was not compatible with the study (Source: Salah Haj Ismail personal Archive).

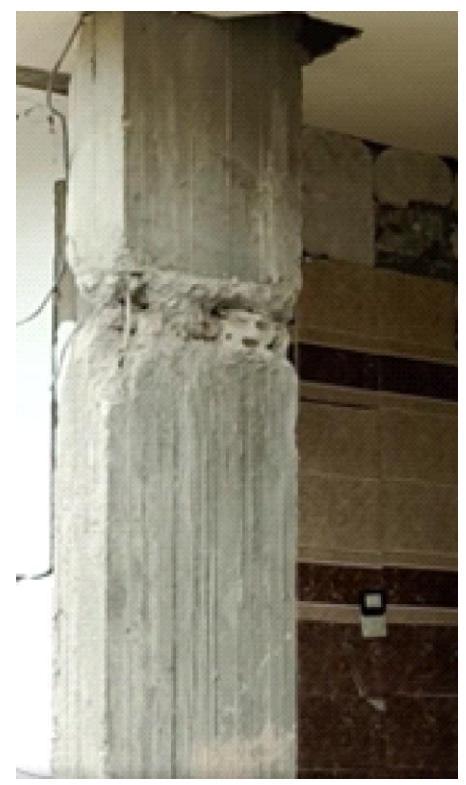
• The multi-story low-rise and mid-rise non-ductile concrete systems in Northern Syria are evidently thin joist slabs with hollow blocks or flat plates, with no drop beams and no or very shallow spandrel beams that are slightly deeper than the slabs. Columns are apparently thin with extremely low reinforcement ratios, small diameter reinforcing bars and poor confinement (refer to Figure 3.3). These buildings appear to be non-engineered or poorly engineered at best with no shear walls, perhaps built post 2011 war. Concrete quality appears low from inspection of damaged photographs. For the low-rise buildings (1 to 2 stories) in these areas, unreinforced masonry seems more common.

Figure 3.3. Damaged RC column with severe deficiency of reinforcement (Source: Personal image by Eng. M. Zakaria member of damage assessment commision).

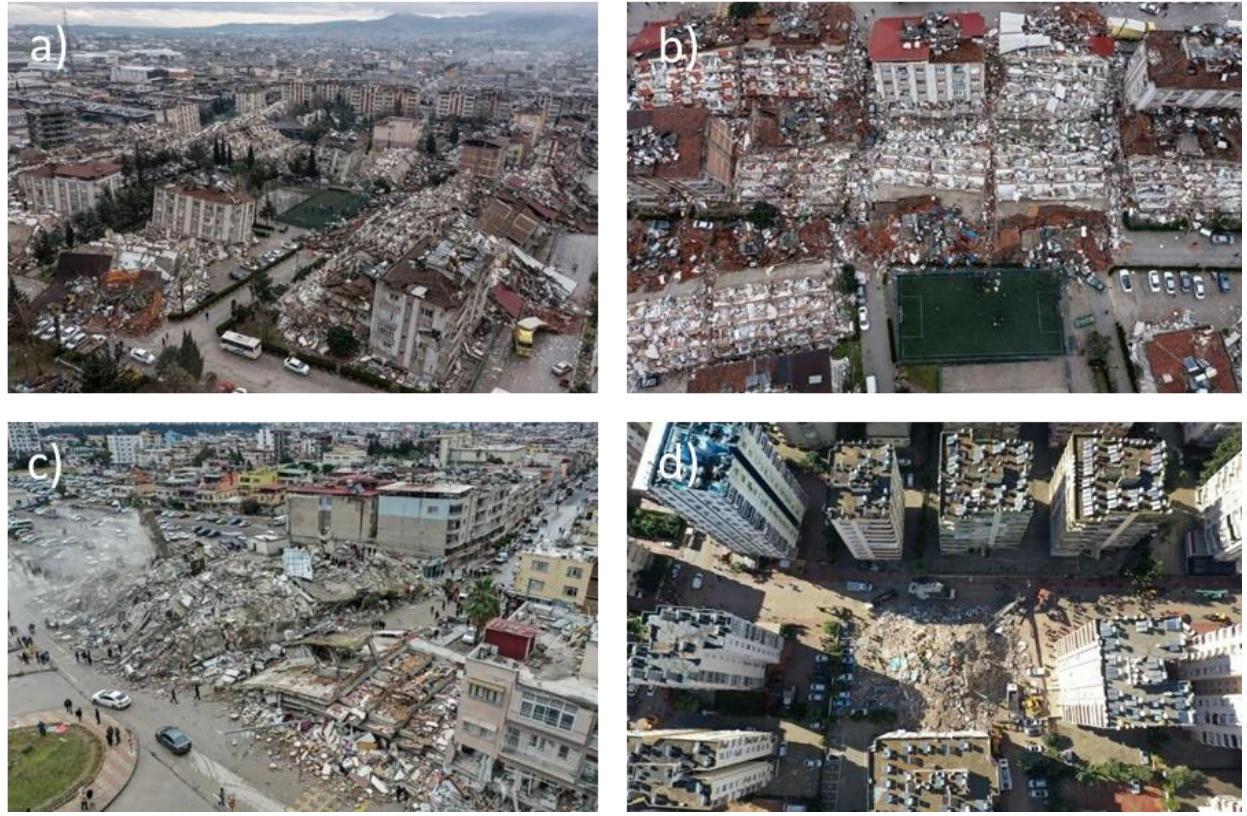
Figure 4.3. Aerial views of the extent of damage in some cities in Türkiye after the earthquakes: a) and b) show mid-rise RC residential buildings that have collapsed in a side-sway manner, while nominally identical buildings in the same developments are damaged but have not collapsed; c) shows two corner RC buildings that have collapsed, possibly due to torsional eccentricity; d) shows a single high-rise building that has collapsed among other similar highrise buildings that did not collapse (Source: (a) <u>Getty Images via BBC</u>, (b) <u>Independent</u>, (c) <u>Getty Images via CNN</u>, (d) <u>Getty Images via CNN</u>).

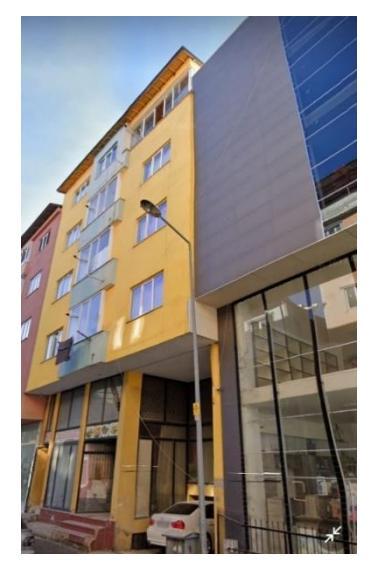
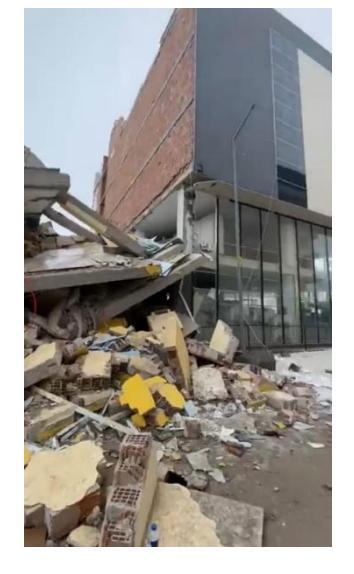
(1) The first story of the 5-story building in Figure 4.4 is much taller than the other stories, leading to a soft story. The intact columns of the collapsed building in the above stories show that most of the lateral displacements concentrated at the soft first story, resulting in eventual collapse of the structure. It is observed that the adjacent building, with glass façades at the first two stories, has also high potential to have soft stories because of the glass façades or openings at the first two stories and the infill walls at the upper stories. This adjacent building has not collapsed. The differences in the concrete and reinforcing bar strength, quantity, and detailing could be the reasons why one building collapsed and the adjacent one did not. However, another reason can be the potential pounding of the first floor of the standing building at a location above the mid-height of the first story corner column of the collapsed building. This additional shear force could have led to the collapse

of the corner column, leading to a progressive collapse. Another set of adjacent buildings with inadequate seismic gap is shown in Figure 4.5, where one of the buildings collapsed. Insufficient seismic gap results in increased damage when the adjacent buildings have different periods (e.g., due to different number of stories) and the consequent pounding of buildings due to the asynchronous motions. Collapse of weak/soft story (due to glass façades of stores at the first story) of adjacent buildings with different number of stories and with insufficient seismic gap is observed in Figure 4.6.

(a) Before (Source: <u>Google Maps</u>).
 (b) After (Source: <u>Eren Uslu via Twitter</u>).
 Figure 4.4. Collapse of a 5-story RC building in Afsin, Kahramanmaras.

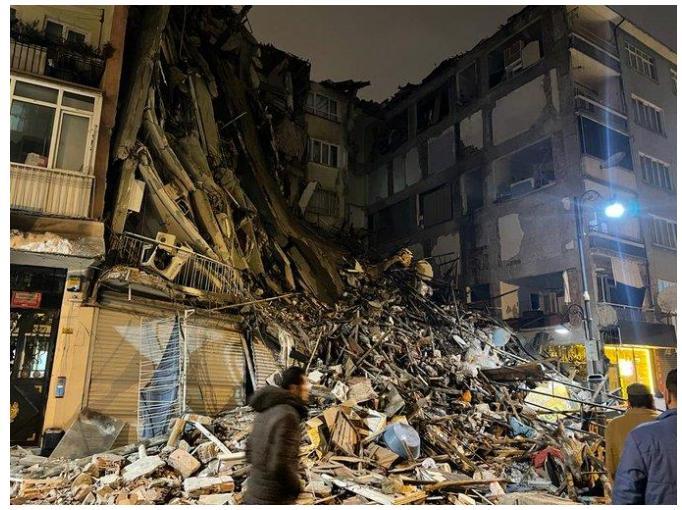
Figure 4.5. Ruins of a collapsed building showing no seismic gap between adjacent buildings, Malatya (Source: <u>Darkwebhaber via Twitter</u>).

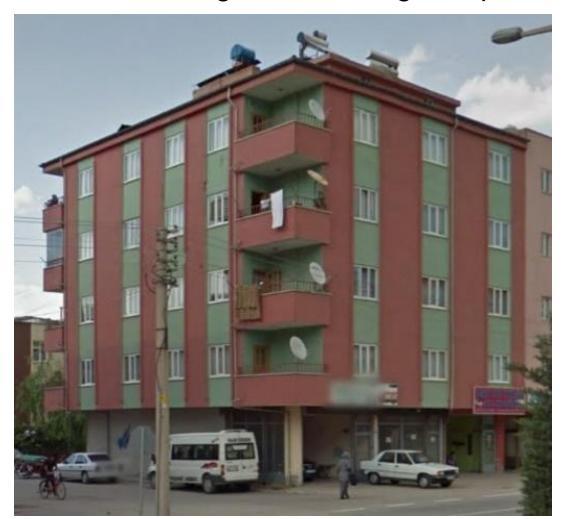
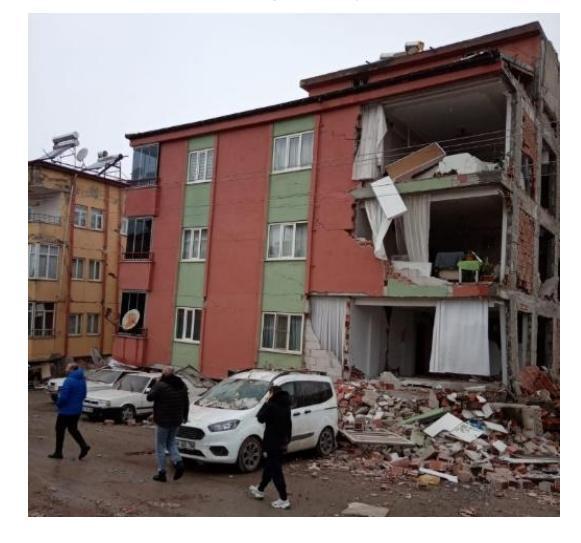
(2) The building in Figure 4.7 has larger openings at the first story, with infill walls at the upper stories, resulting in a weak and soft first story. It is observed that the first two stories of this building collapsed, where the second story collapse likely occurred due to the impact of the first story collapse. Out of plane wall failures in all stories of the exterior bay indicate larger accelerations experienced by these walls due to torsional irregularity and the twist of the building. This building collapsed after the second earthquake (Mw 7.5 in Elbistan).

(a) Before (Source: <u>Google Maps</u>).(b) After (Source: Kece, Local Assessor).Figure 4.7. Soft-story failure of a 5-story RC building with masonry infill walls in Elbistan.

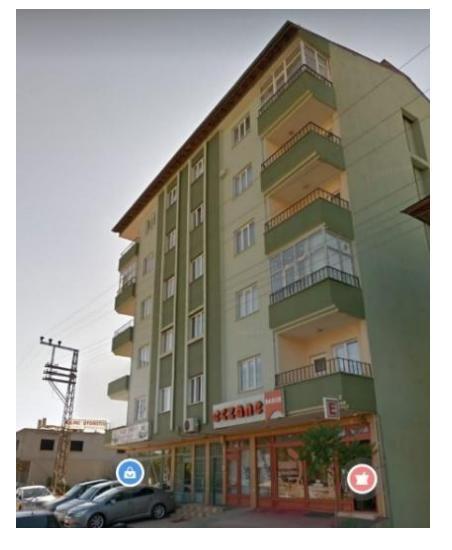
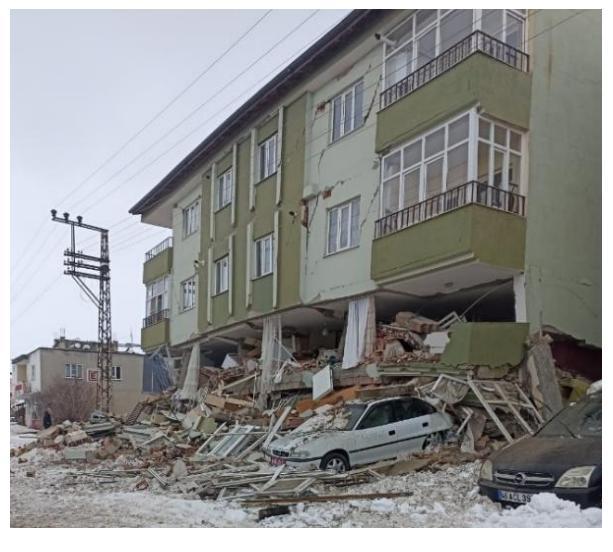
- (3) The 6-story building in Figure 4.8 is a mixed-use building with a pharmacy and a grocery store at the first story, and residential occupancies at the upper stories. The window openings at the first story and the infill walls at the upper stories resulted in a weak and soft first story, leading to collapse of the first story. It is likely that the first story glass façades were only at the front of the building, with infill walls at the back and sides. This nonuniform distribution of infill walls around the perimeter could have increased the torsional response during ground shaking.

Figure 4.8. Soft-story failure of a 6-story RC building in Afsin, Kahramanmaras during the Mw 7.5 earthquake in Elbistan.

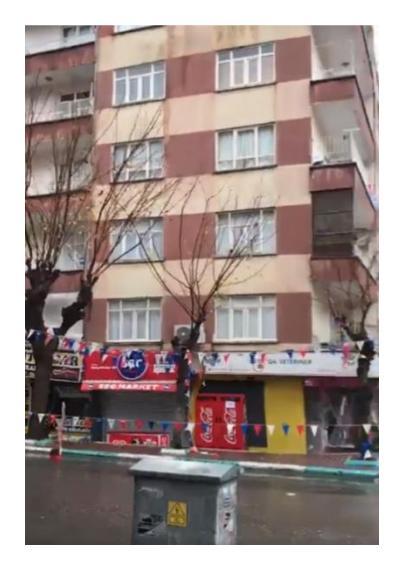
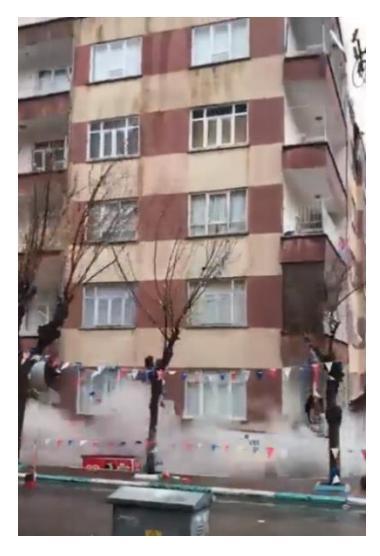
- (4) The 7-story mixed use RC building in Figure 4.9 likely collapsed due to similar reasons as indicated for the collapse of the 6-story mixed use building in Figure 4.8. It is located on a street corner with shopfront openings on both streets, and presumably solid fire walls on the back sides of the building. The torsional effects during ground shaking would impose large shear and bending demands on the front corner column (yellow color in Figure 4.9a). The video of this event indicates that failure of this column initiated total collapse of the building.

(a) Building prior to collapse.
 (b) Collapse of weak/soft story prior to gravity collapse.
 Figure 4.9. Images from collapse videos of a 7-story mixed use building in Sanliurfa during the Mw 7.5 earthquake in Elbistan (Source:<u>https://www.youtube.com/watch?v=I_KCORMZQbI</u>).

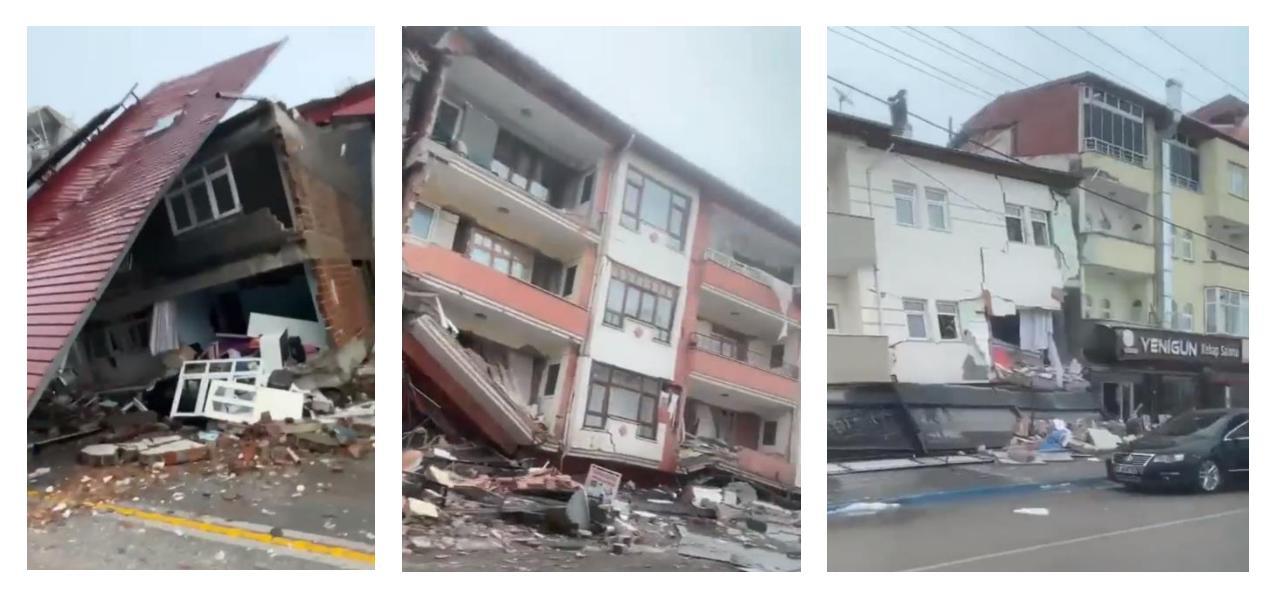
- (5) Other examples of collapses due to potential weak/soft stories are provided in Figures 4.10 and 4.11. RC frames with unreinforced masonry infill walls is a common structural topology in Türkiye. In low levels of excitation, these infill walls add to the stiffness and strength of the structure, providing beneficial contributions. However, even in cases where the infill walls are uniformly distributed along the height of the structure and there are no initial soft or weak stories, brittle failure of the infill walls due to in-plane/out-of-plane interaction can lead to the formation of soft stories during an earthquake (Günay and Mosalam 2015), leading to eventual collapse. Considering the two strong earthquakes (Mw 7.8 and Mw 7.5) and the aftershocks between them, the formation of soft stories due to infill walls in the first event could have led to the collapse of these structures during the second event, as shown in Figures 4.4 to 4.10.

Figure 4.10. Soft-story collapse of residential buildings in different cities (Sources: <u>The Insider</u> <u>Paper via Twitter</u> & <u>AlertaNews24 via Twitter</u>).

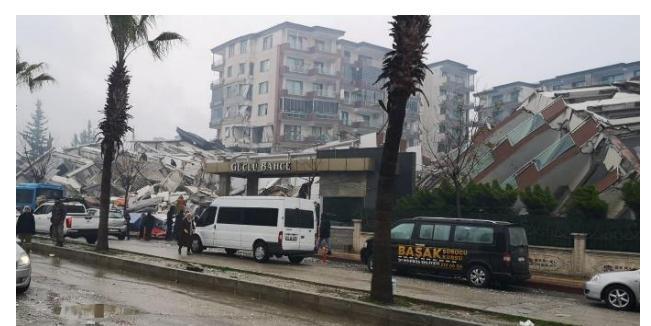
Figure 4.11. Güclü Bahçe residential building complete collapse in Hatay (Source: Twitter).

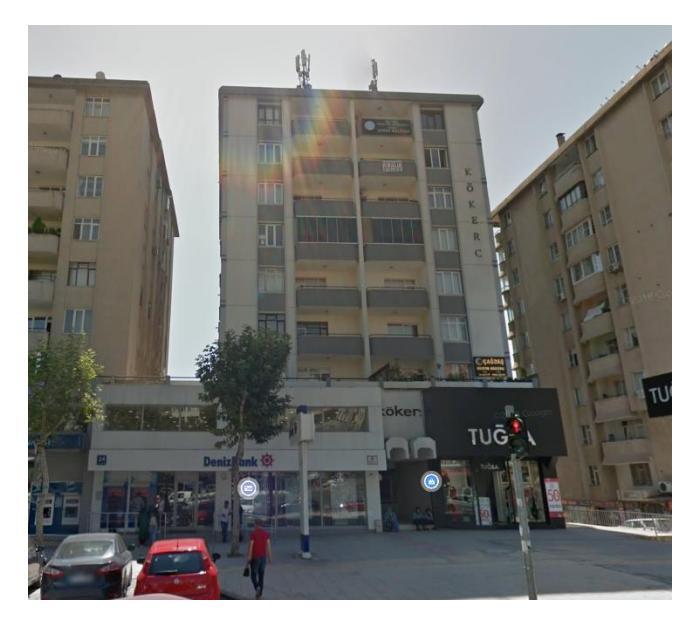
- (9) The 7-story building on a 2-story podium in Figure 4.12 is a mixed-use building, where the podium is used as a commercial space and the 7-story building has residential units. The first story of the podium structure has glass façades and is weaker and softer than the second story of the podium. This is a potential reason for the collapse of this building. As observed from the right figure, all stories of the 7-story building collapsed, likely due to the impact of the podium collapse.

Figure 4.12. Collapse of a 7-story mixed-use building in Kahramanmaraş.

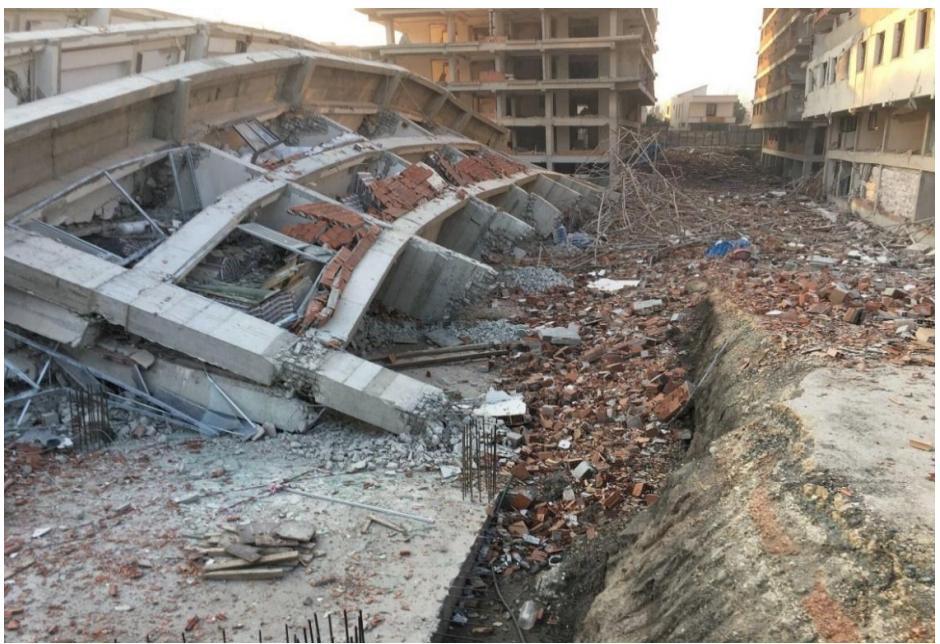
Figure 4.16. Collapse of an RC building under construction (Source: <u>Earthquake Engineering</u> <u>Association Turkey</u>).

An RC residential building with shear walls, newly constructed in 2022, had a catastrophic collapse as shown in before and after images in Figure 4.15. Another new residential RC building with shear walls collapsed while it was under construction (Figure 4.16). In this figure, shear walls are oriented along one direction of the building. Extensive concrete crushing is visible at the shear wall base, denoting sliding-shear failure, as well as diagonal concrete crushing (e.g., refer to the third wall after the corner column), suggesting a combined flexure-shear diagonal failure. Furthermore, an axial failure of a corner beam-column joint is visible, with a possible under-design or shortage of sufficient confinement. Significant beam yielding along the orthogonal direction to

the building lateral collapse in the shear wall direction might have led to shear and axial failure of the joint.

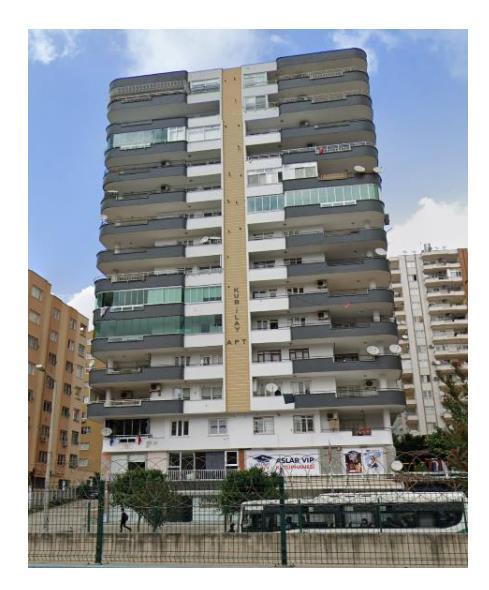
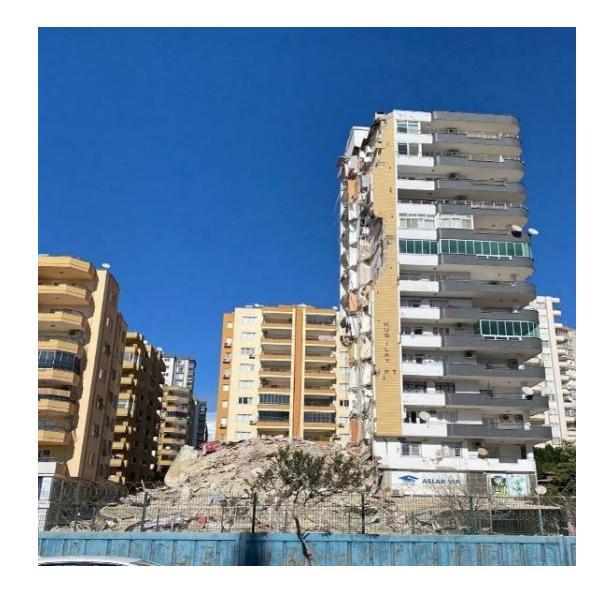
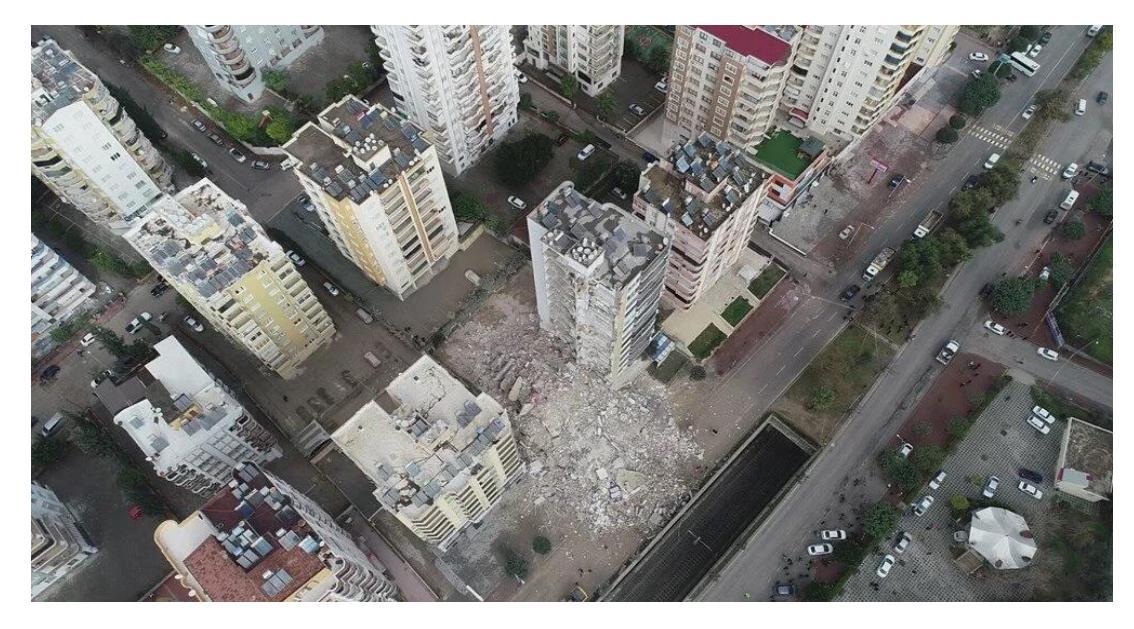
Figure 4.19. Partial collapse of a 15-story concrete mixed-use building, Adana (37.049N 35.275E).

In addition to the numerous failures shown above, Figure 4.19 (b) and (c) show that half of a 15story mixed-use concrete building collapsed by separation from the other half. This collapse was reported to occur after a Mw 6.1 aftershock. From the top view of the building, an excessive reentrant corner can be seen in the middle. This reentrant corner could have led to excessive stress concentrations at that portion of the building (FEMA-P154, 2012). This may have caused the splitting of one half of the building from the other contributing to the collapse of the split half. It is also noted that the same reentrant corner is present in similar buildings in the neighborhood that are standing, hinting at possible other structural issues of this collapsed building.

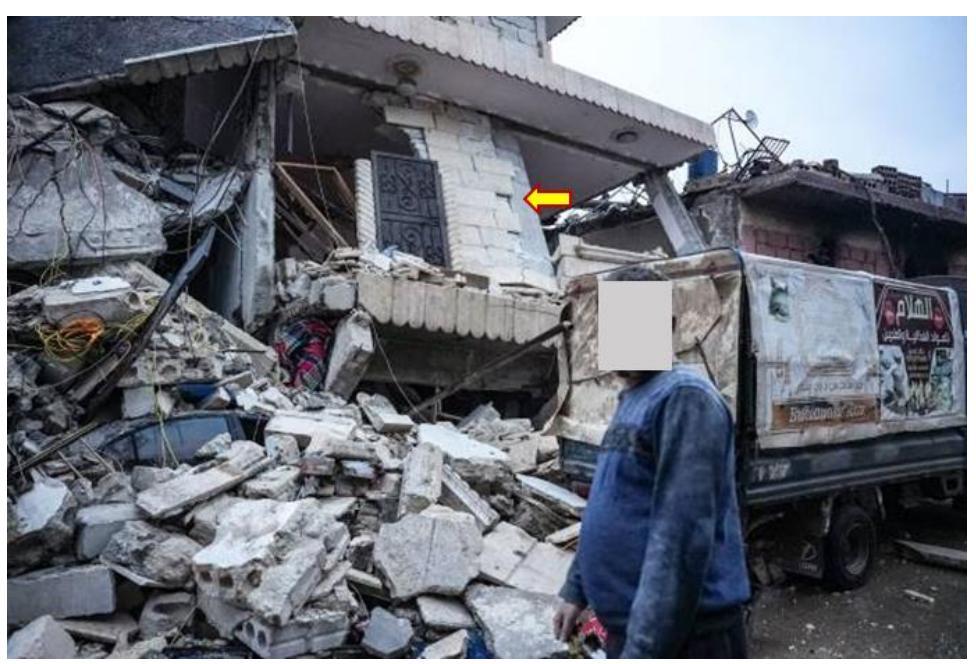
Figure 4.22. Collapse of a multi-family low-rise unreinforced masonry building in Aleppo (Source: <u>Getty Images</u>).

It is evident from the partial collapse photographs that some older buildings in Syria were constructed with no gap to neighboring buildings of the same height, perhaps using the neighboring building as formwork for concrete elements (Figures 4.22, 4.23 and 4.27), which may have helped avoiding total collapse or preventing collapse in some instances. Pounding effects may have been relatively reduced due to such configurations.

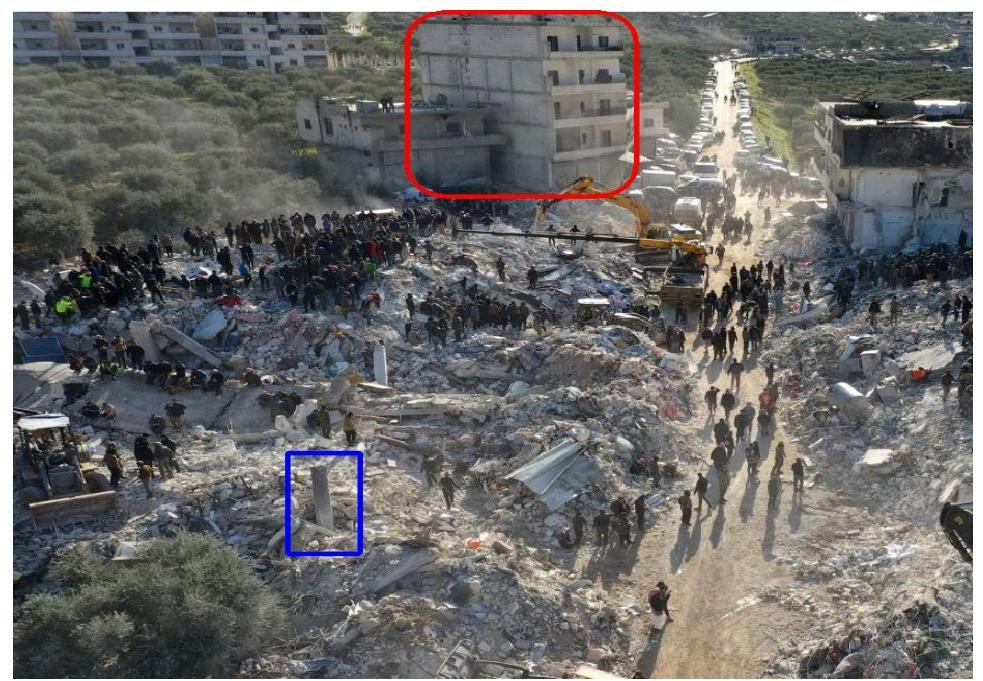
Figure 4.26. Collapsed masonry & RC buildings, Besnaya, Reef Idlib (Source: AFP via npr.org).

- Concrete quality/strength appears very low by visual inspection of texture and color, as well as the severity of crushing following collapse. Syrian engineers contacted after the event confirmed the low quality of the concrete used. This can be observed in Figures 4.25, 4.26 and 4.30 to 4.32.

- Thin RC column sections, suggesting no seismic design was conducted, and even in some cases appearing to be under-designed for gravity loads. This is common in non-engineered buildings. Thin columns can be observed in many damaged buildings; examples are seen in Figures 4.26 to 4.29, 4.31, and 4.32.

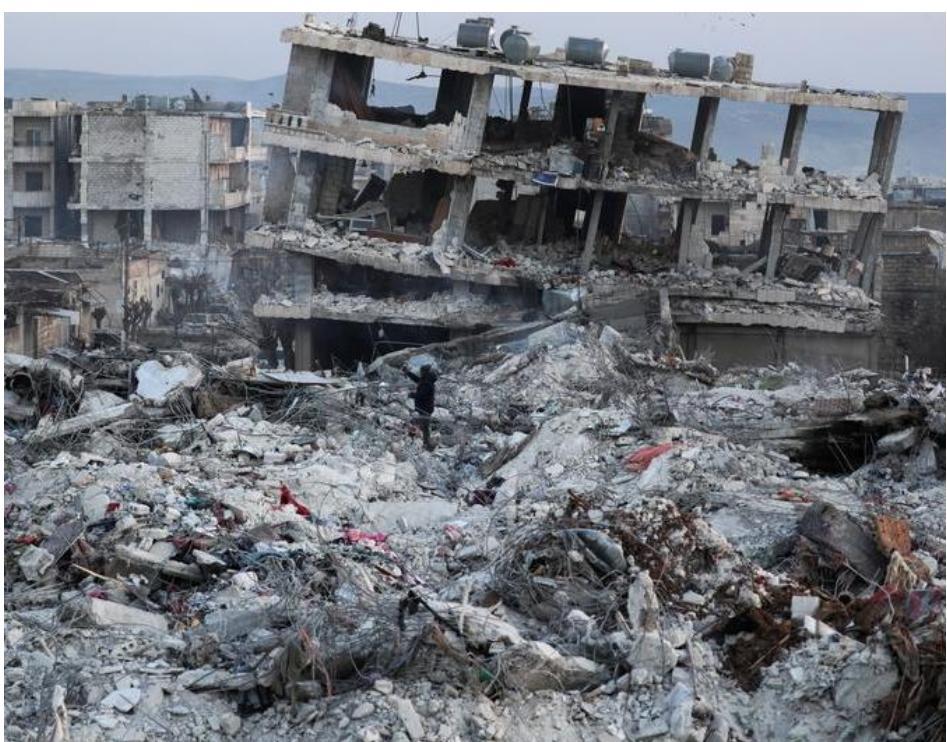
- Many buildings had lightly reinforced column sections, with no or little transverse reinforcement, and potentially inadequate lap splices located immediately above the slabs. Examples of such deficiencies can be observed in Figures 4.27 to 4.32.

- The orientation of the column section in several buildings is in one direction for all columns, rendering the weak-axis direction of the building, in the absence of shear walls, very vulnerable even to moderate shaking. These columns are often extremely thin in one direction. This can be observed in the columns at the right side of the building in Figure 4.30, the exterior columns in Figure 4.31, and all columns in the building in Figure 4.33.

Figure 4.30. Collapsed building (foreground) and a partially collapsed RC building (background) in Jandires, Northern Syria (Source: <u>Reuters</u>).
