StEER-EERI: 2023 Mw 7.8 Kahramanmaras, Türkiye Earthquake Sequence Joint Preliminary Virtual Reconnaissance Report (PVRR)

JOINT PRELIMINARY VIRTUAL RECONNAISSANCE REPORT (PVRR)

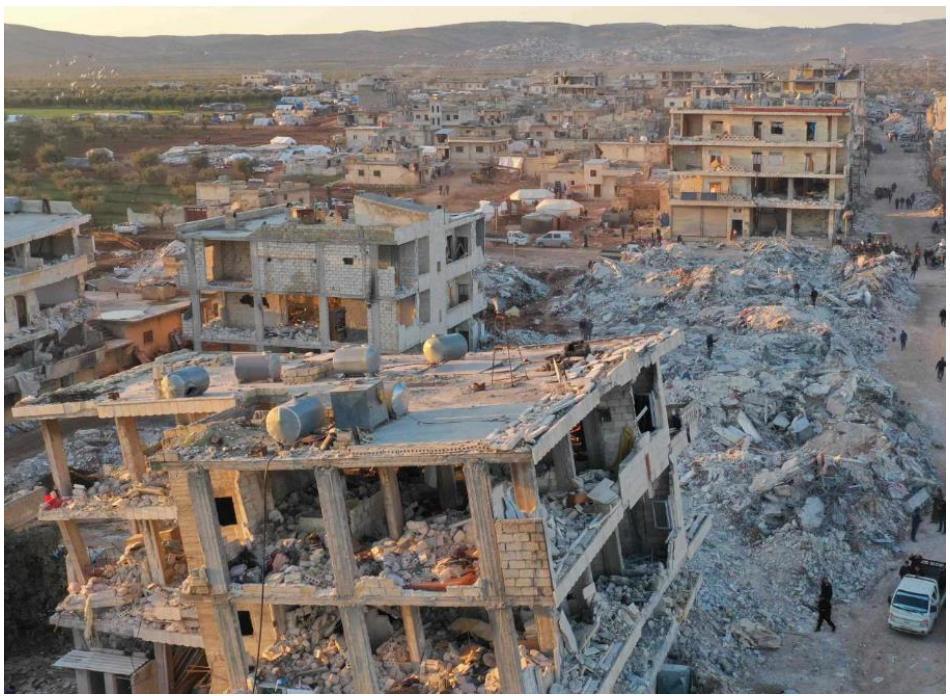
- Concrete quality/strength appears very low by visual inspection of texture and color, as well as the severity of crushing following collapse. Syrian engineers contacted after the event confirmed the low quality of the concrete used. This can be observed in Figures 4.25, 4.26 and 4.30 to 4.32.

- Thin RC column sections, suggesting no seismic design was conducted, and even in some cases appearing to be under-designed for gravity loads. This is common in non-engineered buildings. Thin columns can be observed in many damaged buildings; examples are seen in Figures 4.26 to 4.29, 4.31, and 4.32.

- Many buildings had lightly reinforced column sections, with no or little transverse reinforcement, and potentially inadequate lap splices located immediately above the slabs. Examples of such deficiencies can be observed in Figures 4.27 to 4.32.

- The orientation of the column section in several buildings is in one direction for all columns, rendering the weak-axis direction of the building, in the absence of shear walls, very vulnerable even to moderate shaking. These columns are often extremely thin in one direction. This can be observed in the columns at the right side of the building in Figure 4.30, the exterior columns in Figure 4.31, and all columns in the building in Figure 4.33.

Figure 4.31. Collapsed buildings in Harem, Reef Idlib, Northern Syria (Source: <u>wsiu.org</u> 2023).

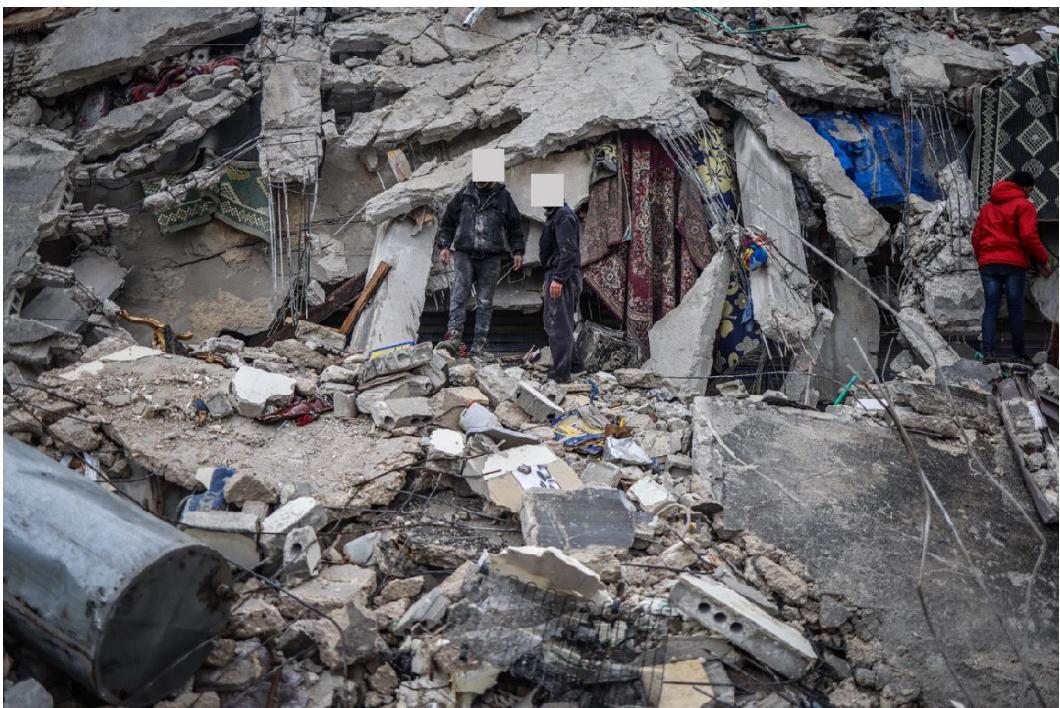
- Absence of drop (projected) beams below the ribbed slab and flat plate systems. This creates a slab-column connection situation (no beam-column joints) which is known to perform poorly under severe earthquake shaking unless well reinforced. This condition can be observed in Figures 4.27 to 4.29, 4.32, and 4.33.

- Absence of seismic details throughout as seen on most photographs of damage. These include insufficient anchorage, development length, and continuity of slab reinforcement, and absence of integrity reinforcement. Refer to Figures 4.27 to 4.29, and 4.32 to 4.35.

Figure 4.32. Collapsed RC building in Idlib. Notice the poor or absent confinement in columns, small and light longitudinal column bars, and poor concrete quality (Source: Anas <u>Alkharboutli/picture alliance via CNN</u>).

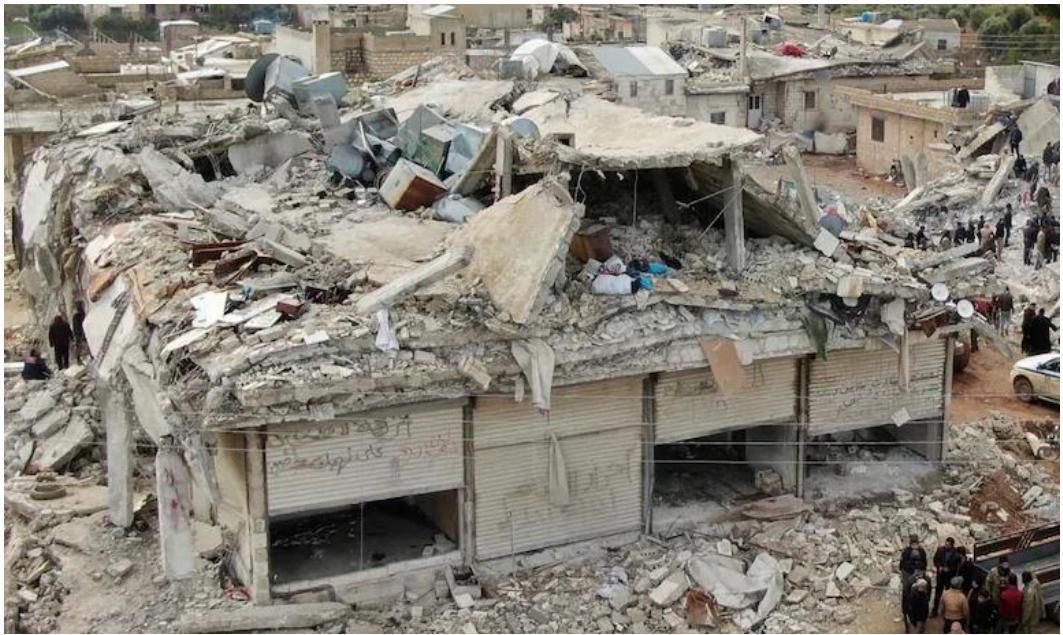
The diaphragm (floor slab) failure was commonly observed in many buildings (Figures 4.27 to 4.29, 4.32 and 4.33) when the horizontal diaphragm is unable to resist lateral forces during strong shaking or it is separated from the vertical system due to anchorage failure. The absence of slab integrity reinforcement, lack of continuity reinforcement, and poor anchorage to columns are evident in these figures. Very vulnerable slab-column connection conditions resulted from the absence of beams along with poor anchorage to columns, and in many instances, it is speculated that the collapse sequence was triggered by these vulnerable connections, as shown in the red rectangles in Figure 4.28.

Figure 4.33. Collapsed concrete slab without beams and lacking continuity and integrity reinforcement. Note also the extremely narrow columns in one direction (Source: The Telegraph, 2023b).

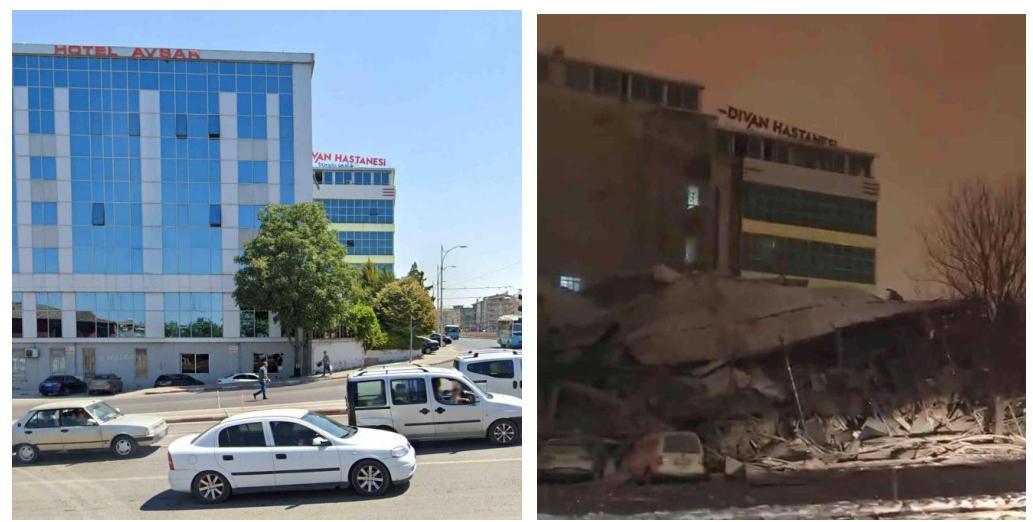
Figure 4.37. Before and after photographs of Hotel Avsar showing the building collapse in Malatya (38.3516N 38.3002E) (Source: <u>NY Times</u> and <u>Yedinoktabir via Twitter</u>).

Several partial and total collapses of commercial buildings were reported in Türkiye. In Malatya, Hotel Avsar (a 10-story RC building) and Trend Garden Residence (an 8-story RC building) completely collapsed (Figures 4.37 and 4.38). According to Google Earth data, the buildings had been renovated during the past two years and appear new. However, Google Earth imagery shows that the buildings have existed at least since 2001. Therefore, these buildings are in the category of pre-2000 buildings in Türkiye that were not designed according to the advances in the 1998 version of the TBSC. This can be one of the reasons for the observed collapse. Malatya was close to the end of the fault rupture in both the Mw 7.8 and Mw 7.5 earthquakes, impacted by forward directivity. The large displacement demands due to the forward directivity effects during these two events and the strong aftershocks in between likely contributed to the observed collapse.

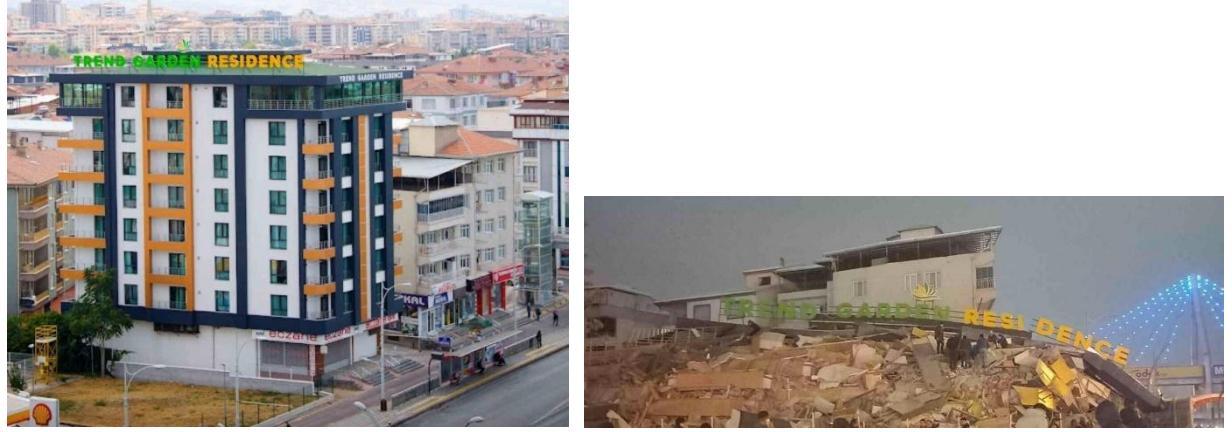
Figure 4.38. Before and after photographs of Trend Garden Residence showing the building collapse in Malatya, the pancake collapse of all stories suggests major structural problems. (38.347N 38.283E) (Source: <u>NY Times</u>).

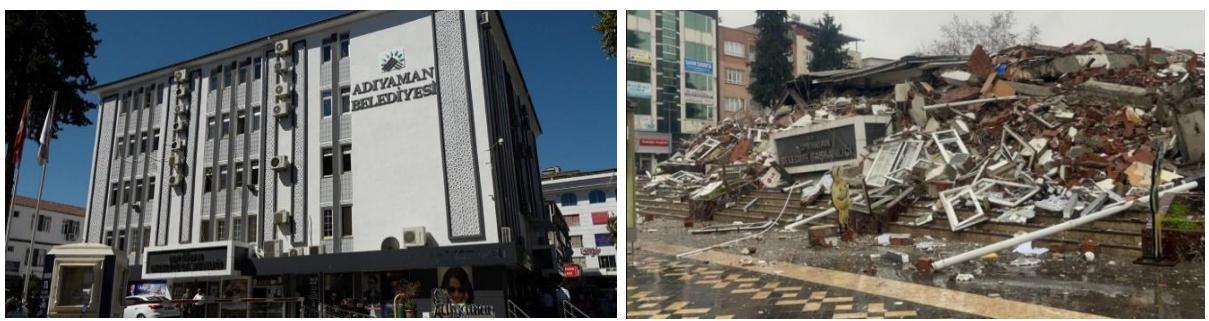
Figure 4.39. Adiyaman municipality building before and after the earthquake sequence (38.2441N, 36.9151E) (Source: <u>Twitter</u>).

Government facilities play a key role during extreme events like earthquakes. The continuing functionality of these facilities is essential. Some of the government buildings in Türkiye experienced extensive damage and some collapsed. For instance, Figure 4.39 shows the collapse of a municipality building in Adiyaman, Türkiye. Figure 4.40 shows the collapse of the first story and extensive damage to the second and third stories of a municipality building in Afsin, Türkiye.

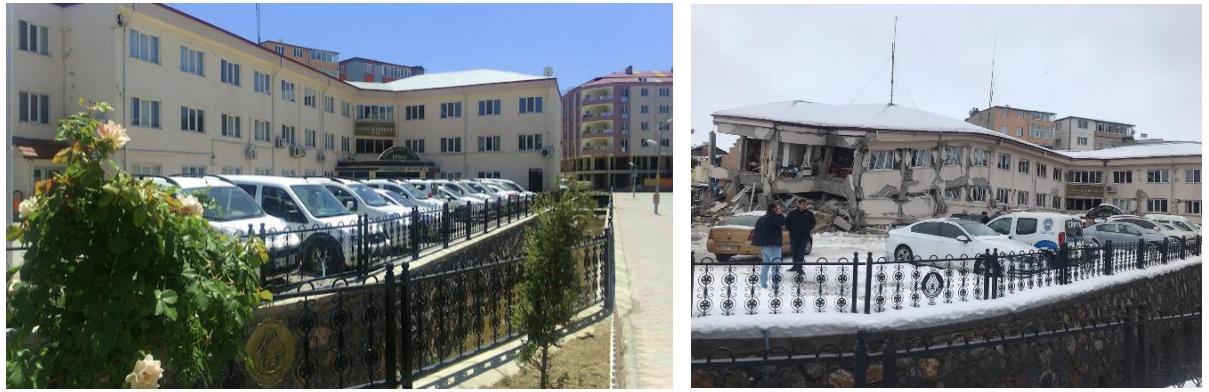
Figure 4.40. Afsin-Kahramanmaras municipality building before (Source: <u>Google Map</u>) and after (Source: <u>Twitter</u>) the earthquake sequence (38.2441N, 36.9151E). The collapse of one wing of this building with an L-shape plan might be due to torsional effects and plan irregularity.

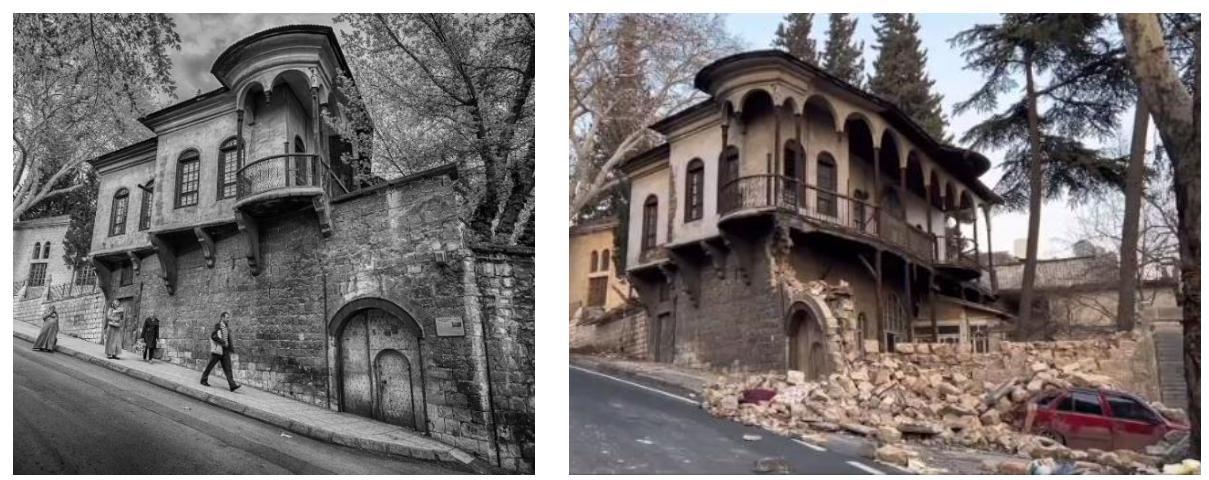
Figure 4.41. Damage in a masonry structure in Kahramanmaraş province, 37.5870N 36.9307E (Source: <u>Twitter</u>).

Figure 4.41 shows the partial collapse of Ciftarslan House external enclosure wall in Kahramanmaraş province. This house is a 2-story structure built in 1928 and is part of the Turkish architectural heritage that has survived for nearly a hundred years. According to Paköz (2019), this house is a part-masonry and part-timber structure. The lower floor perimeter walls of the house were built of stone masonry, and the intermediate and upper floor walls were made of wooden frames filled with adobe material. After the earthquake sequence, no visible cracks were recognized in the house facade. However, part of its enclosure wall collapsed. This collapse might

be due to an out of plane (OOP) bending mechanism of the very tall walls without transverse restraining elements.

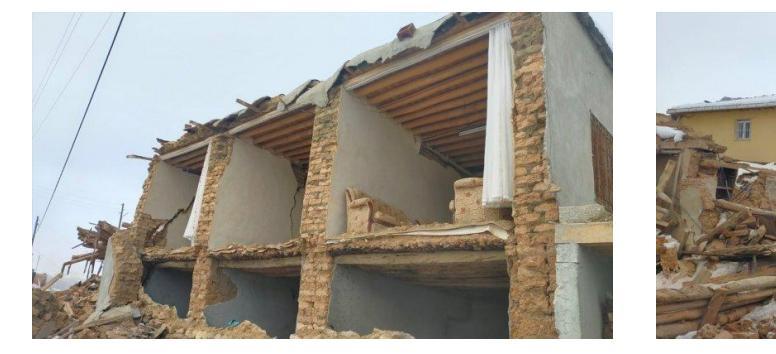
Figure 4.42. Damage in masonry structures in Kozluca District, Malatya province, 38.3840N 37.6836E (Source: <u>EN SON HABER</u>).

Turkish media has reported that 200 houses in Malatya province have been declared unusable. The rural area buildings were apparently built with adobe masonry walls and earth slabs supported by wooden beams, and experienced severe damage during the earthquake sequence (Figure 4.42). The buildings were used as residences or barns. There was one casualty in this historical neighborhood, which was known as a symbol of the region due to these old buildings. Figure 4.42(a) depicts an OOP failure mode of one of the house façades. The standing walls exhibit a vertical failure plane which may indicate the lack of horizontal bond elements and a poor connection between perpendicular walls.

(a) Severely damaged house.

(b) Collapsed house.

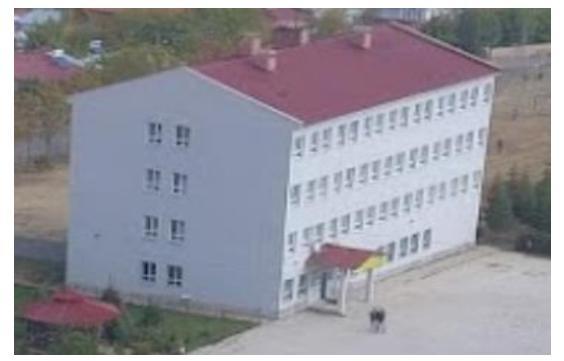
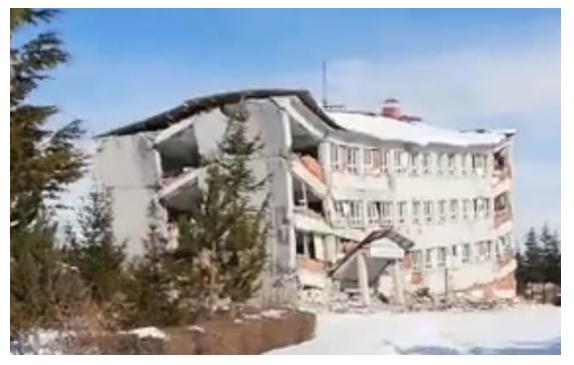
Figure 4.43. Vocational and Technical Anatolian High School collapse due to crushed first floor, 38.2578 N 36.9286 E (Source: (a) <u>Google Maps</u> and (b) <u>Reddit</u>).

Figure 4.43 shows the total collapse due to the failure of the first floor of a 4-story school building located in Elbistan, Kahramanmaraş in Southern Türkiye. From the image before the earthquake, the school was a regular building in plan and height. The post-earthquake image shows that the structure was an RC moment resisting frame in one direction and a shear wall system in the other direction. Although it is not clear from the images, a problem with this type of schools is the short columns due to partial height infill walls, which could have played a role in the observed collapse.

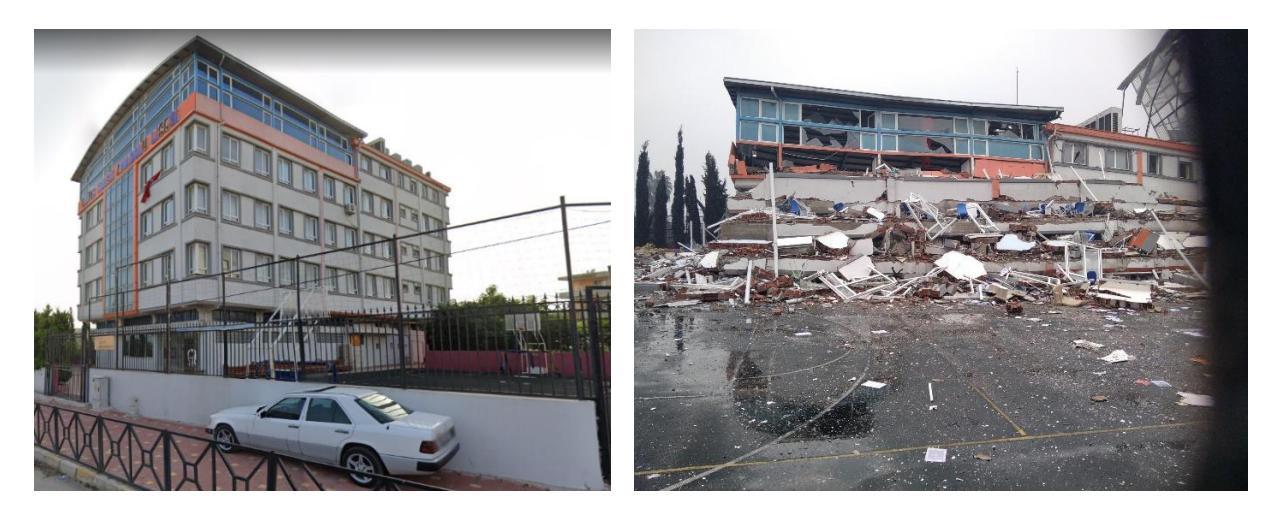
Figure 4.44. Collapsed building of the "REAL SUCCESS COURSE CENTER" school in Antakya, Hatay province, 36.1853N 36.1210E (Source: (a) <u>Google maps</u>, (b) <u>Twitter</u>).

In Antakya, Hatay province, a school building collapsed. Figure 4.44 shows this building with a lateral load resisting system composed of moment resisting frames with unreinforced masonry infill walls. In the pre-earthquake image, the building had a reduced footprint and open two-story frame with possible captive column effects, which may have contributed to the observed collapse.

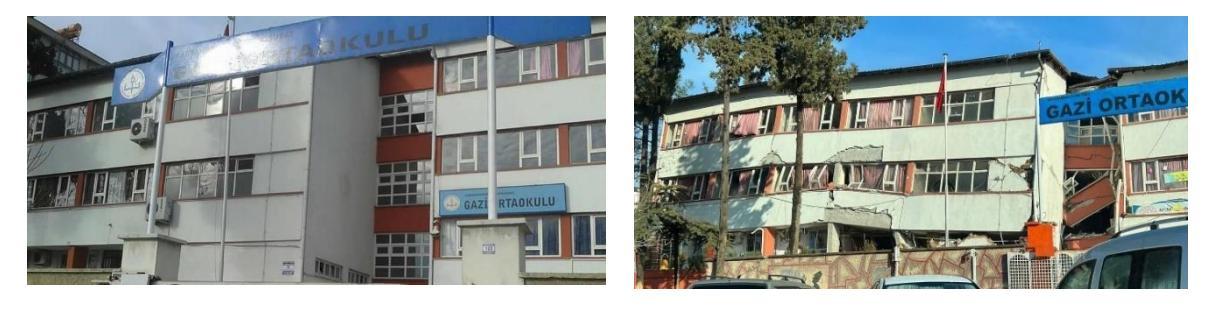
Figure 4.45. Partial collapse of the Gazi Primary School in Kahramanmaras province, 37.5754N, 36.9239E (Source: (a) <u>Google Maps</u>, (b) <u>Facebook</u>).

The Gazi middle school was an RC structure with unreinforced masonry infill walls. Figure 4.45a depicts the left wing of the building, it had three stories, while the right wing had four stories with shorter story heights. At a façade level, both parts were connected by middle-height horizontal panels, which coincided with the story heights of the right wing. Figure 4.45b shows these panels were severely damaged, which suggests there was no seismic joint between the two wings of the structure, despite their irregularities in story height. Several ground-floor vertical elements in the left wing of the building collapsed.

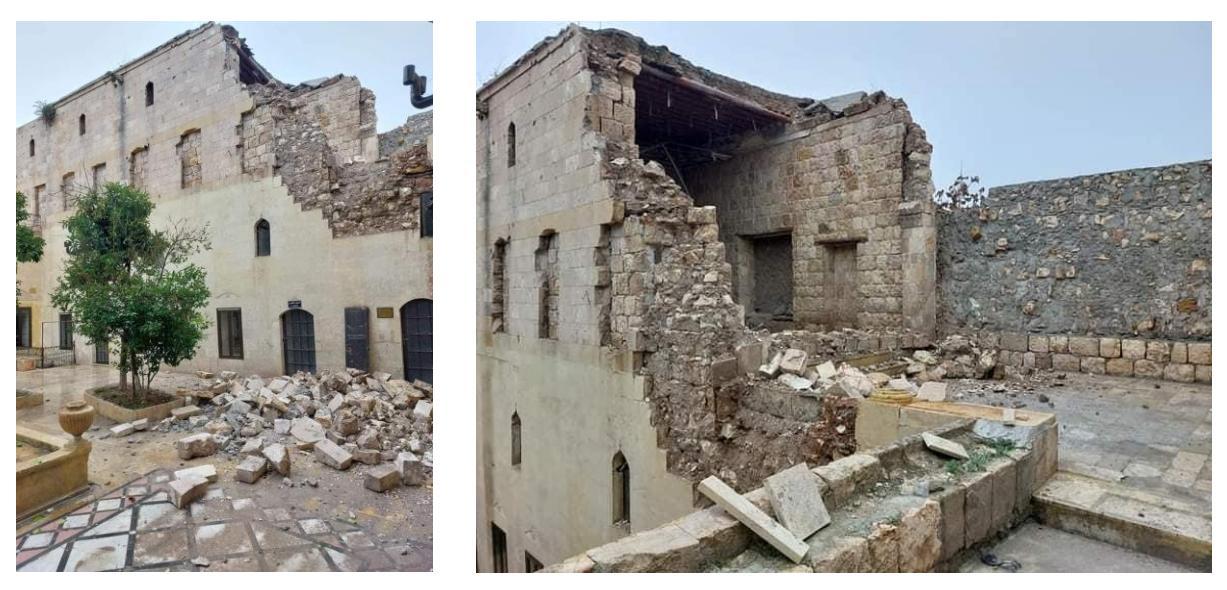
Figure 4.46. Damage at a Cilician Armenian high school of Aleppo, 36.2082°N, 37.1559°E (Source: <u>Massis Post</u>).

The severity of the structural damage to schools is still being assessed, and related visual evidence is scarce at the moment of writing this report due to efforts that might be primarily addressed to more pressing needs. Figure 4.46 shows the partial collapse of a Cilician Armenian high school in Aleppo, Syria. This structure, built in 1921, is a double-leaf masonry construction with transversal connections made with regular-shaped stone blocks. The observed damage suggests that some top-floor walls experienced an OOP bending failure mechanism, leading to the falling of stone blocks and the partial collapse of the roof structure.

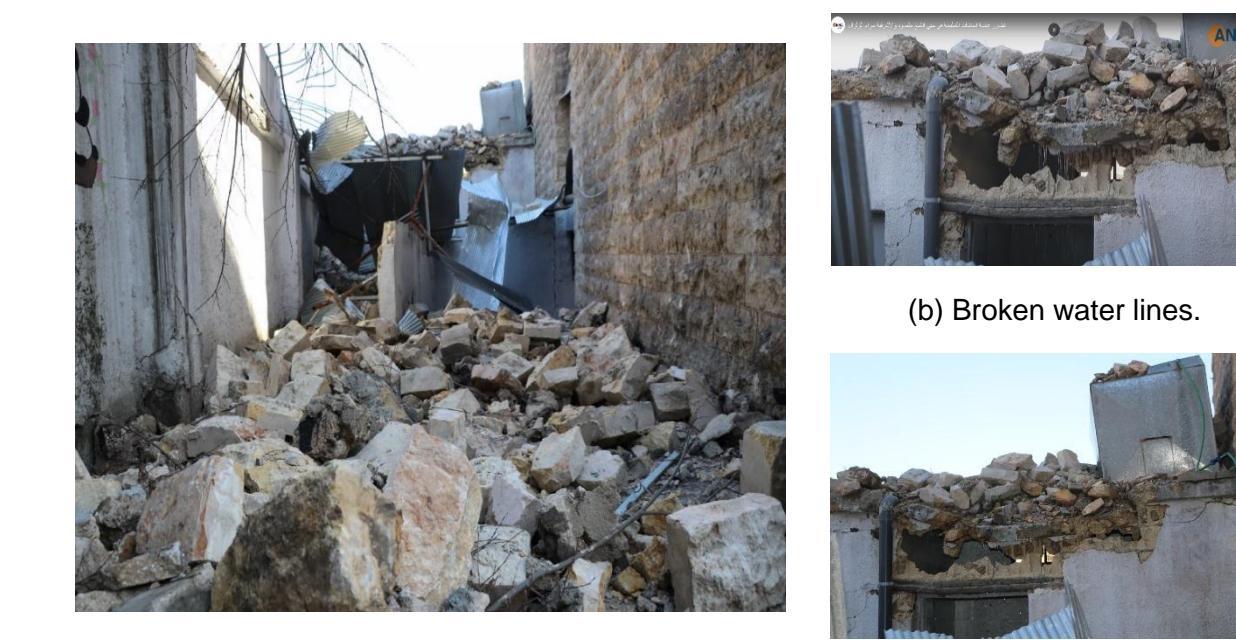
Figure 4.47. Damage documented at Martyr Gian Kindergarten (Source: ANHA).

According to local news, the most affected schools in Aleppo were the Martyr Judy Amanous School, the Michael Nehme School Complex, and the Martyr Gian Kindergarten located in the neighborhood of Ashrafieh and the Halima Al-Saadia School located in the neighborhood of Sheikh Maqsoud (ANHA 2023). Figure 4.47 shows some images of the damage documented at Martyr Gian Kindergarten, where the wreckage of the damaged walls, water gushing out from broken water lines, and a fallen non-structural component can be observed.

- (a) Wreckage of damaged walls.
- (c) Fallen non-structural component.

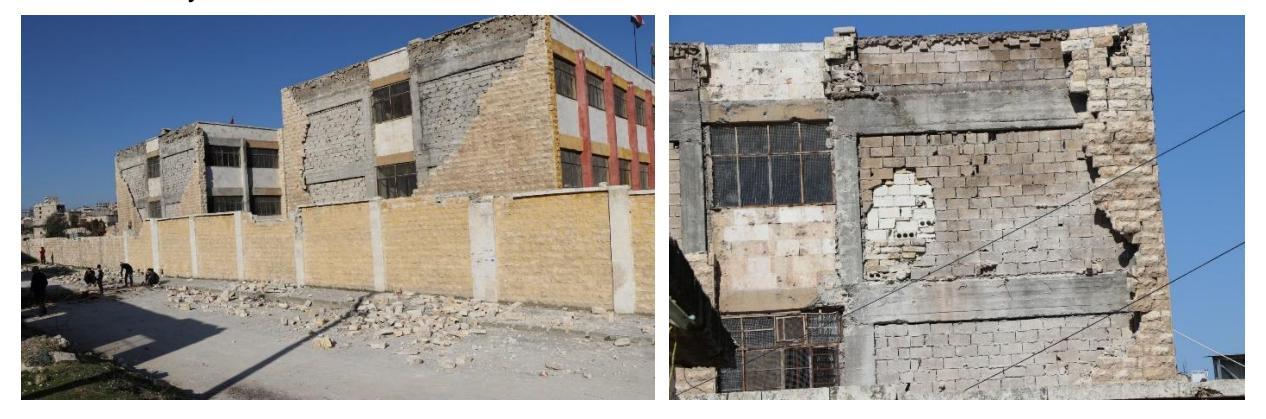
Figure 4.48. Damage at Martyr Judy Amanous School (Source: ANHA).

Figure 4.48 depicts the damage observed at Martyr Judy Amanous School, an RC building complex with masonry infill walls. It can be observed that the façade tiling was severely damaged, probably triggered by a lack of support anchoring and tiling joints. This is particularly important because, during a seismic event, the falling non-structural elements can cause serious injury to people evacuating the buildings. A shear failure mechanism is observed in concrete beams and an OOP bending failure in the enclosing walls. It is important to comment that geographical localization of the damaged schools and visual evidence of the infrastructure before the earthquake sequence has not been easy to obtain, as services like Google Street View are restricted in Syria.

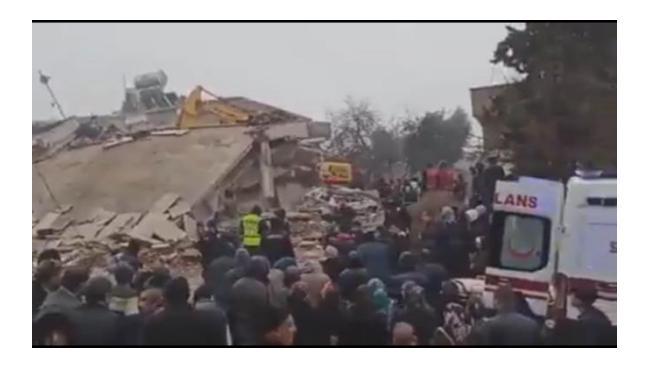
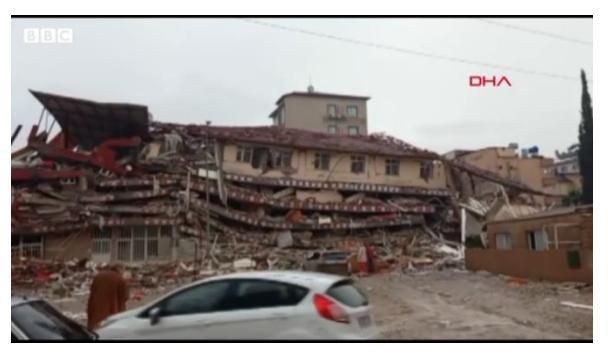
Figure 4.49. Collapsed buildings of state hospitals in Hatay province where rescue teams were needed to take survivors from the rubble.

Hatay province is one of the most affected regions after the earthquake sequence. Its government announced that two state hospitals were completely destroyed, one of the three private hospitals collapsed, and the City Hospital was damaged (TGRT HABER 2023). Figure 4.49 shows collapsed hospitals in Hatay province. The images suggest that the buildings were old, thus they very likely did not meet the structural provisions required in the current TBSC.

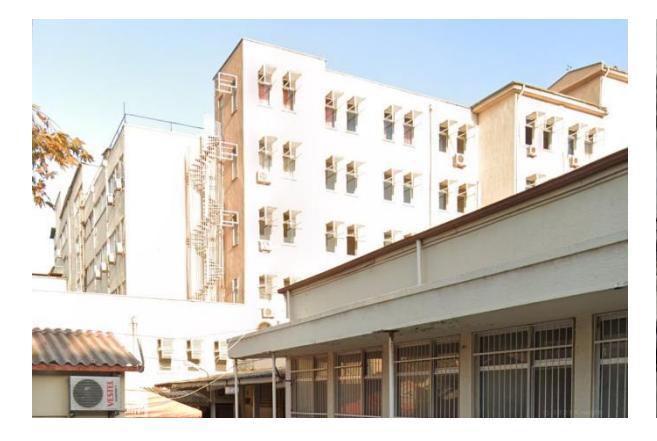
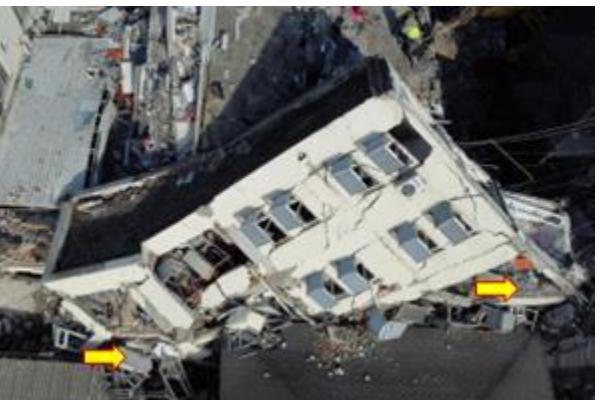
Block A of Iskenderun State Hospital in Dumlupinar neighborhood collapsed. It was built in 1968 and included Intensive Care Units (ICUs), physical therapy department, polyclinic services, and administrative units (Oksijen 2023). Figures 4.50 and 4.51 show two views of a complete collapse of an RC structure, which was detached from the main building. Government officials claimed it was an old building that was supposed to be retrofitted in 2023 (NTV 2023c). Figure 4.52 depicts further examples of damage to structural and non-structural components within "Block A" building.

(b) After the earthquake sequence showing three fully collapsed stories of the RC structure (Source: Reuters via ARAB NEWS).

Figure 4.50. Structural collapse in Iskenderun State Hospital, Hatay province, 36.5820N, 36.1738E where doctors report people trapped inside the damaged structure.

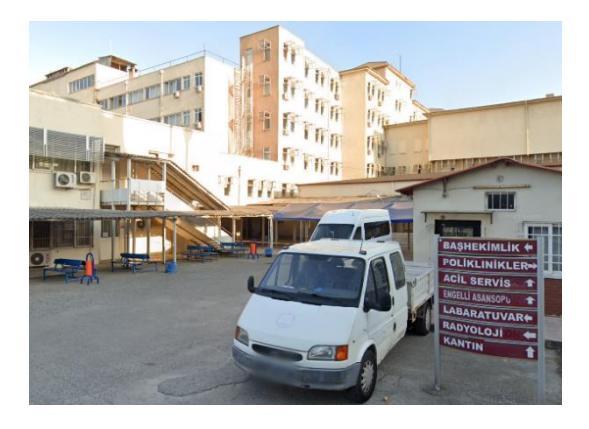
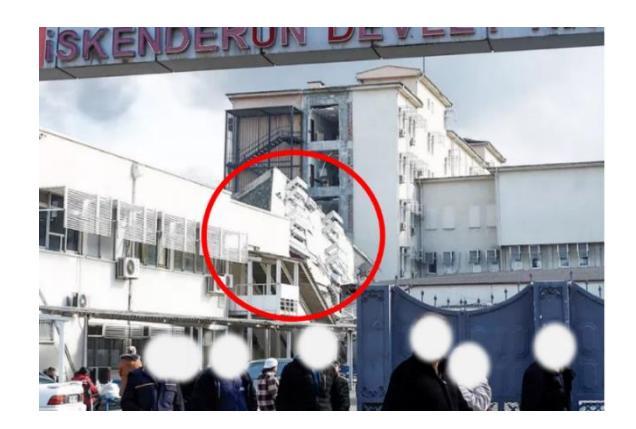
Figure 4.51. Entrance to the Iskenderun State Hospital, 36.5820N 36.1738E. The 5-story reinforced concrete building which collapsed was adjacent, but not structurally joined, to another five-story building which survived.

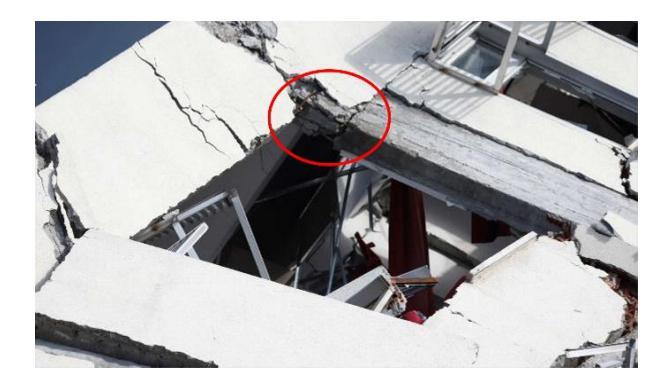
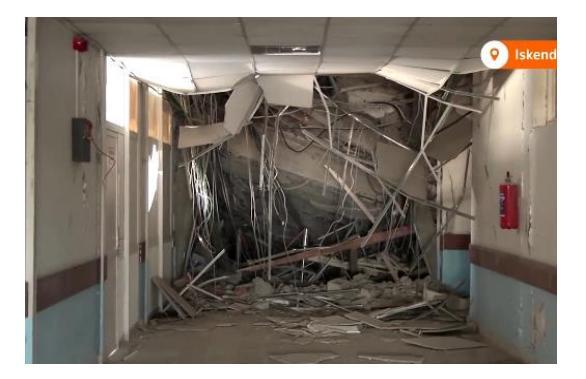
(a) Exposed reinforcing bars in beams and columns with evidence of corrosion, which could limit the ductility of the connection during the earthquake sequence (Reuters via zawya.com).

(b) Fallen panels from the ceiling and blocked corridor, indicating loss of functionality and giving evidence of the significant interior damage that can occur even if the exterior looks undamaged (extracted from <u>Reuters via</u> <u>Twitter</u>).

Figure 4.52. Structural and non-structural damage to "Block A" building of Iskenderun State Hospital in Hatay province, 36.5820N 36.1738E.

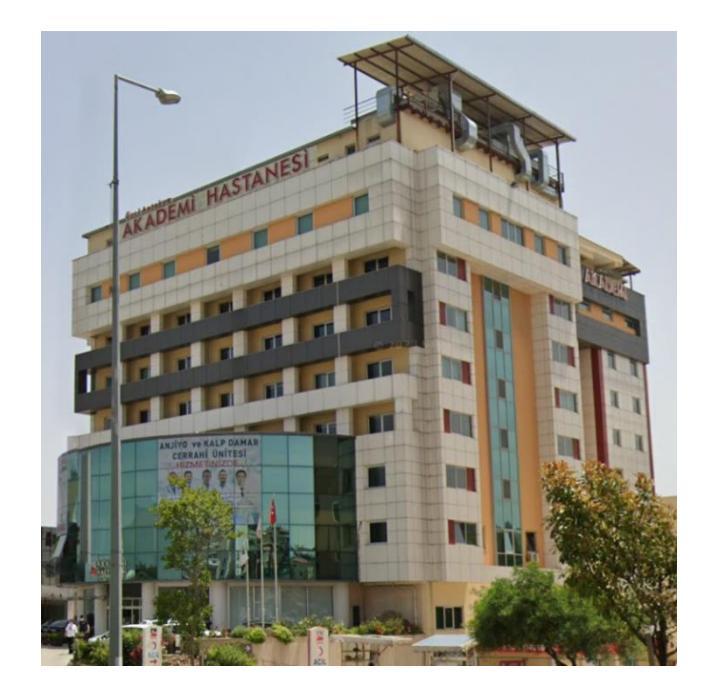
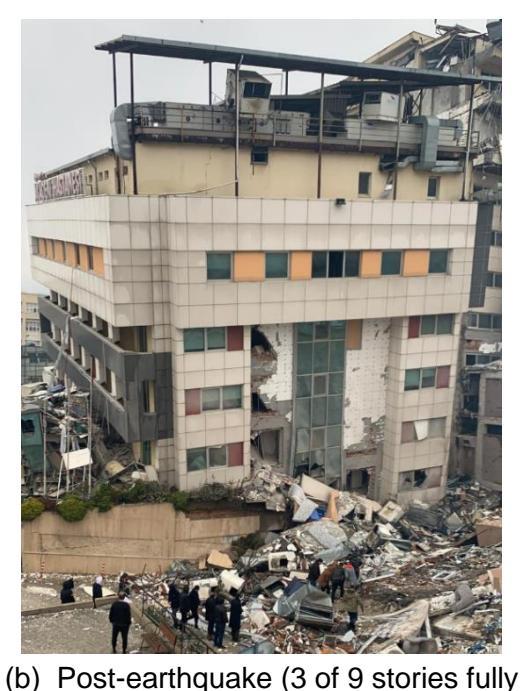
Antakya Academy Hospital in Hatay province and the old 750-bed Antakya State Hospital were destroyed. In the Academy Hospital, people remained under the rubble (Figure 4.53), and in the old building of the Antakya State Hospital, users from social media claimed that more than 70 people died under the rubble (Twitter 2023p). Starting from 2016, the regional hospital services were offered in the new facilities of Hatay Training and Research Hospital. Figures 4.54 and 4.55 show the collapsed hospital, which was built in 1939.

- collapsed, with the southern portion more damaged than the northern portion) (Source: <u>Twitter</u>).
- (a) Pre-earthquake view (Google Maps)

Figure 4.53. Structural collapse of the building of Antakya Academy Hospital in Hatay province, 36.2354N 36.1694E.

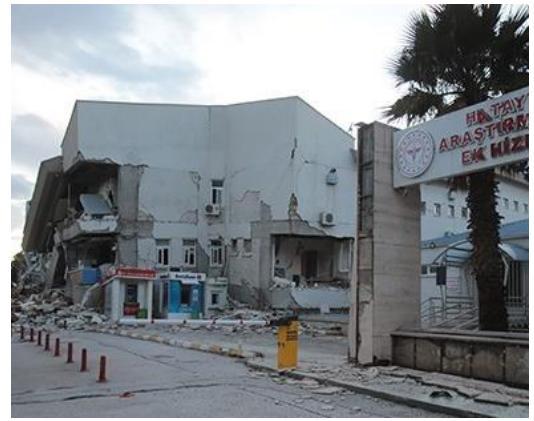
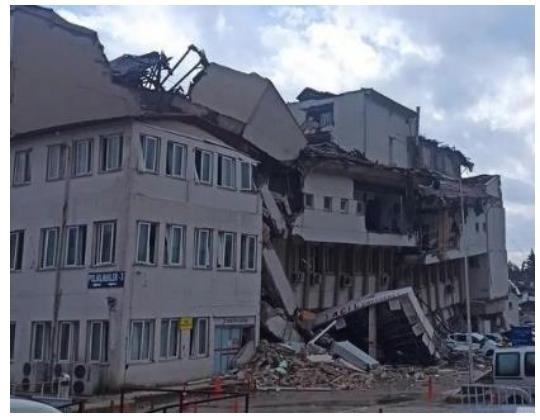
View of the southeast corner of the collapsed facility (Source: <u>DepoPhotos via Birgun.net</u>).

View of the northeast side of the collapsed facility (Source: <u>Twitter</u>).

Figure 4.54. Structural collapse of the building of Old Antakya State Hospital in Hatay province, 36.2149N 36.1374E. Similar to many other collapsed buildings, the collapse mechanism is gravity collapse, with the collapse of vertical members primarily centered in the middle third of the structure and lower stories, along with out-of-plane wall failures in the upper stories.

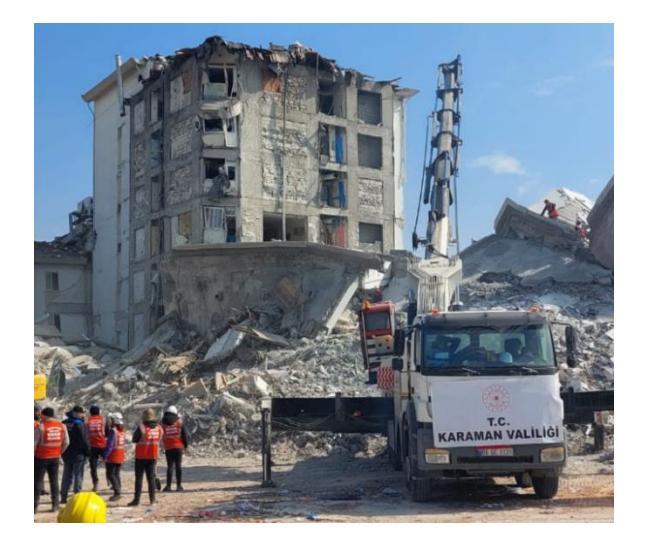
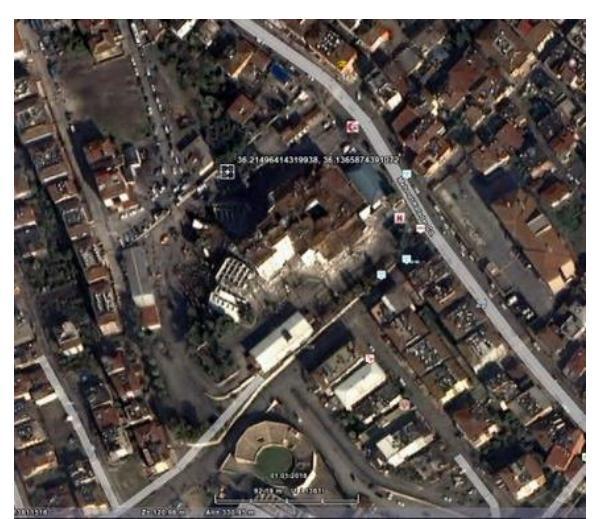
- (a) Post-earthquake view from the west of the hospital (<u>Twitter</u>), showing minimal structural tie-in between the collapsed and still standing portions of the northwest wings of the hospital.
- (b) Satellite image, centered on the hospital, showing adjacent infrastructure without total structural failure (<u>Twitter</u>).

Figure 4.55. Collapsed old building of Antakya State Hospital, Hatay province, Türkiye.

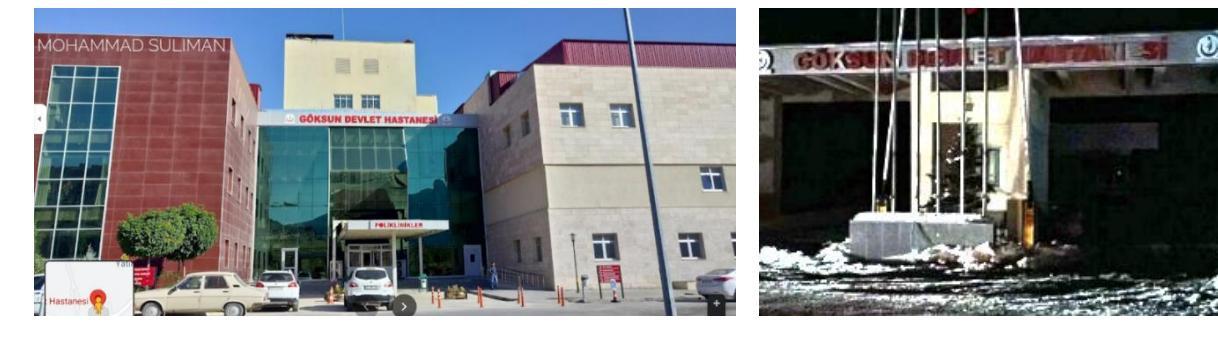
According to the Turkish news and social media publications, Göksun State Hospital in Kahramanmaraş province was severely damaged after the earthquakes. It was delivering emergency healthcare assistance in a tent at the hospital garden (<u>Sözcü</u> 2023). Figure 4.56 shows the hospital before and after the earthquake sequence.

Figure 4.56. Göksun State Hospital, Kahramanmaraş province, 38.0294N 36.5506E.

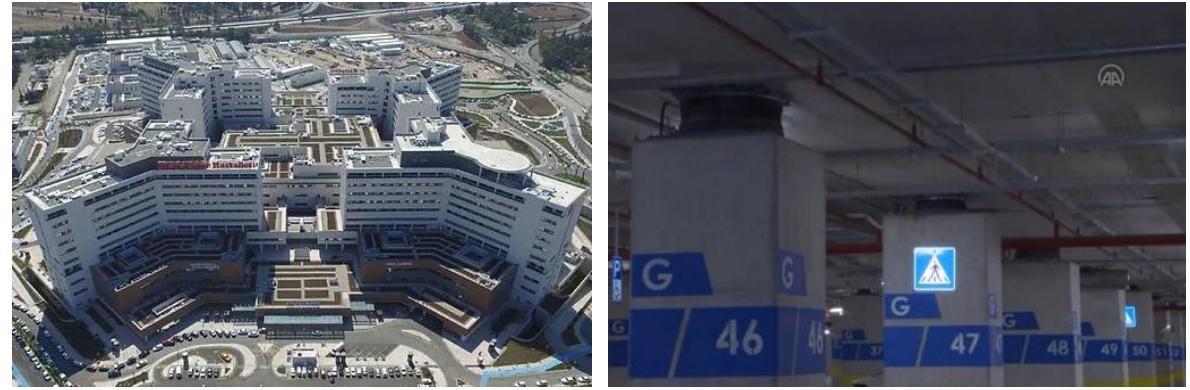
A particular example of the benefits of using seismic protection systems in healthcare infrastructure is the post-earthquake response of the 1,600-beds Adana City Hospital (Figure 4.59). It has been recognized as the World's Largest Seismically Base-Isolated Hospital, with a 550,000 m² footprint and 1,552 seismic base-isolators (RÖNESANS 2023). After the earthquake, the hospital was able to offer 24-hour uninterrupted health services to injured people, including

Figure 4.59. Adana City Hospital, 37.0301N 35.3483E (left) (Source: <u>EPS 2023</u>) and Frictional pendulum-type base-isolation devices in the hospital building (right) (Source: <u>Anadolu Ajansi</u> 2023).

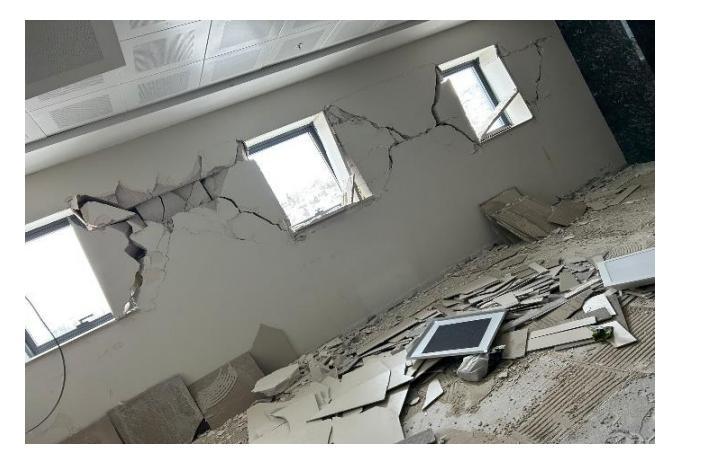
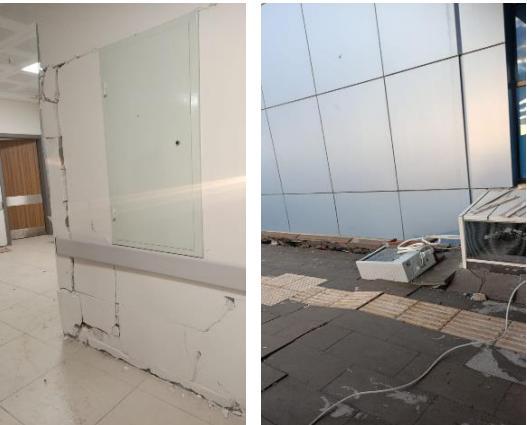
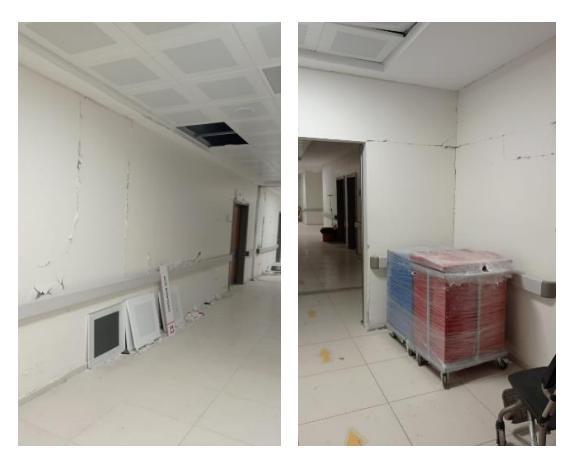
- (a) Façade walls and falling of ceiling tiles.
- (b) Gypsum/plaster division walls.

(c) Cracking evident in the covering of multiple gypsum/plaster division walls.

Figure 4.64. Damage to non-structural components of Pazarcık State Hospital, built in 2018 (Source: <u>Twitter</u>).

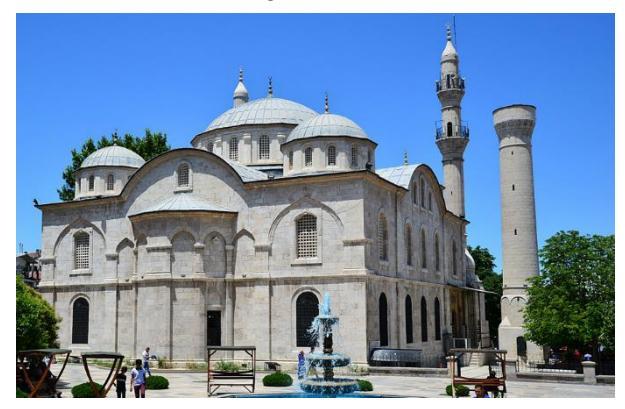
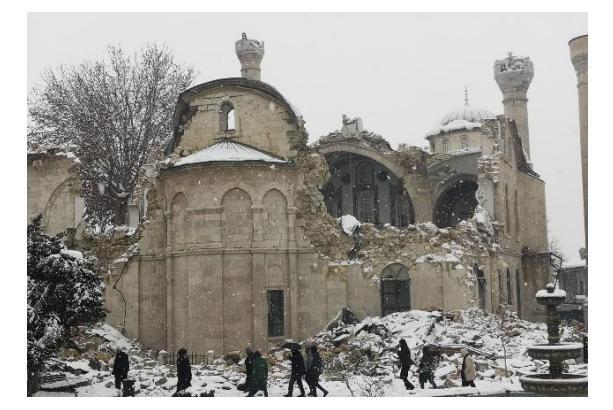
The Yeni Camii or New Mosque, in Malatya, was extensively damaged when its roof structure and domes collapsed (Figure 4.65). The mosque was constructed on the site of the former Haci Yusuf Mosque destroyed by an earthquake on March 3, 1894. The mosque was reconstructed on March 14, 1964, when another significant earthquake caused severe damage to the building. There were cracks in the dome and some of its walls and the top stones of the cone fell off. The

Figure 4.65. Collapsed domes and walls, and damaged minarets of Yeni Camii, Malatya, 38.3495N 38.3180E (Source: Google Earth and <u>DHA Photo via Ruetir 2023</u>).

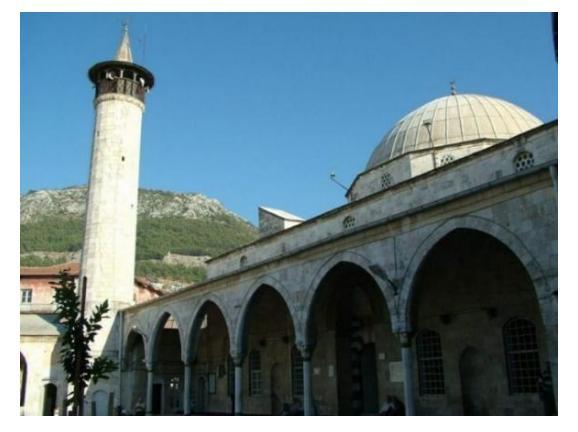
Figure 4.66 shows the partial collapse of Habib-i Neccar Mosque, Hatay, the first mosque in Anatolia. The dome was completely destroyed while the masonry walls and the courtyard roof partially collapsed. The long-span dome roof and significant vertical accelerations during this earthquake sequence may have contributed to the roof collapse of this structure, as well as the Adiyaman Ulu Grand Mosque in Adiyaman, Türkiye (Figure 4.67), which also experienced collapse of the roof and most supporting walls. Collapse sometimes initiated in the walls however, with the roofs remaining intact, as observed in damage to a mosque in Kahramanmaras, Turkiye (Figure 4.68). It is likely that the long-span dome roof structures, with large open interiors and limited number of supporting columns make these structures particularly susceptible to earthquakes, especially those containing large vertical accelerations such as those observed during this sequence.

Figure 4.66. Damage to Habib-i Neccar Mosque, the first Anatolian mosque, Hatay, Southeastern Türkiye (Sources: (a) <u>hataygastronomi.com</u>, (b) <u>IHA Photos via Daily Sabah</u>).

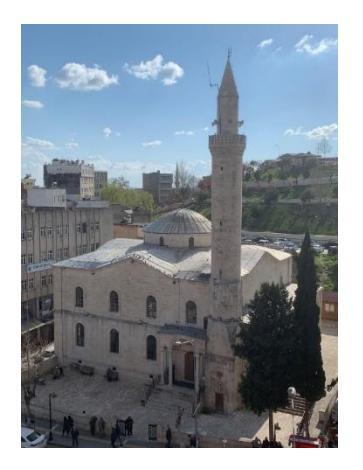
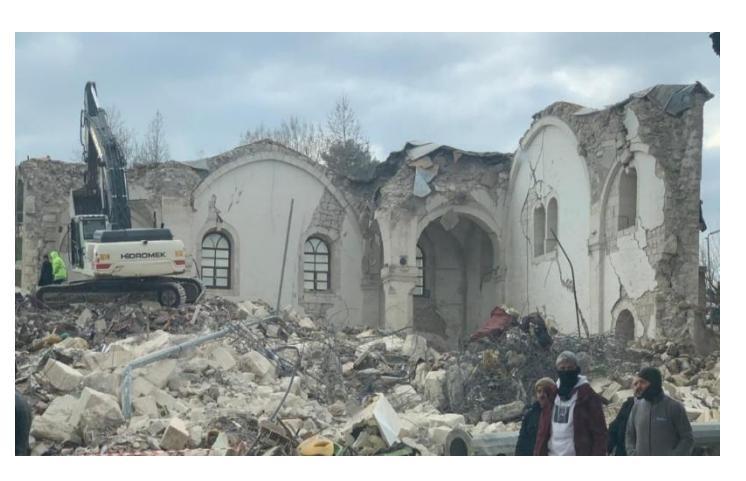
Figure 4.67. Damage to the Adiyaman Ulu Grand Mosque in Adiyaman, Türkiye (Sources: (a) <u>Twitter</u> (b) <u>Middle East Eye</u> 2023).

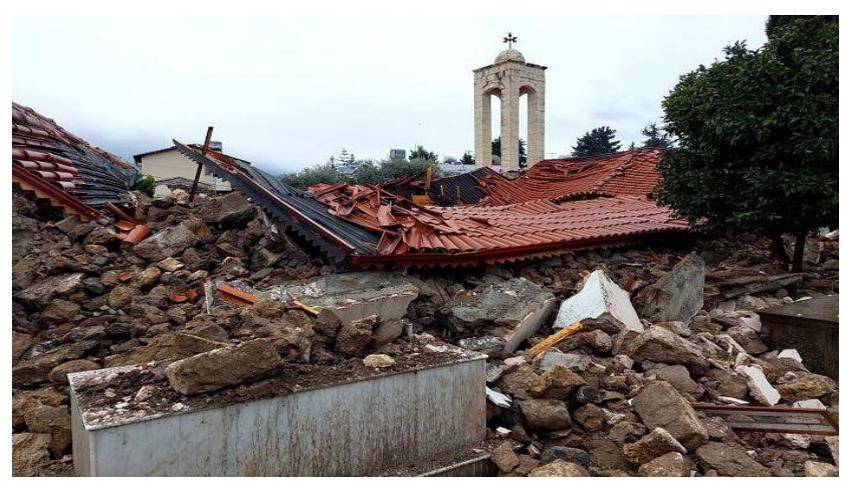
Figure 4.70. Collapsed Mar Yuhanna Orthodox Church in Arsuz where walls were constructed of unreinforced stone masonry (36.4120N 35.8849E) (Source: <u>haber.sat7turk.com 2023</u>).

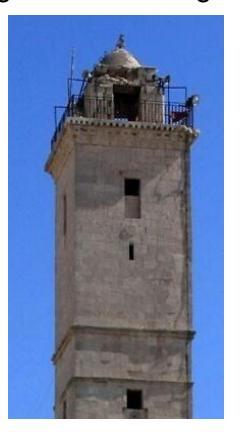
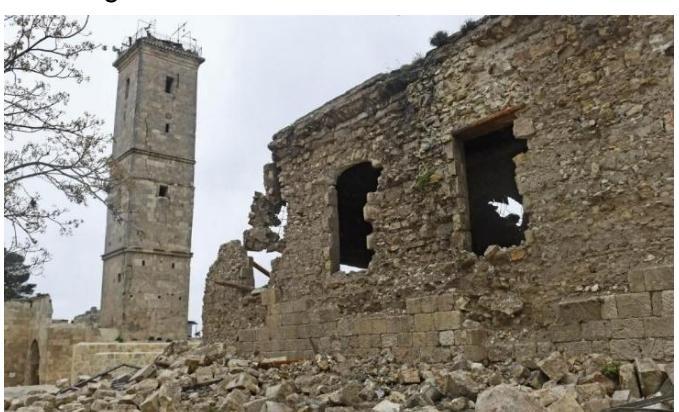
Several mosques and churches in Syria collapsed or were partially damaged during the earthquake sequence. Figure 4.71 shows damage to a historic mosque minaret made of unreinforced stone masonry in Aleppo. Figure 4.72 shows the collapse of a mosque in a residential area in Idlib, Northwestern Syria. The heavy dome roof appears to have been supported on a long-span roof supported by rectangular reinforced concrete columns with inadequate reinforcement. Some of these columns are visible in Figure 4.72 without any evidence of reinforcing bars extending from the column segments.

Figure 4.71. Collapse of the roof structure on the minaret, and partial collapse of unreinforced masonry walls of a mosque inside UNESCO-listed citadel in Ancient city of Aleppo (36.1994N 37.1622E) (Sources: (a) <u>AFP via Time of Israel</u> 2023; (b) <u>AFP via Middle East Eye</u> 2023).

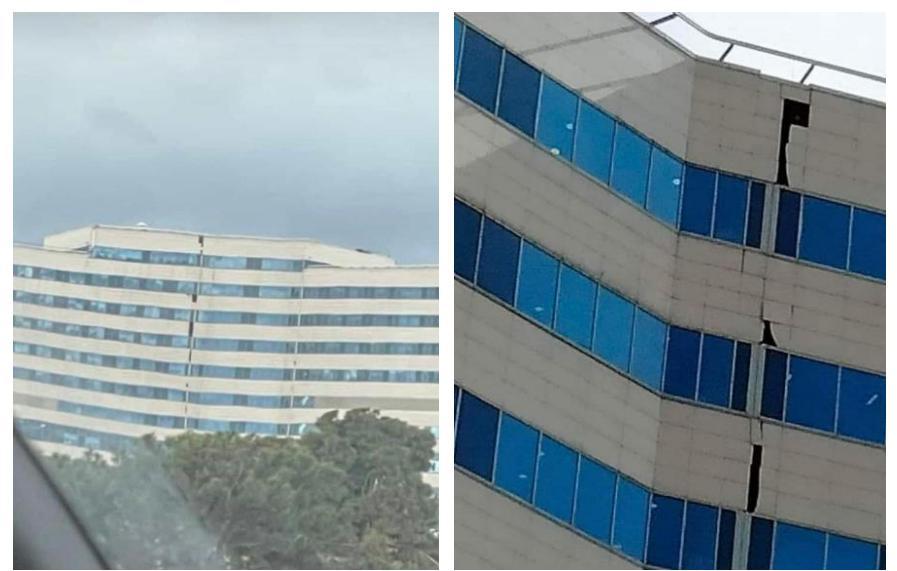
Figure 4.74 shows the damage to the façade of the Mersin City hospital in Mersin, Türkiye. Vertically spanning nonstructural components and systems such as façade, curtain walls, and the stair system are exposed to multi-support excitation due to attachment at multiple levels within a building. Therefore, it is essential to design these nonstructural systems such that they are drift compatible.

Figure 4.74. Damage to Mersin City Hospital, Türkiye (Source: Twitter).
