StEER-EERI: 2023 Mw 7.8 Kahramanmaras, Türkiye Earthquake Sequence Joint Preliminary Virtual Reconnaissance Report (PVRR)

JOINT PRELIMINARY VIRTUAL RECONNAISSANCE REPORT (PVRR)

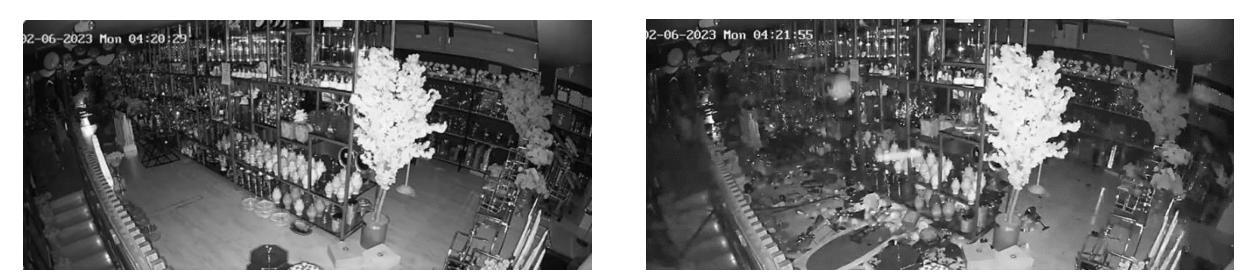
Other nonstructural damage is shown in Figure 4.76 for items fallen off shelving units at a store in Gaziantep, Türkiye. Moreover, Figure 4.77 shows broken window panes (refer to the arrows) of a building in Aleppo, Syria, due to out-of-plane accelerations, which can be a falling hazard.

Figure 4.76. Items fallen off shelving units at a store in Gaziantep, Türkiye (Left: Before earthquake sequence; Right: After earthquake sequence) (Extracted from <u>Twitter</u> video).

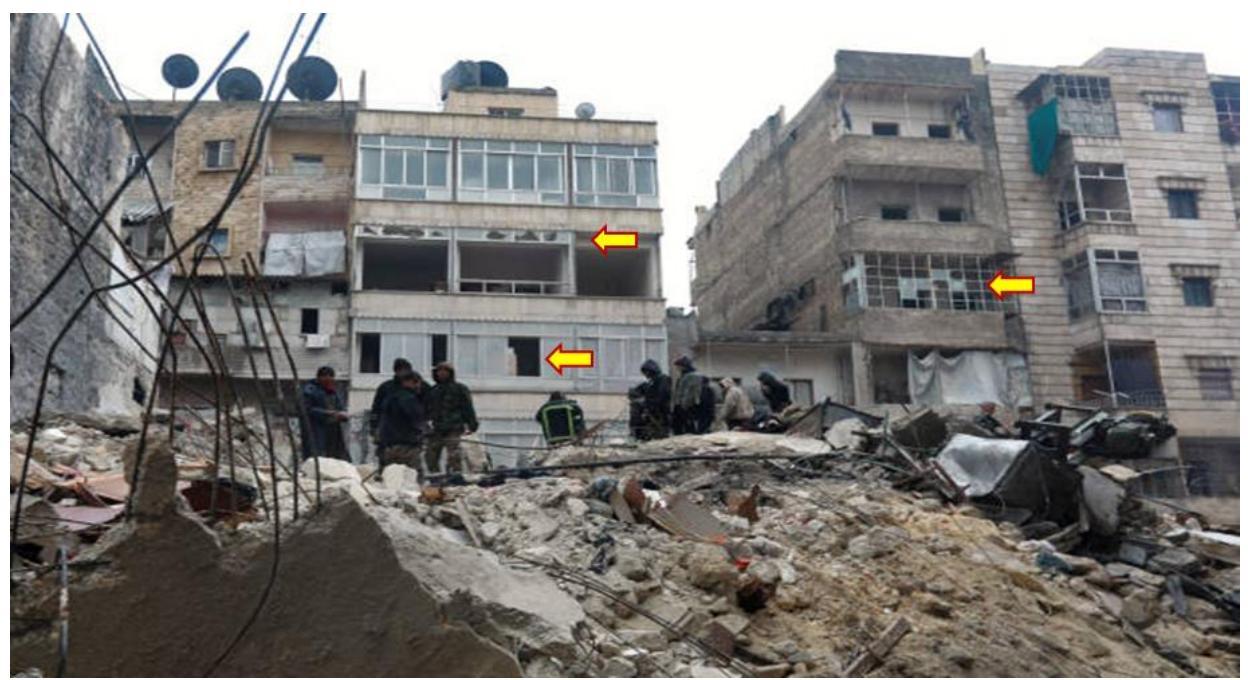
Figure 4.77. Broken window panes, Aleppo, Syria (Source: <u>LOUAI BESHARA/AFP via Getty</u> Images 2023).

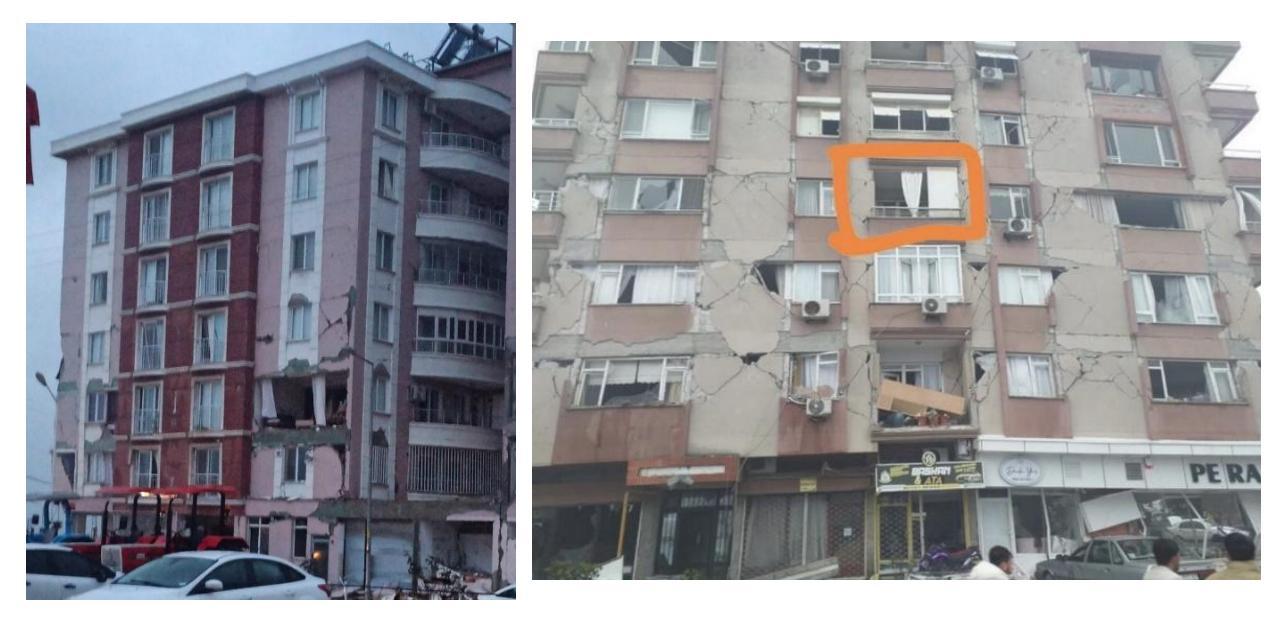
residential building received significant damage, but the building did not collapse. However, the residents of these buildings were not able to evacuate the building due to the collapse of stairwells. Therefore, the functionality and serviceability of these buildings were compromised, and the life of the residents were endangered.

(a) Residents had difficulty exiting the building due to stairwell collapse (Source: <u>Tommy Shelby via Twitter</u>).

(b) Residents sought help from a rescue team as they were stuck inside the building due to stairwell collapse (Source: Husamettin Dogan via <u>Twitter</u>).

Figure 4.78. Damage to structural and nonstructural systems of residential buildings, Hatay, Türkiye.

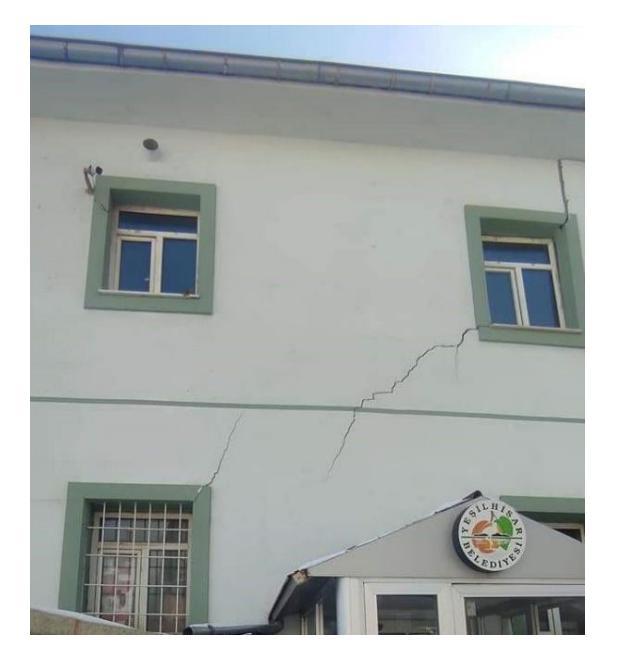
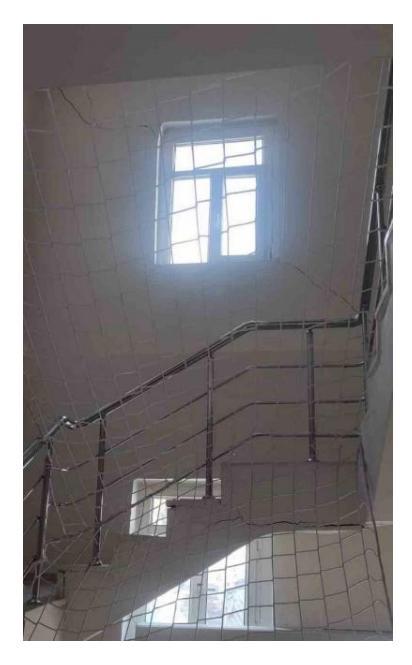
Significant damage to the Yesilhisar municipality building and stair flight was reported (see Figure 4.79). Yesilhisar municipality building is approximately 250 km away from Elbistan, and 290 km away from Pazarcik Kahramanmaras.

(a) Diagonal tension cracks of building exterior wall.
 (b) Crack parallel to stair run direction.
 Figure 4.79. Damage to Yesilhisar municipality building, Kayseri, Türkiye (Source: <u>Only53.com</u> 2023).

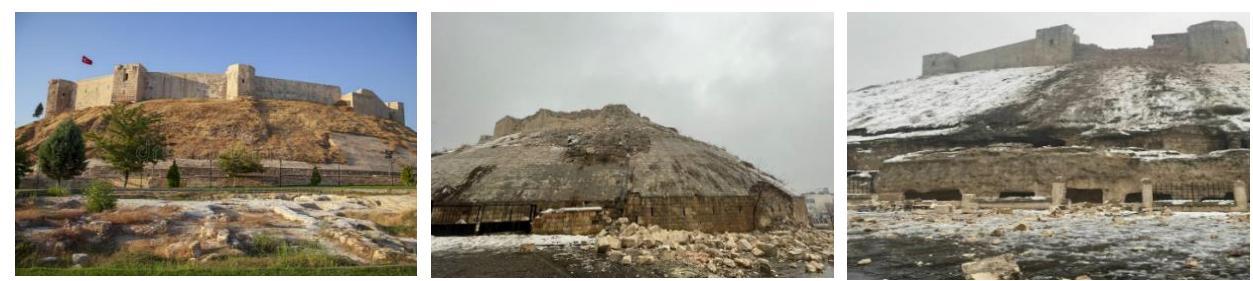
Gaziantep Castle, located in the heart of the city, closest to the epicenter, was constructed as an observation point during the Hittite Empire, fortified during the Roman Empire, and expanded under Byzantine Emperor Justinian I in the 6th century. Although the castle withstood centuries of invasions, it was badly damaged in this earthquake sequence (Figure 4.81) (NPR 2023). The unreinforced masonry walls present a significant mass that induces large internal forces during ground shaking. The shear strength of an unreinforced masonry wall is relatively low, and appears to have been exceeded in many areas around the perimeter wall of this castle. These walls often consist of neatly stacked exterior stone plies, enclosing loose rubble masonry on the interior of the wall as is visible in Figure 4.81 (d(and (e). This construction is effective against cannonball impact, but susceptible to collapse during ground shaking.

Figure 4.81. Gaziantep Castle damage (Source: (a) and (b) Thomas van Linge via <u>Twitter</u>, (c) and (d) Getty Images via <u>TheGuardian.com</u>, (e) Getty Images via <u>Smithsonian</u> 2023).

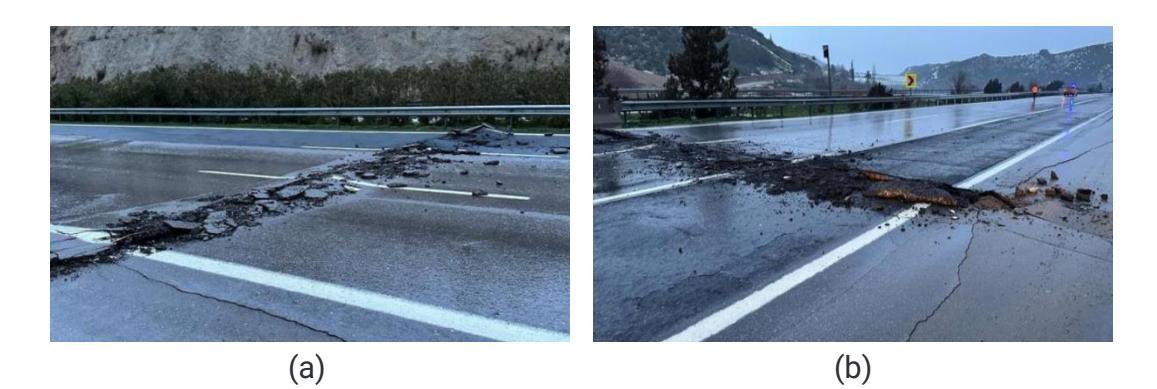
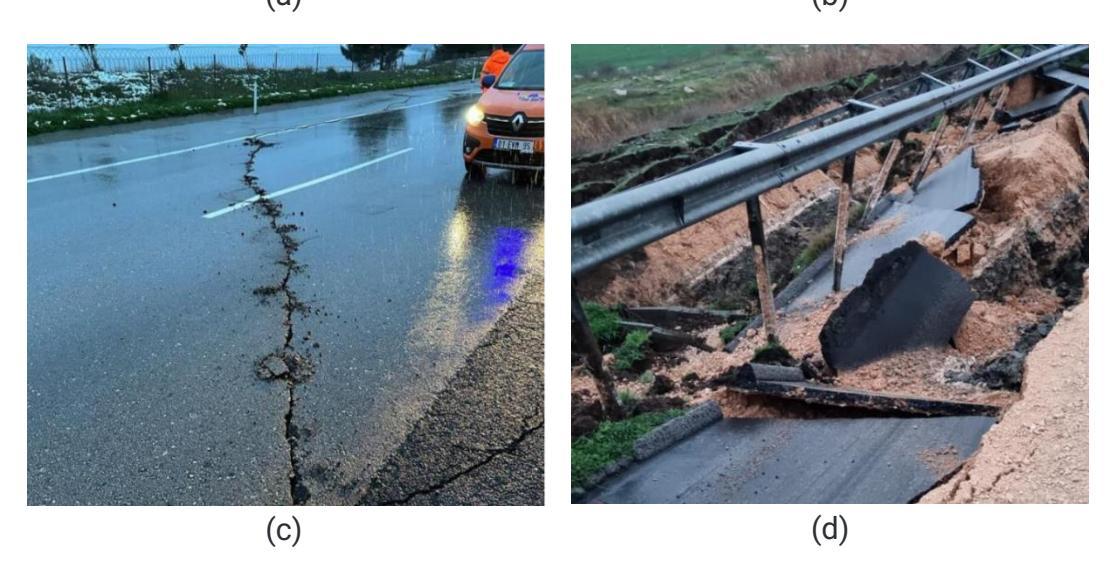
Damage to the Tarsus-Adana–Gaziantep (TAG) Highway occurred due to the Mw 7.8 earthquake. Traffic along the Osmaniye-Gaziantep West Junction portion of the TAGHighway was diverted to the D-400 state road (Demirci 2023). Figure 5.1 shows representative damage of roadways observed after the Mw 7.8 earthquake along the TAG Highway. In several places, cracking of pavement (e.g., Figures 5.1(a-c)) due to seismic compression and vertical settlement induced distortional shearing caused surface failures (Figure 5.2). Vertical settlement of the pavement could be associated with the cyclic softening of materials due to large shear strain imposed by the earthquake sequence. Differential movement of a road near the Tevekkelli village on the Kahramanmaraş-Gaziantep Highway was also observed (Figure 5.3). This movement was measured to be approximately 3 meters.

Figure 5.1. Damage to Tarsus-Adana-Gaziantep (TAG) Highway (Expat Guide Türkiye 2023).

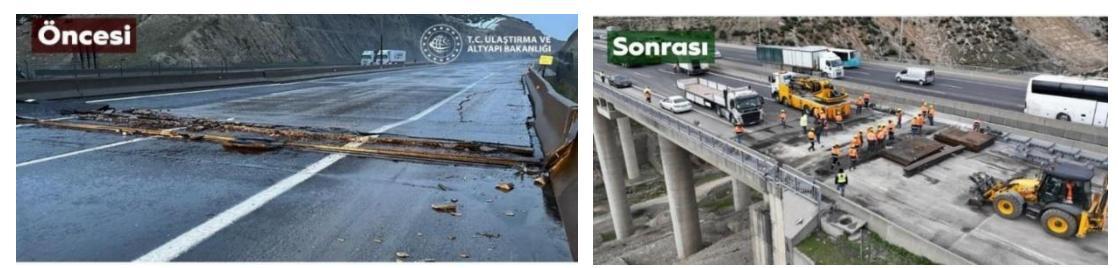
A limited number of bridges were reported to be damaged after the earthquake sequence. Figure 5.4 shows the damage at the expansion joint of a bridge on the Adana-Gaziantep Highway and the repair work which was reported to be completed on February 11, 2023 per <u>Twitter</u>. Extensive damage at the deck of Şekeroba bridge on the Kahramanmaraş-Osmaniye Highway (Figure 5.5) and unseating and falling girders at an overpass at Nurdağı (Figure 5.6) were reported to be the few cases of bridge damage after the earthquake sequence.

Figure 5.4. Damage and repair work of an expansion joint of a bridge on Adana-Gaziantep Highway (Source: <u>Twitter</u>).

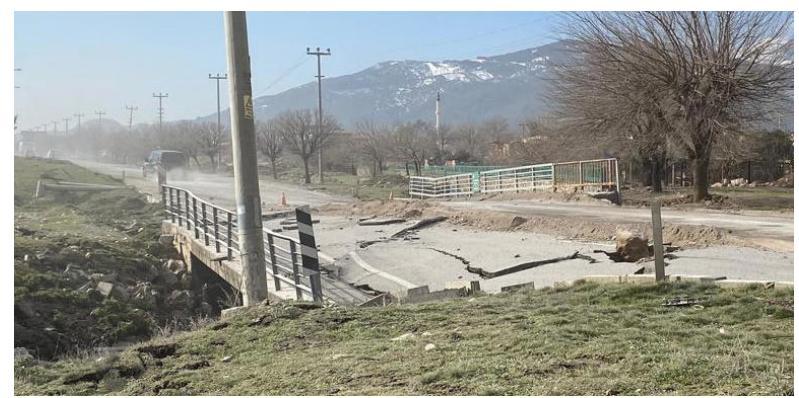
Figure 5.5. Extensive damage at the deck of Şekeroba Bridge (Source: Olay53).

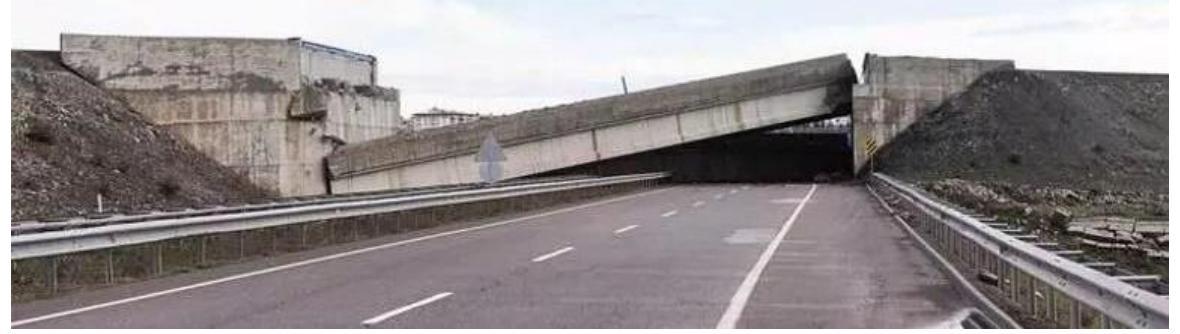
Figure 5.6. Unseating failure of an overpass in Gaziantep Nurdağı (Source: hurriyet.com).

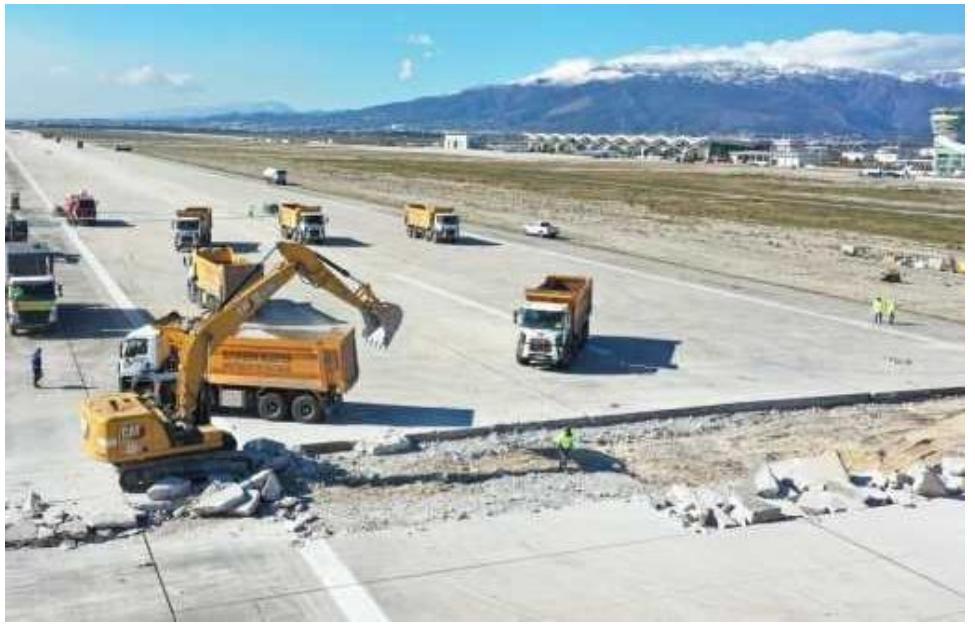
Gaziantep, Hatay, Kahramanmaraş, and Adana airports remained closed for a few days after the earthquake sequence. The Hatay Airport is closed due to a surface rupture of the tarmac (Figures 5.7 and 5.8). In addition, aftershocks have caused planes to be grounded at airports throughout the region (Aerotime Hub 2023). Flights across Türkiye were also being canceled due to adverse weather conditions.

Figure 5.8. Image posted on February 8 1:04 am documenting repair work on the Hatay airport runway (Source: <u>Raillynews</u>).

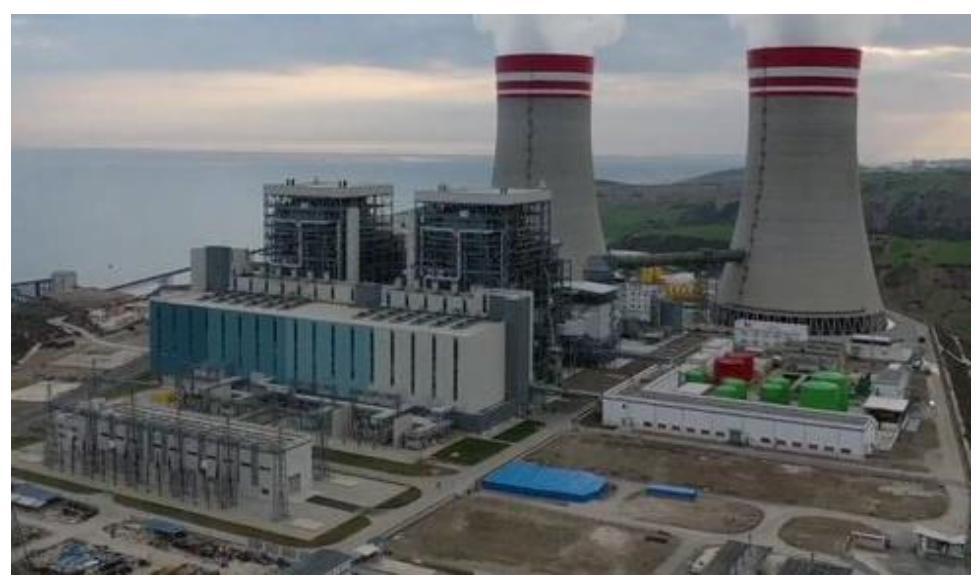
It was reported that the Hunutlu thermal power plant was undamaged (Figure 5.10) and the personnel were safe. None of the equipment of the plant was impacted and the plant continued to provide electricity to the earthquake affected region. No damage was reported at Akkuyu nuclear power plant (Figure 5.11). This nuclear plant is under construction, which continued after a prompt operational inspection of all buildings, structures, and tower cranes was performed with no observed damage as the outcome of this inspection.

Figure 5.10. Undamaged Hunutlu thermal power plant in the Adana province (Source: Twitter).

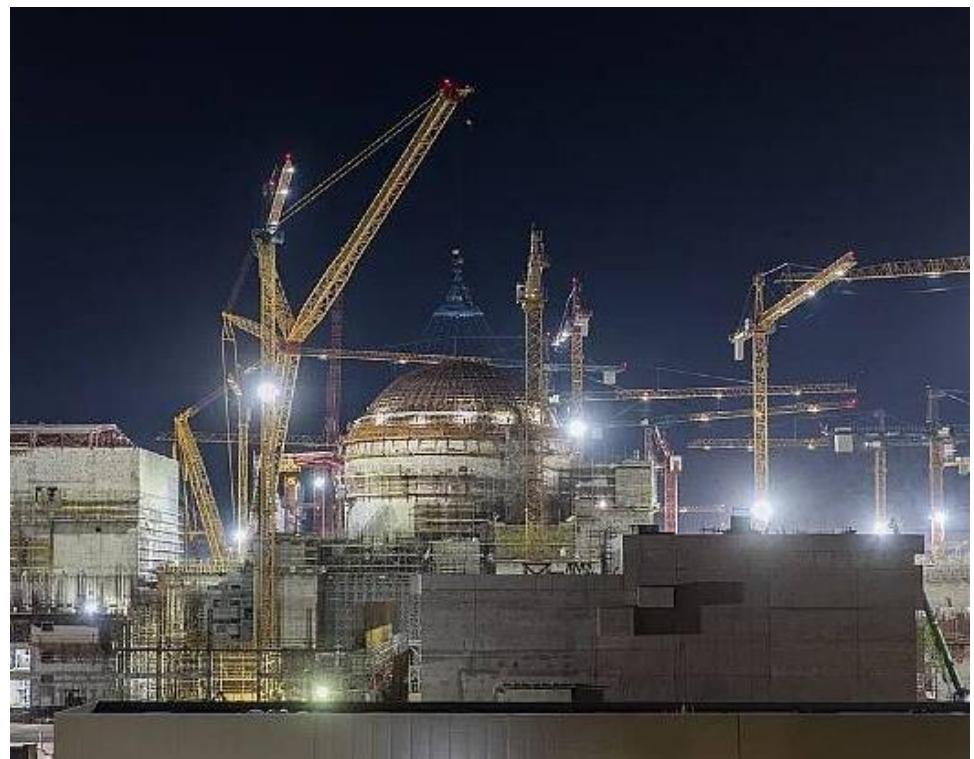
Figure 5.11. Undamaged Akkuyu nuclear power plant (Source: World Nuclear News).

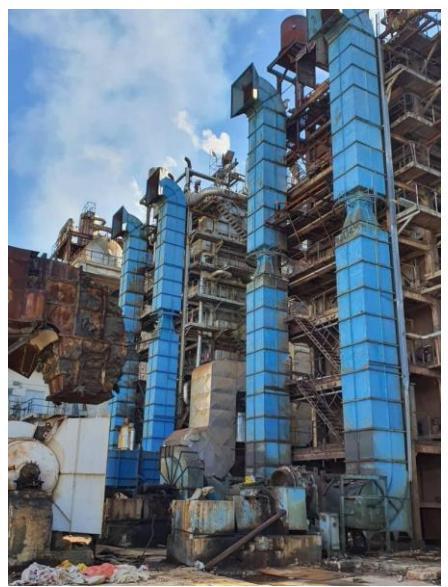
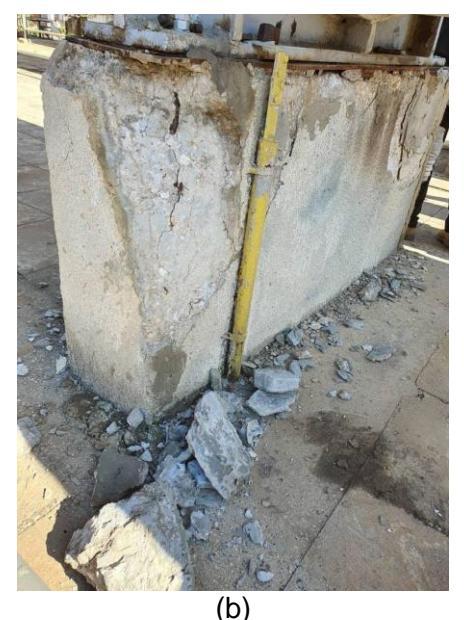
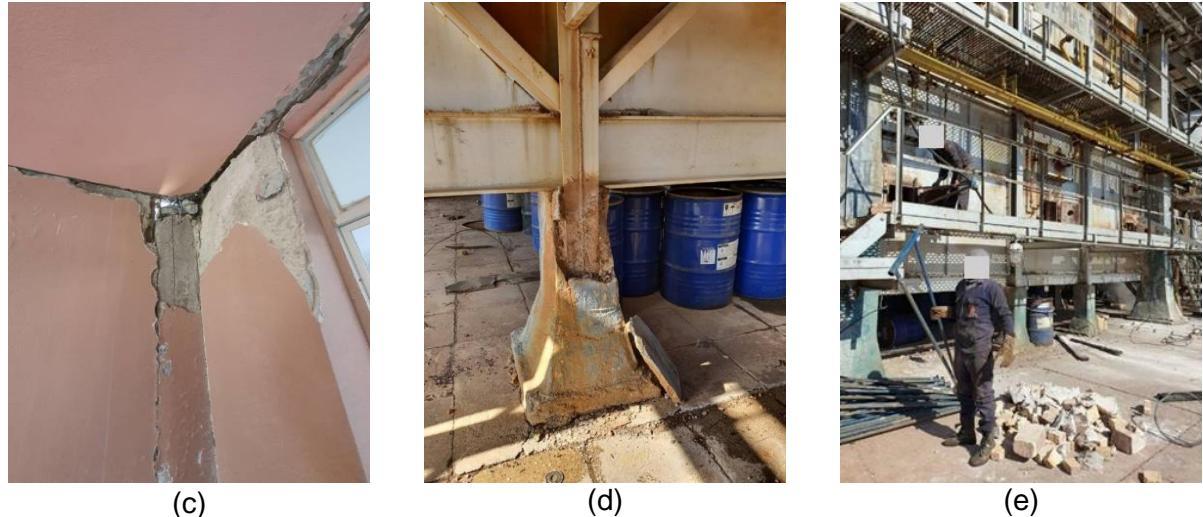
The Banias refinery in Syria was partially damaged due to the earthquake sequence. The main damage to the refinery was to the concrete bases of equipment, separation, and failure of furnaces' linings, displacement of the center of the gasoline reactor, in addition to the damage to the main chimneys of the power unit (Figure 5.15). Therefore, the refinery was out of service. The technical staff continued the repair work, and the distillation unit has been functioning since the afternoon of February 8, and the furnaces were started on February 9 (as they needed 48 hours for the slow drying of the tile lining).

Figure 5.15. Damage of Banias Oil Refinery in Syria (Source: <u>Syrian Ministry of Oil and Mineral</u> <u>Resources</u>).

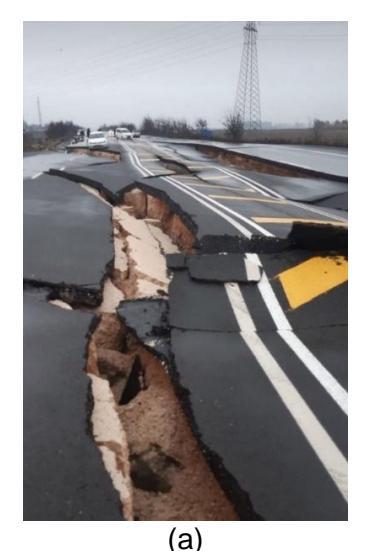
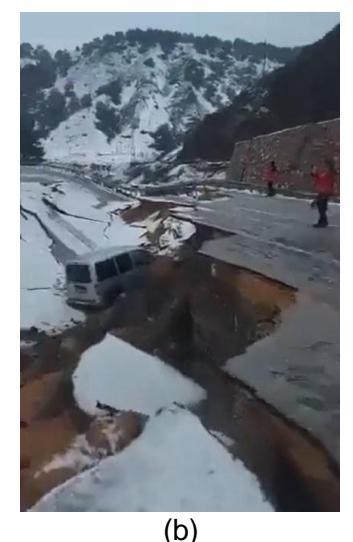
The USGS landslide inventory map shows the probability of landslides in the area (Figure 6.8). Based on this map, it is likely that some landslides will occur during strong ground shaking, and a substantial number of roads could be blocked by slope or embankment failures. This will impede the rescue work, especially in remote areas during the initial, all-important, 24-hour rescue and recovery period. In general, landslides from strike-slip earthquakes cluster close to the surface expression of the fault trace, although some can still occur at considerable distances. A lateral spreading induced landslide was observed on the road between Adana and Gaziantep following the Mw 7.8 and Mw 7.5 earthquakes on February 6 (Figure 6.9). Ground movements caused extensive damage to this roadway.

Figure 6.9. (a) Potential lateral spread failure (Source: <u>Reuters via National Post</u>). (b) Landslide & lateral spreading failure (Source: Extracted from <u>Sokagin Sesi Gazetesi, Twitter</u>).
