# The Establishment of an Absorbent Hygiene Product Waste Collection System in Two Informal Settlements in South Africa

**Student Paper**

Author: Dominik Huber

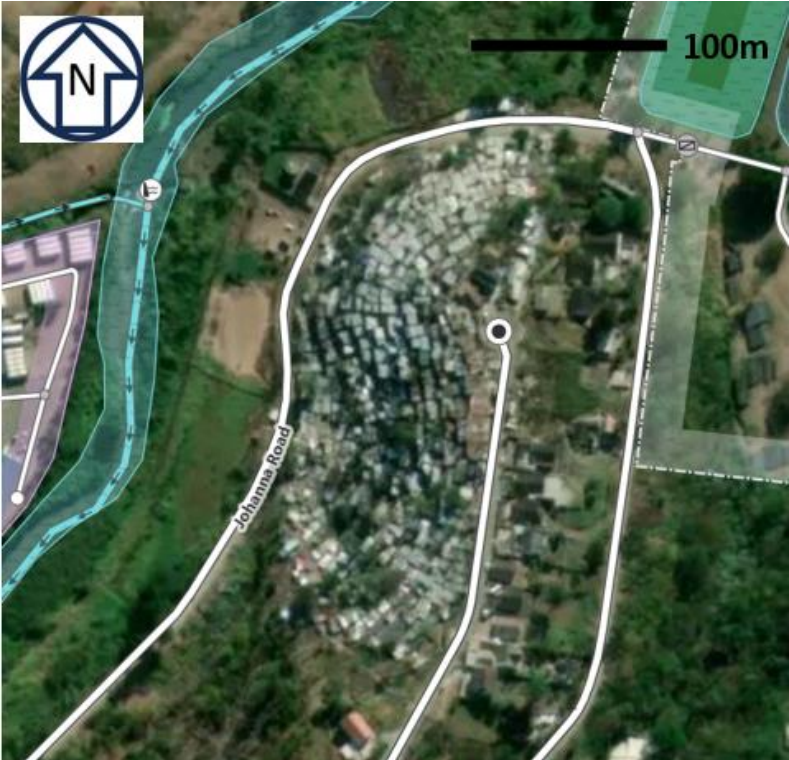
Johanna Road is situated in the northern part of Durban, as indicated in Figure 1. It is a densely populated community on a hillside above Sea Cow Lake. The settlement, named after the road it borders, is characterized by precarious housing conditions as residents do not own the land on which their dwellings are built. Despite its informal status, the community has access to some municipal services, including two communal ablution blocks, each with three working toilets, free black refuse bags, and regular waste collection once a week. However, solid waste management remains challenging, as illegal disposal sites are common within the settlement, and collection is centralized and unreliable (Kalina. Over time, residents have built unhygienic and unsafe pit latrines. Johanna Road can be accessed via two roads; one along the Sea Cow Lake may be flooded if heavy rain occurs.

Figure 2: Map of Johanna Road (OpenStreetMap (2024) Johanna Road. Available at <https://www.openstreetmap.org/> (Accessed: 16. January 2024))

After the first collection was successful, the locations in Blackburn Village were analyzed and chosen. Therefore, the local contractors were involved in determining suitable spots. The radius for Blackburn Village was calculated at 234m, corresponding to the average willingness to walk. The locations are indicated in Figure 2.

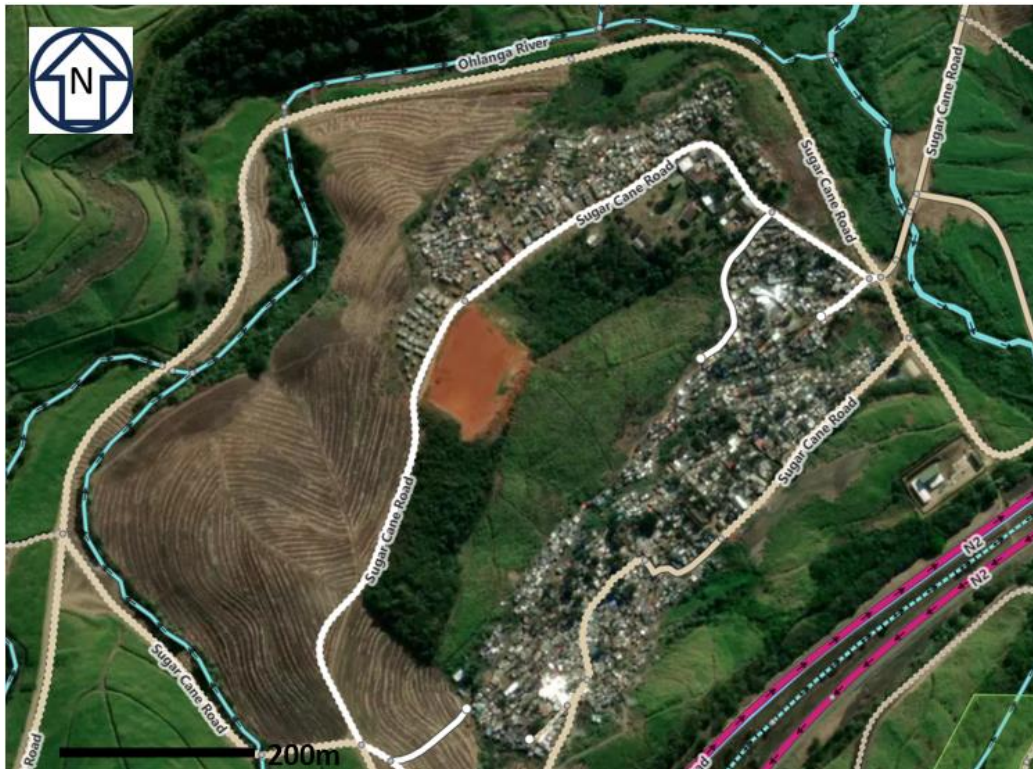
The informal settlement Blackburn Village is located on Sugar Cane Road near Cornubia Mall and the N2 Freeway. It shares its borders with the Ohlanga River and is surrounded by sugar cane

fields, as shown in Figure 3. To the east of the N2 Freeway lies Umhlanga Ridge, an area characterized by high-income residential properties and expansive commercial developments. On the one hand, residents have access there to low-skilled retail and security job opportunities within one to two kilometers of walking distance. On the other hand, the village is surrounded by sugarcane fields, owned and actively farmed by Tongaat Hulett, which is still one crucial employer for the residents (Kemper & McManus, 2019). The village is accessible by a gravel

Figure 3: Maps of Blackburn Village (OpenStreetMap (2024) Blackburn Village. Available at <https://www.openstreetmap.org/> (Accessed: 16. January 2024))

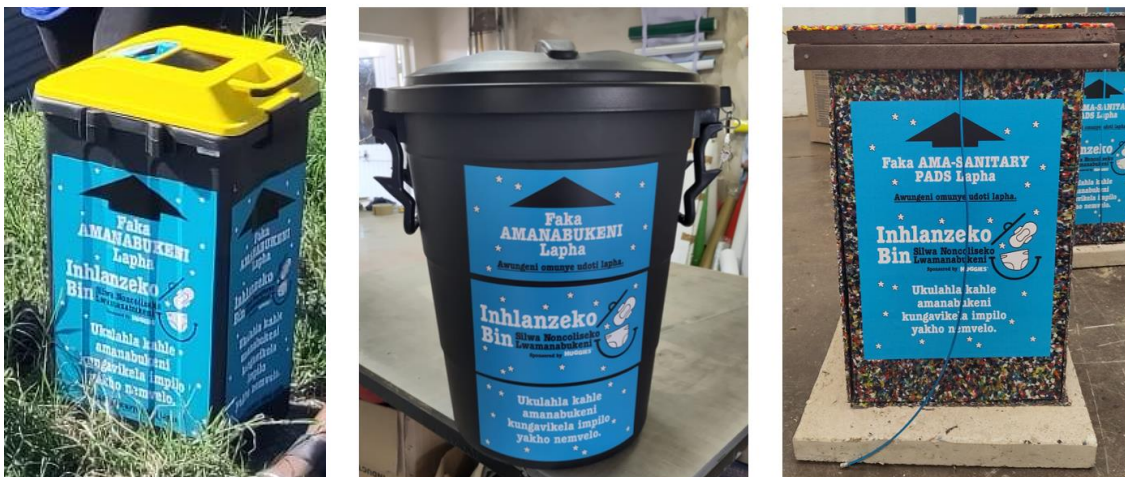
The first generation of bins had a volume of 45 liters with a yellow lid spring lid and stickers on three walls and the top of the bin. It was appreciated by the community. They liked the design and stickers and thought the bin would be treated with respect. However, if it is more colorful and handmade, the bin would have a higher status and a more appealing appearance. Given this feedback, the team mixed different colors of bottle tops to produce a colorful big sheet, as depicted in Figure 7. The third generations of bins were also assembled by hand at KMBC; therefore, the community's feedback was implemented.

Figure 7: Evolution of bin designs: 45l 1<sup>st</sup> generation bin (left), 80l bin 2<sup>nd</sup> generation (middle), and the bin manufactured at KMBC as the 3<sup>rd</sup> generation bin (right)

Moreover, for the first generation, the volume of the bin was considered too small by the community. Therefore, the 45-liter bin was increased to 80 liters with the second generation of bins. However, the heat press at KMBC only allowed a sheet of size 1300 mm x 650 mm. Therefore, the 3<sup>rd</sup> generation bins were limited to a volume of 70 liters. Concerning volume, the heaviest bag was collected in a creche in Blackburn Village after the Christmas holidays on 03.01.2024. It weighted 20.5 kg, which refers to a volume of 41 liters. Therefore, it is considered that the bins do not need to exceed the size of 50 liters, which exceeds the biggest collected bag by 22%. Furthermore, a higher mass might tear the municipal waste bag.

With the second generation of bins, the disposal opening was modified: The opening consisted of a lid loosely connected to the bin by two wire ropes. Due to the backlash of the wire, the lid could now be lifted to dispose of the AHP waste. It was ensured that the lid always fell back onto the garbage can to remain rainproof. The wire on one side could now be removed to remove the black bag, and the lid could be opened completely. First, a lock was used to remove the wires. However, this additional cost was too high, so it was decided to establish a plug connection with the wires. This system especially worked well since the bin was slightly bendable due to its material.

This characteristic was not possible to reproduce with the third bin. Therefore, the disposal opening was replaced by a flap top. This wider disposal opening did not influence the AHP waste purity as the result show in Johanna Road.

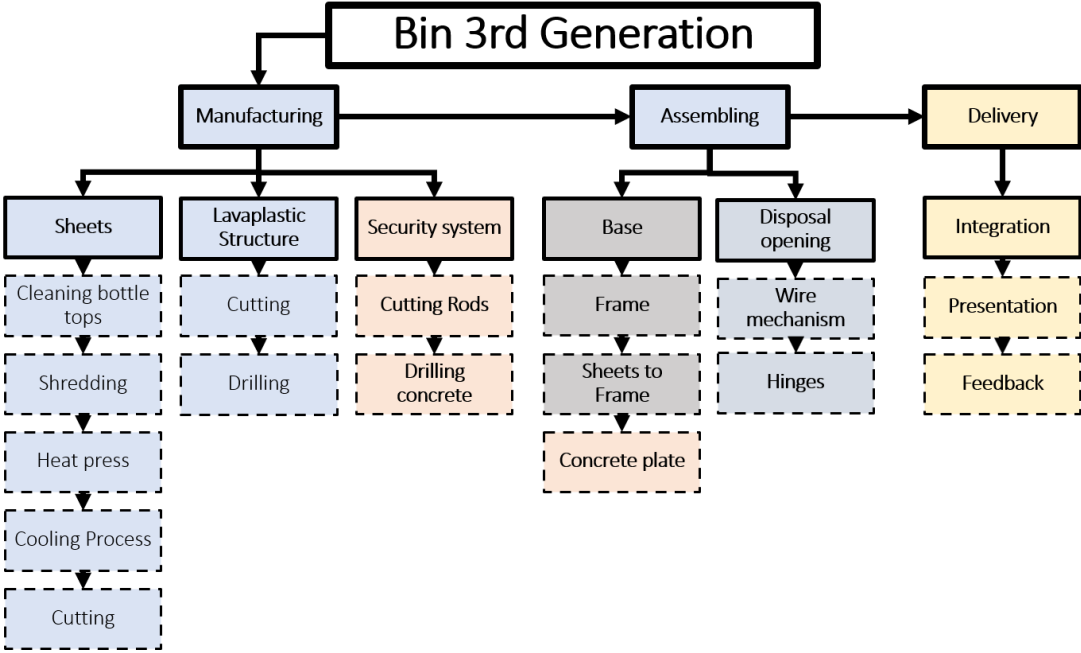
The assembly of the single sheets and the planks happened at KMBC. Therefore, the bins were manufactured by low-skilled staff with no technical apprenticeship. A work breakdown structure was used to demonstrate the production's different steps, depicted in Figure 8.

Figure 8: Work-breakdown-structure of manufacturing the bin of the 3rd generation. The colors of the single work packages correspond to the colors of the different design specifications in Figure 4.

It turned out that the PP sheet pressing process required proper training to minimize the staff's risk. Moreover, the central heat flux from the heat presses plates to the sheets caused a non homogenous temperature distribution on the plate. As a result, the edges of the boards showed a coarse granulation at the edges. As a result, the time in the heat press was increased to produce a high-quality sheet with clear edges, ensuring the temperature did not exceed 300°C.

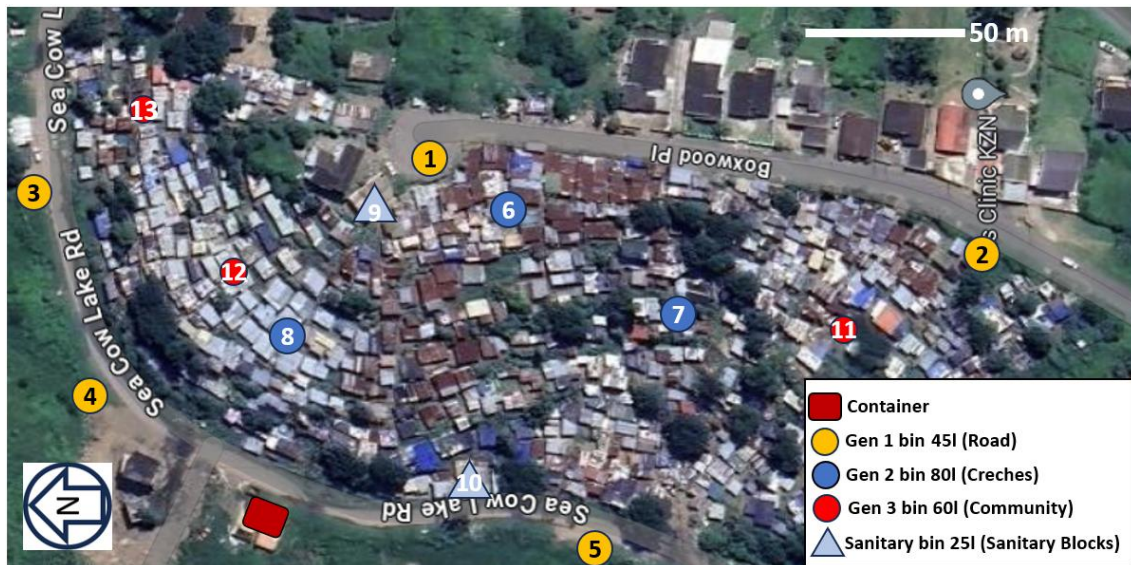
Figure 11: Location of bins in Johanna Road

The implementation of the AHP collection system was carried out first in Johanna Road and consisted of 3 phases. First phase I was implemented in Johanna Road with five first-generation bins, depicted in Figure 711, with a total capacity of 225 liters. Although it represents 18% of the average AHP waste per week in Johanna Road, it is the start of the implementation process. After the first week, all bins were still in place in Johanne Road. Moreover, none of them was damaged. Therefore, it was assumed that tolerance and respect were paid to the project.

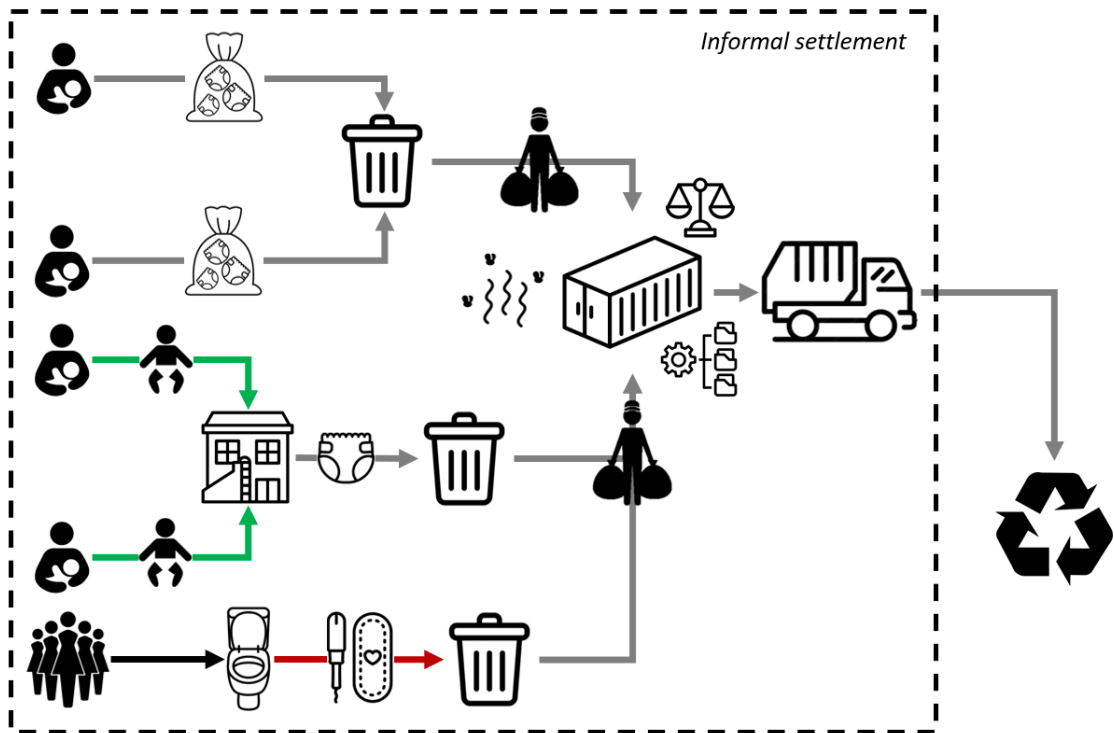
overestimating the number of households or an inaccurately high assumption of the AHP fraction in municipal solid waste, as suggested by Stutz's study (Stutz, 2023). Another contributing factor could be caregivers disposing of nappies in black municipal trash bags, which municipal services do not collect regularly. Nevertheless, the collected AHP waste increased as the project progressed. Therefore, the collection systems' organization shown in Figure 17 has proved its worth.

Figure 17: AHP waste canalization with further improvements
